NATIONAL REGISTER OF HISTORIC PLACES
REGISTRATION FORM

historic name: McNaughton, John Patrick, Barn

other name/site number: Max Mirage View Farm Barn

The John Patrick McNaughton Barn, built in 1893, is a three-and-one-half-story, wooden barn with a Dutch hip roof. The building, built in a vernacular interpretation of the Prairie barn style, features a long, low profile, a gabled peak above the hay loft, and gabled dormers. Today the McNaughton Barn continues to be part of a working ranch as it stands alone on a rising hill surrounded by corrals and grazing cattle. It sits one-quarter-mile off Highway 137 near Quapaw, Oklahoma. The barn possesses a high degree of architectural integrity.

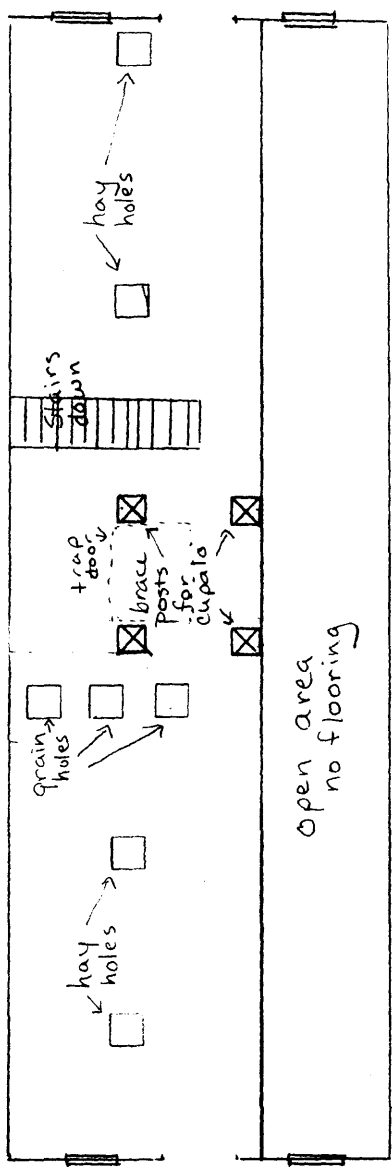
McNaughton, John Patrick, Barn
Quapaw, Ottawa County
Third floor diagram
Prepared by Sandy Ankenman

A narrower set of stairs leads up to the third floor. One-third of this floor was left open to allow the hay on the second floor to cure (see third floor diagram). In the past, a pulley system elevated the grain from the first floor through trap doors. The grain was then poured into one of the three grain column openings on the third floor. Only the bottom wheel of the pulley system is extant.
