KENTUCKY HISTORIC RESOURCES  
Individual Inventory Form

Resource # 84  
Shelby County

1. Name of Resource:  
Graham House

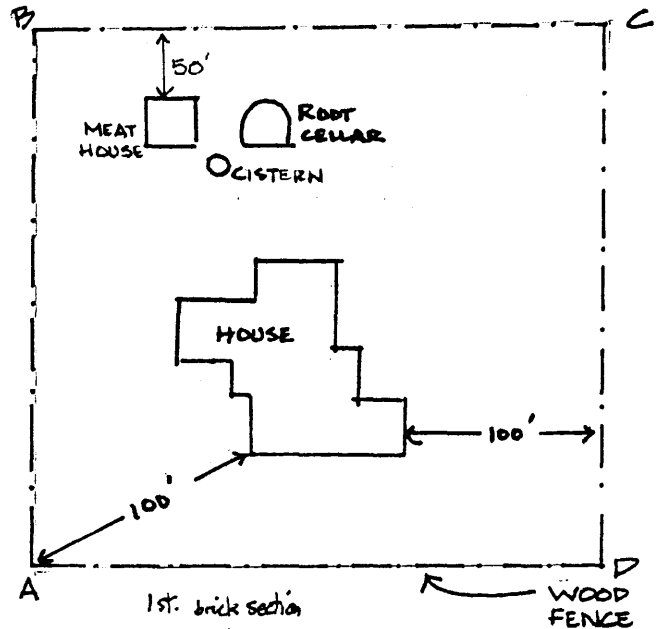
42. Total Acreage in Present Property: 1.62 43. Acreage included in proposed N.R. boundary: 4.1

The boundaries were chosen to encompass the house and domestic yard area which incorporates three contributing outbuildings in addition to the house.

The boundary of the property contains the house, root cellar, meat house and cistern located in a domestic yard area of the farm. The boundary begins at point A, 100' Ne of the NE corner of the house at the edge of a board fence that marks the front domestic yard area; from this point go south to a point 50' south of the south wall of the meat house; then west from this point on a line 50' south of and parallel to the south wall of the meat house to a point 100' beyond the west wall of the house; then north along a line 100' west of and parallel to the west wall of the house to a point on the first fence mentioned; then along that fenceline east to the point of origin.

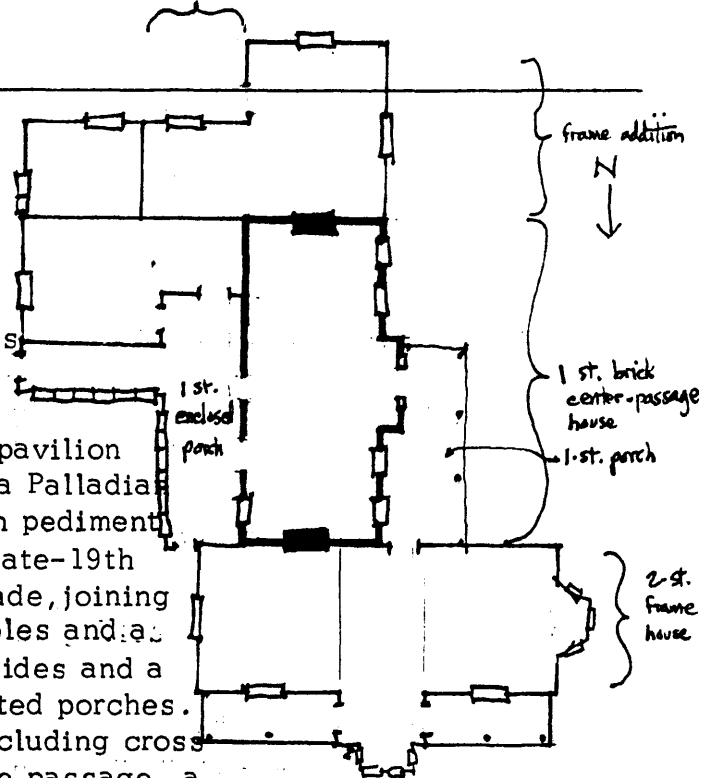
45. Description and House Plan:

The site consists of an early nineteenth-century one-story brick single-pile center-passage house to which was added an 1870's (?) frame single-pile center-passage dwelling addition, making the early house function as an ell to the later building. The brick building, which appears to date from the 1830's has an ashlar foundation, gable roof, slightly projecting exterior end chimneys, Flemish bond facade with jack arches, and a slightly projecting central pavilion above which is a gabled brick pediment containing a Palladian window. The house shares the pavilion and Palladian pediment with the Blaydes Ho., built in 1833. 9/6 sash. A late-19th century porch shelters the northern 2/3's of the facade, joining it to the later frame house, which has projecting gables and a central bay, which contains entry doors in the sides and a square bay in the front opening onto 1-story bracketted porches. All the gables contain elaborate decorative work, including cross gables flanking the center tower. Chimneys flank the passage, a polygonal bay stands on the W end, while enclosed porches and frame additions to the rear surround a frame ell associated with the earlier house.

In addition to the house are two buildings and a structure in the rear, domestic yard area. A meat house has lower walls of stone and upper walls of common bond brick with gable roof, shingled gable end, standing seam metal roof, a single, solid wood door in the north gable end and brick flue in the opposite gable end.

To the west of the meat house is a stone perimeter-walled root cellar with stone entry, earth berm over the roof area, and single, solid wood entry door. Both the root cellar and meat house face the rear of the residence.

Slightly north of and between the two out buildings is a metal, crank-type cistern pump and cistern.
