National Register of Historic Places
Registration Form

historic name Davis Coal & Coke Company Administration Building
other names/site number Western Maryland Railway Engineering Building; Old Western Maryland Railroad Office

street & number 570 Douglas Road ☐ not for publication
city or town Thomas ☐ vicinity
state West Virginia code WV county Tucker code 093 zip code 26292

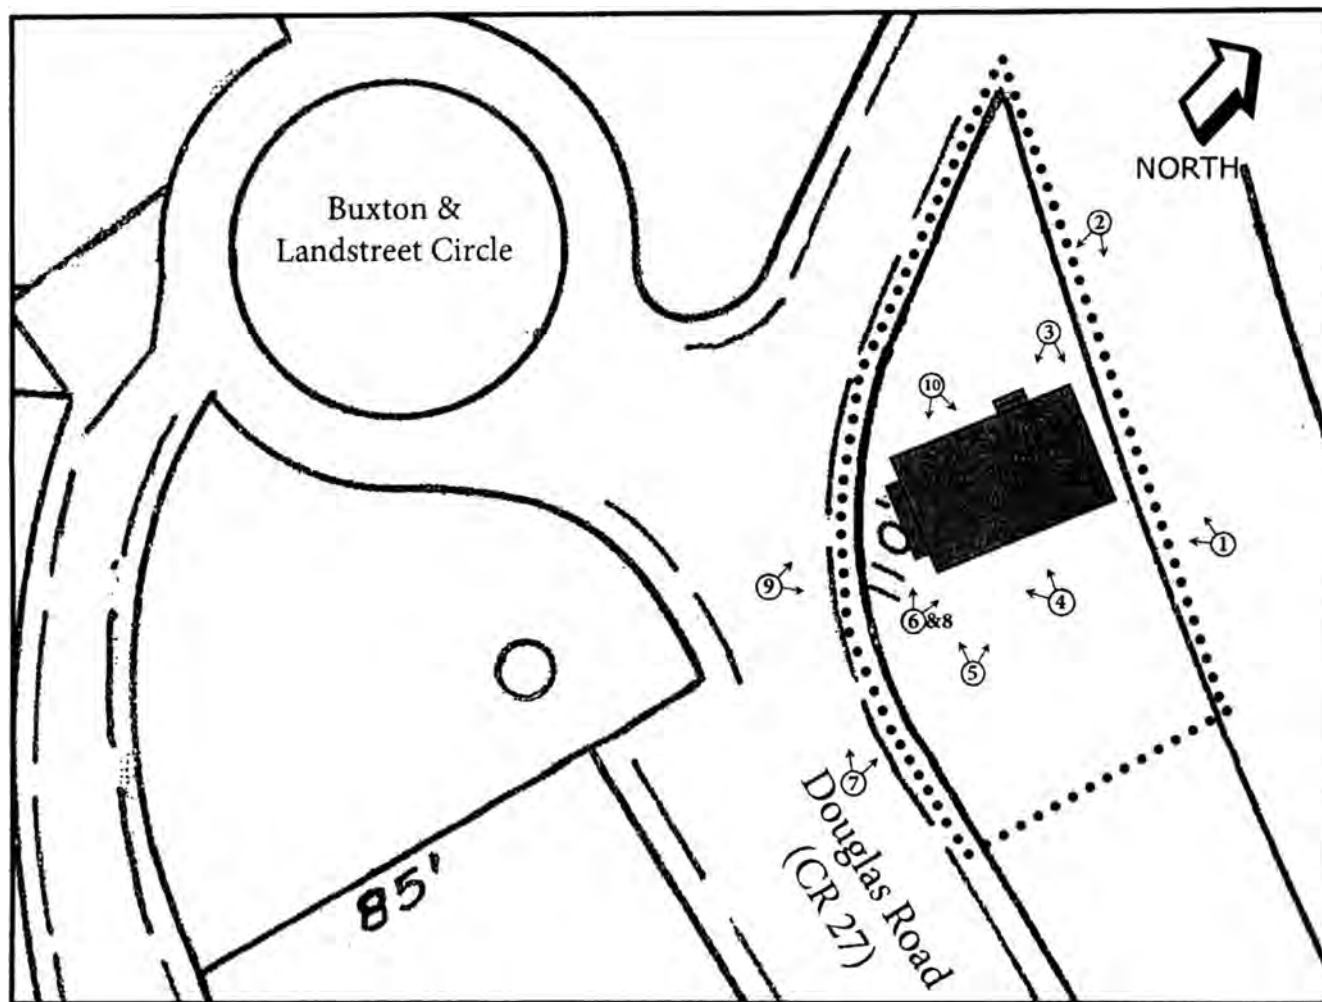
Photos taken from Photo Vantage Points Numbered 0001-0010

..... Proposed National Register Boundary

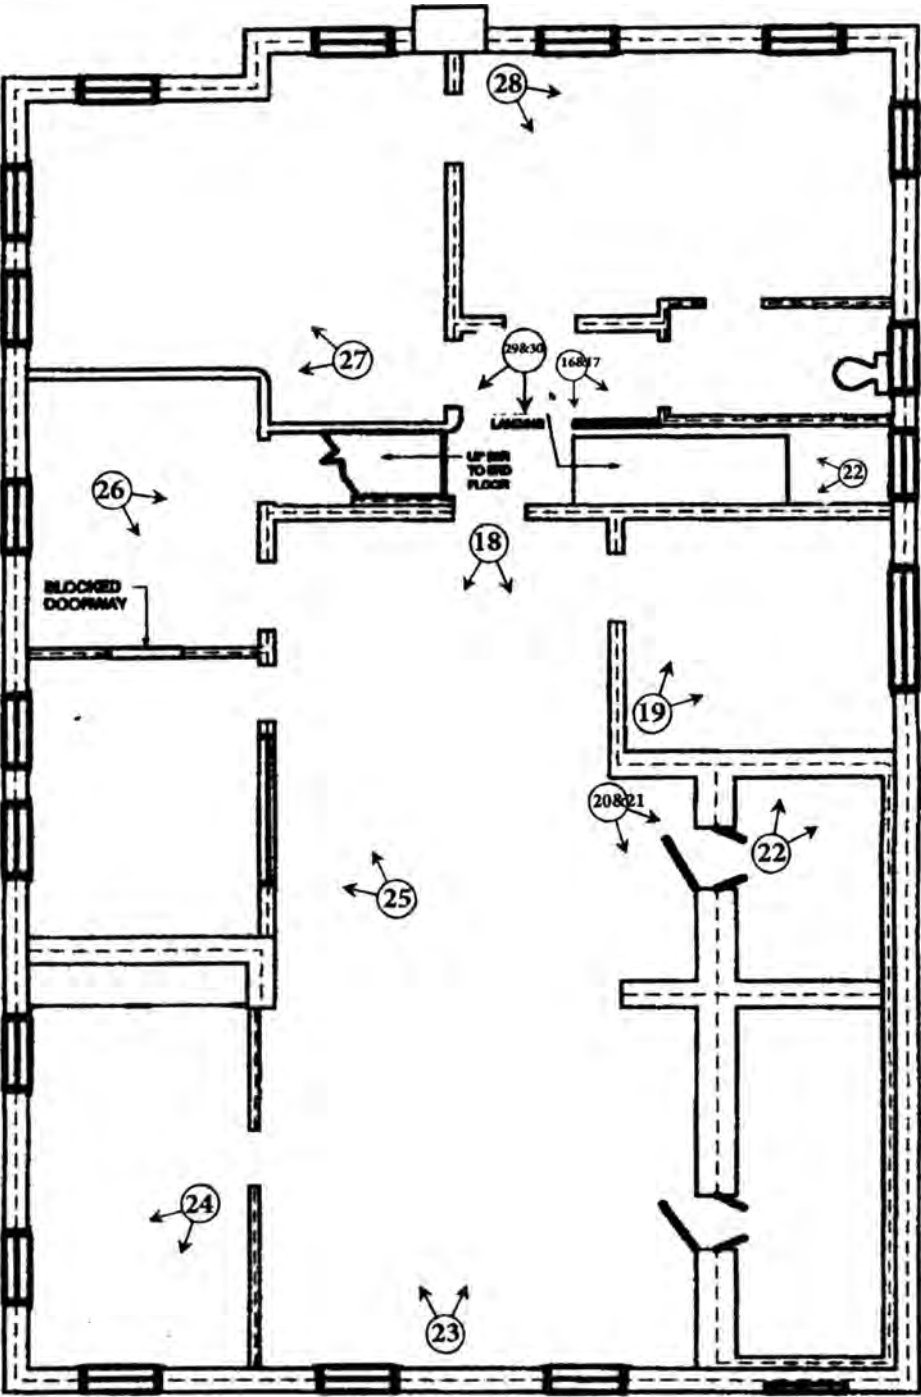
SECOND FLOOR Davis Coal & Coke Company Administration Building
Tucker County, West Virginia
with Photo Vantage Points, Numbers 0016-0030

2nd FLOOR PLAN
SCALE 1/4"=1'-0"

On the second floor are six offices, a bathroom, and two walk-in vaults. Wall modifications exist in some areas. In particular, the use of ca. 1970s wood paneling forming the southwest corner office indicate the office was originally open space combined with the larger draughting area (see photo 18). Other minor modifications exist, for instance a door has been "walled in" between two offices, leaving the door frame intact. Some interior walls appear to be later-manufactured material replacing original plaster. Some of the walls are enhanced with curved corners. The east wall of the draughting room is dominated by the vaults. Also in the central draughting room, features such as marks on the floor locate the spot of now-missing draughting tables, and a wooden panel on the wall show indications that dozens of drawing tools (or drawing templates) hung there for many years.

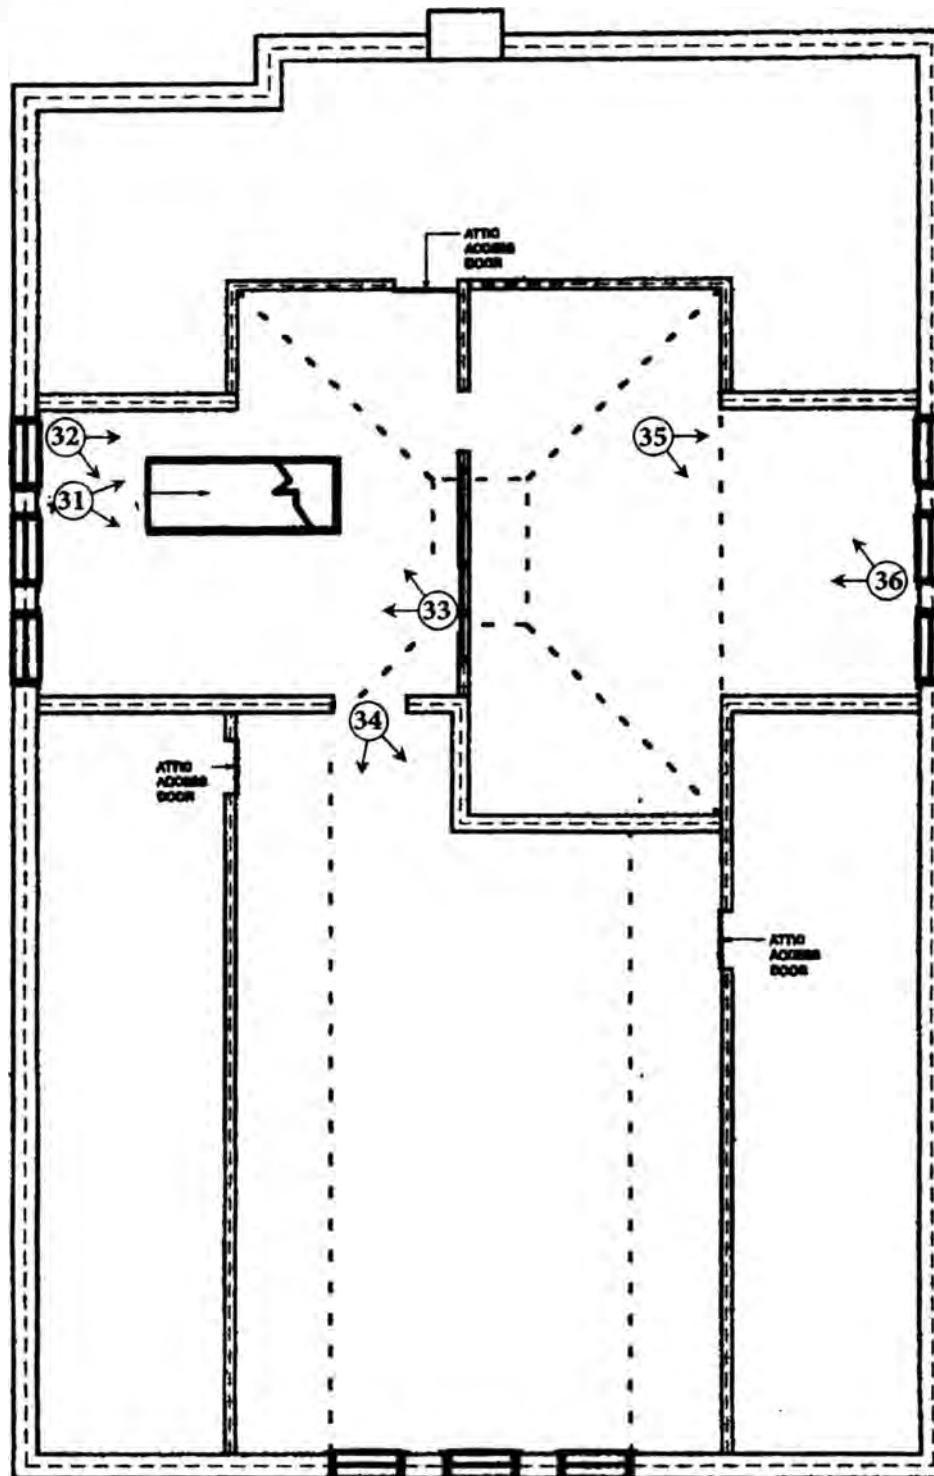
THIRD FLOOR Davis Coal & Coke Company Administration Building-
Tucker County, West Virginia
with Photo Vantage Points, Numbers 0031-0036

3rd FLOOR PLAN
SCALE: 1/4" = 1'-0"

The third floor holds only two rooms aside from the stairwell entry area, all with sloped ceilings due to the roof just overhead (see photo 34). In the stairwell entry area in the west dormer, the stair opening is surrounded on three sides by balusters and four box newels.

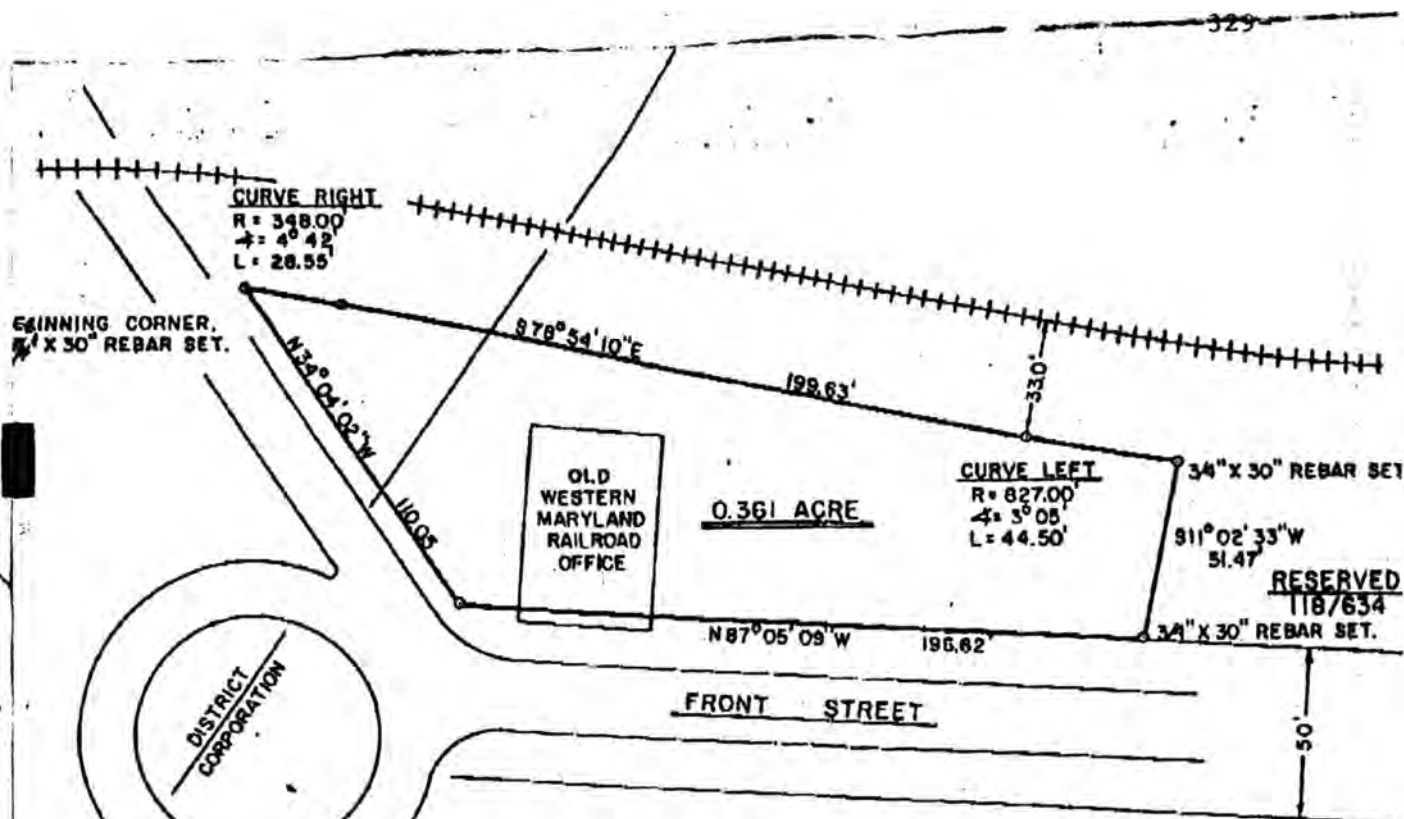
PLAT OF SURVEY
FOR
POWER CONSTRUCTION AND MAINTENANCE

BEING A PORTION OF TRACT A5 OF THE LAND
CONVEYED BY CSX MINERALS, INC., TO WESTERN
POCAHONTAS PROPERTIES LIMITED PARTNERSHIP BY
DEED DATED DECEMBER 31, 1986 AND RECORDED IN
THE OFFICE OF THE CLERK OF TUCKER COUNTY,
WEST VIRGINIA IN DEED BOOK 118, AT PAGE 634.

TOWN OF THOMAS, WEST VIRGINIA
FAIRFAX DISTRICT
TUCKER COUNTY, WEST VIRGINIA
0.361 ACRE

SCALE: 1 INCH EQUALS 50 FEET
SURVEYED: AUGUST, 1987
SURVEYED BY: LARRY L. KITZMILLER
LICENSED LAND SURVEYOR
#280
MT. STORM, WEST VIRGINIA
