National Register of Historic Places Registration Form

Historic name: Atchison, Topeka & Santa Fe Railway Locomotive Shops
Other names/site number: Albuquerque Rail Yards
Name of related multiple property listing:
Historic and Architectural Resources of Central Albuquerque, 1880-1970

Street & number: Roughly bounded by 1st and 2nd streets and the BNSF rail line in southwest Albuquerque
City or town: Albuquerque State: New Mexico County: Bernalillo
Not For Publication: Vicinity:

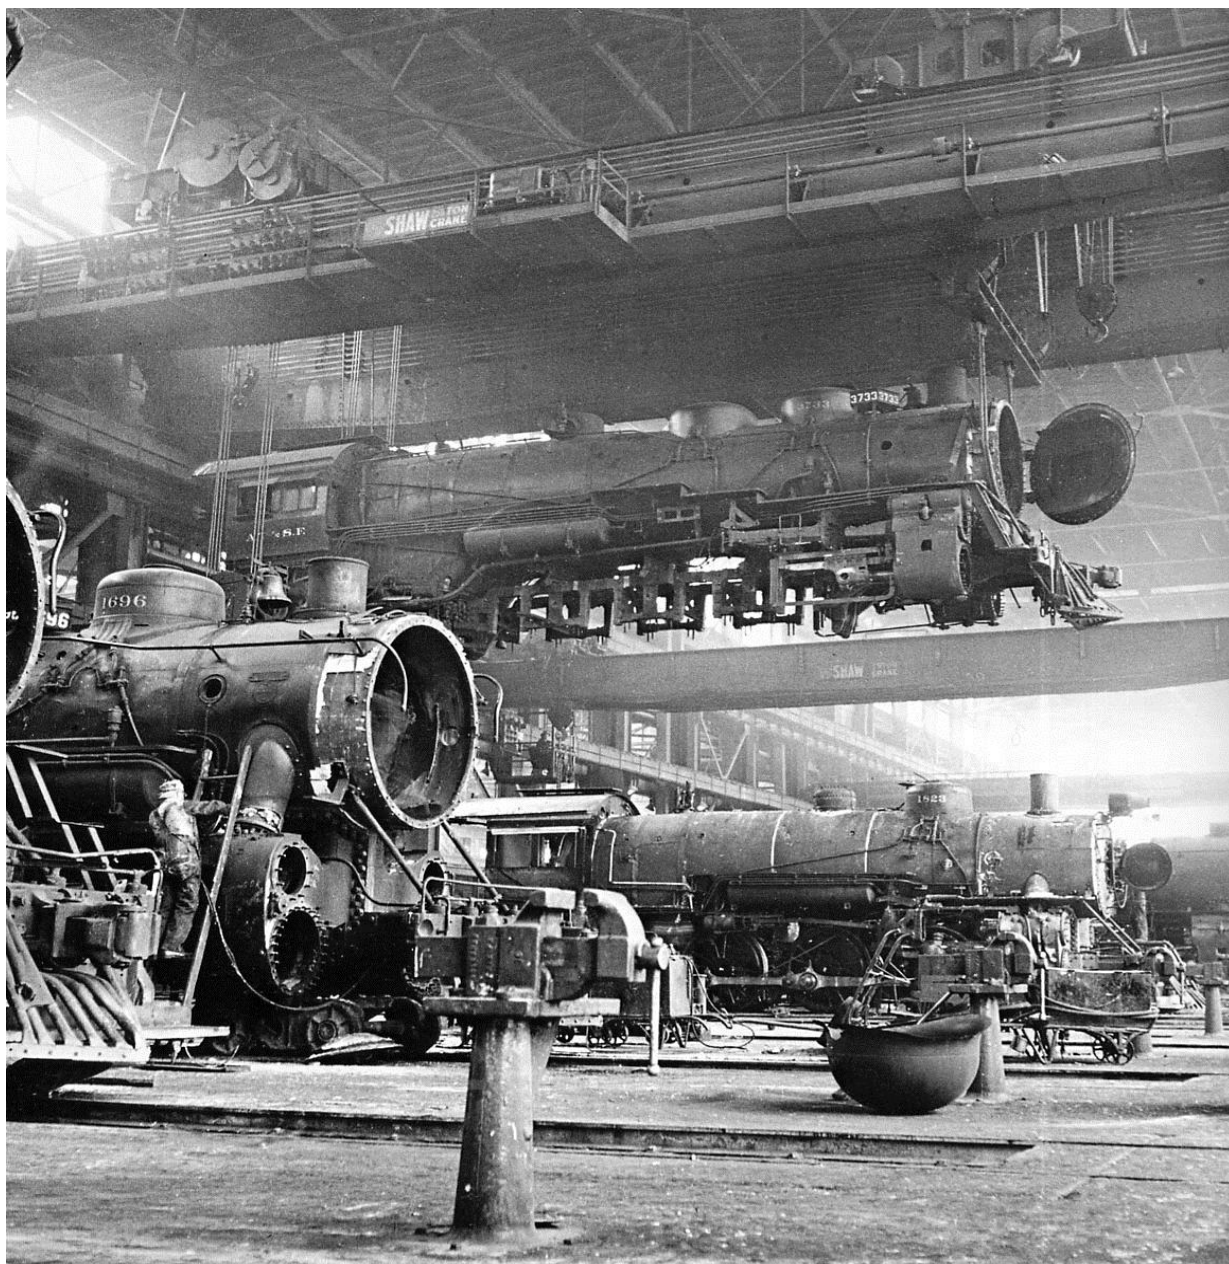
Figure 1. Machine Shop where locomotives were dismantled and the parts sent for cleaning, inspection and repair. Note the locomotive suspended from the bridge crane.

In the erecting bays of the machine and boiler shops, for instance, the engine was completely dismantled and the parts sent for cleaning, inspection, and repair to various departments housed in the lower bays of the machine and boiler shops and in the blacksmith, flue, tender repair, welding, and Babbitt shops (see Figure 1). After being cleaned in a lye vat, working parts were reconditioned and necessary replacements fabricated. Lathes turned the large driving wheels so that each was exactly the same size. Breaks in the frame were repaired. The boiler and fire box were patched with steel plate or, if needed, replacements were fabricated. Each part was given a final inspection and tested to meet precise standards before the locomotive was reassembled. On average, a complete overhaul took about a month to perform. Over the fifteen-year life of an average locomotive, it might be rebuilt or receive other major shop repairs once every 12 to 18 months. In the twentieth century, the Albuquerque shops serviced 40 locomotives in a normal month (Wilson 1986: 7).

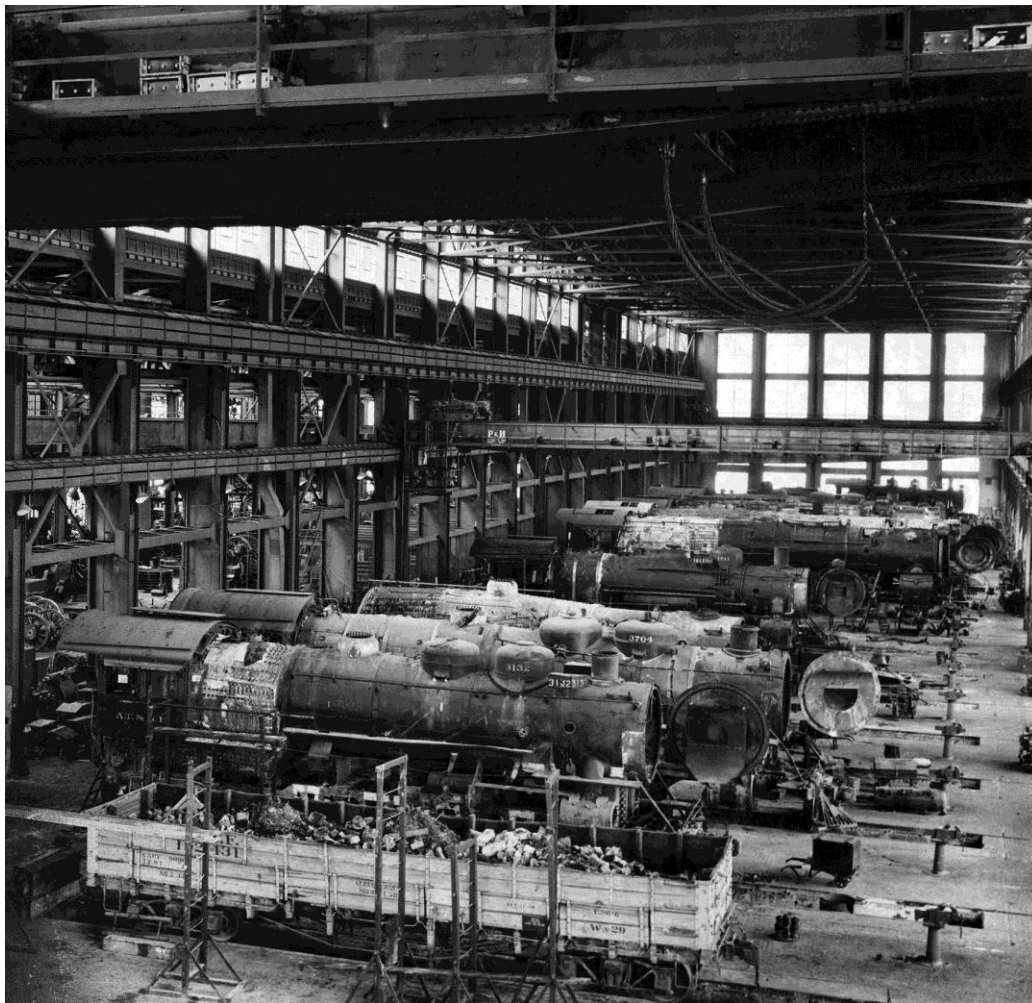
*Figure 3. Machine shop with locomotives in the erecting bay, looking southwest.
Note concrete pits and 250-ton bridge crane in background.*

The machine shop’s erecting bay is the complex’s largest covered space. It is roughly 600 feet by 90 feet in plan and 57 feet in height. It includes concrete engine repair pits side-by-side along the length of the bay. Originally the bay had 26 pits, one of which was 136 feet long. Twelve of the pits have been filled with concrete. The remaining 14 pits are 63 feet long and about 3 feet deep (See Figure 3). Each pit had connections for steam, gas, and electricity. The erecting bay has one 250-ton-capacity bridge crane on an upper rail and two 15-ton-capacity cranes on a lower rail.

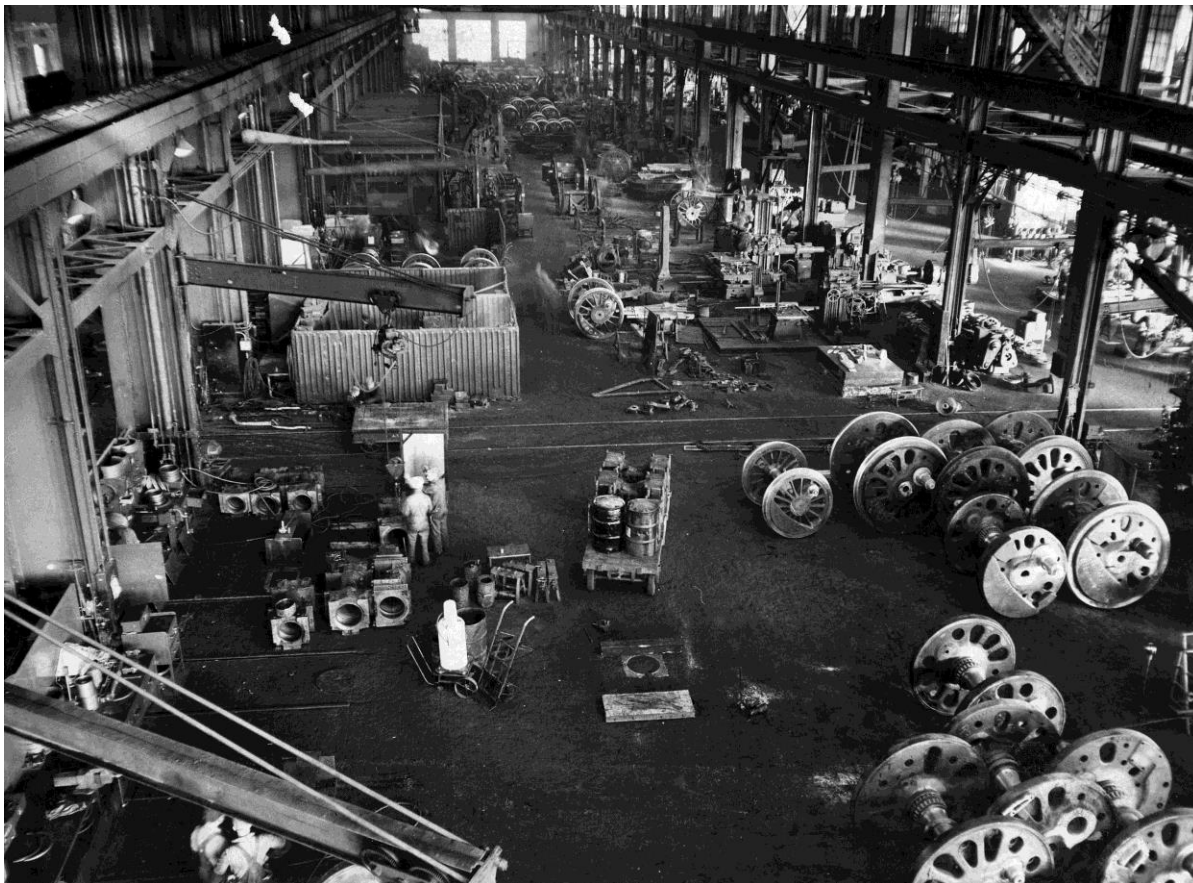
Figure 4. Machine shop with locomotive parts in the heavy machinery bay, looking east.

The heavy machinery bay is 65 feet wide, runs the full length of the machine shop, and has 35 feet of clear height. It is illuminated by 23 skylights. Its crane rail matches heights with the lower crane rail of the neighboring erecting bay. As indicated by the name, this bay was where especially heavy locomotive parts such as driver wheel sets were repaired. It had two 15-ton capacity bridge cranes and many jib cranes mounted on the building’s columns. One of this

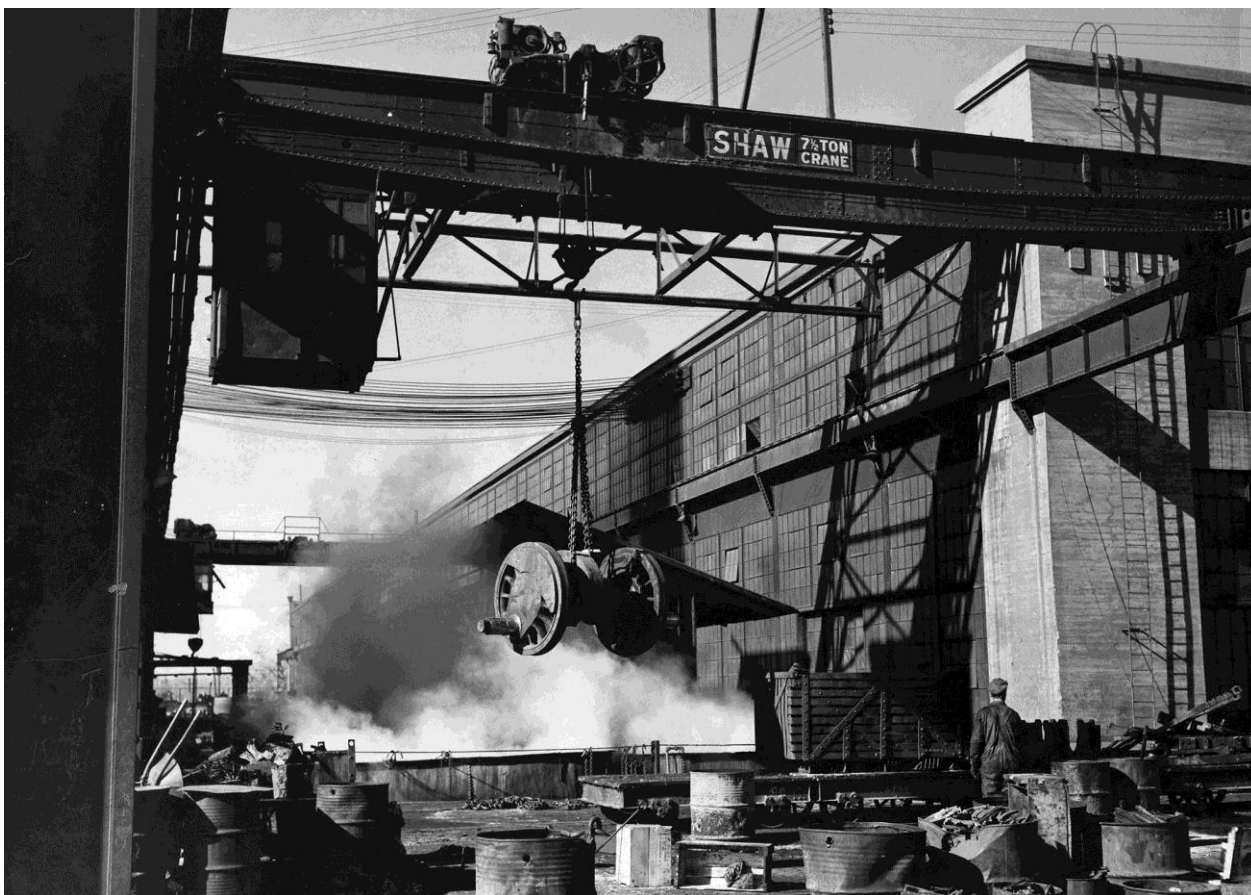
Figure 5. Crane runway with bridge cranes on the south side of the machine shop.

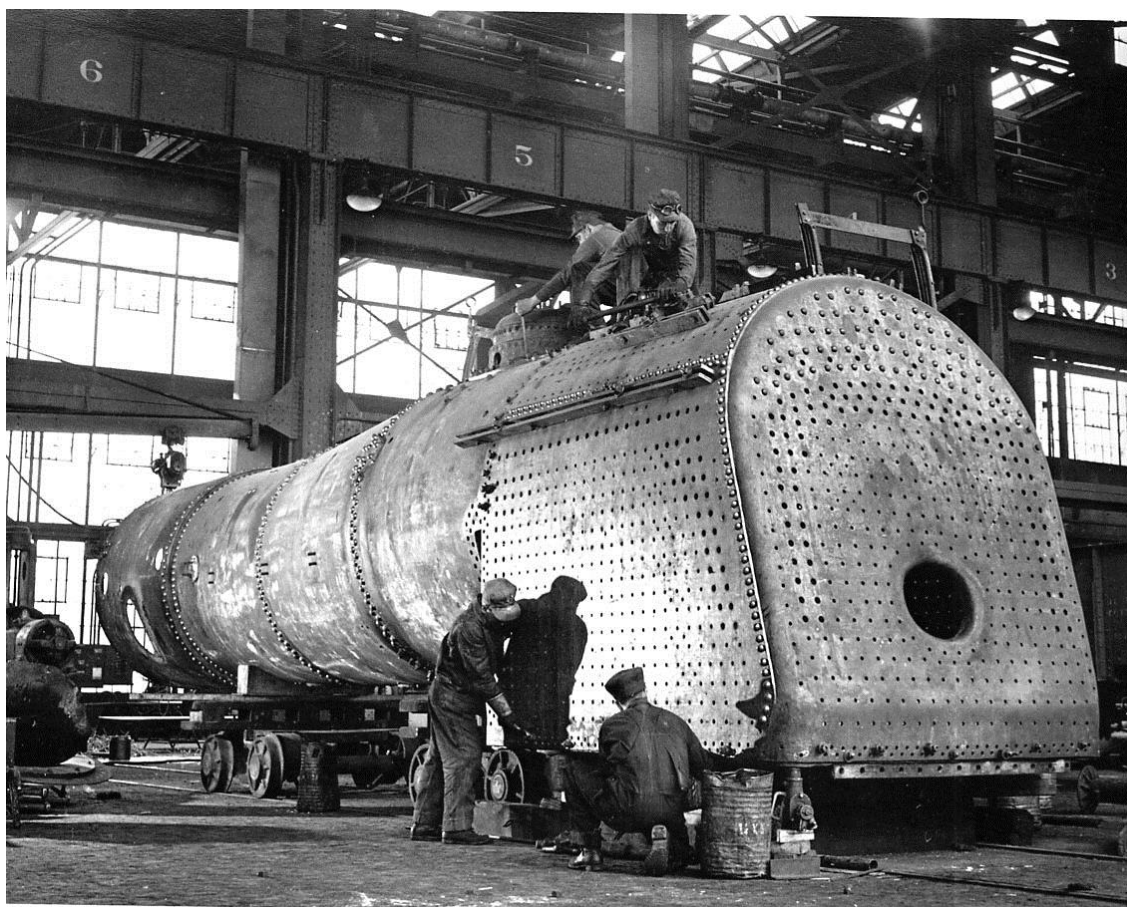
Figure 6. Boiler shop with men working on the fire box of an engine.

The boiler shop stands just north of the machine shop, joined by the transfer table. Repair and rebuilding of boilers and fireboxes took place in the boiler shop. This included installation of new braces, flue sheets, tubes and flues, entire new boiler courses, new fireboxes, replacement of broken stays, boiler and fire box side sheet patches, and similar work (See Figure 6).

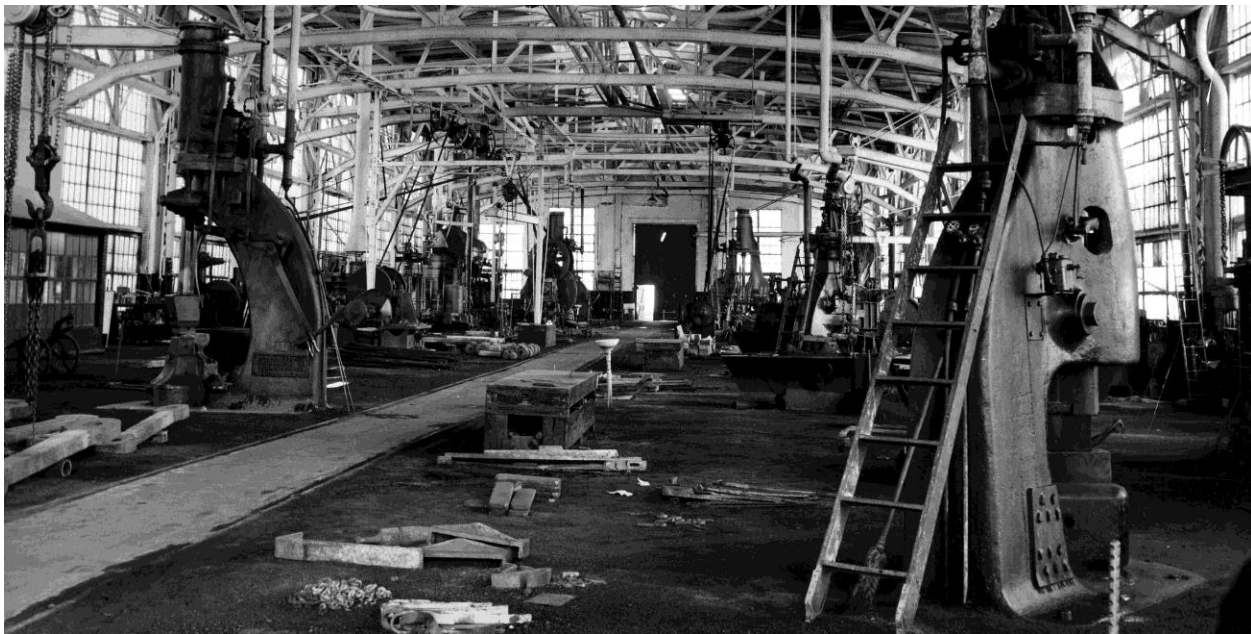
Figure 7. Blacksmith shop with large presses. Steel trusses span the interior.

The blacksmith shop has the third largest in the complex with 13 structural bays. It measures 80 feet by 306 feet. The steel Warren roof trusses with crowned lower chords is supported by steel columns (See Figure 7). The trusses span the full width of the open interior. Overhead, the steel framing and wood decking, the engaged columns, and the bracing are exposed. Pipes, insulated steam lines, and the gas line to the forge enter the building overhead at the south end. The forge flue and a second flue near the west wall remain in place. The floor, which is now reinforced concrete, was earthen until at least 1957.

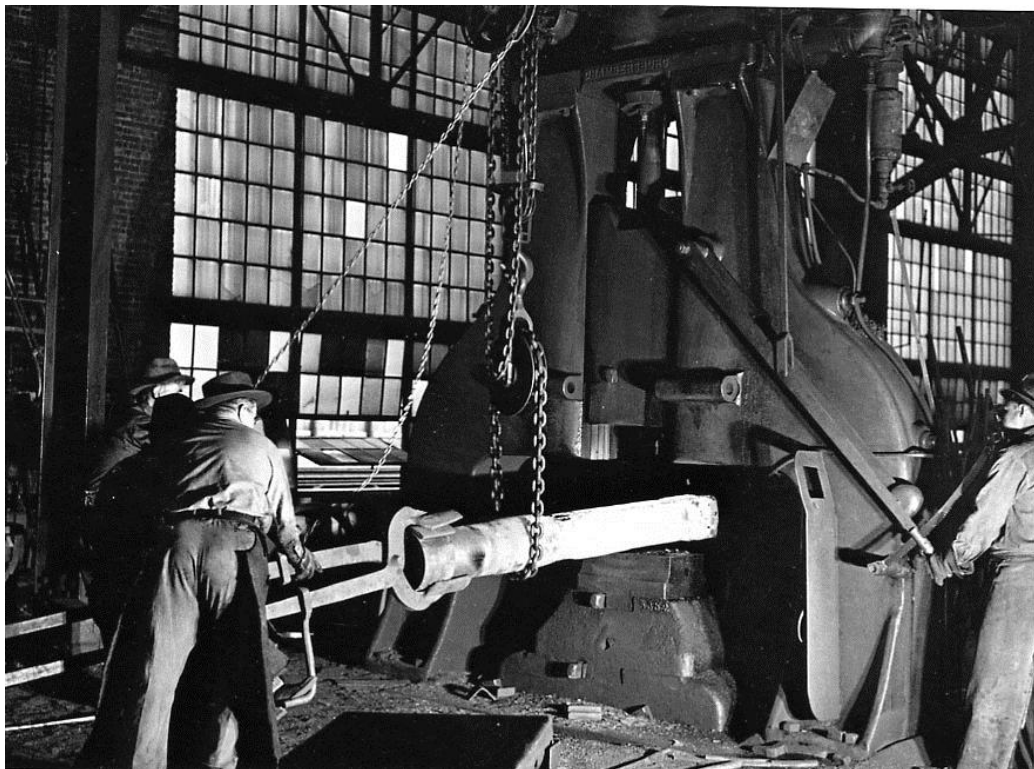
Figure 8. Blacksmith shop with men hammering a drawbar with a steam hammer.

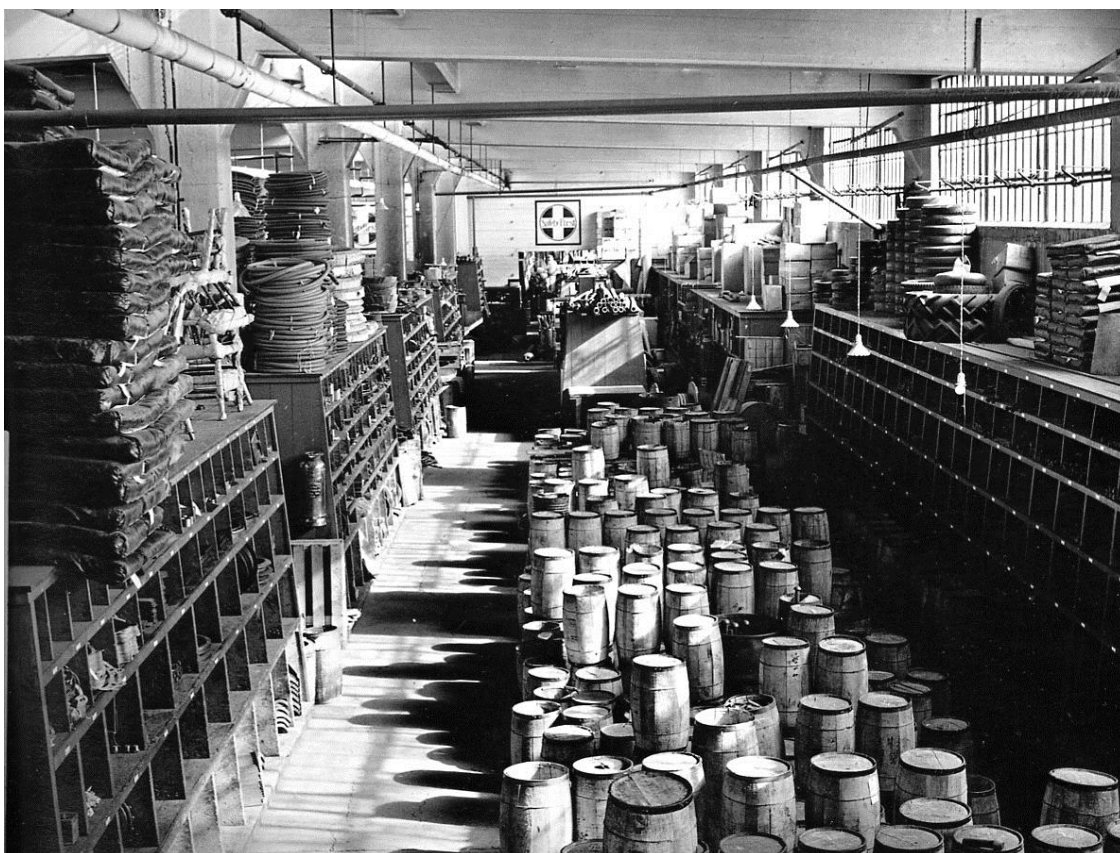
Figure 9. Storehouse with stock to support the shops and the railroad operations of the AT&SF's New Mexico Division. The storehouse carried over 35,000 different items.

The interior is divided into three unequal-sized spaces. The northern part is a suite of offices and restrooms. The larger center section serves as open storage (See Figure 9). The southern section

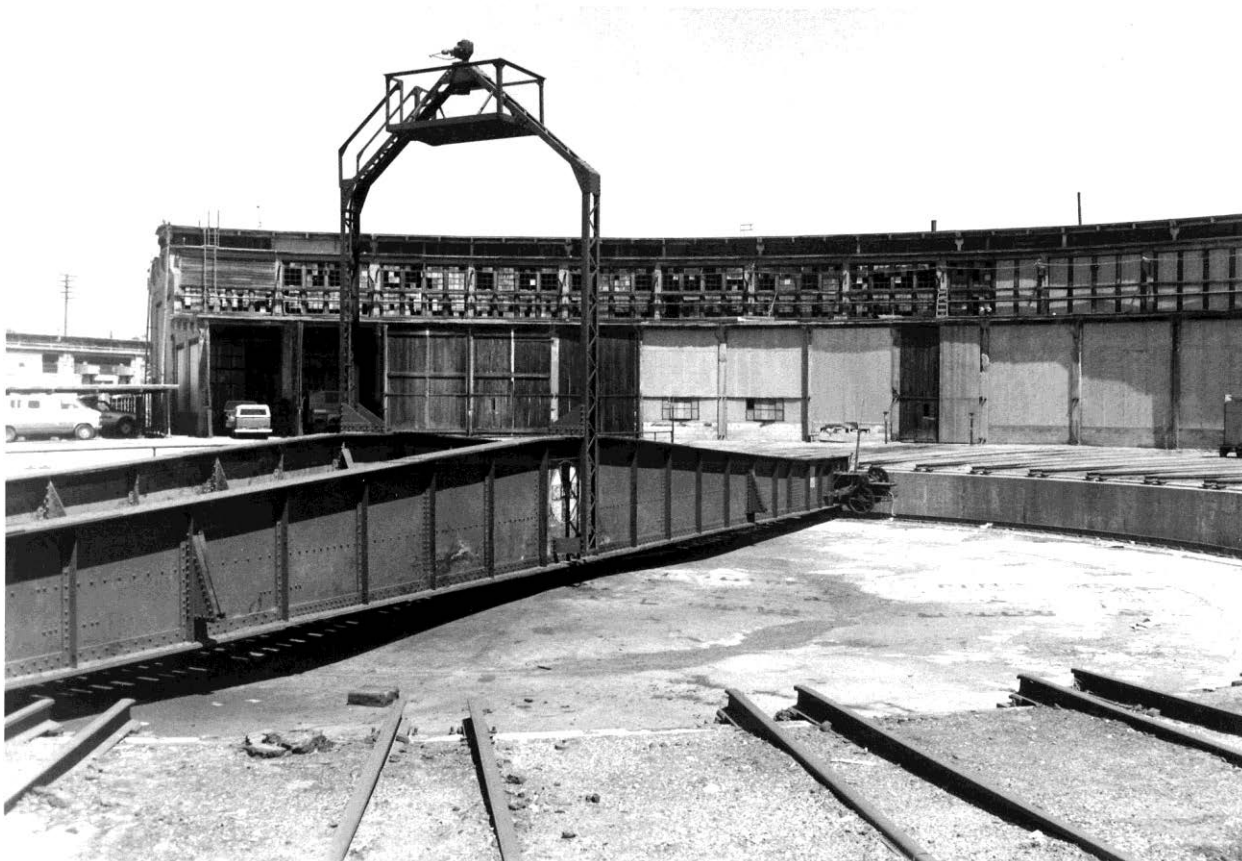
Figure 10. Turntable with roundhouse. The roundhouse was demolished in 1986.

The roundhouse, which was razed in 1986, is survived by its massive concrete foundation and at-grade features, including portions of the foundation, brick paving, and track lines. Located at the center of the south side of the complex, the turntable, described above, remains at the center of the site. The roundhouse foundation is a contributing site because it contributes to the historic district's sense of time and place and historic historical development. The roundhouse roof covered about 100,000-square feet and it had 35 stalls. It followed a standardized stall plan of 1914 designed by the AT&SF engineering department in Chicago, and is likely the first roundhouse built according to that plan (Wilson 1986). The Chicago plan is dated May 1914 and the Albuquerque roundhouse plan is dated May 22, 1914.

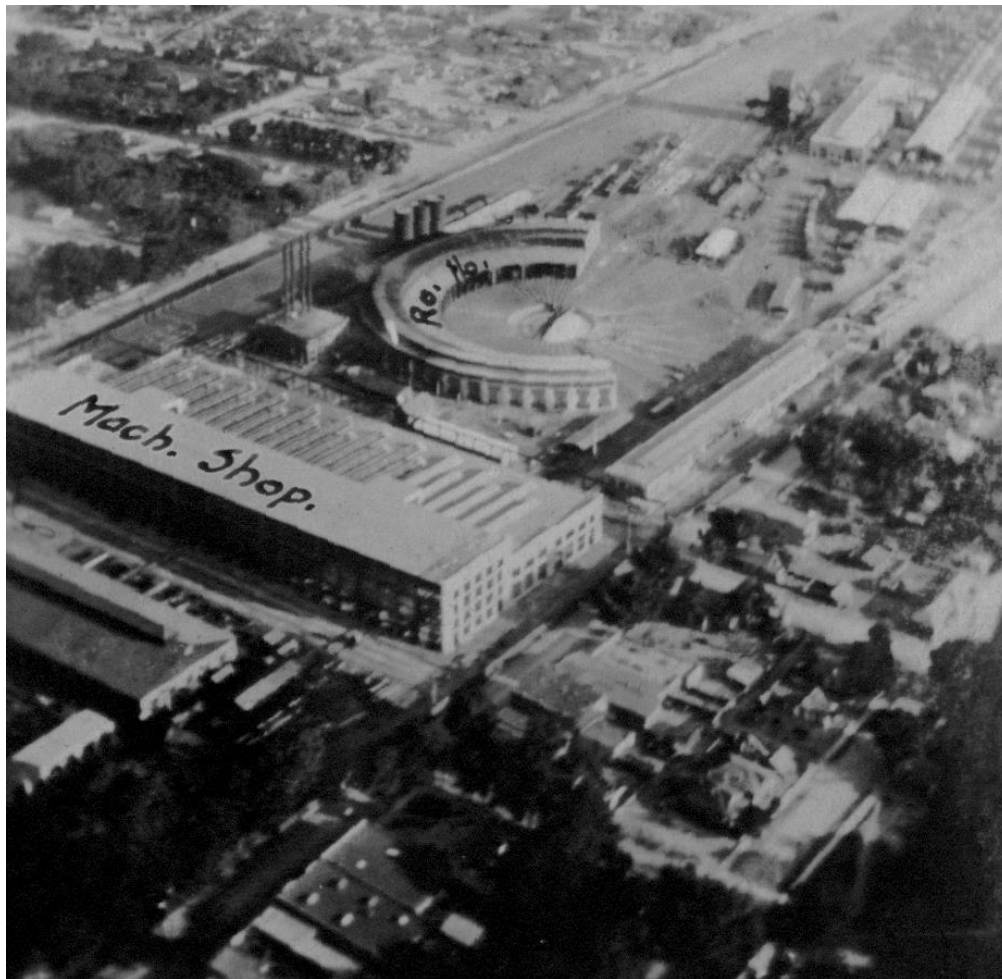
Figure 11. AT&SF shops with roundhouse, reservoir and tanks, power house and smokestack, and machine shop. View looking southwest.

The roundhouse, which was demolished in 1986, was where most daily maintenance functions were carried out. The footprint of this structure is evident today as a 113,000-square-foot, concrete, brick, and metal foundation, the center of which is occupied by a revolving turntable that once directed locomotives into 35 covered stalls. The Albuquerque roundhouse was constructed from a newly designed, standard plan created by the AT&SF in 1914 (Wilson 1986: 6). Roundhouses were required every 100 to 150 miles along a rail line. The Albuquerque facility, along with roundhouses in Las Vegas, San Marcial, and Gallup, served northern and central New Mexico.

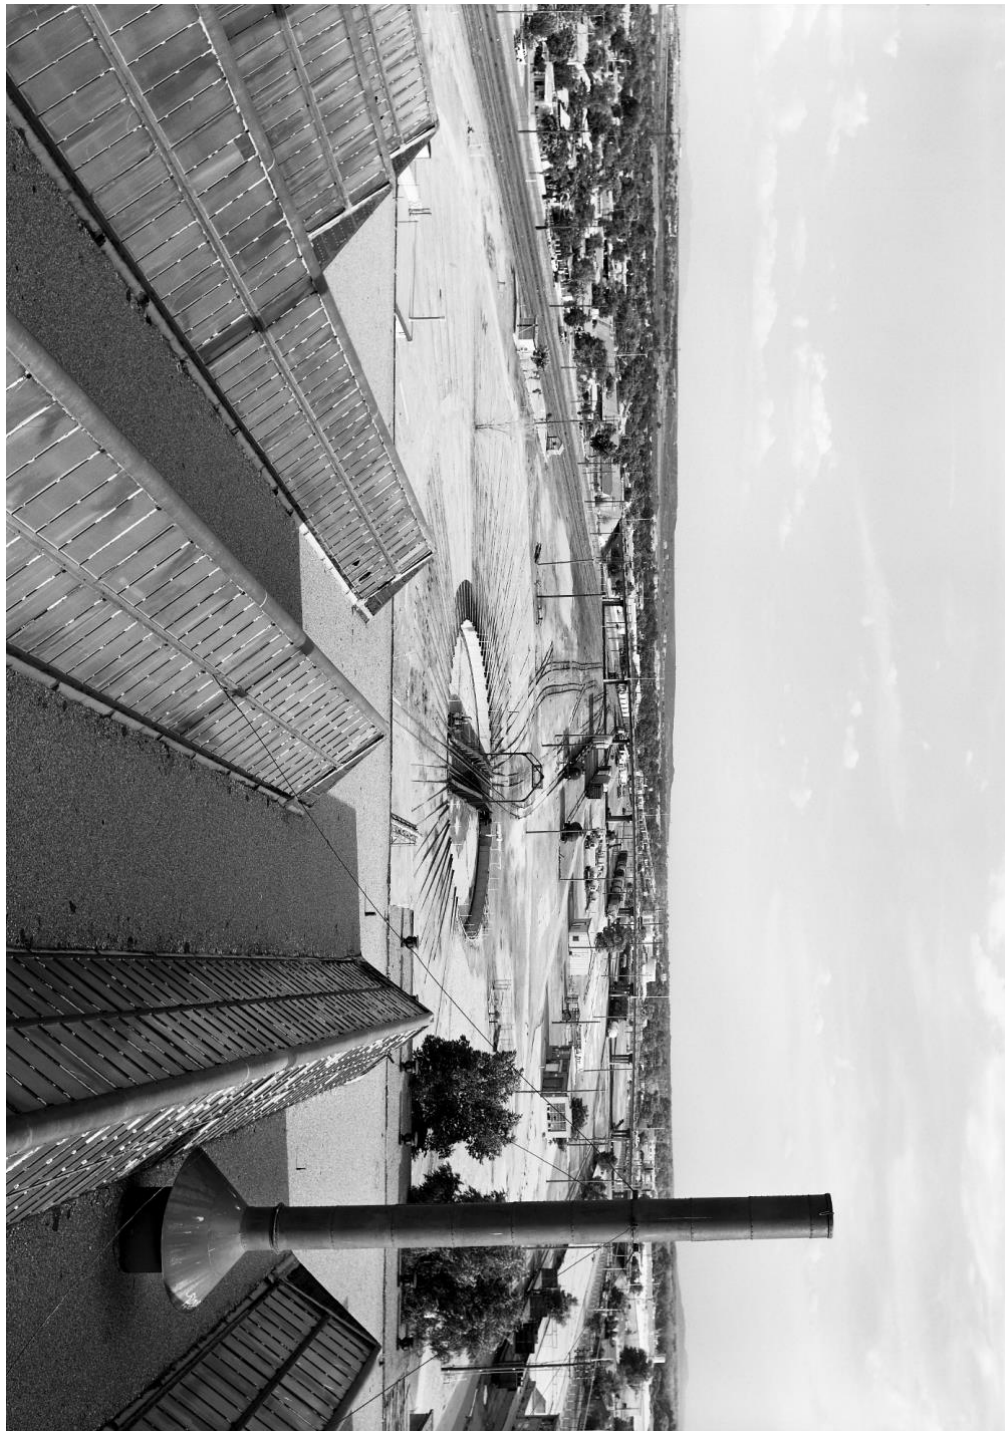
Figure 21. Turntable seen from roof of machine shop looking south. Photograph by Jet Lowe, April 8, 2009
