1. Administration and Museum Building,
NPS Building #20. (Significant.)

White Sands National Monument
Historic District
Alamogordo vicinity, New Mexico

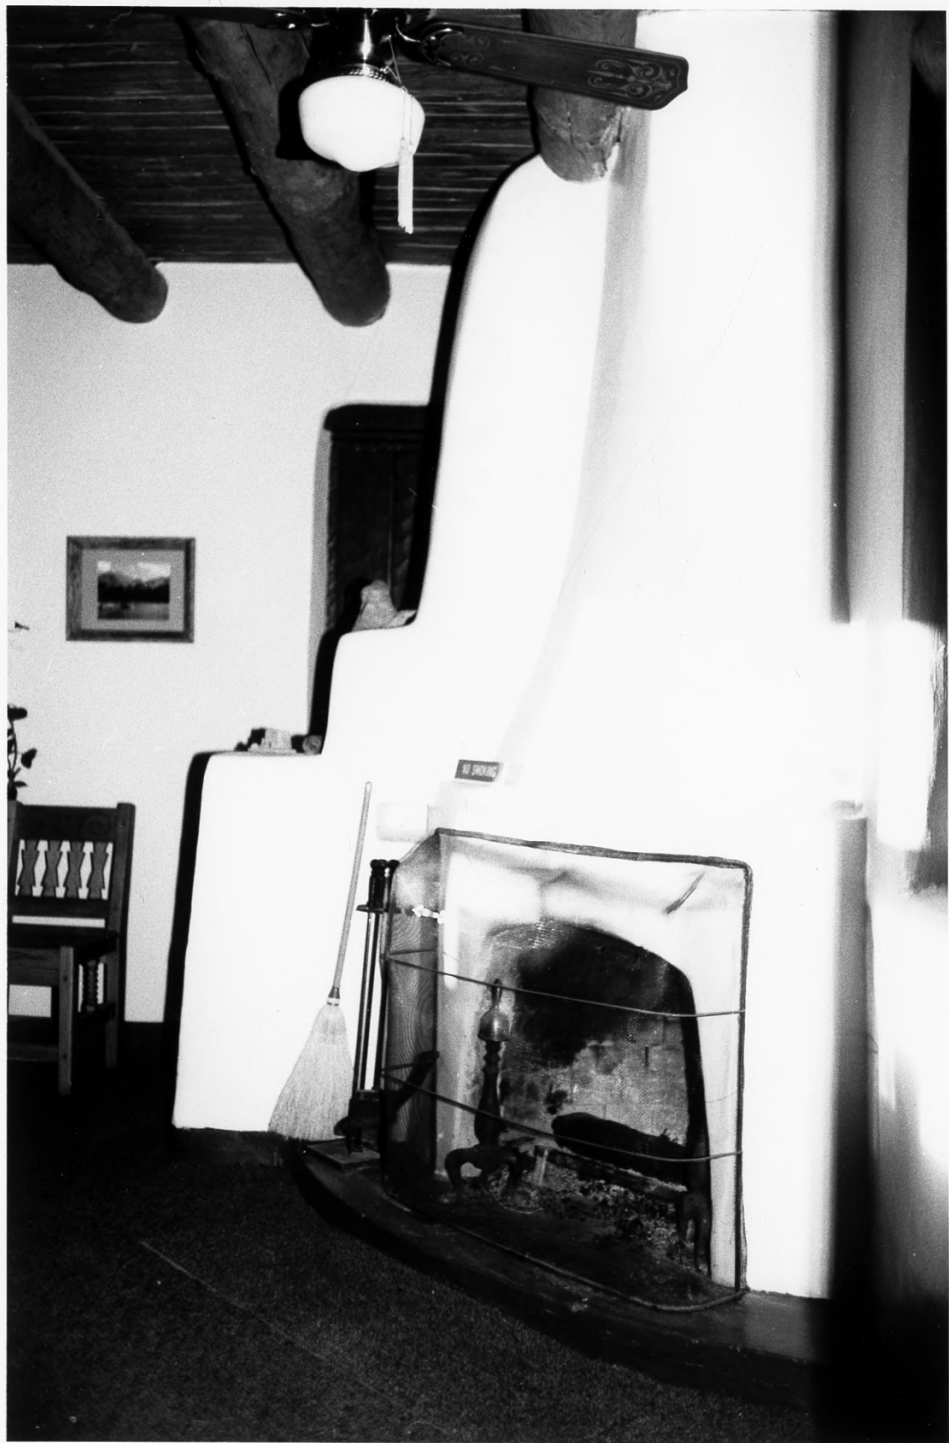
1. Administration and Museum Building,
NPS Bldg #20. (Significant.)

Superintendent's office on south-
west side of building, showing
corner fireplace, vigas and latias,
painted vertical plank door, New
Mexican Colonial Style chair.

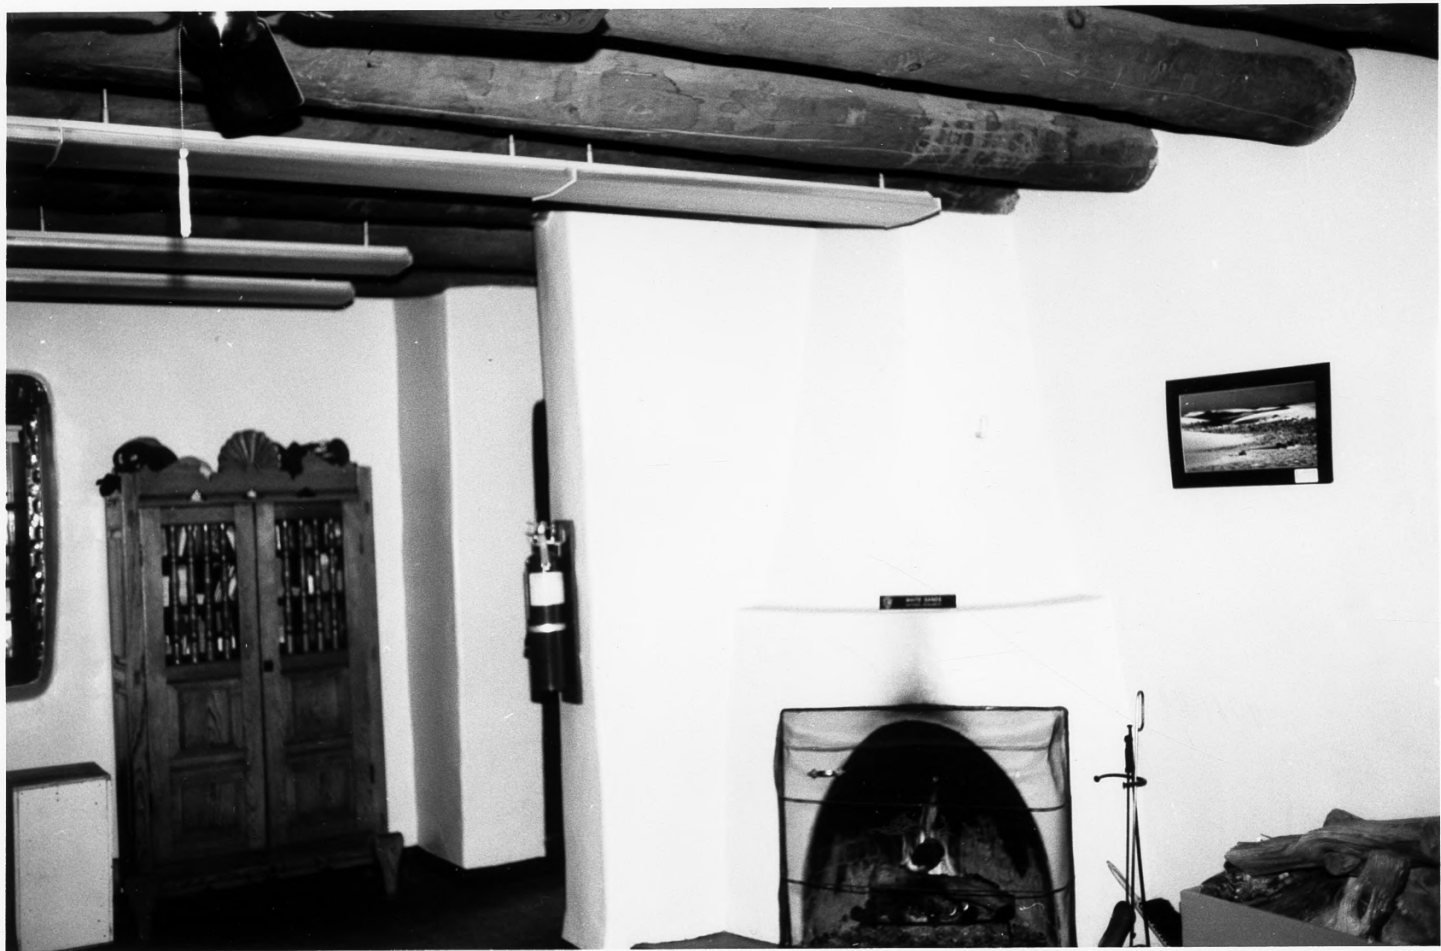
1. Administration and Museum Building,
NPS Bldg #20. (Significant.)

Ranger's office at south corner
of building showing vigas, corner
fireplace, and New Mexican Colonial
Style trastero or cabinet.

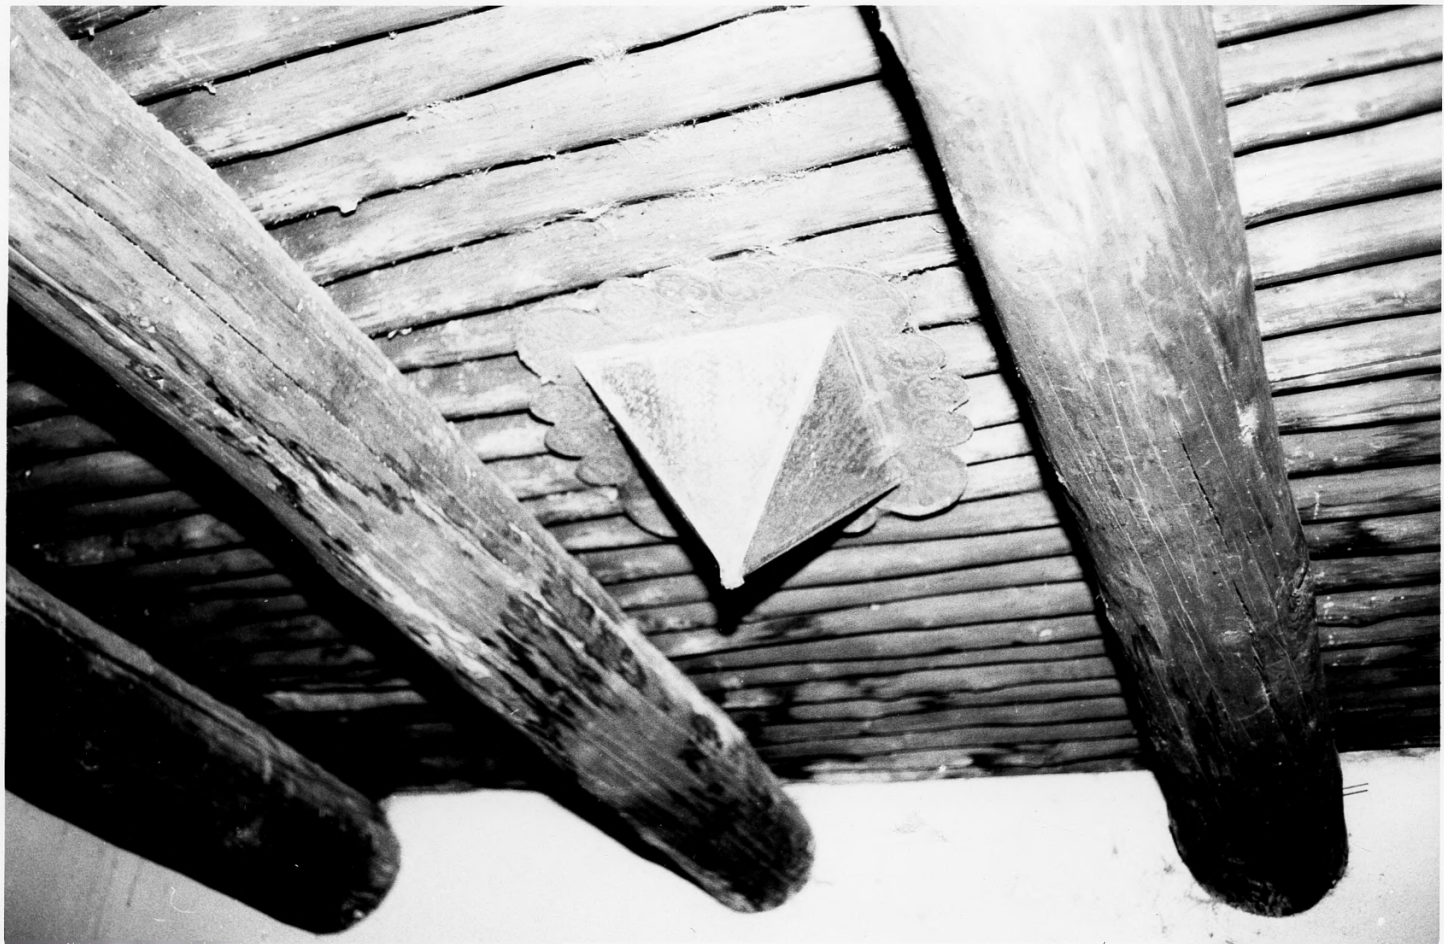
1. Administration and Museum Building,
NPS Bldg #20. (Significant.)

Ceiling of front portal showing
vigas, latias, and tin light
fixture.

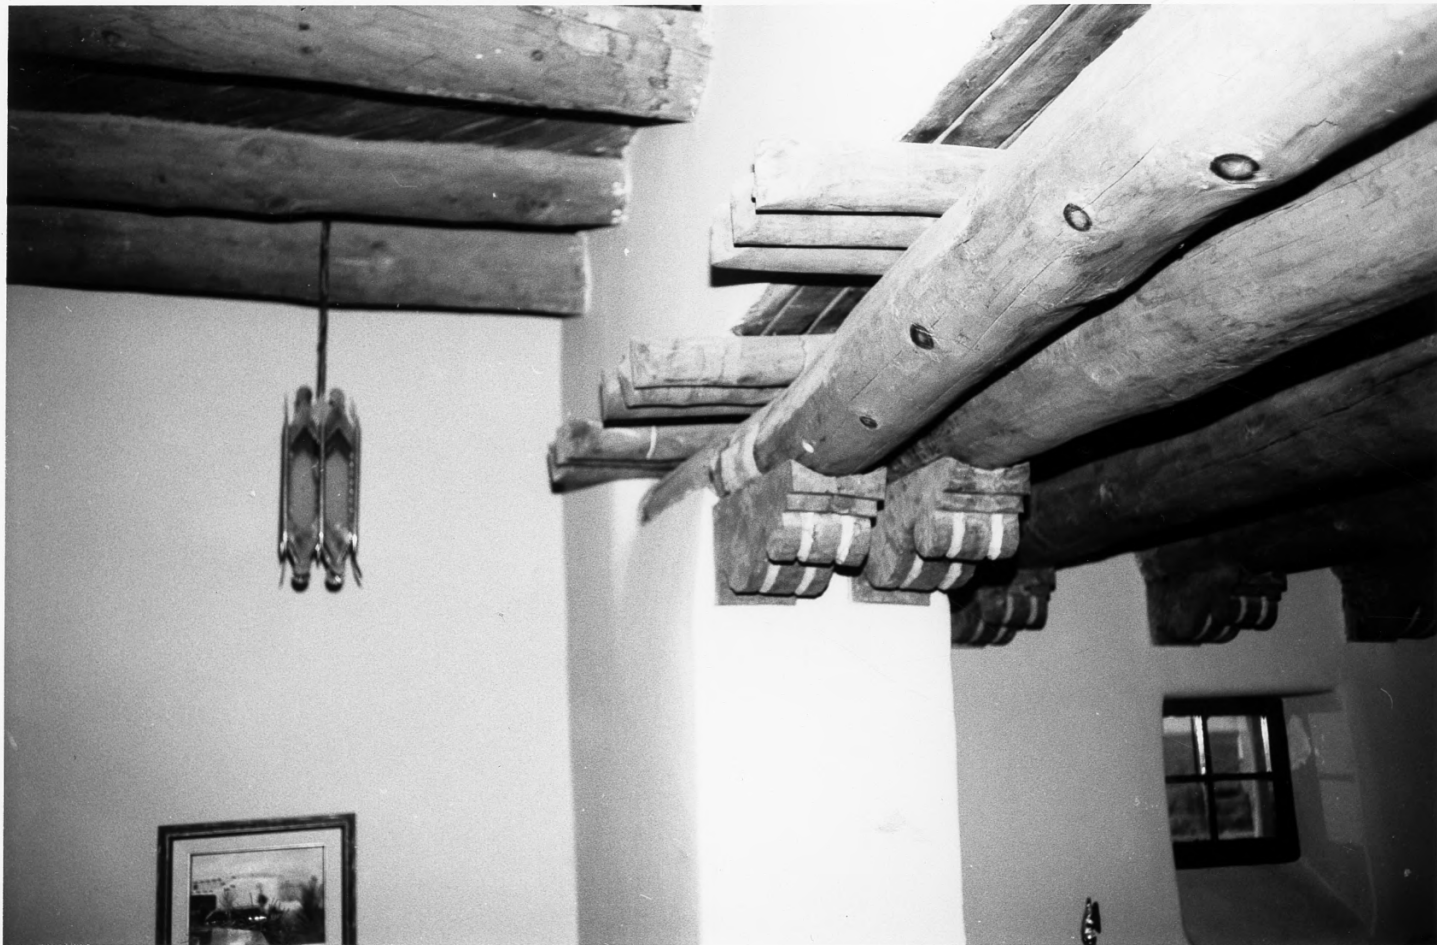
1. Administration and Museum Building.
NPS Bldg #20. (Significant.)

Lobby ceiling showing vigas and
corbels.

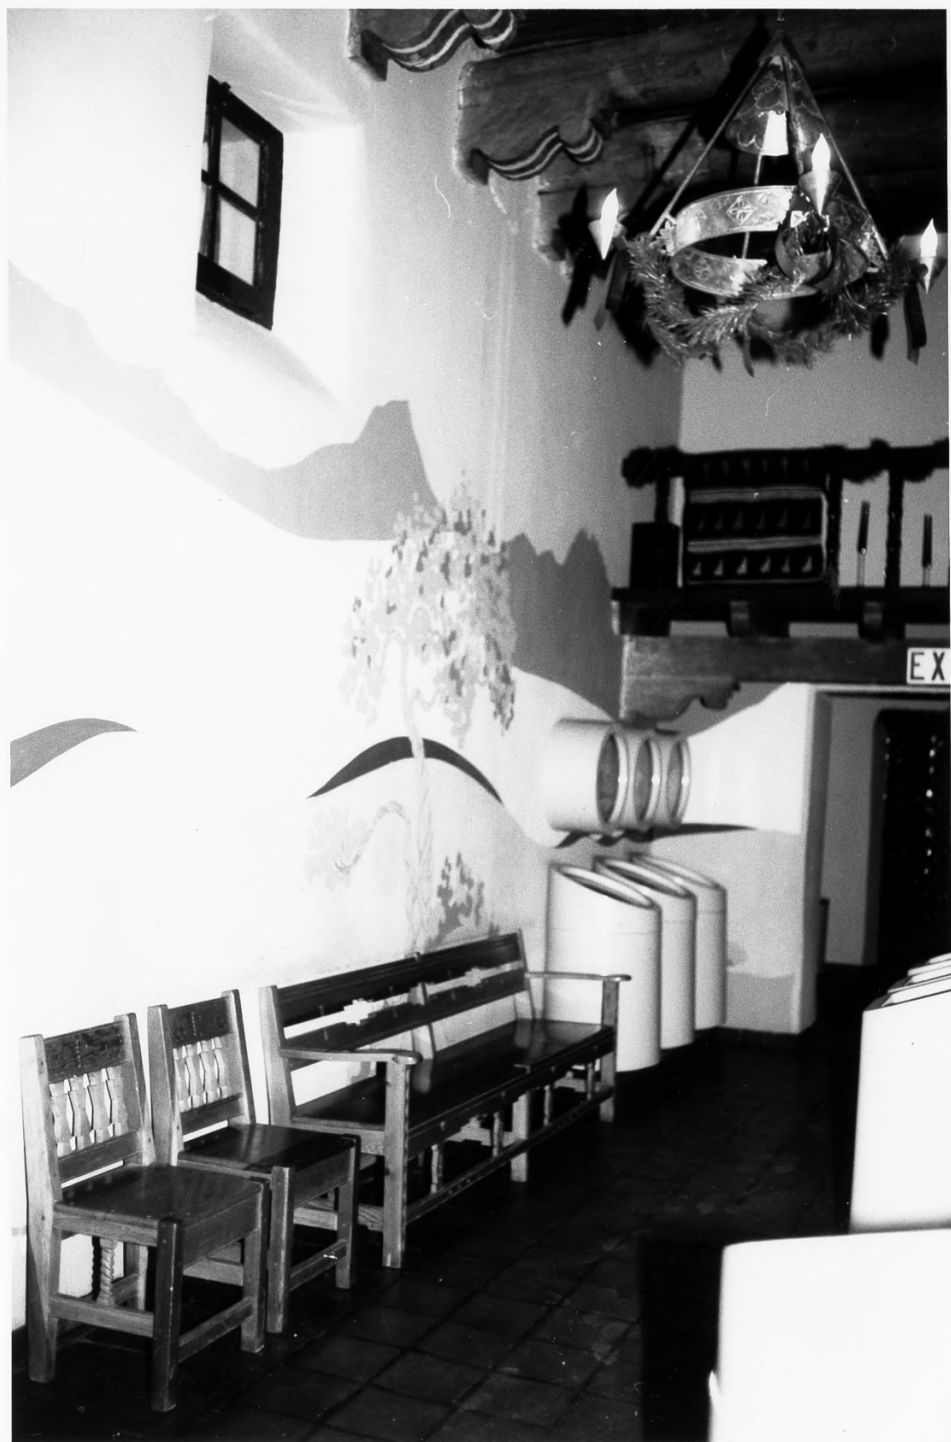
1. Administration and Museum Building,
NPS Bldg #20. (Significant.)

Lobby looking toward entrance
foyer showing vigas with corbels,
balcony, small wooden pivoted win-
dow, tin chandelier, New Mexican
Colonial Style furniture, tile
floor, 1976 exhibit installation
and wall mural.

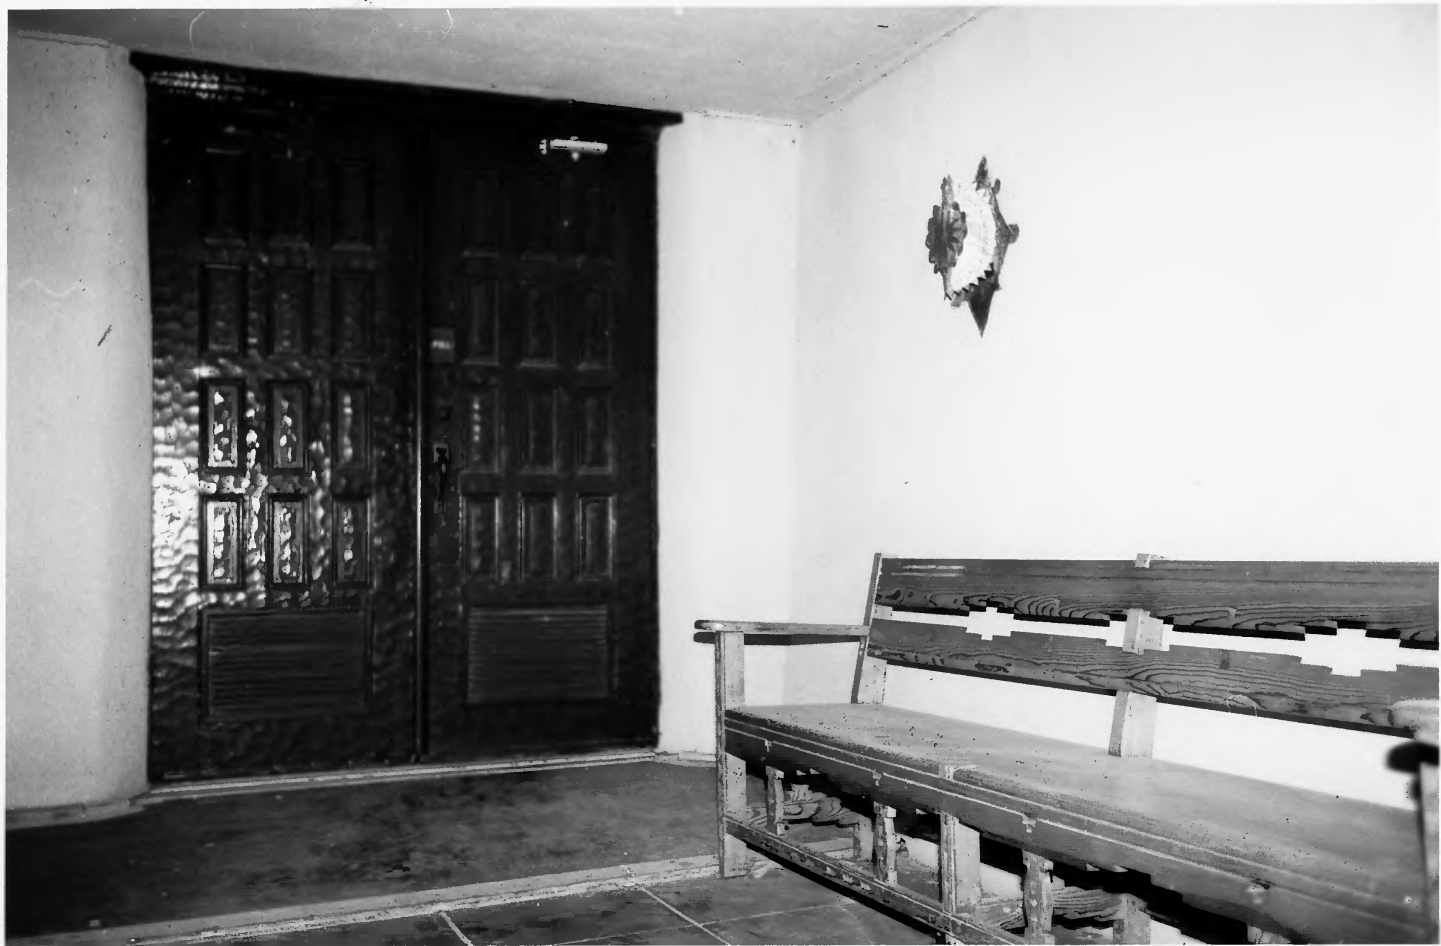
1. Administration and Museum Building,
NPS Bldg #20. (Significant.)

East corner of portal in rear patio showing adzed paneled door, tin light fixture, bench in New Mexican Colonial Style, handicapped access ramp, false ceiling for bat control.

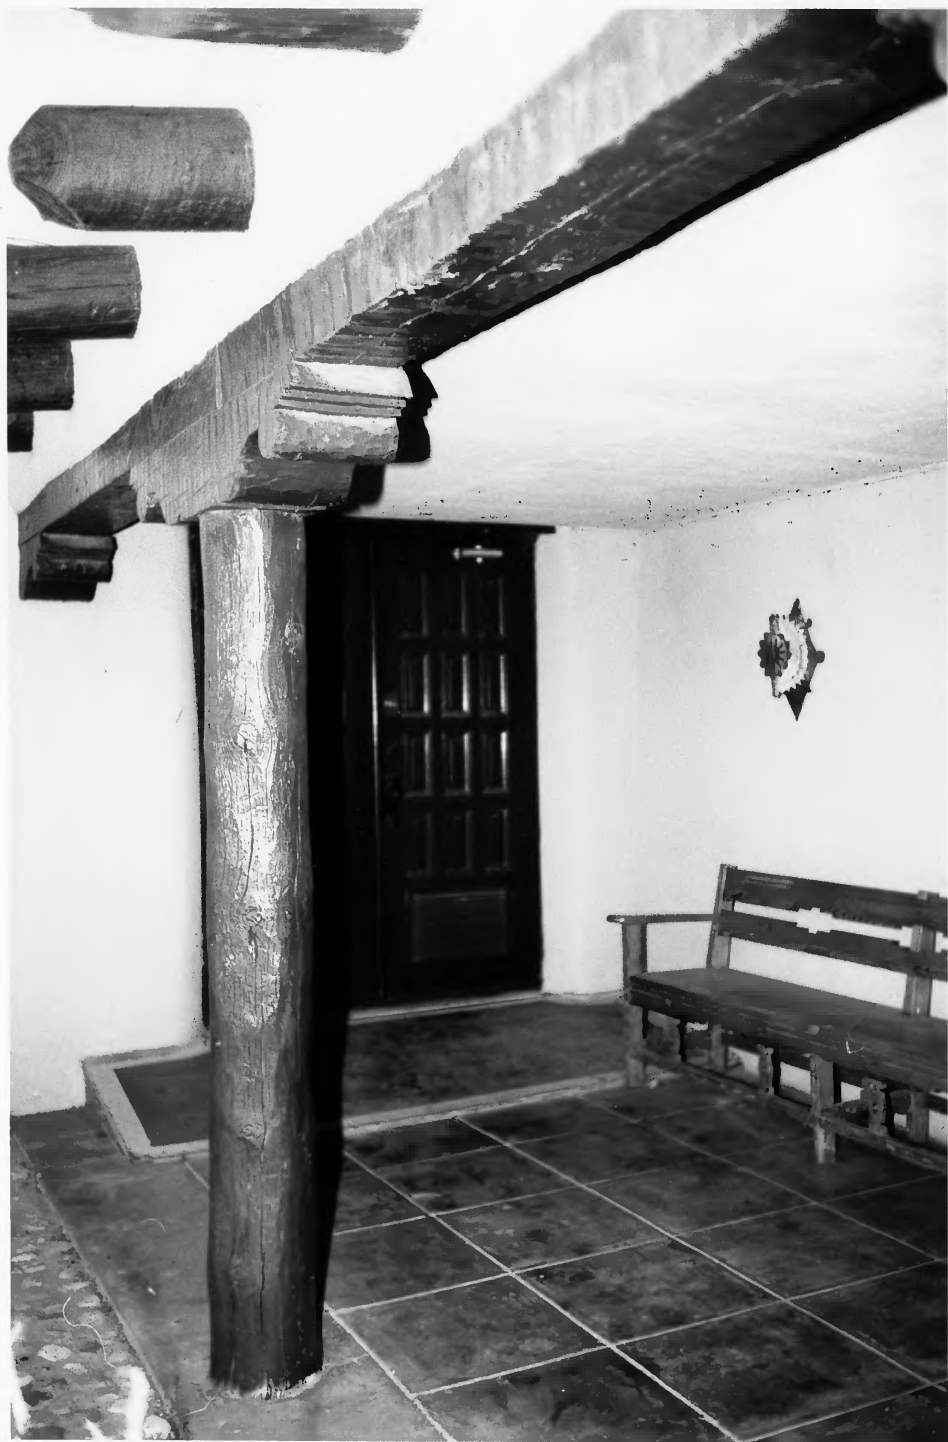
1. Administration and Museum Building,
NPS Bldg #20. (Significant.)

East corner of portal in rear patio showing log column with zapatas, adzed lintel, viga ends and false ceiling for bat control that covers vigas under portal, scored cement floor of portal, paneled door, tin light fixture, wooden

bench in New Mexican Colonial Style.

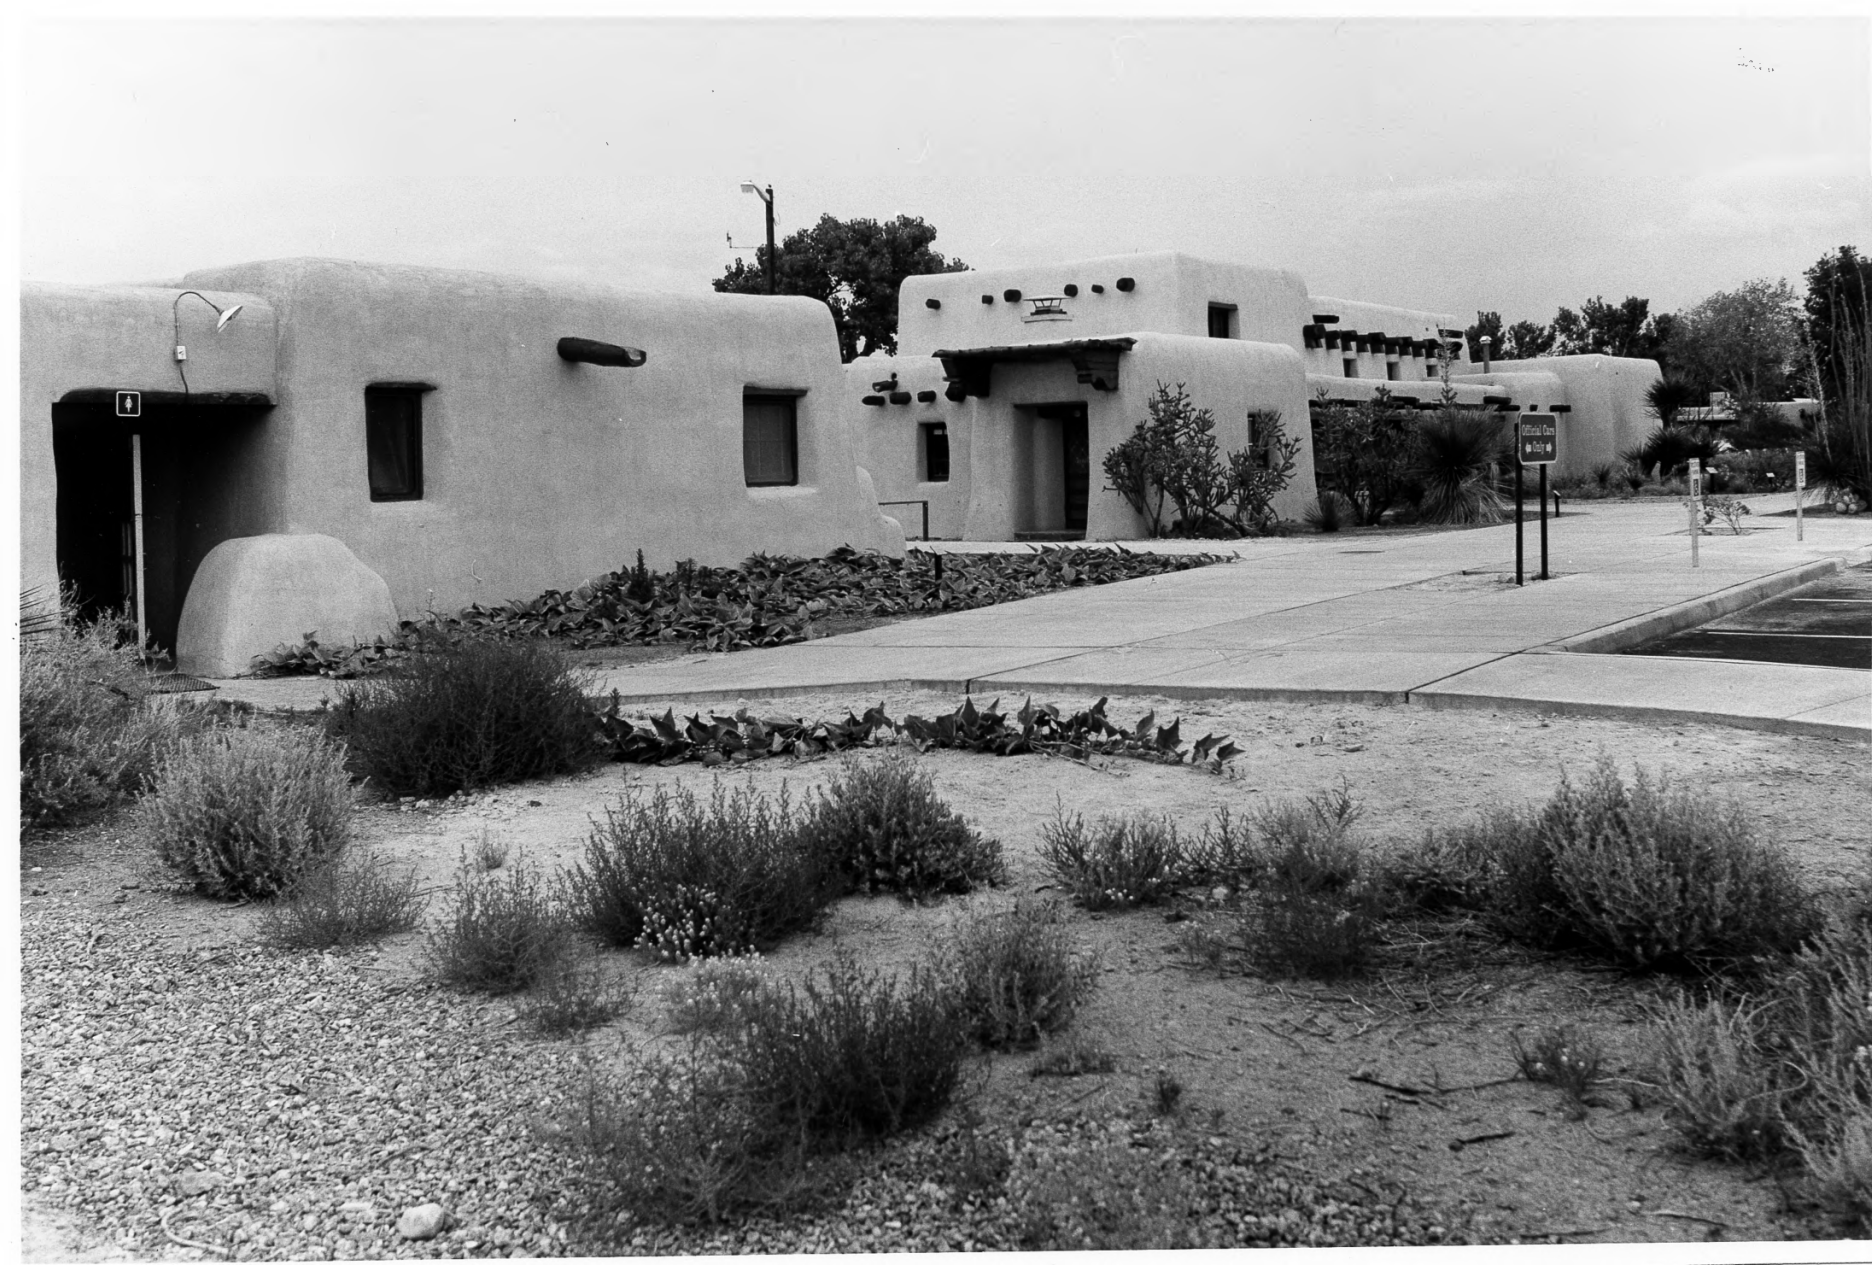
2. Comfort Station, NPS Bldg #21,
left. (Significant.)
1. Administration and Museum Building
NPS Bldg #20, right. (Significant.)

Looking north at front facades
showing concrete walkway installed
1985-6 in place of original asphalt
entrance road to dunes.

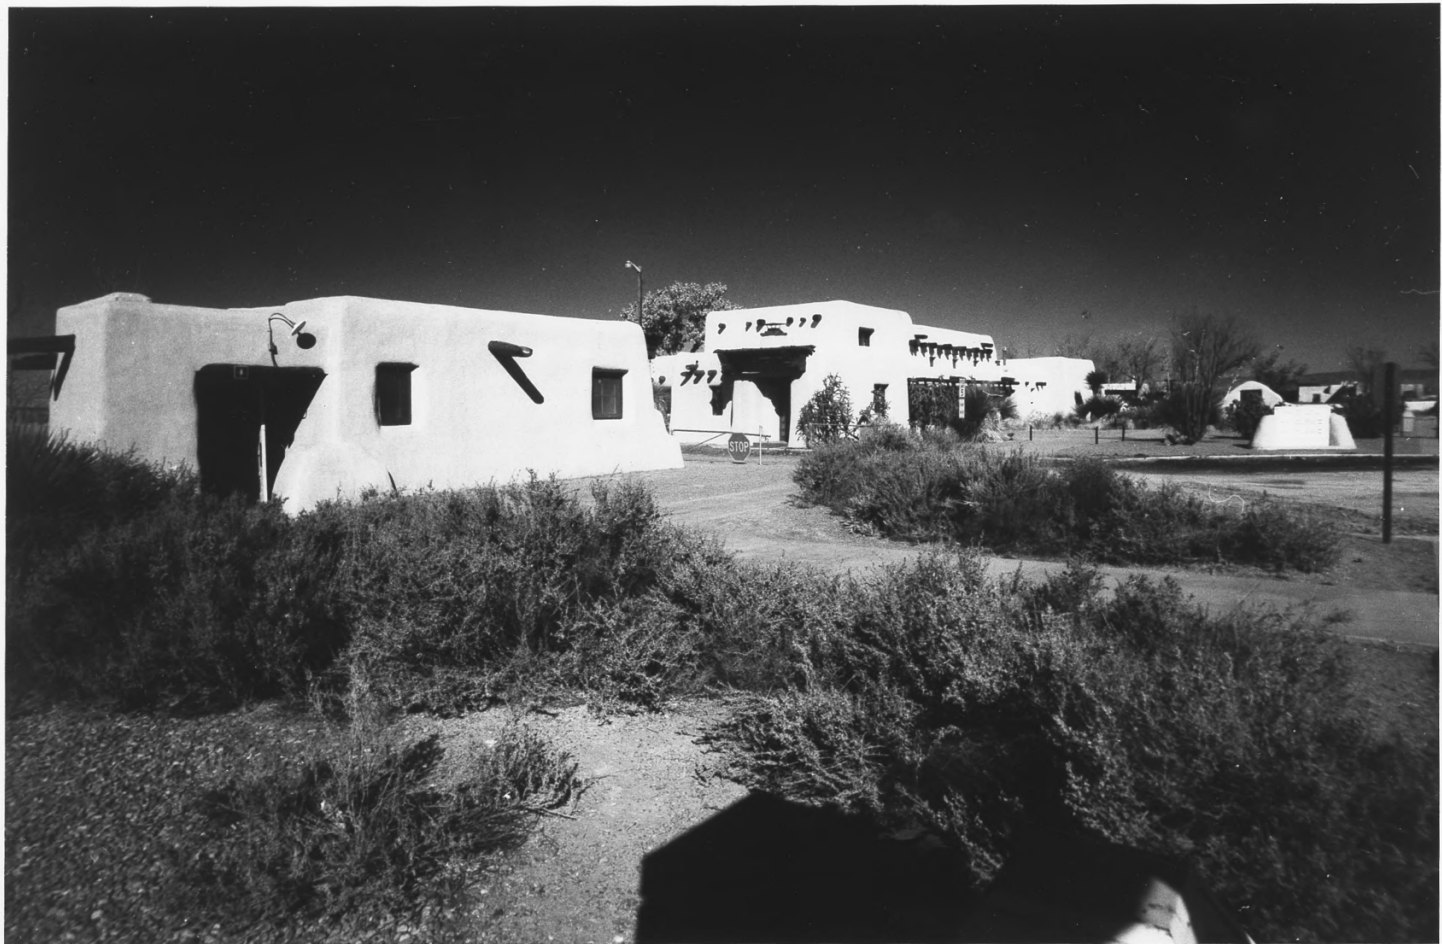
2. Comfort Station, NPS Bldg #21,
left. (Significant.)
1. Administration and Museum Building,
NPS Bldg #20, right. (Significant.)

Looking north at front facades
showing original asphalt entrance
road to dunes passing between
buildings, before relocation of
road in 1985-6.

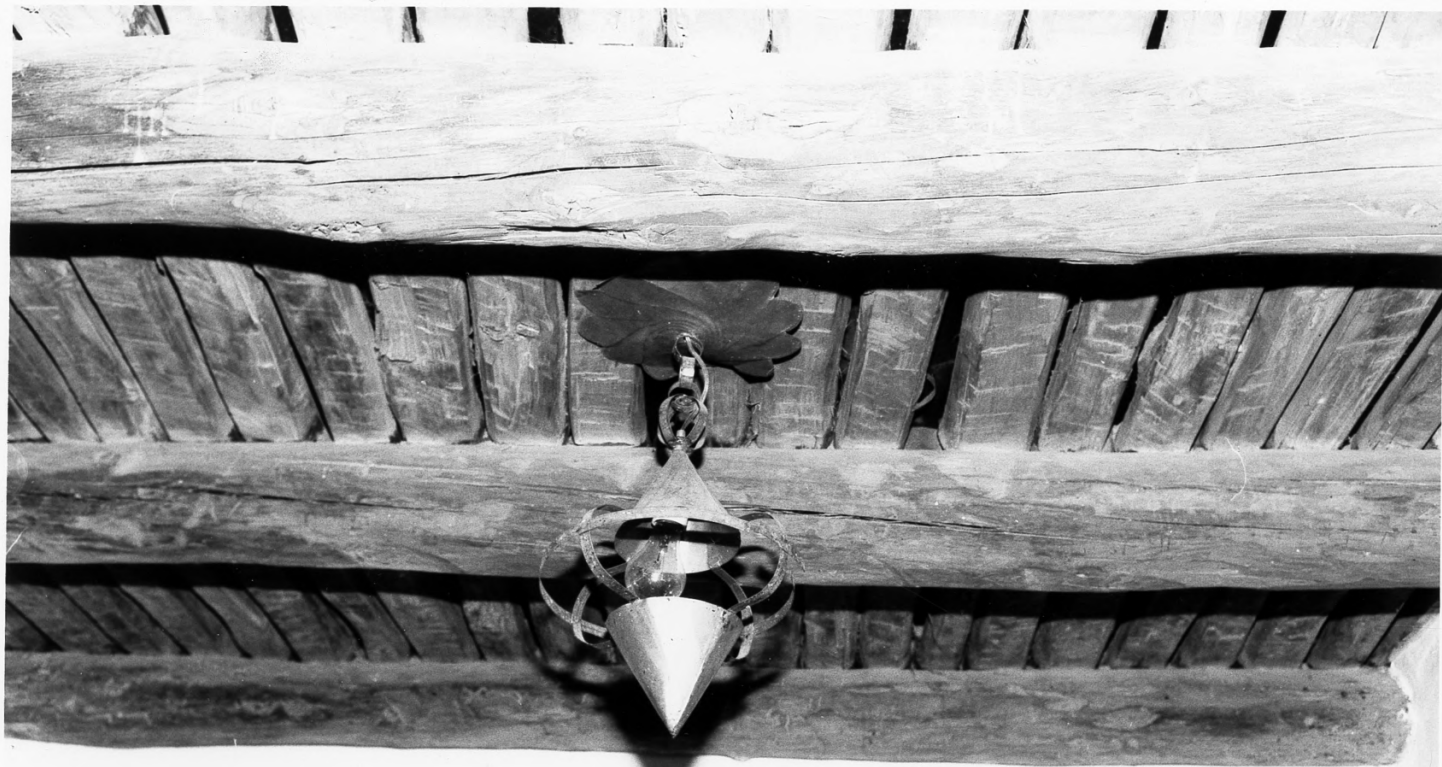
2. Comfort Station, NPS Bldg #21.
(Significant.)

Cut-and-hammered-tin light
fixture, vigas and latias, ceil-
ing of ladies' room.

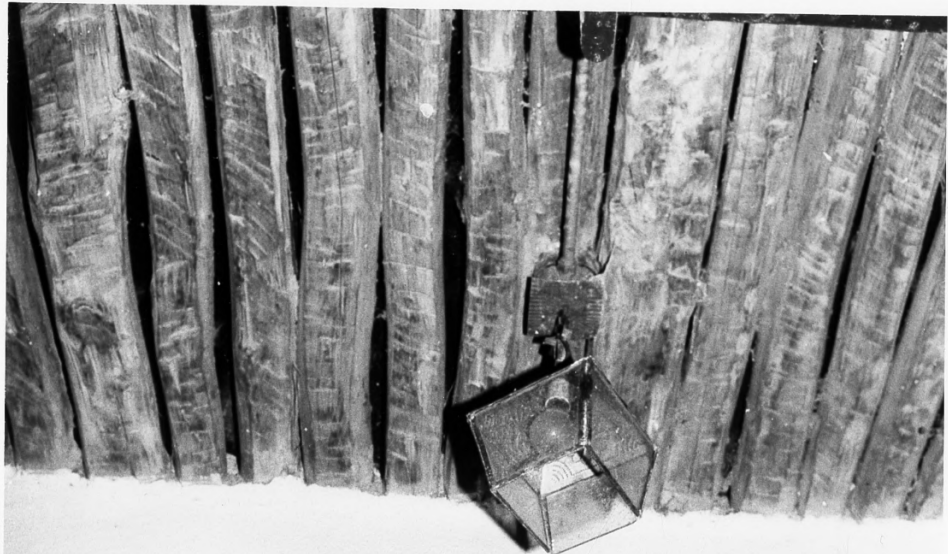
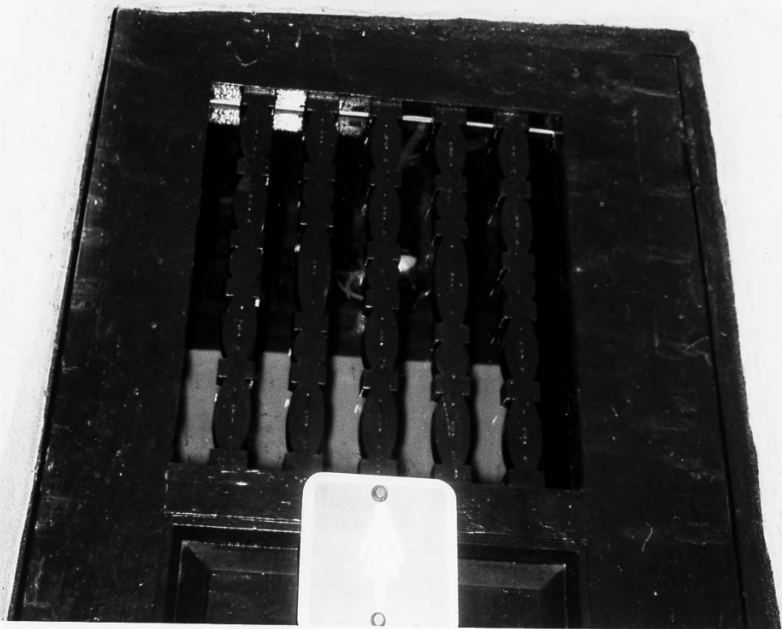
2. Comfort Station, NPS Bldg #21.
(Significant.)

Entry alcove of ladies' room,
showing tin light fixture, latias,
adzed, paneled door with grille.

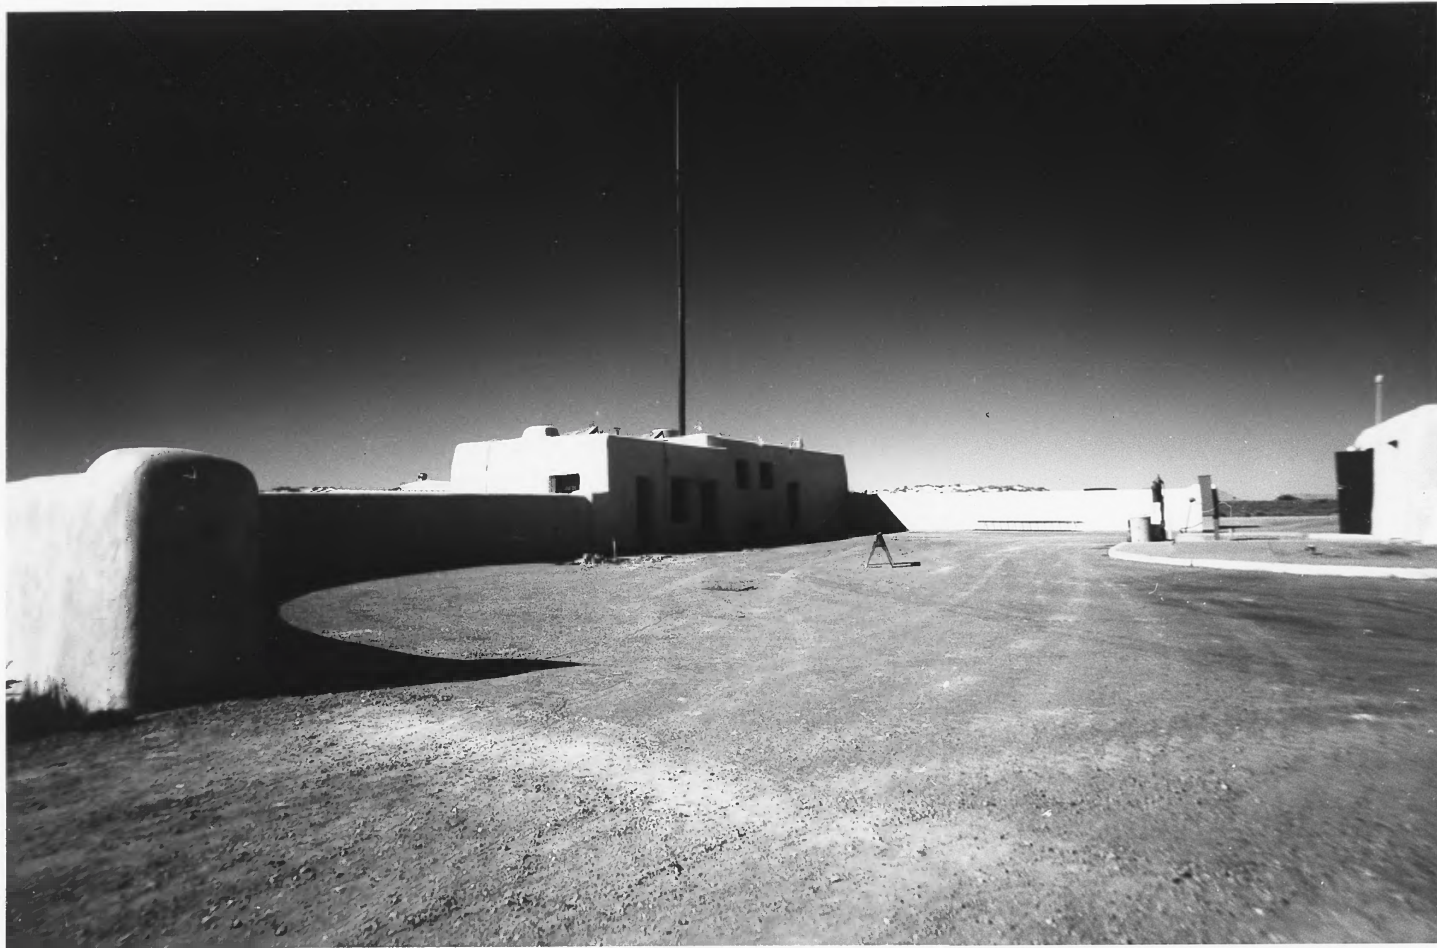
5. Warehouse and Laundry, NPS Bldg #32 showing stuccoed adobe wall attached to building. Building and wall are Significant.

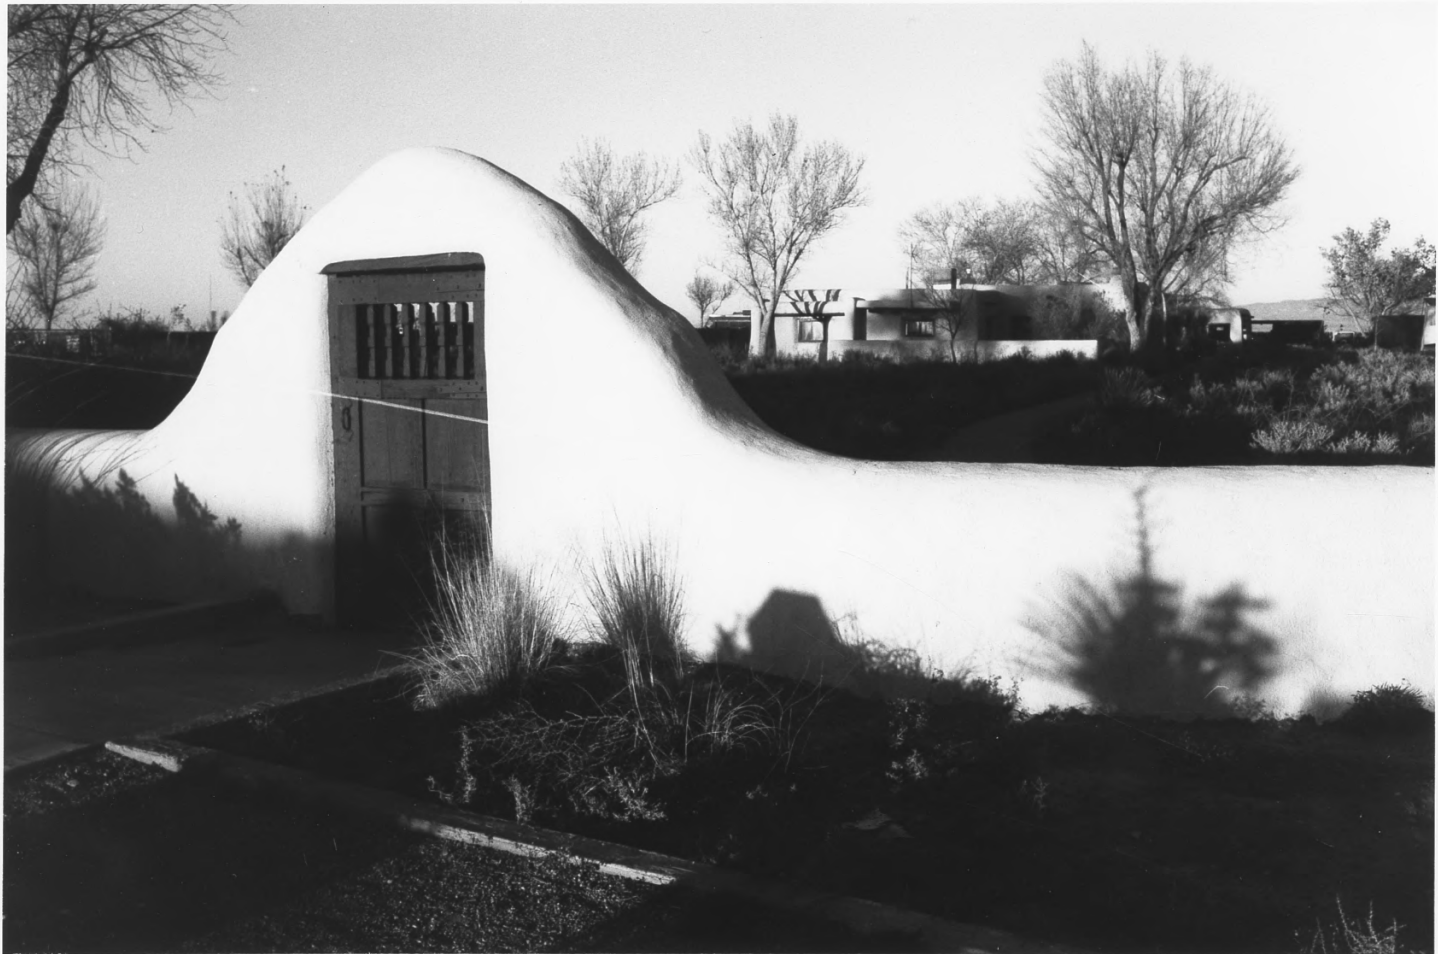
Original stuccoed adobe wall of front parking lot with original wooden paneled gate with wooden grille and wrought-iron hardware, walkway leading to residential complex, looking north. In background: (6) Residence, NPS Bldg #1; (and) (7) Residence, NPS Bldg #2. Wall, gate and buildings are significant.
