U. S. Inspection Station-Moyes, Minnesota
Property Name

National Register of Historic Places Registration Form

Historic name U.S. Inspection Station— Noyes, Minnesota
Other names/site number Noyes Inspection Station

U.S. Inspection Station—Noyes: Description

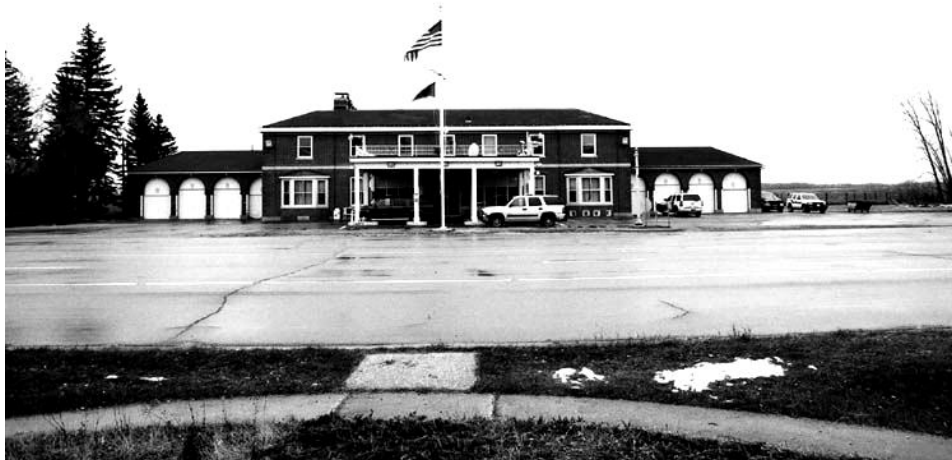
Photo number: MN_KittsonCounty_BorderStation1.tiff

Description of view: front elevation, view: southwest

From the front elevation, the general massing of the U.S. Inspection Station—Noyes reads as horizontally oriented and highly symmetrical. The front elevation of the primary building is of seven horizontal bays. The center portion of the first level, front elevation of the primary building is largely obscured by a c.1964 modernist addition that traverses the three original middle bays. This rectangular plan entry addition is a grid of aluminum mullions with fiberglass paneling in its upper and lower courses, and fixed glass running along the middle course across all three sides of the addition. The dimensions of this addition fit squarely into one of three bays beneath the porte-cochere. A pair of centrally placed storefront aluminum doors within this addition serves as the main entry into the inspection station. Behind and at either side of the entry addition, two bays of windows are present at the primary building's first level. The inner of each of these bays features a large, rectangular 1/1 aluminum-frame window that is set above a marble sill. Each is topped with gauge brick jack arching with a centered, marble keystone. Each outer window bay at the first level of the front elevation consists of a three-sided protruding bay window that is topped by a copper clad canopy roof with stepped flashing where it is affixed to the front elevation. This canopy is underscored with a simple painted aluminum fascia, and the windows themselves are set above marble sills. The base of each bay window is brick. The southernmost of these window bays features an inset concrete commemorative plaque within its base. The bay window at the northern end of the front elevation features small, wood framed and screened ventilation ducts to the basement. The portion of the front elevation where each of these bay windows is located protrudes out slightly,

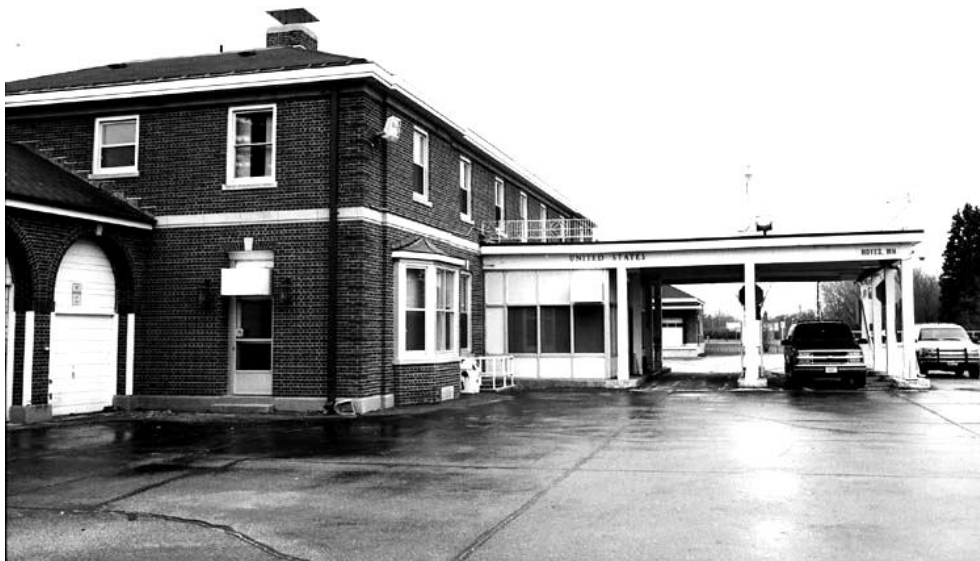
Photo number: MN_KittsonCounty_BorderStation2.tiff

Description of view: front and side elevations, view: west

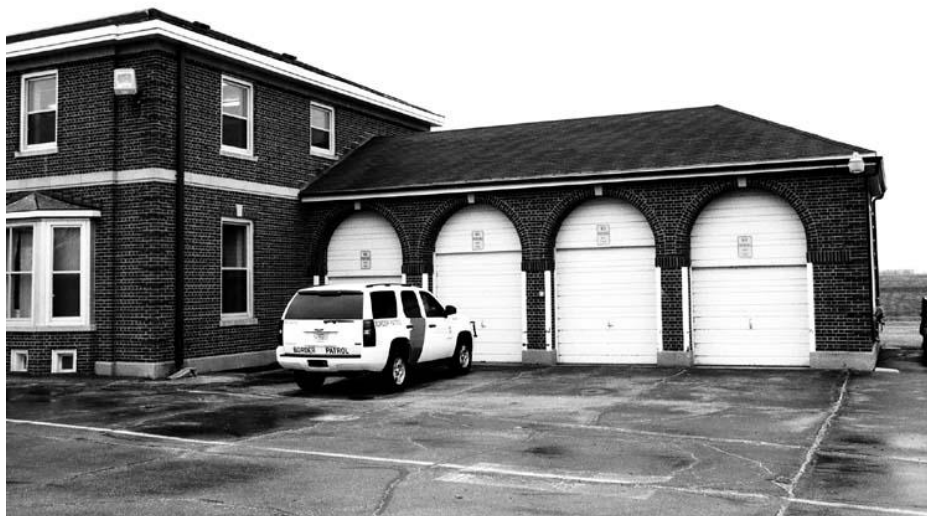
Photo number: MN_KittsonCounty_BorderStation3.tiff

Description of view: north garage wing, view: southwest

Affixed to either side of the primary building is a 4-bay garage wing of the same English bond brickwork as the primary building. Each of these wings features a hipped roof. The southern wing was originally used for inspection purposes, and the north wing originally housed officer's vehicles and confiscated vehicles. Each of the garage bays on each wing features an aluminum door. Each garage bay is topped with undulating header and soldier course voussoir arching with an oversized, centered marble keystone. Scored aluminum cladding is present above each garage door within the arch itself. The spring beneath these arches consists of a running brick soldier course. Brick quoins are present at each outer corner of each garage wing. The window bay of the south-facing side elevation of the southern garage wing is in filled with glass block. The rear elevation of the garage wing is of four bays. The two outer bays contain 24-unit fixed aluminum-frame windows each set above a marble sill. The two inner bays have milled aluminum ventilation ducts that are a later alteration. The gauge brick jack arching and keystone detail top each of the rear bays of the south garage wing.

The rear elevation of the north garage wing features four window bays each with 24-unit fixed aluminum-frame windows with the gauge brick jack arching, centered marble keystones, and marble sill underscores seen above similar windows across the first level of the inspection station. A paired set of these same 24-unit aluminum-frame windows,

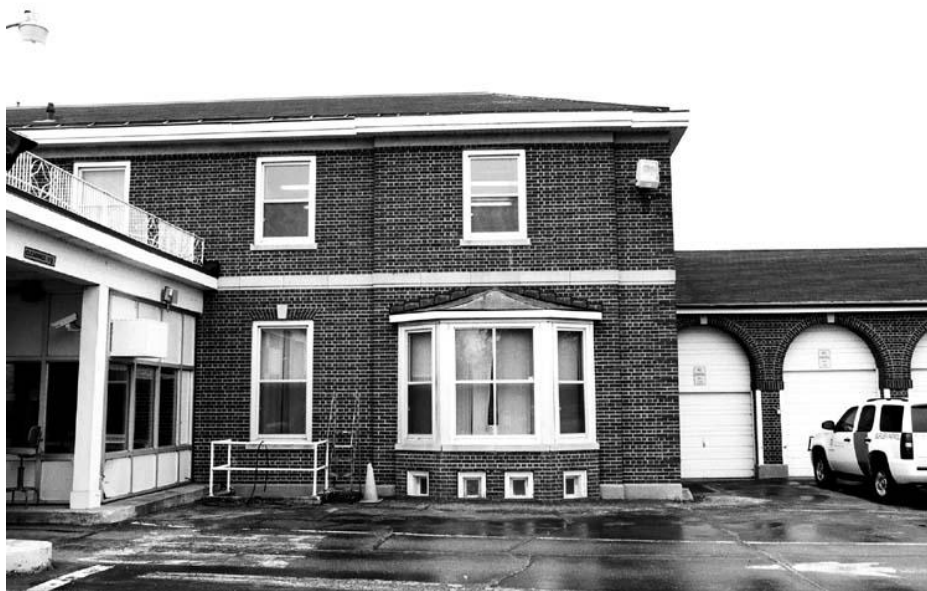
Photo number: MN_KittsonCounty_BorderStation4.tiff

Description of view: front elevation detail, view: southwest

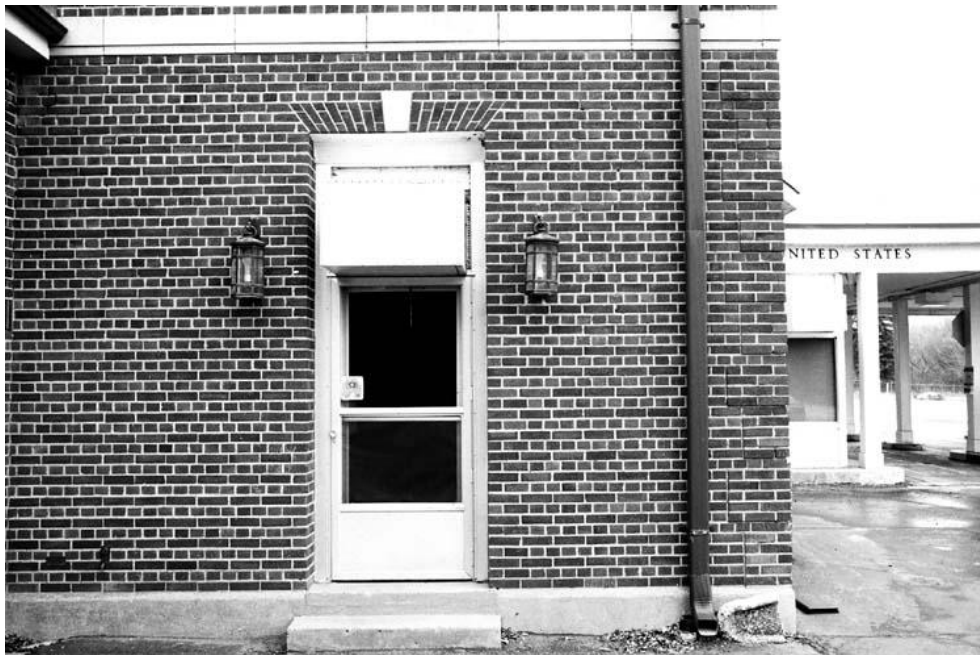
Photo number: MN_KittsonCounty_BorderStation6.tiff

Description of view: side entry into primary building, view: northwest

Each garage wing is affixed to the primary building at the rear portion of its side elevation. The front portion of the primary building's first level at its south side elevation contains a pedestrian entrance with a storefront aluminum and glass entry door. A boxed air conditioner is set into the transom above this door, which is topped with ogee molding and a wood frieze. Above this is the gauge brick jack arching and oversized marble keystone commonly seen above first level window bays. At either side of the door are lantern style decorative light fixtures held by large rings affixed to hooks in the wall. The second level of the south elevation features two 1/1 aluminum-frame windows: one toward the front of the building and one over the middle of the elevation. The one near the front is larger than the middle sash. The lower level of the north-side elevation of the primary building features a 1/1 aluminum-frame window of the same proportion as those seen at the first level, front elevation. This window is similarly accentuated as those commonly seen across the rest of the first level. A similar placement and sizing of two 1/1 aluminum-frame windows, as found on the south-side elevation, is also present at the upper level of the north-side elevation.

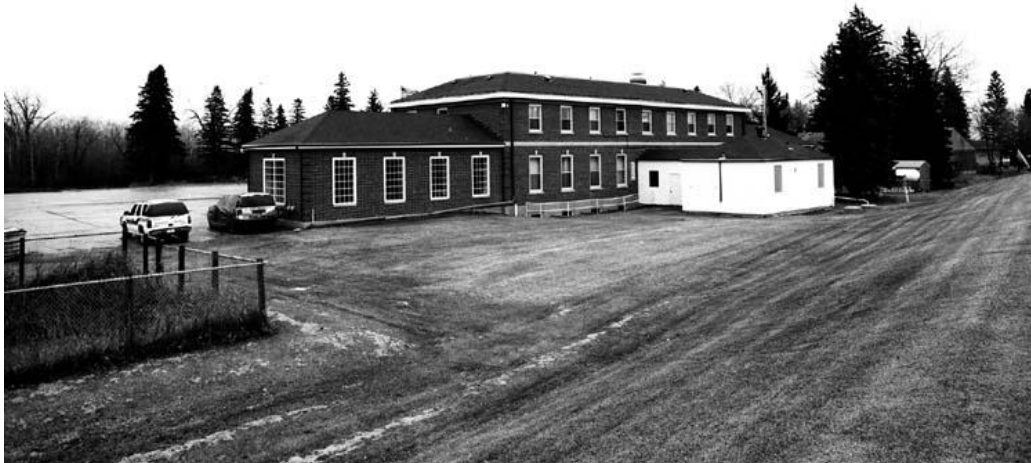
Photo number: MN_KittsonCounty_BorderStation7.tiff

Description of view: rear of the property and resource, view: southeast

The rear elevation of the primary building is nine bays long. At its lower level are eight large rectangular window bays each consisting of a 1/1 aluminum-frame window. Each is topped with the gauge brick jack arching and oversized marble keystone seen above most other first level window bays, and each is set above a marble sill. A vinyl lap-clad, gable-roofed, enclosed entry hall, with a centered wood door and two fixed windows at either side of it, covers the center bay at the first level. This hall leads to a square plan, vinyl lap clad hipped roof auxiliary restroom facility that is located behind the inspection station. It is windowless, except for two boarded symmetrically placed window openings at its rear, west-facing wall. The roof of the restroom facility and its connecting hall are both clad in asphalt shingle. The auxiliary restroom facility is original to the Noyes Inspection Station.

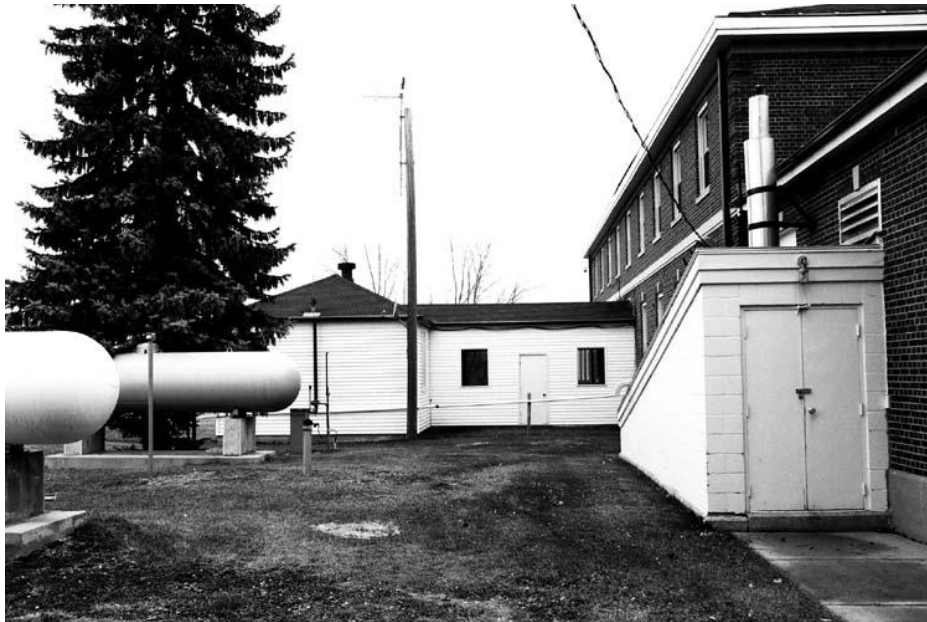
Photo number: MN_KittsonCounty_BorderStation8.tiff

Description of view: toilet facility, underground stair, and tanks at rear of the property; view: northwest

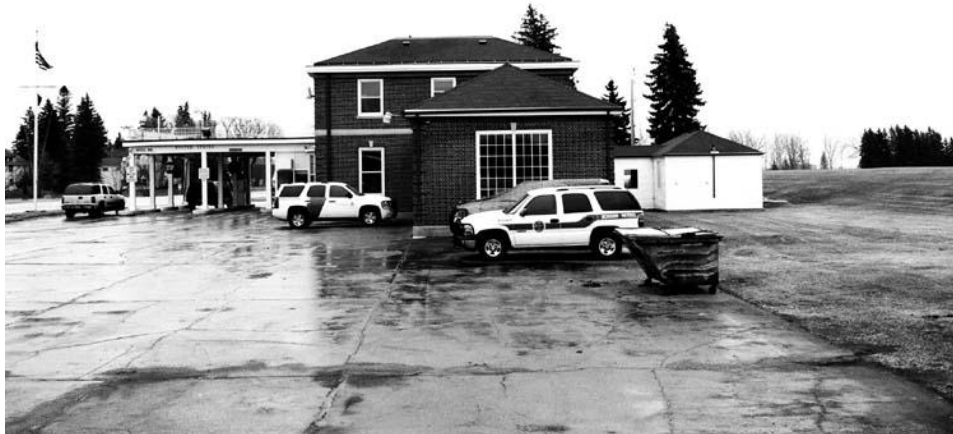
Photo number: MN_KittsonCounty_BorderStation9.tiff

Description of view: side elevation, view: southeast

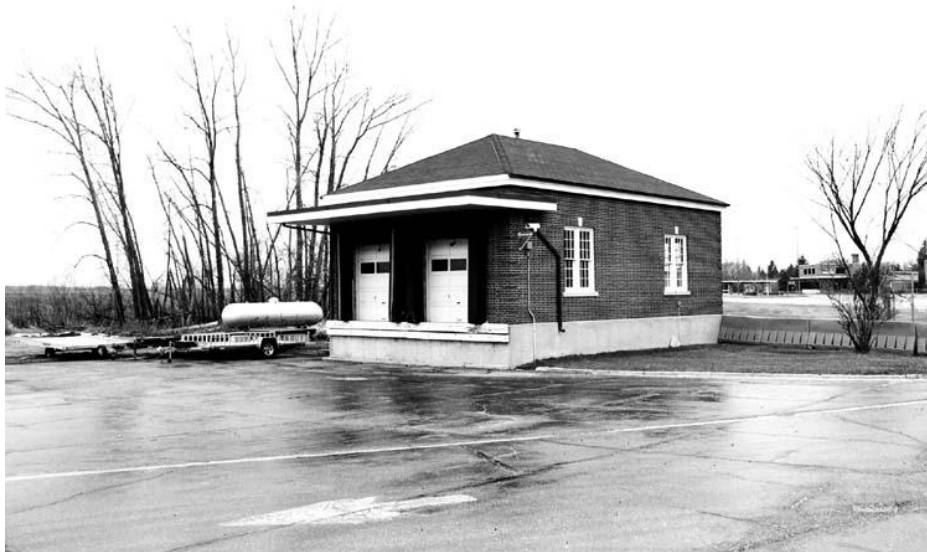
Photo number: MN_KittsonCounty_BorderStation10.tiff

Description of view: truck inspection facility, view: northwest

A square plan, 1-story truck inspection garage with a hipped roof and English bond brick cladding is present at the northern portion of the property. This structure is elevated on a tall, concrete foundation, and has two garage bays that face south. An affixed flat roofed overhang is present above these garage bays. A simple painted fascia underscores

the roof of the structure. The east-side elevation of the structure has two symmetrical bays with a pair of 9/9 wood-frame double-hung windows topped by gauge brick jack arching with an oversized decorative marble keystone. A similarly accentuated 6/6 wood-frame double-hung window and entry door is present on the west-side elevation. A shared marble sill underscores each window pair. Brick quoins are present along the corners of this structure. A grove of mature trees is present directly behind/west of the truck inspection structure. A small triangular yard of grass is located in front of this structure. Though this structure is in keeping with the design system of the inspection station, it was built in 1961, is outside of the period of significance for the Noyes Inspection Station, and is not a contributing resource.

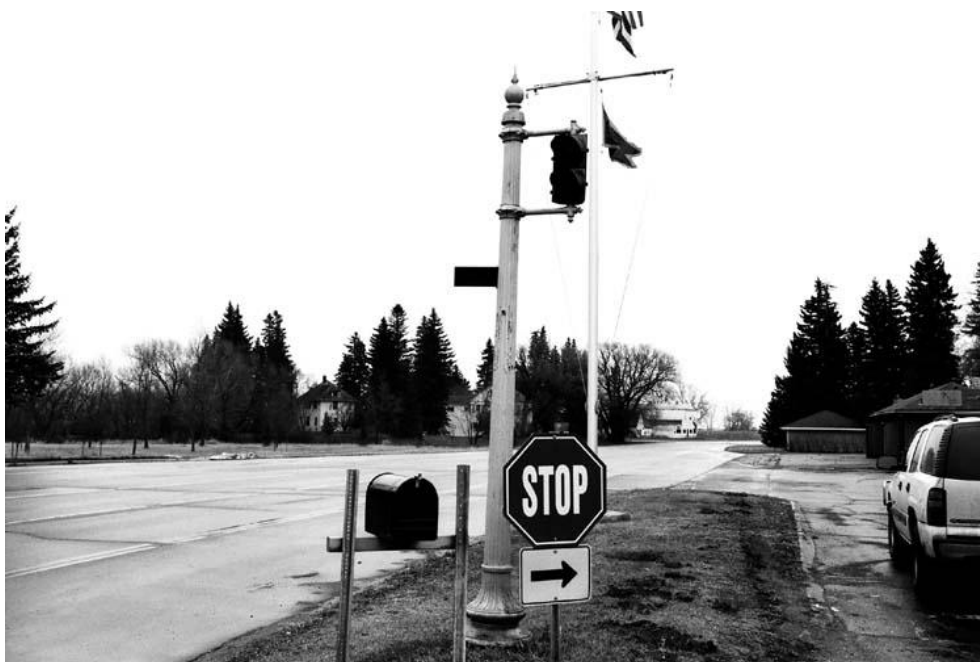
Photo number: MN_KittsonCounty_BorderStation11.tiff

Description of view: stop signal, view: southeast

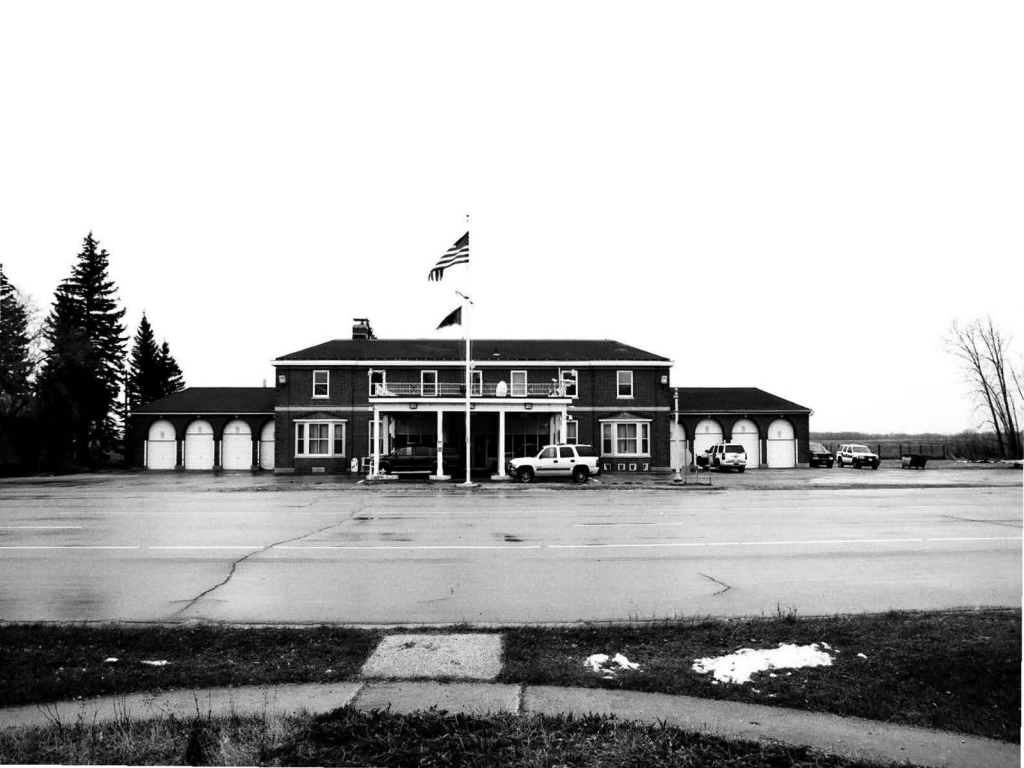
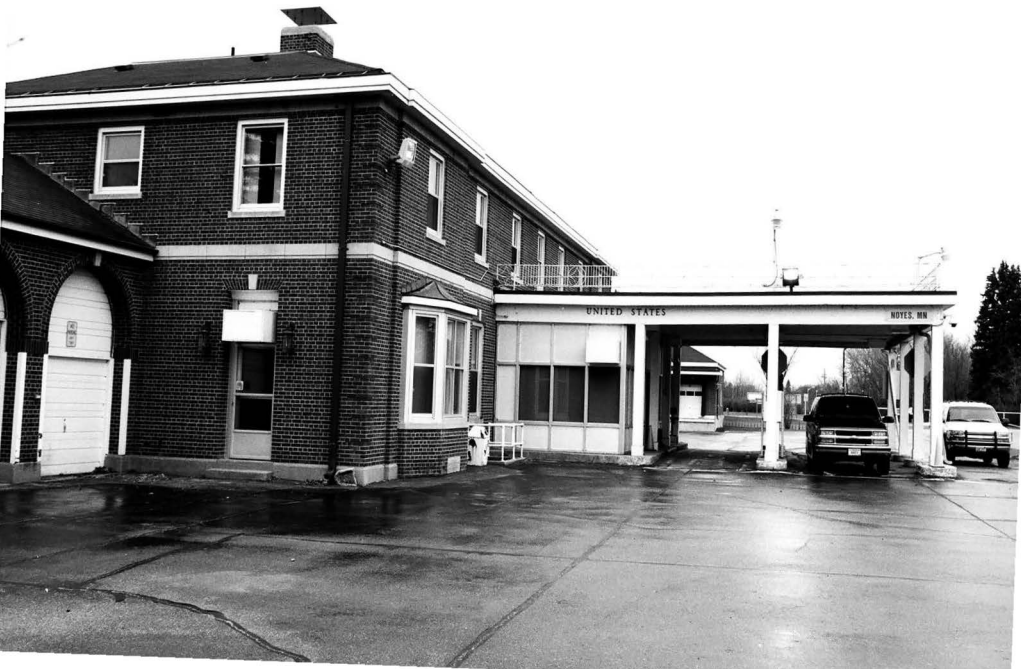
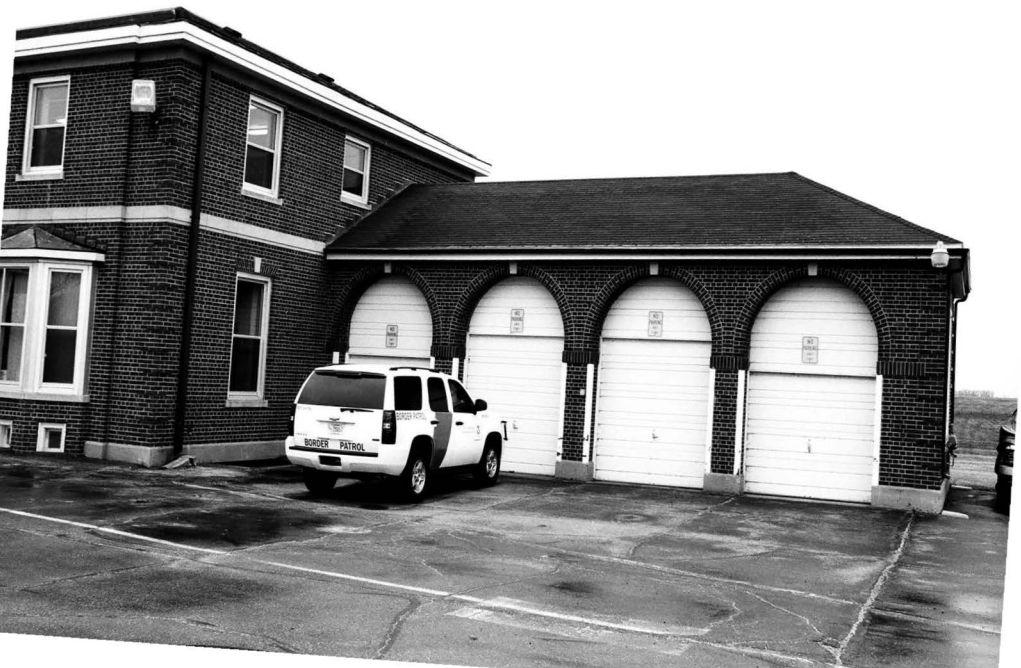
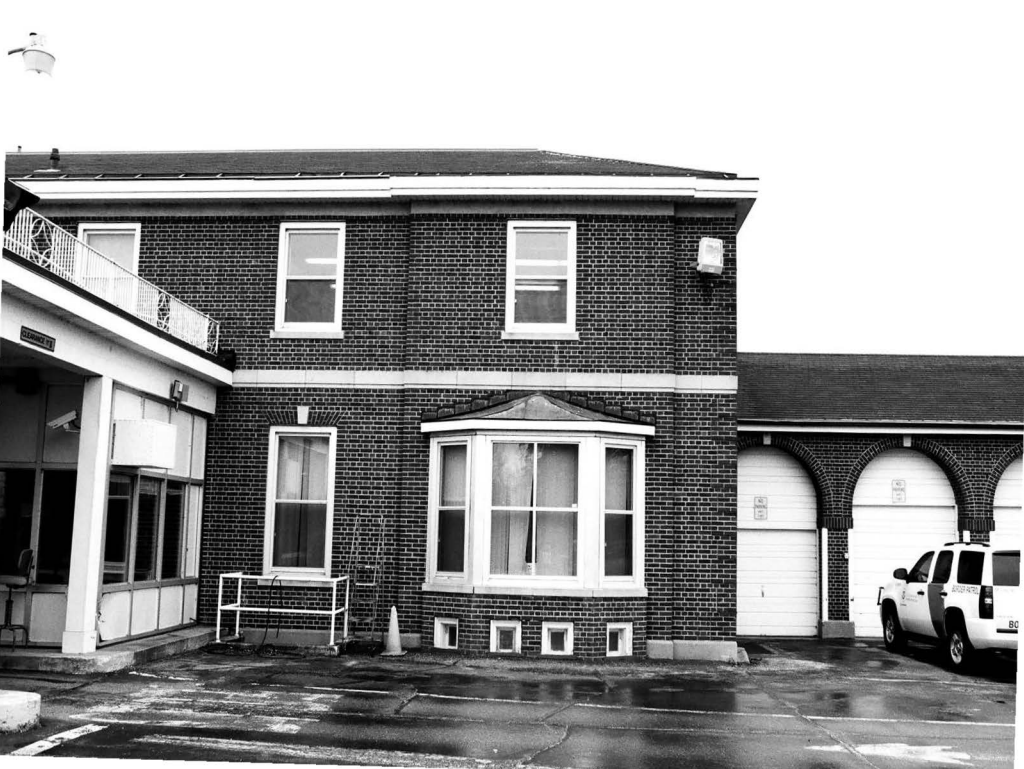
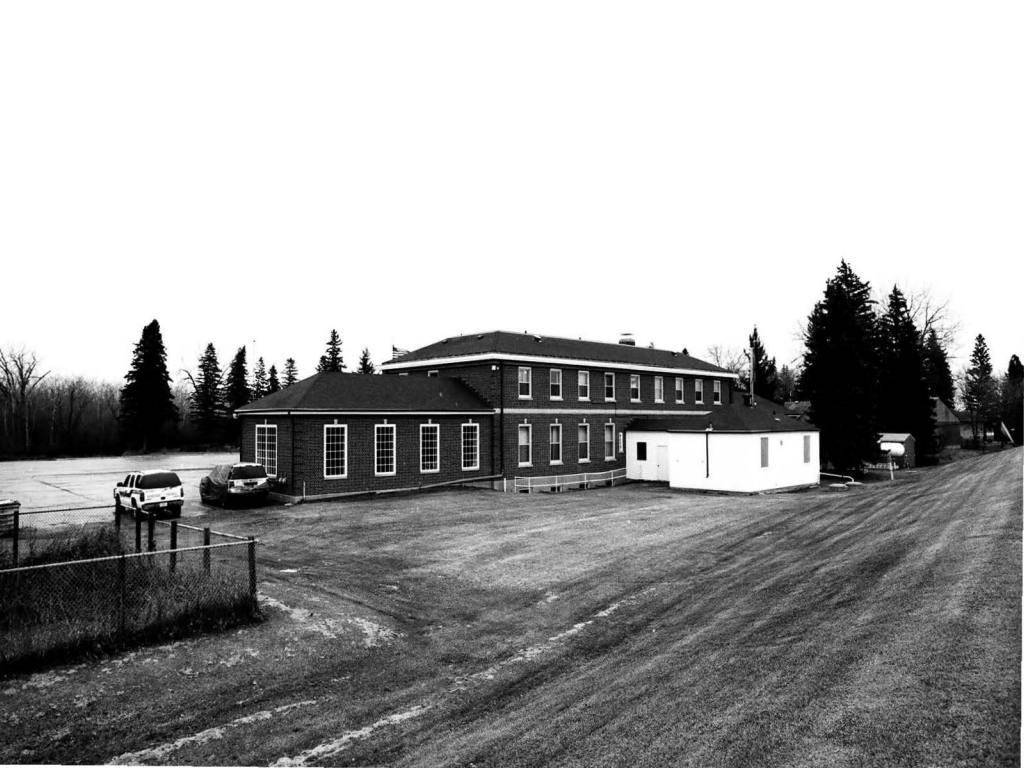
U.S. Inspection Station – Noyes
Kittson County, Minnesota
Courtesy: National Archives and Records Administration
Date: 1933
Description of view: front elevation and floor plan including wings

The renderings for the U.S. Inspection Station—Noyes can still be found at the National Archives and Records Administration (NARA).⁴ Aside from the front elevation addition and the 4-bay north garage wing (which is original), the U.S. Inspection Station—Noyes as extant today looks remarkably similar to its original front elevation rendering. The renderings for the U.S. Inspection Station—Noyes date from 1931, which is the same year the building was completed. This makes the U.S. Inspection Station—Noyes one of the earliest of the Public Works Administration (PWA)-era inspection stations. During this time, Judge James A. Wetmore was the Supervising Architect of the Treasury, and his name is on the commemorative plaque at the front of the building. Wetmore, however, had no formal architectural training. The U.S. Inspection Station—Noyes design is likely the product of Louis Simon, who effectively directed Wetmore's office during this period, and who had worked with the Treasury continually since 1896.⁵ "Simon, trained in architecture at MIT, was instrumental in the image of government projected by its public buildings, an image derived from classical western architecture, filtered perhaps through the English Georgian style or given a regional gloss, but one which continues to operate in the collective public vision of Government. Simon was unwavering in his defense of what he considered a "conservative-progressive" approach to design in which he saw "art, beauty, symmetry, harmony and rhythm."⁶
