National Register of Historic Places
Registration Form

historic name Hatch Homestead and Mill HD

other names/site number "The Red House"

street & number 385 Union Street not for publication

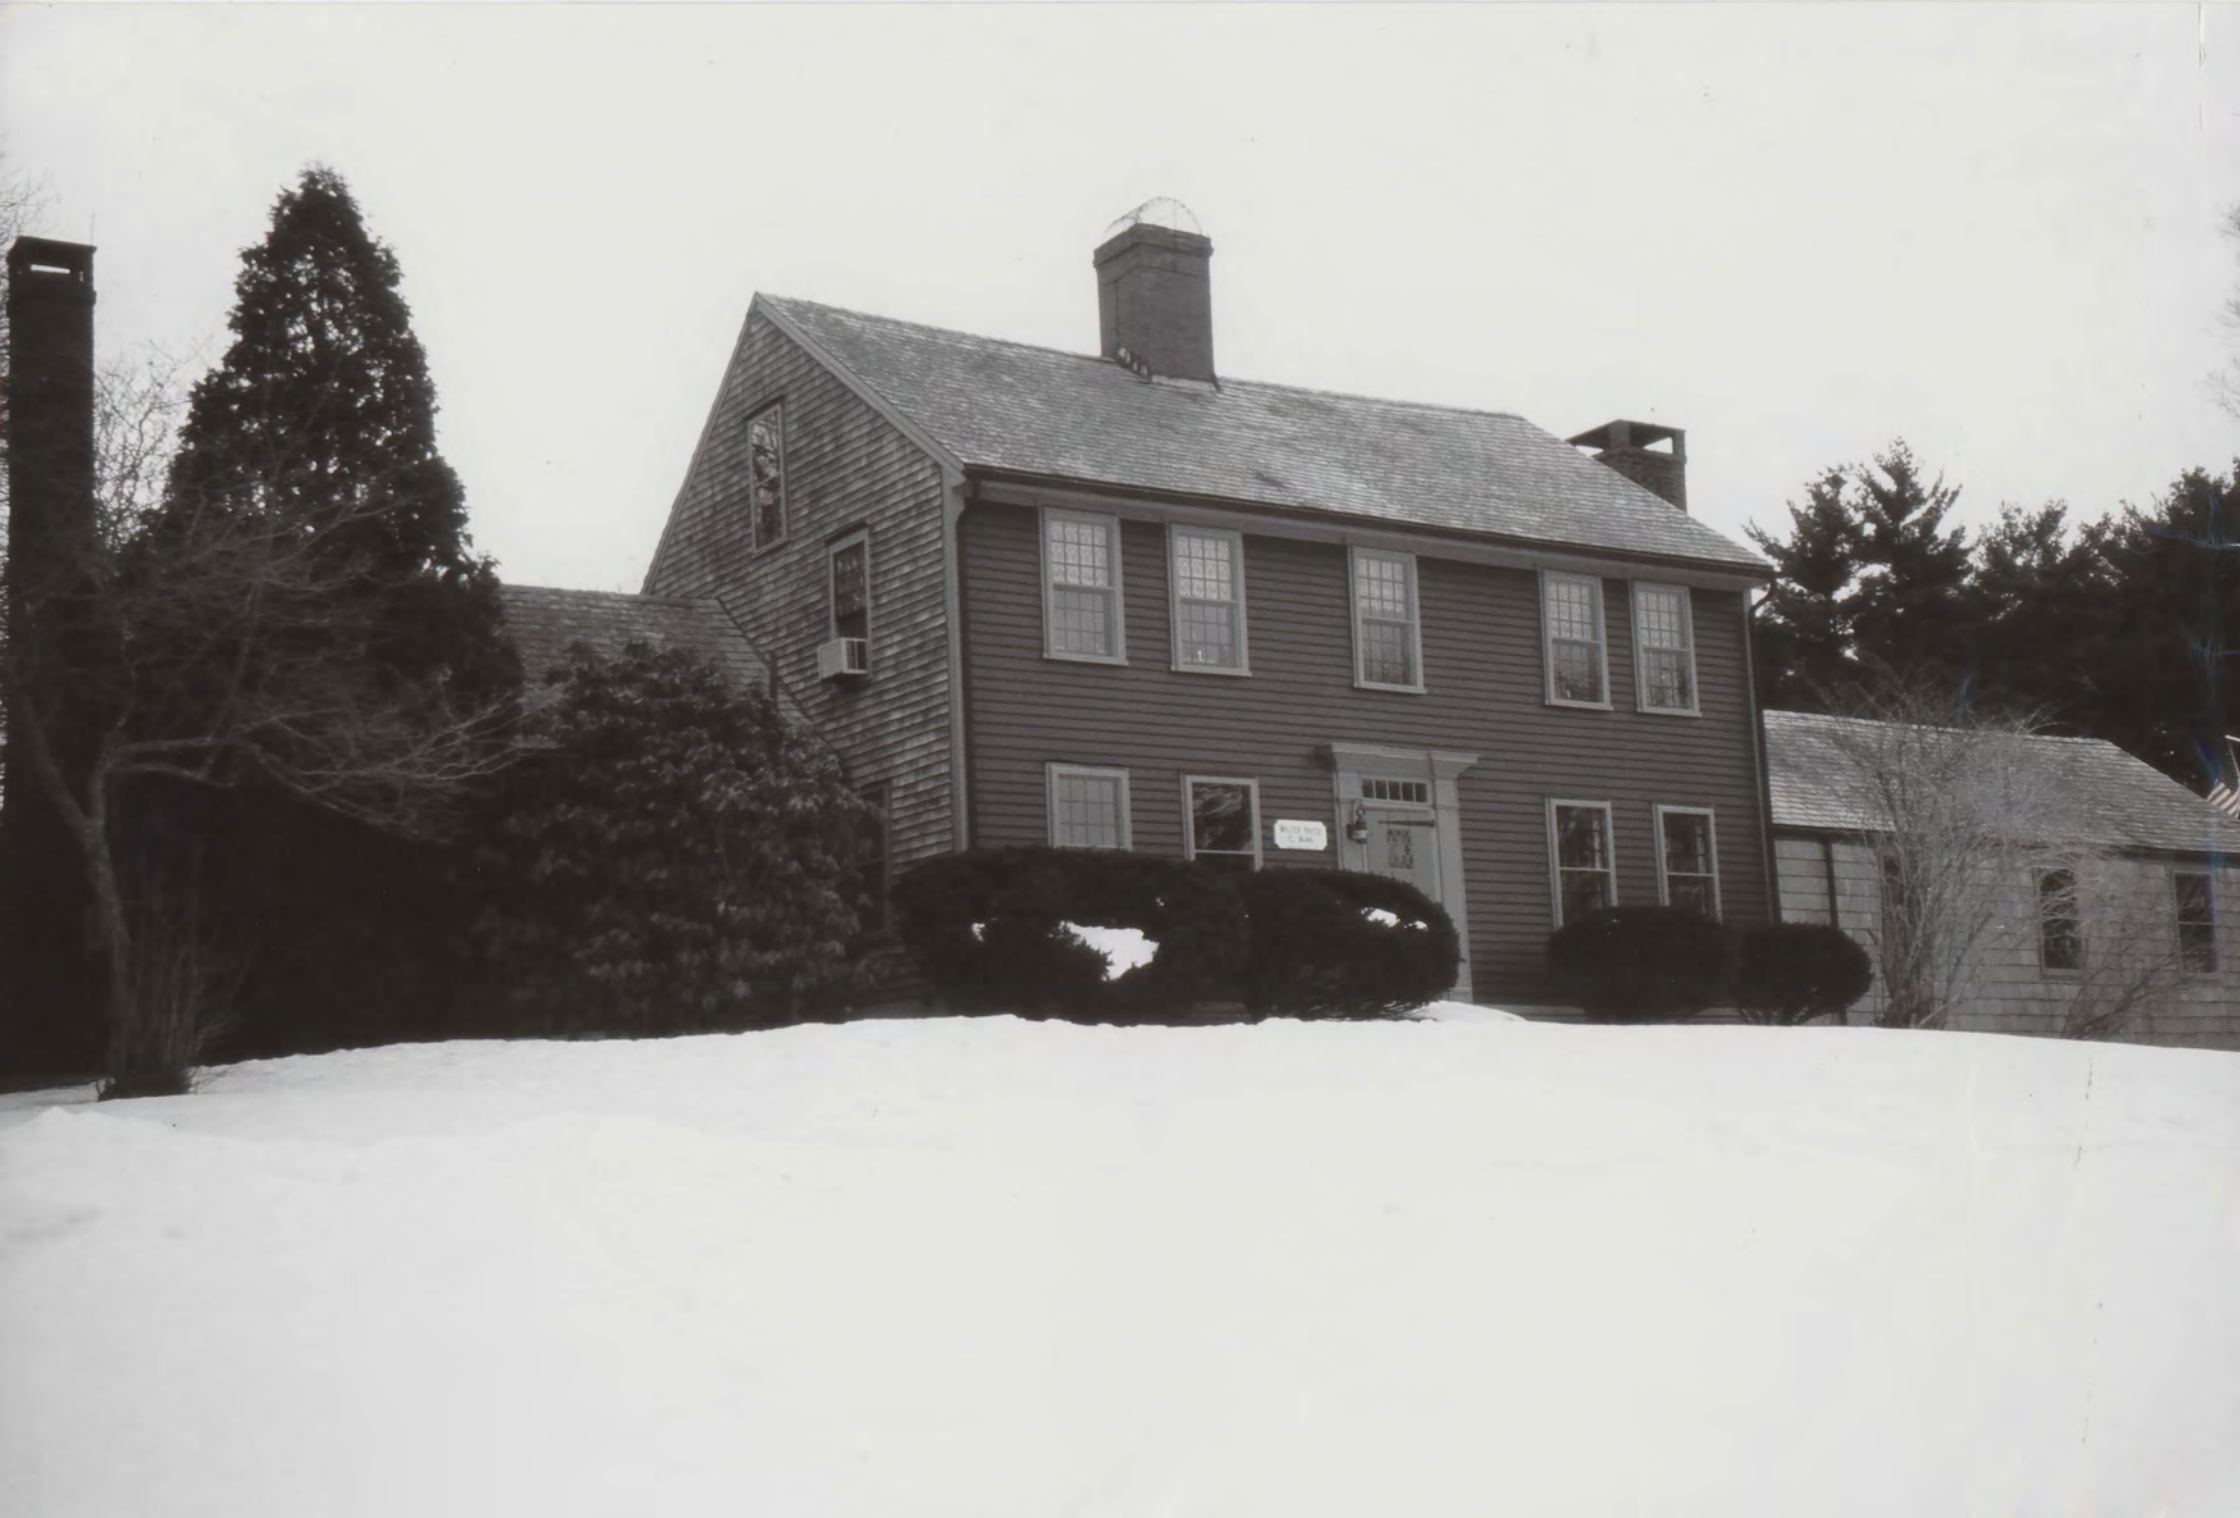
Photo 1 of 10

MAIN BLOCK ... NORTH & EAST ELEVATIONS... FACING SOUTHWEST.

The Hatch Homestead consists of a central 2½-story main block flanked by two small, single-story additions. (Photo 1)

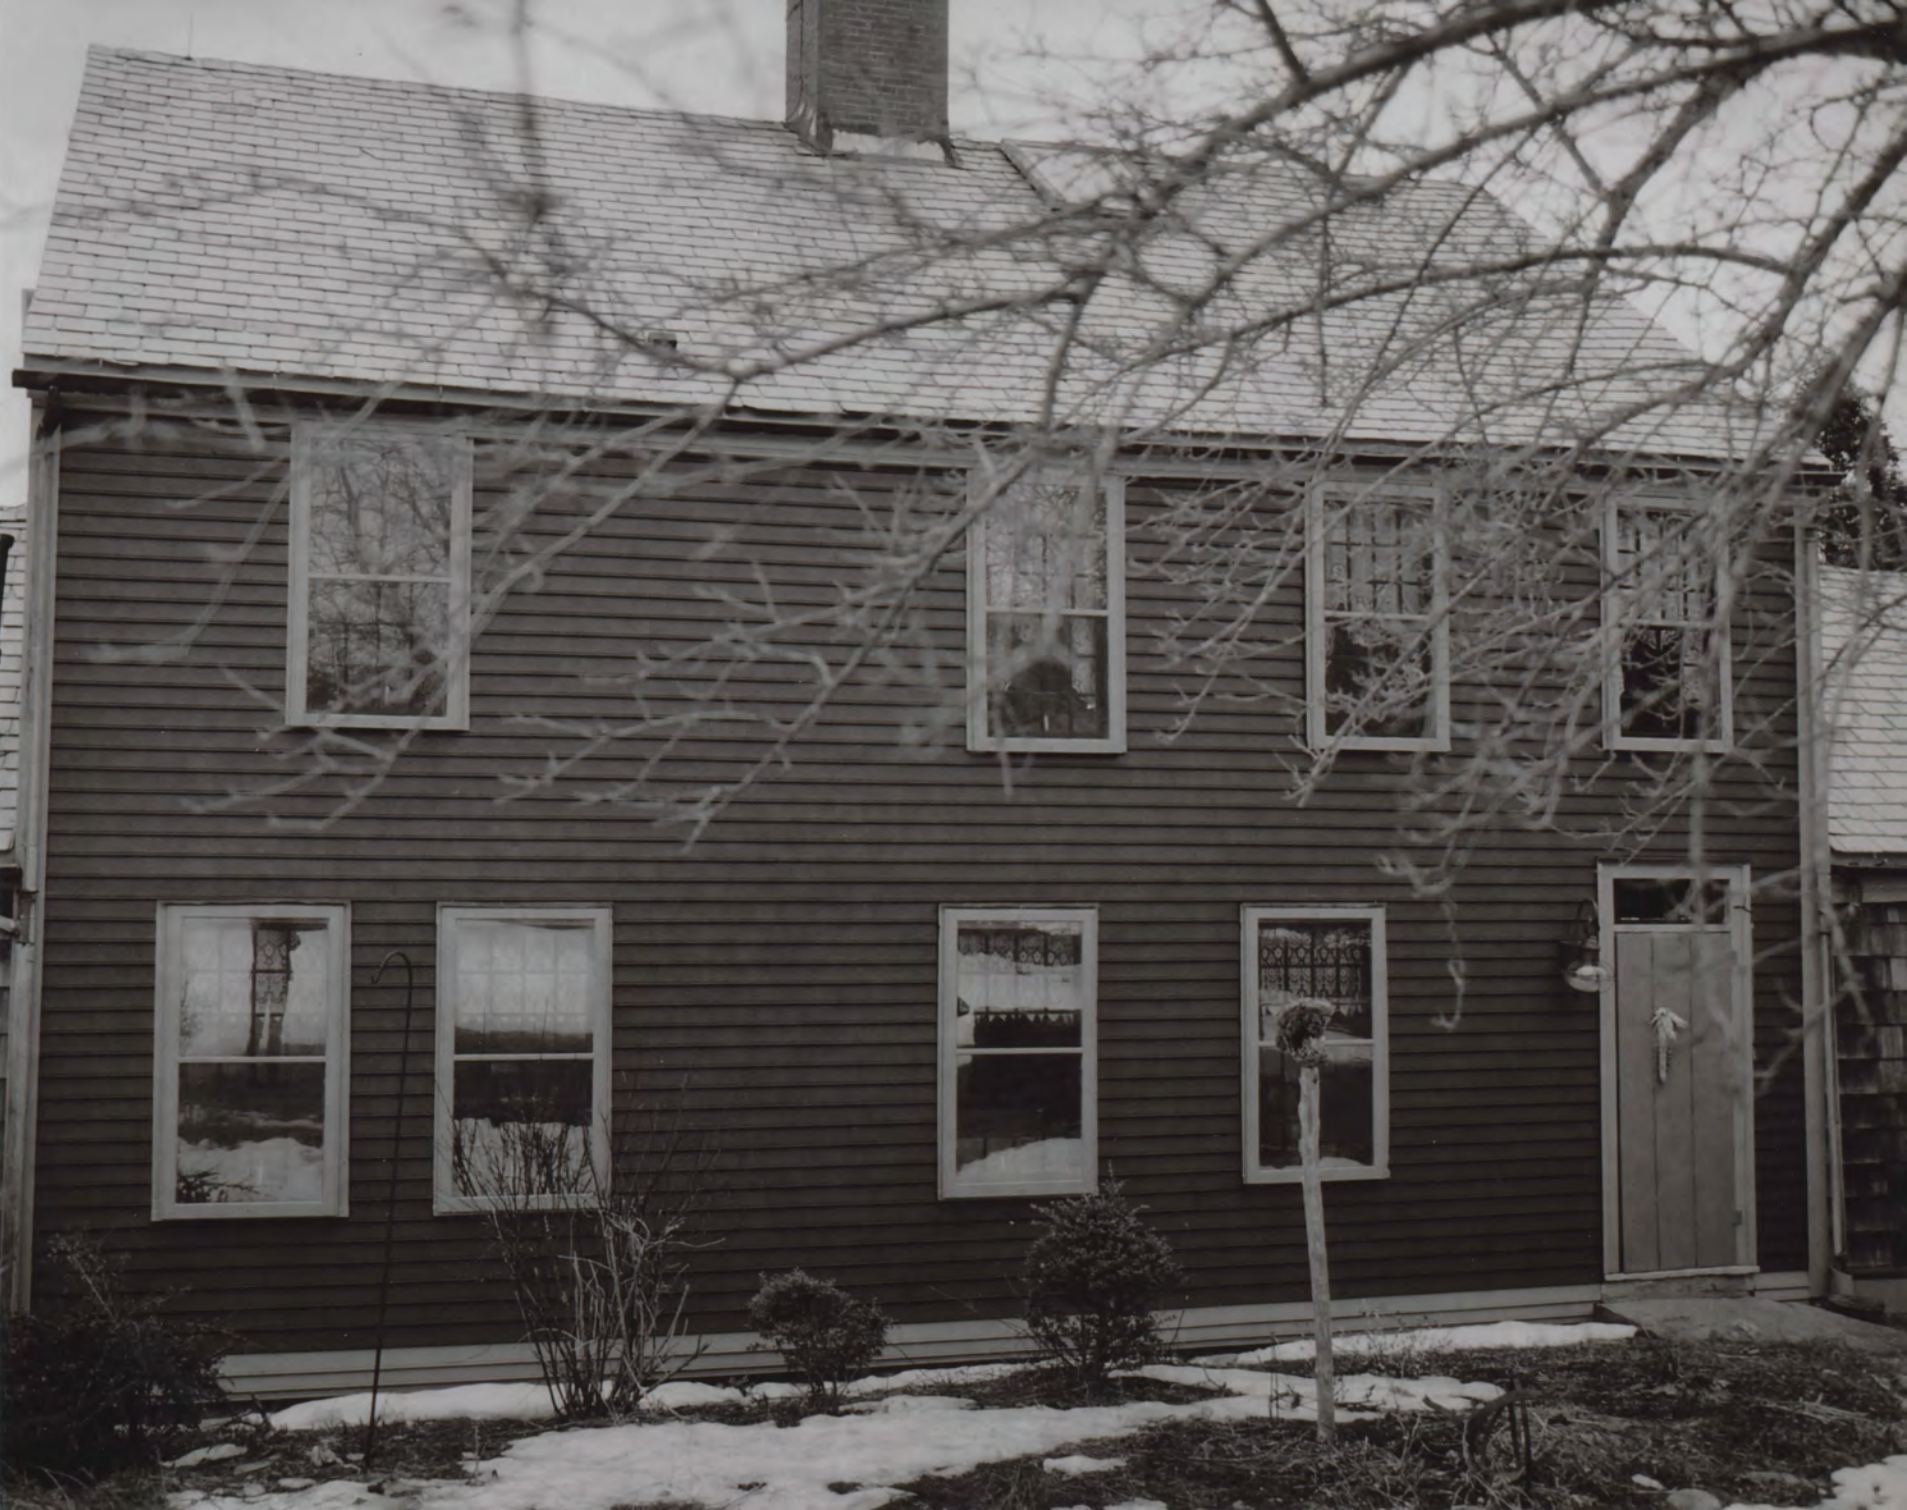
Hatch Homestead
385 Union St.
Marshfield, MA
Photo 3 of 10

DETAIL of REAR ELEVATION... MAIN BLOCK... VIEW NORTH

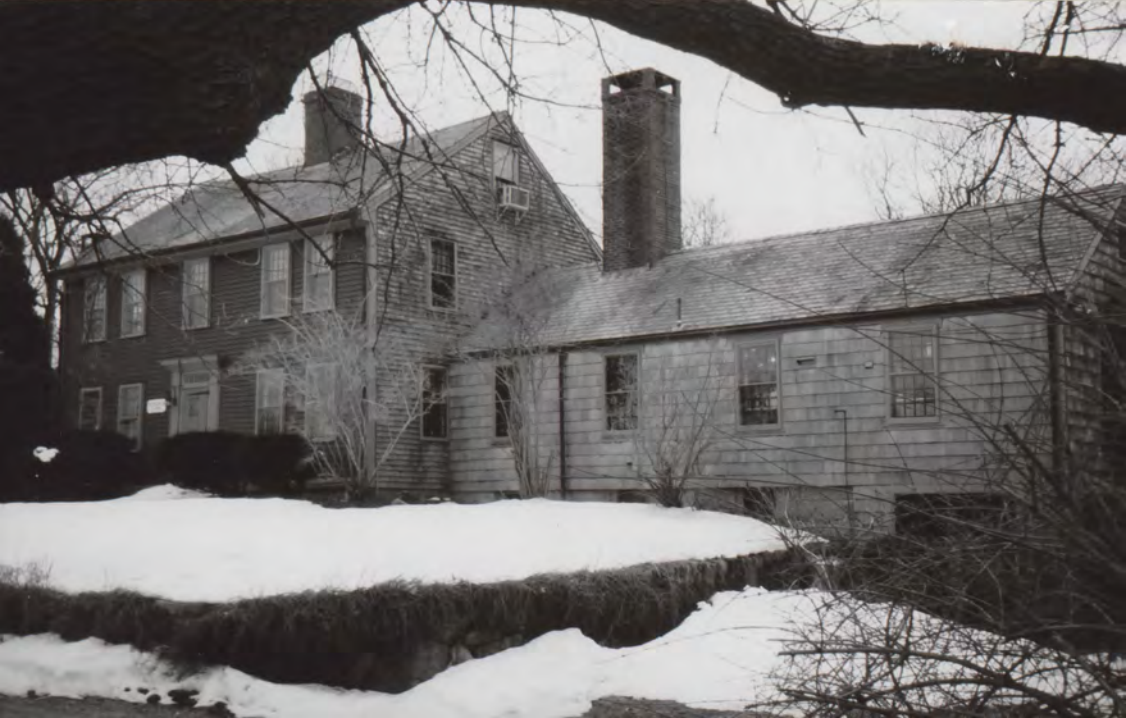
Hatch Homestead
385 Union St.
Marshfield, MA
Photo 4 of 10

MAIN BLOCK ... NORTH & WEST ELEVATIONS ... VIEW
SOUTHEAST

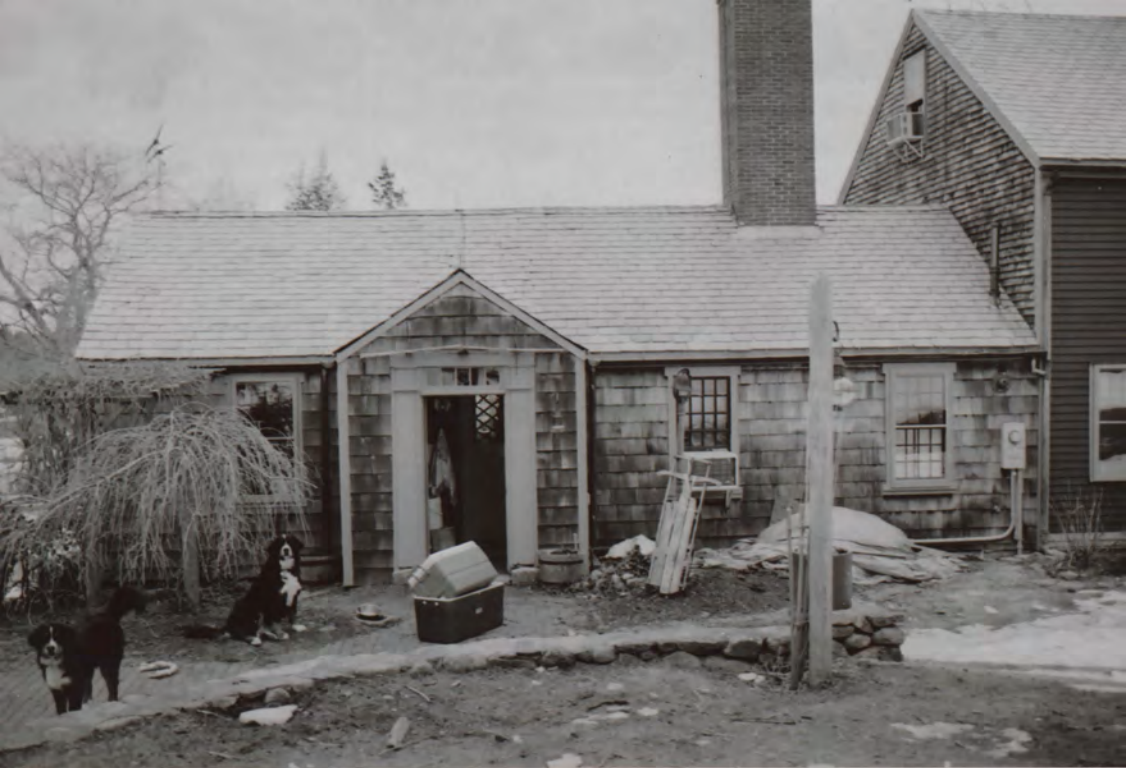
Photos of 10

WEST WING... REAR ELEVATION... VIEW NORTH

The west addition was built in two phases. The three easternmost bays were part of a connector that formerly joined the house to a large barn (see attached ca. 1900 photos). The barn and a portion of the connector were removed by 1936, as evidenced by Historic American Building Survey photographs of the house taken that year. In 1968, a porch was constructed off the west end of the connector. At the same time, a large brick chimney was built in the connector. The porch was enclosed and expanded in 1972 to create the existing western bay of the addition. (Photo 4) The 1972 renovation included installation of a picture window and doorway at basement level, and a bay window at the first floor. At that time, an entry enclosure was also constructed on the rear (south) face. The entry sheltered by the enclosure contains a modern wood door. Today, the west addition has unpainted wood-shingle siding, a simple boxed cornice, and modest wood trim, in the form of narrow cornerboards, window surrounds, and rake boards. (Photo 5)

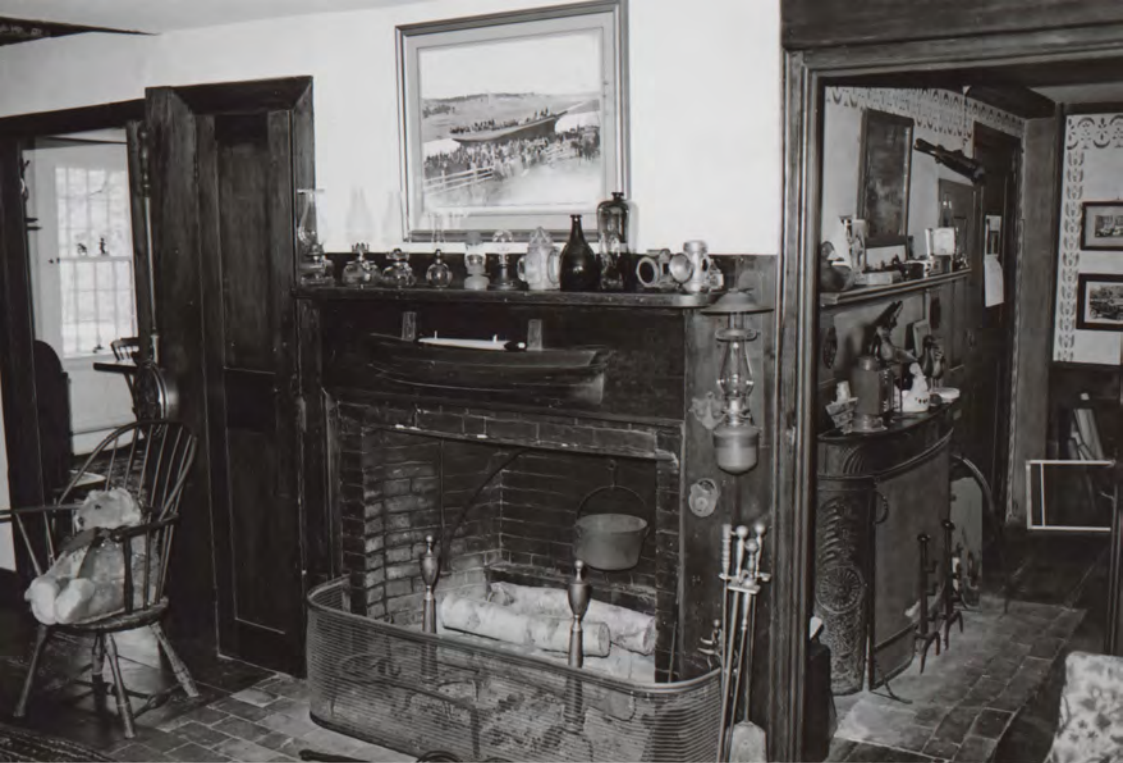
SOUTH (LEFT) and EAST FIREPLACES ... 1st FLOOR ...
MAIN BLOCK ... VIEW NORTHWEST.

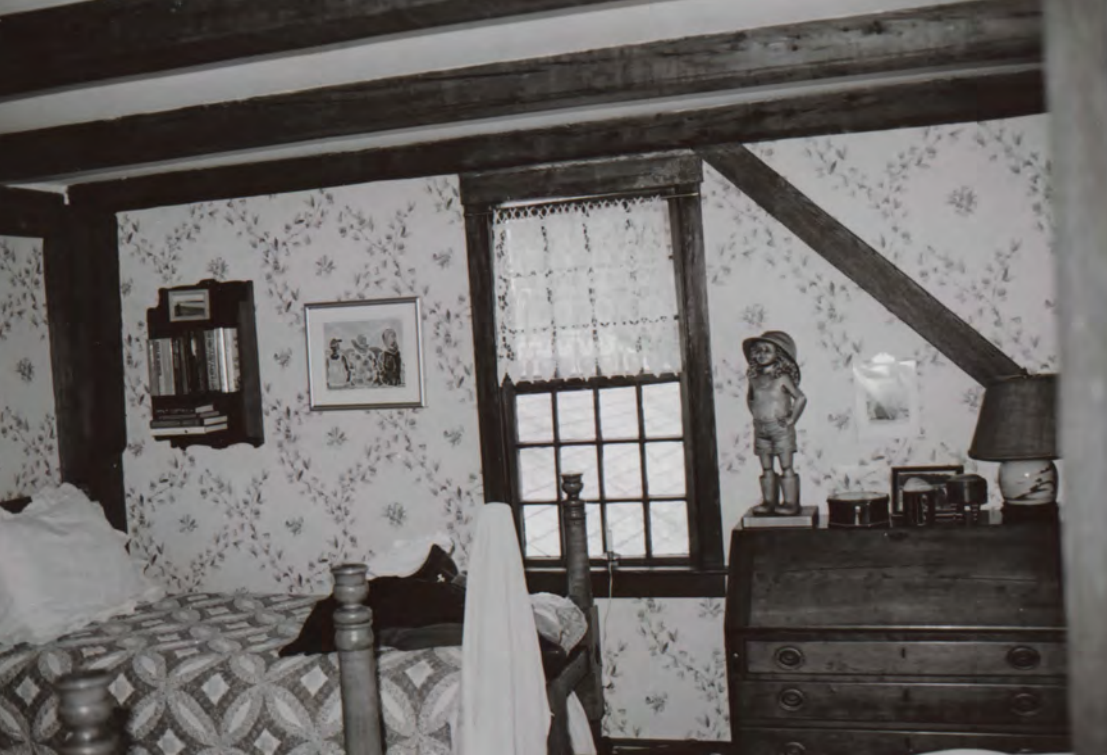
Hatch Homestead
385 Union St.
Marshfield, MA
Photo 9 of 10

EXPOSED FRAMING... 2nd FLOOR... NORTHWEST ROOM...
VIEW WEST

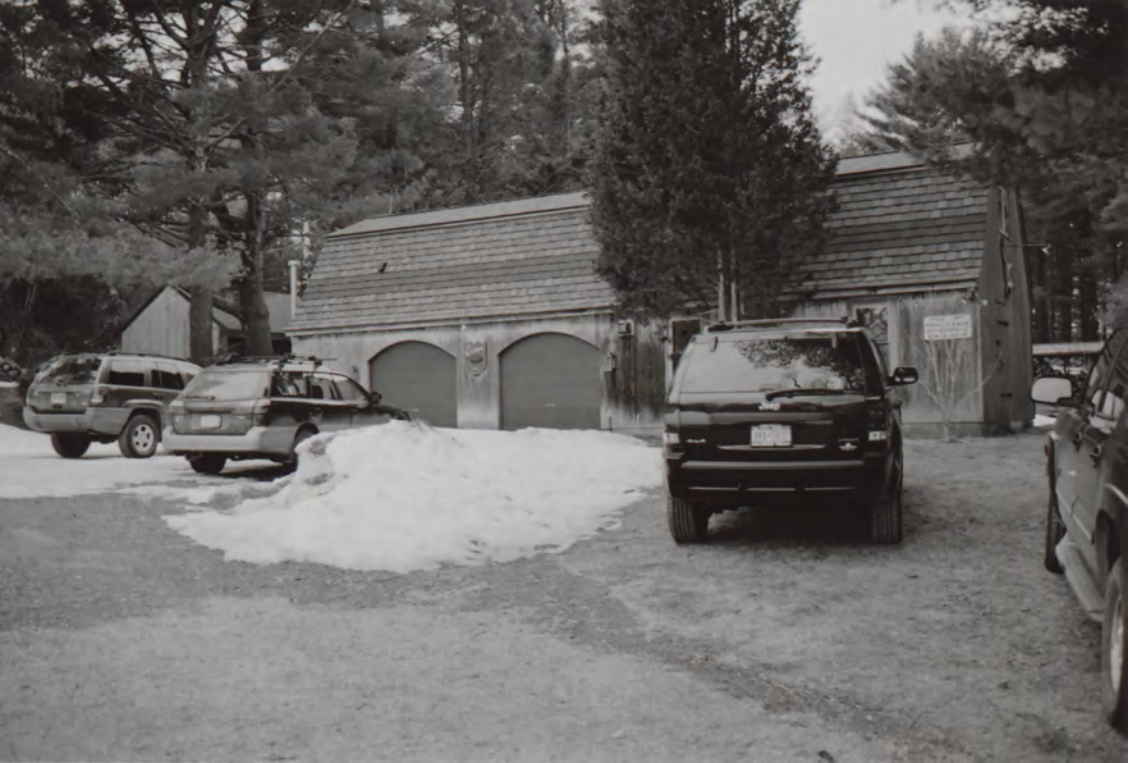
Hatch Homestead
385 Union St
Marshfield, Mass
Photo 10 of 10

CHRISTINE BEARD photo MARCH 2005
WEST ELEV. of GARAGE, SOUTHWEST VIEW

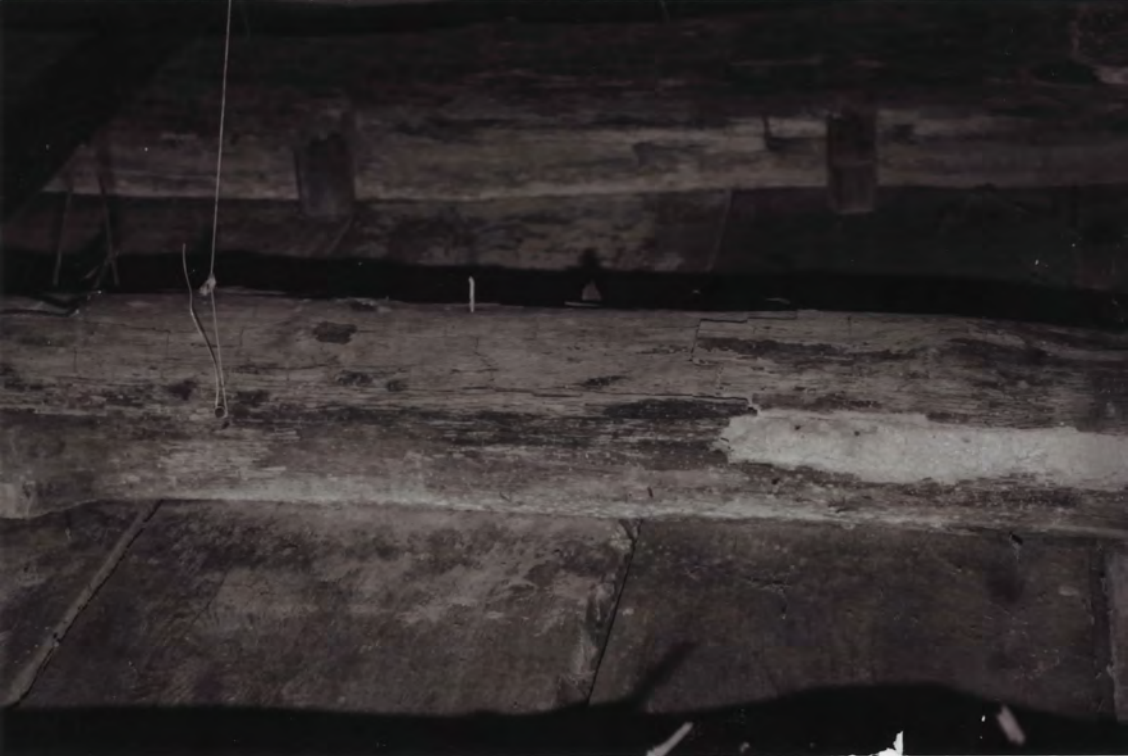
Photo 11 of 19

CELLAR ... HALF LOG JOISTS ... VIEW SOUTH

The cellar foundation of the Hatch Homestead was constructed in several phases, the earliest being beneath the parlor, main stairhall, and living room, where the exposed foundation walls are of fieldstone construction with rough log sleepers tied into the chimney girt. (Photos 11, 12) The area beneath the dining room is not excavated. The massive fieldstone chimney base occupies much of the space. A small alcove for root storage is tucked into the east sidewall. The basement stairs are made up of half logs. A narrow passageway, having the same construction as the early cellar, leads to a modern basement beneath the west wing.

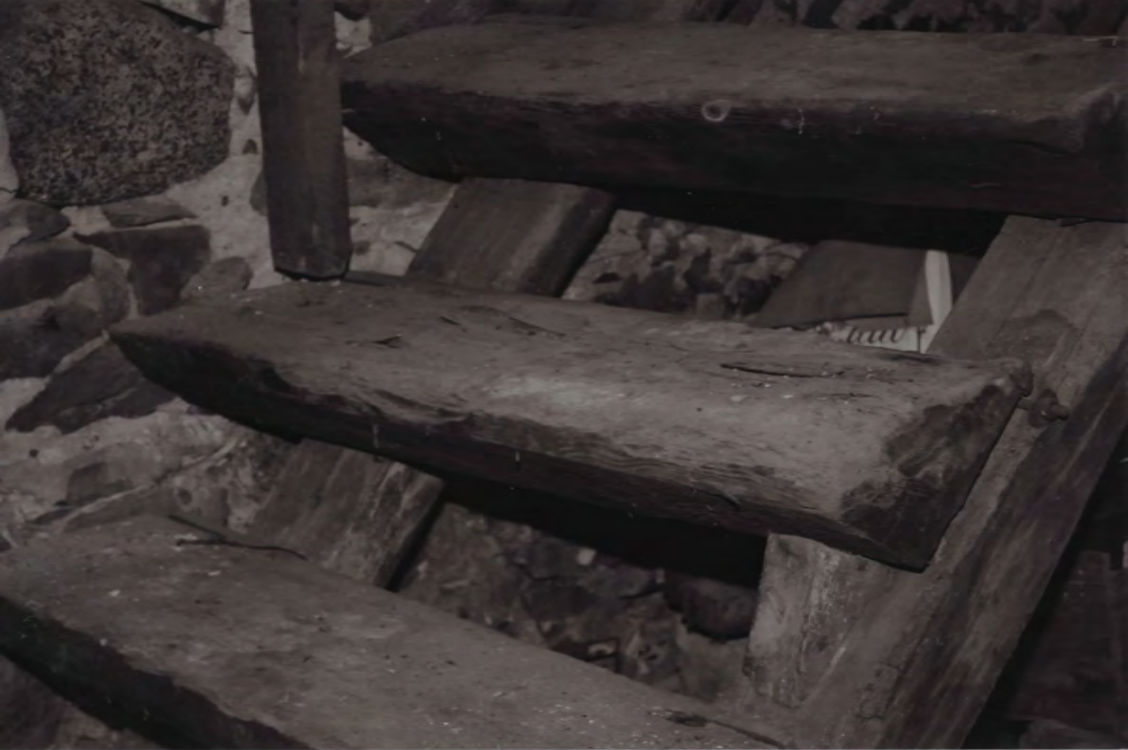
CELLAR ... HALF-LOG STEPS ... VIEW NE

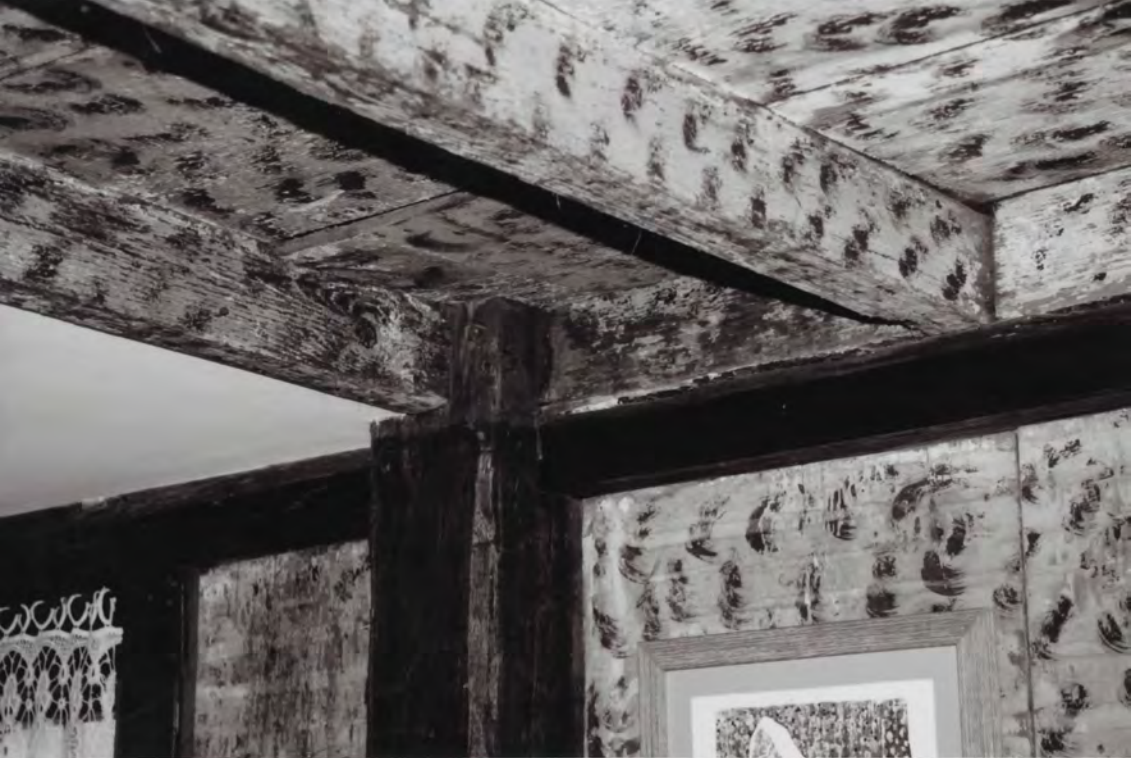
DETAIL, CHAMFERED POST and DECORATIVE WALL PAINTING.
... 1ST FLOOR ... LIVING ROOM ... VIEW SE

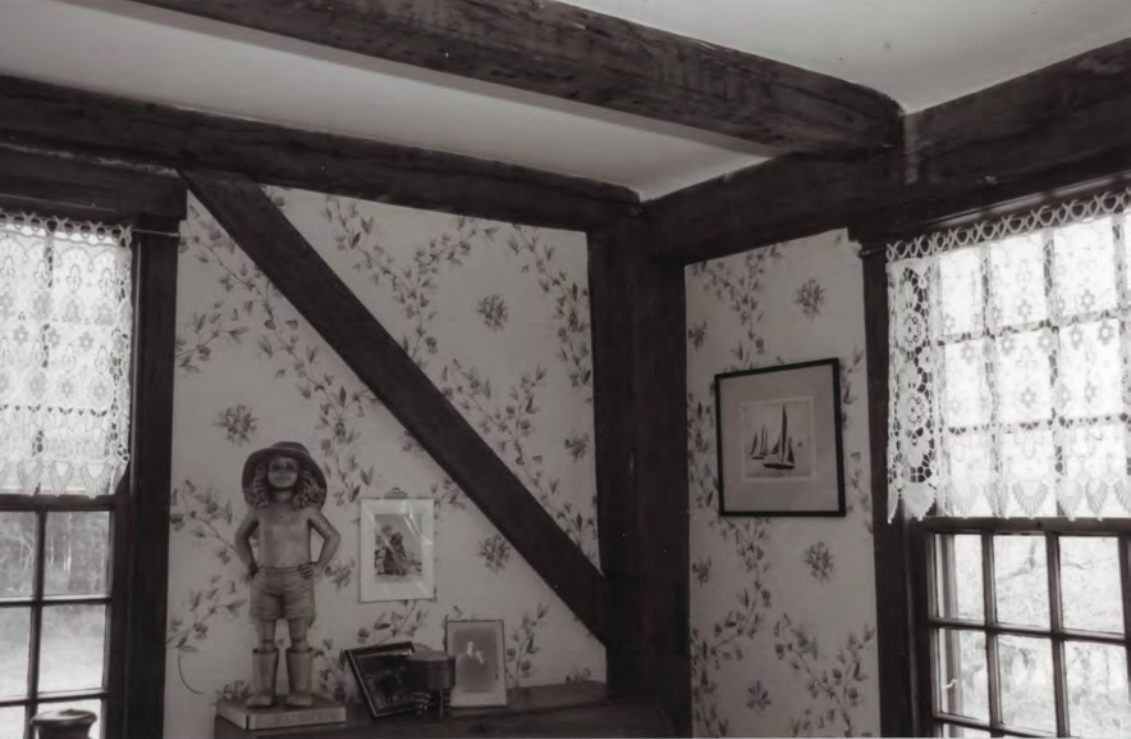
Walter Hatch Homestead
Marshfield (Plymouth County), MA
Photo 14 of 19

CHAMFERED CORNER POST... 2nd FLOOR ... NORTHWEST
BEDROOM ... VIEW SW

purlins or common rafters -- in which the interrupted, underlying tie beams (or joists) are well articulated in the second story ceilings. (Photo 14)

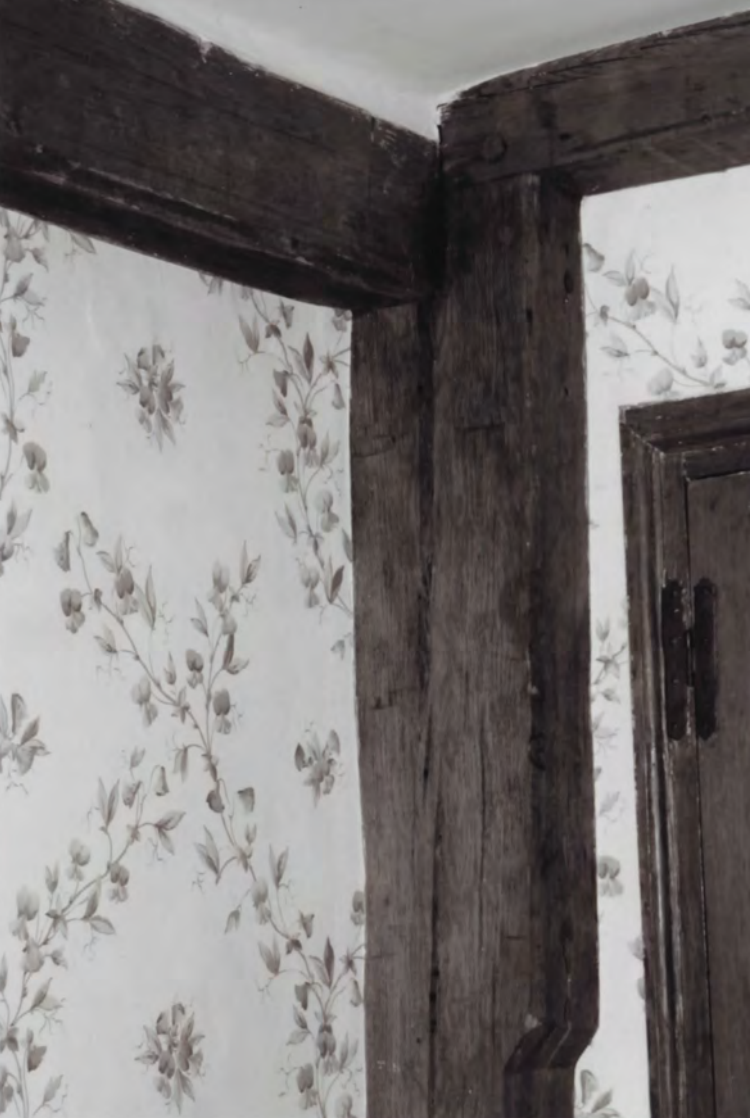
KNEE BRACE, CHAMFERED BEAM & CORNER POST... 2nd FL.
... REAR BEDROOM... VIEW SE

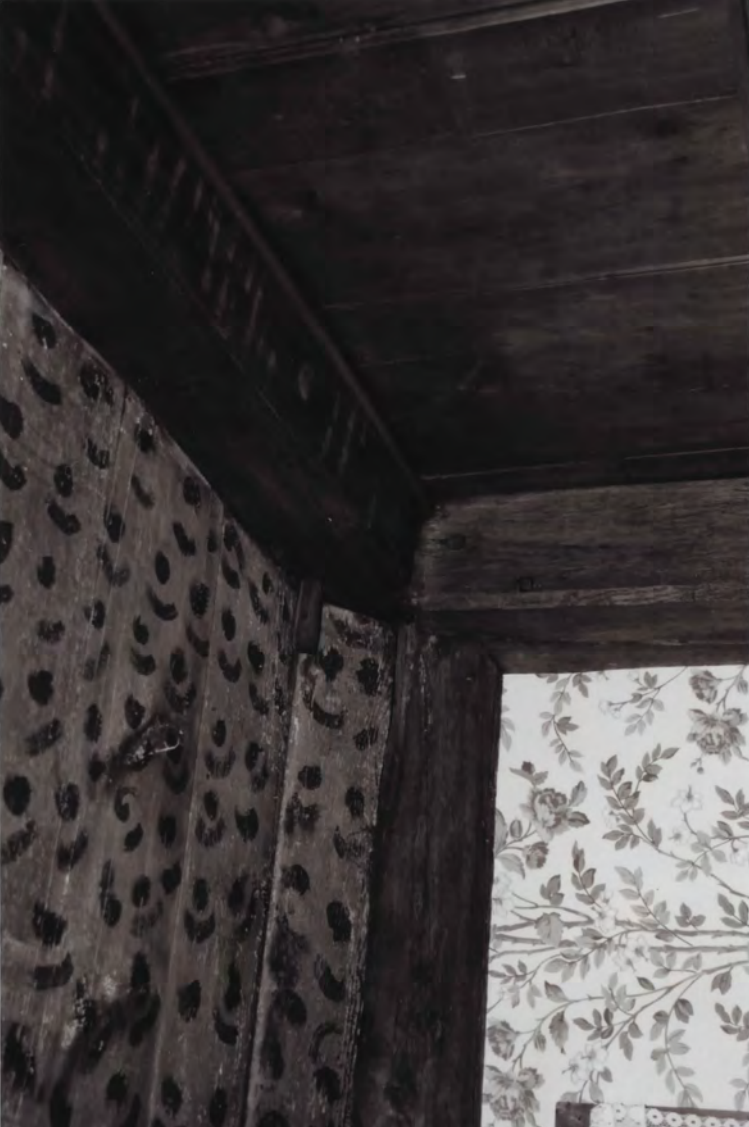
DETAIL ... CHAMFERED CORNER POST... 2nd FLOOR...
REAR BEDROOM... SW VIEW

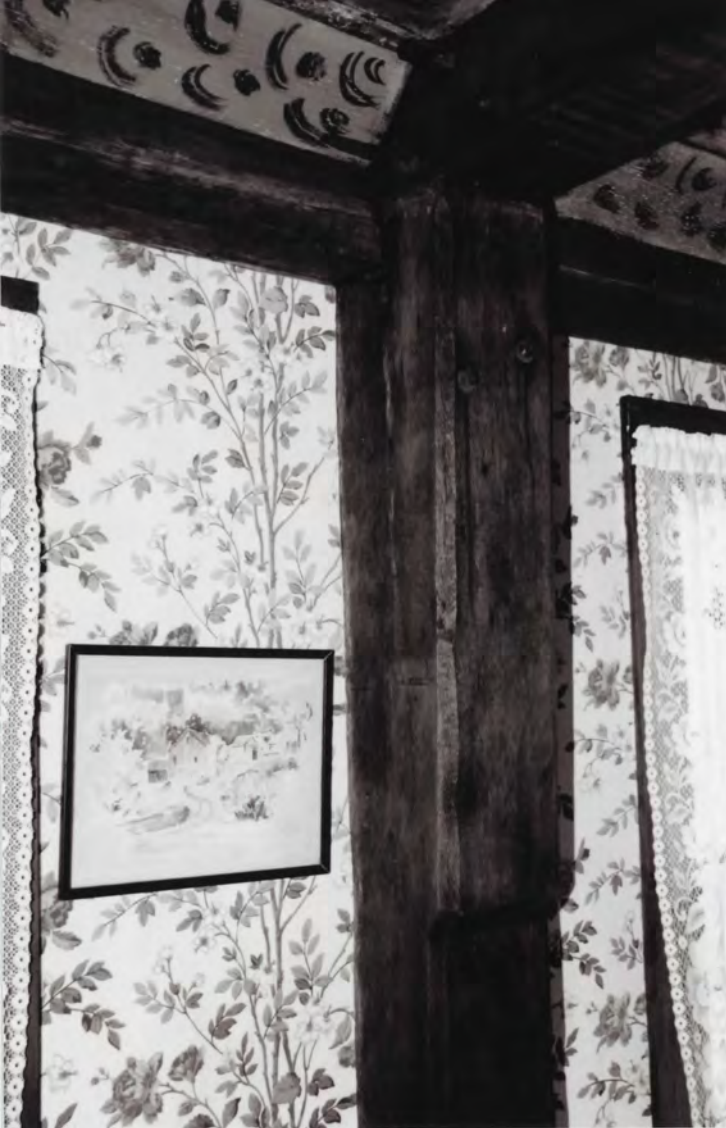
CHAMFERED POST... 2nd FLOOR... REAR BEDROOM
VIEW SW

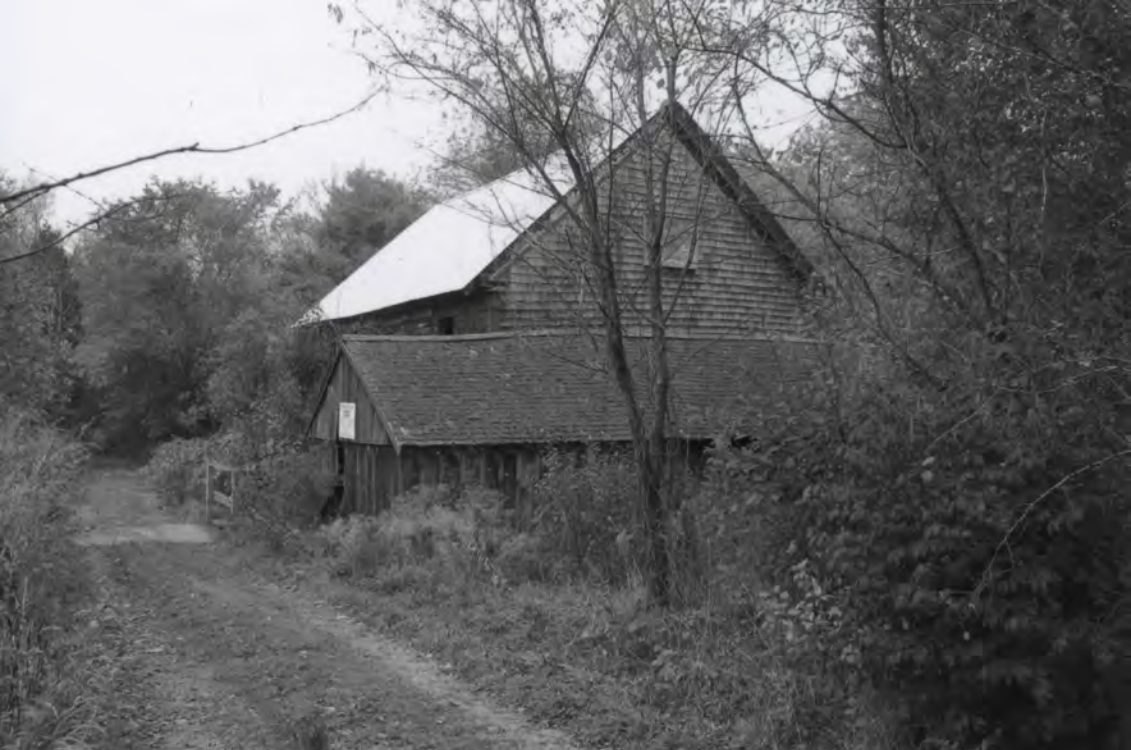
Hatch Mill
Plymouth County
Marshfield, MA
Photo 1 of 21

VIEW NE SHOWING SOUTH & WEST ELEVATIONS
OF MILL.

On the adjacent parcel to the Hatch Homestead is the Hatch Mill, a T-shaped, heavy timber-framed building that was constructed in multiple phases (Mill Photo 1). The older component, believed to have been built in 1812 as a sawmill,

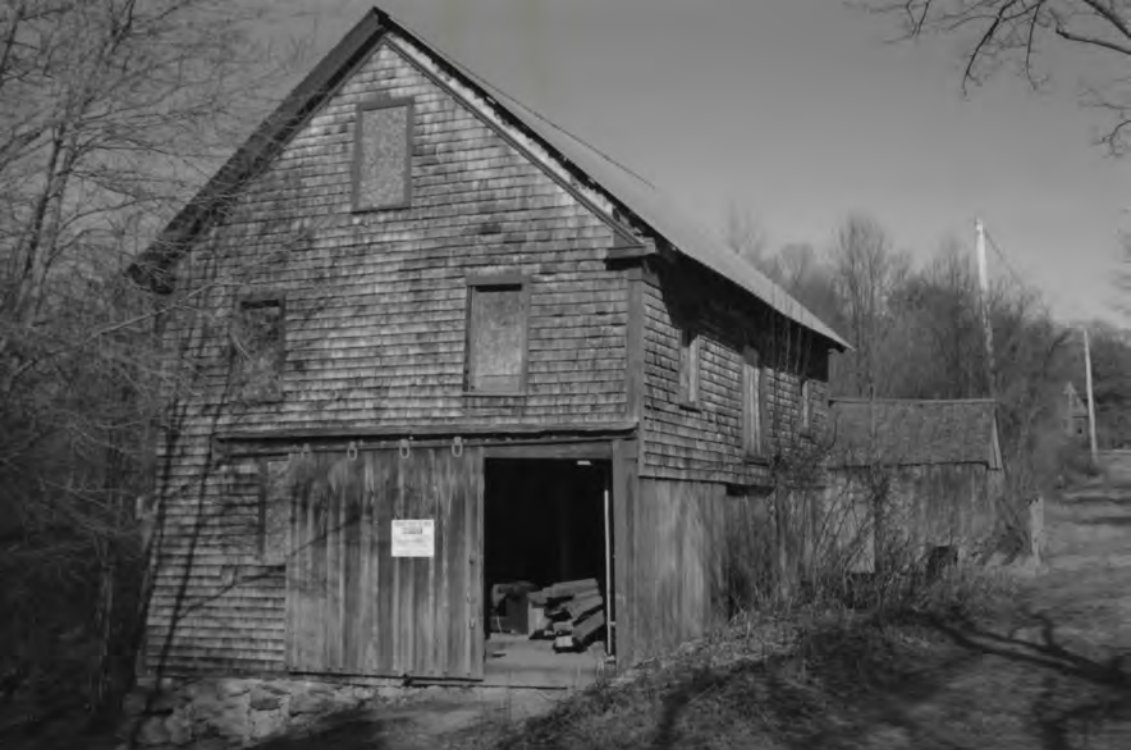
Hatch Mill
Plymouth County
Marshfield, MA
Photo 2 of 21

VIEW W SHOWING E ELEVATION OF MILL
MA - MARSHFIELD (PLYMOUTH COUNTY) - HATCHMILL 002.tif
CHRISTINE BEARD photo

is the one-story eastern portion (Mill Photo 2), which with subsequent additions measures roughly 15 feet by 60 feet. The two-story western portion of the building is approximately 29 feet by 53 feet and is believed to have been constructed in 1859; the earliest known use was for the manufacture of wooden boxes.

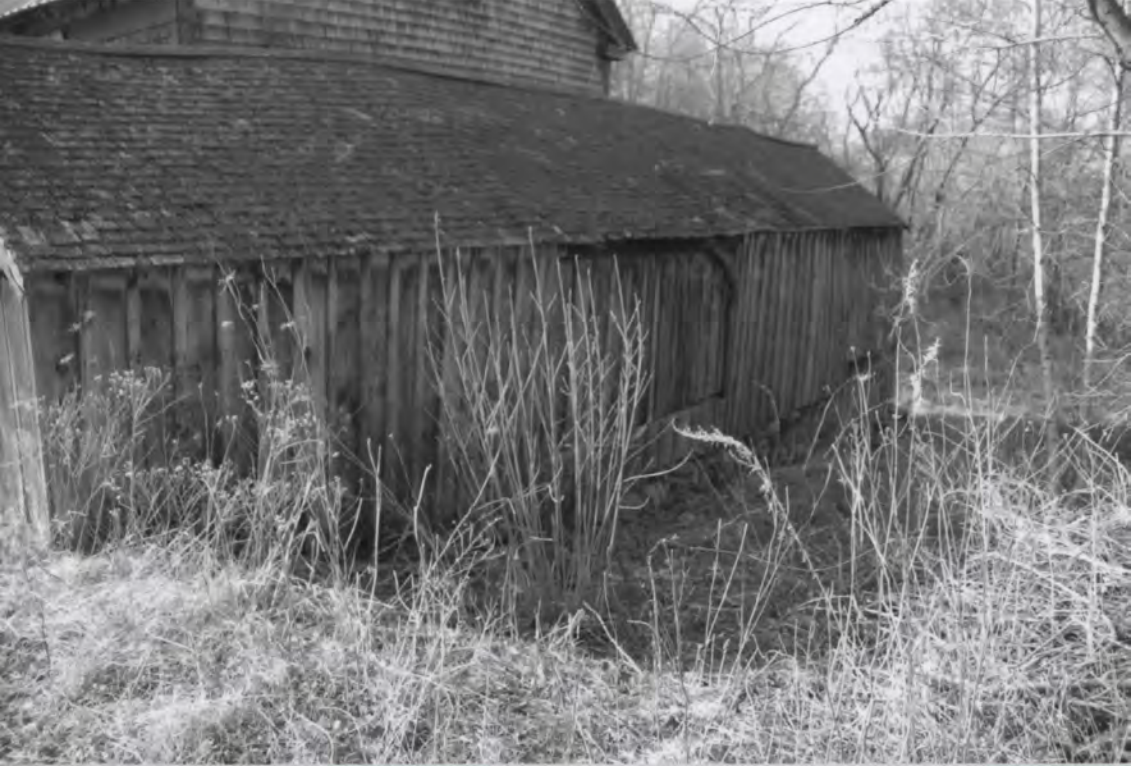
Hatch Mill
Plymouth County
Marshfield, MA
Photo 3 of 21

VIEW NE SHOWING E ELEVATION OF SAW MILL
SECTION

The sawmill is a single-story, heavy timber frame structure enclosed by a gable roof covered with wood shingles that are modern (1974) replacements. (Mill Photo 3) The original, ca. 1812 core of the building frame consists of the two central bays composed of three bents set on a substantial fieldstone foundation. This was extended by additions to the north and south. In the 1812 core, hewn pine was used for the center bent, and hewn oak was used for the end bents. This use of pine and oak is indicative of a late 18th- or early 19th-century structure, as is the use of a lead screw auger on the framing. The frame was laid out using scribe rule, which was used until ca. 1825 in this area. The bents are marked using Roman numerals I, II, III on the reference face of the tie beams. The sash mechanism for the saw is framed into the center bent. English tying joints are used to join the posts, plates, and rafters. While this joint went out of favor for use in houses by the end of the 18th century, it can still be seen in service buildings until the 1850s. The ca. 1812 core is a rather short building for saw operations and would have been capable of producing timbers only of limited length. This may indicate that this building was always intended to be a boxmill. There is a ca. 1820s, single-bay addition of scribe-rule, hewn-pine framing on the north. It rests on a combination of wood posts (from 1983) and rubble footings and is framed independently of the main block. An addition to the south is of uncertain date due to the fact that it was completely reconstructed in the restoration work of 1983 (Photos 3 & 16). There are no scars on the south face of the earliest framing to show that exterior siding was ever attached, indicating that perhaps there was always some sort of construction off the south end of the sawmill. Photographs from 1958 and the 1960s confirm that at one time the northeast and southeast corners of the sawmill were without siding and open to the exterior. A photo taken in 1968 confirms that the south bay had been fully enclosed by then.

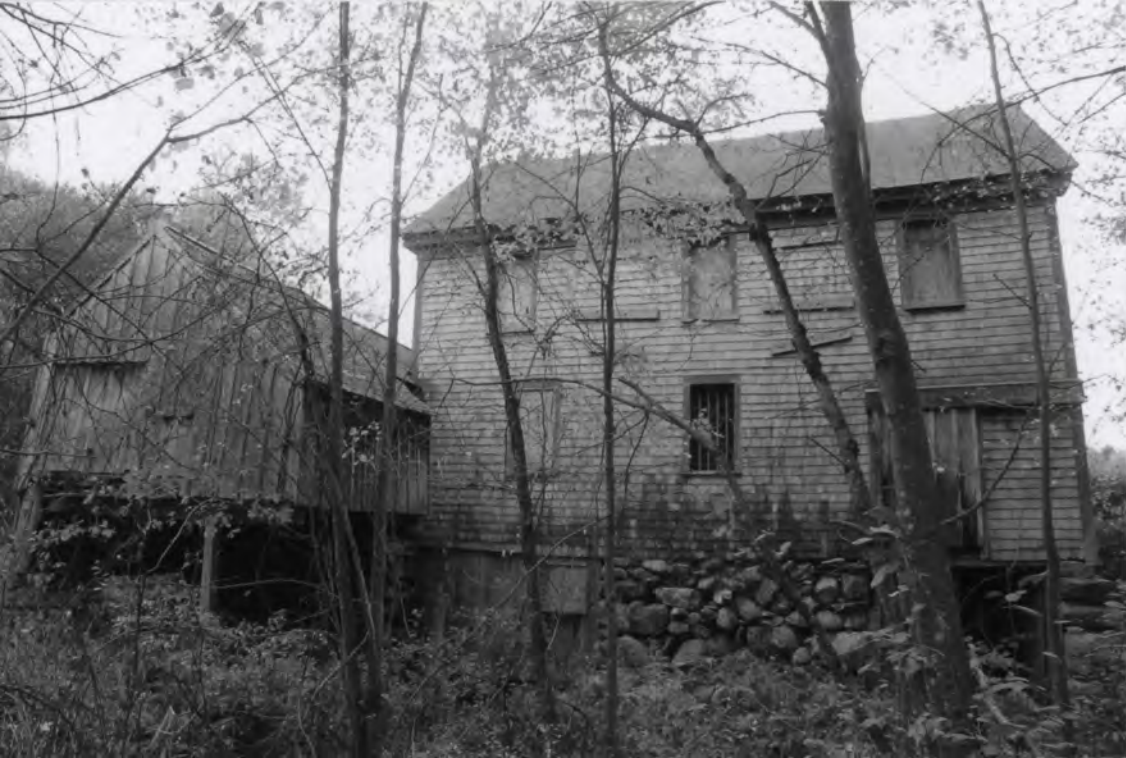
Hatch Mill
Plymouth County
Marshfield, MA
Photo 4 of 21

VIEW SE SHOWING N ELEVATION OF MILL
MA - MARSHFIELD (PLYMOUTH COUNTY) - HATCHMILL004.tif

There are two secondary entries, both located in the westernmost bay of the north elevation (one at the main level and another at the lower level – Mill Photo 4). These two doorways served as access between the mill and a small rear ell, which was used to store sawdust. The ell was removed around 1970 after becoming dangerously unstable. Remnants of the stone foundation remain. Today the upper doorway holds a sliding board-and-batten door, while the lower entry has a set of double doors made of vertical wood planks. Both doors appear to date to the 1976 restoration. In addition to these entries, fenestration at the north elevation includes two windows at the main level and three windows at the upper level. At the east end of the lower level, where the tailrace exits the mill, there is an opening for the sluice gate. The opening currently holds a metal security grille covered by vertical planking that was installed in the 1970s to secure the opening.

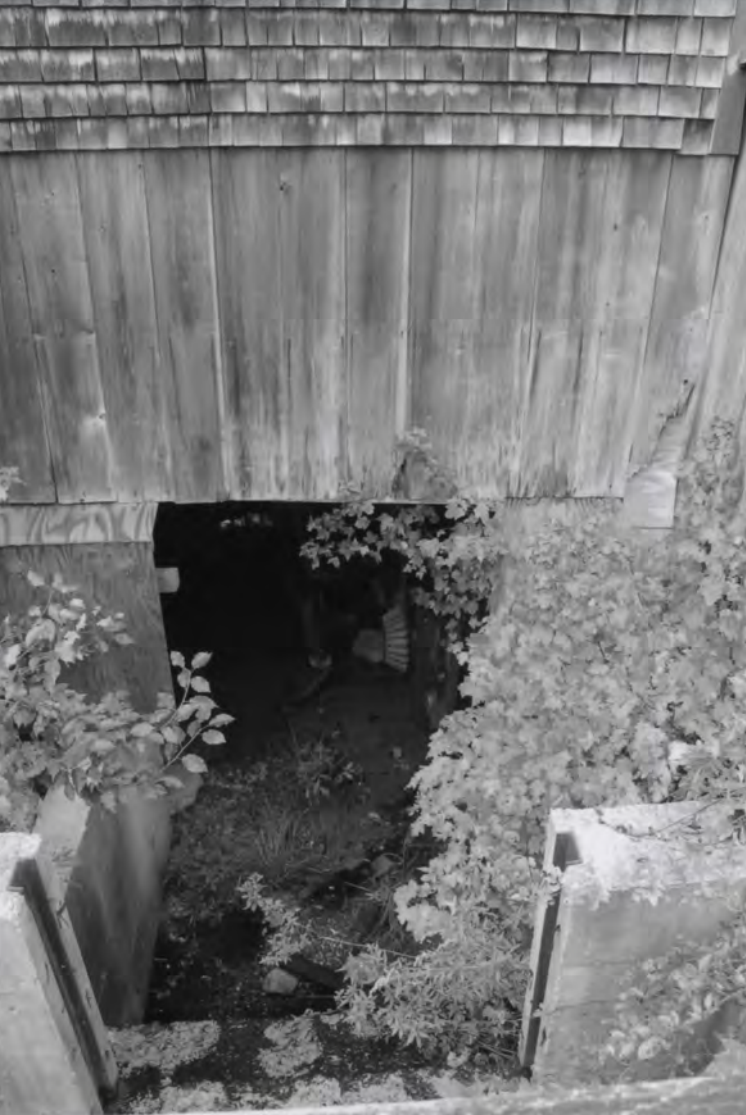
Hatch Mill
Plymouth County
Marshfield, MA
Photo 5 of 21

VIEW N SHOWING HEADRACE
OPENING IN BOX MILL SECTION
