National Register of Historic Places
Registration Form

historic name Hatch Homestead and Mill HD

other names/site number "The Red House"

street & number 385 Union Street not for publication

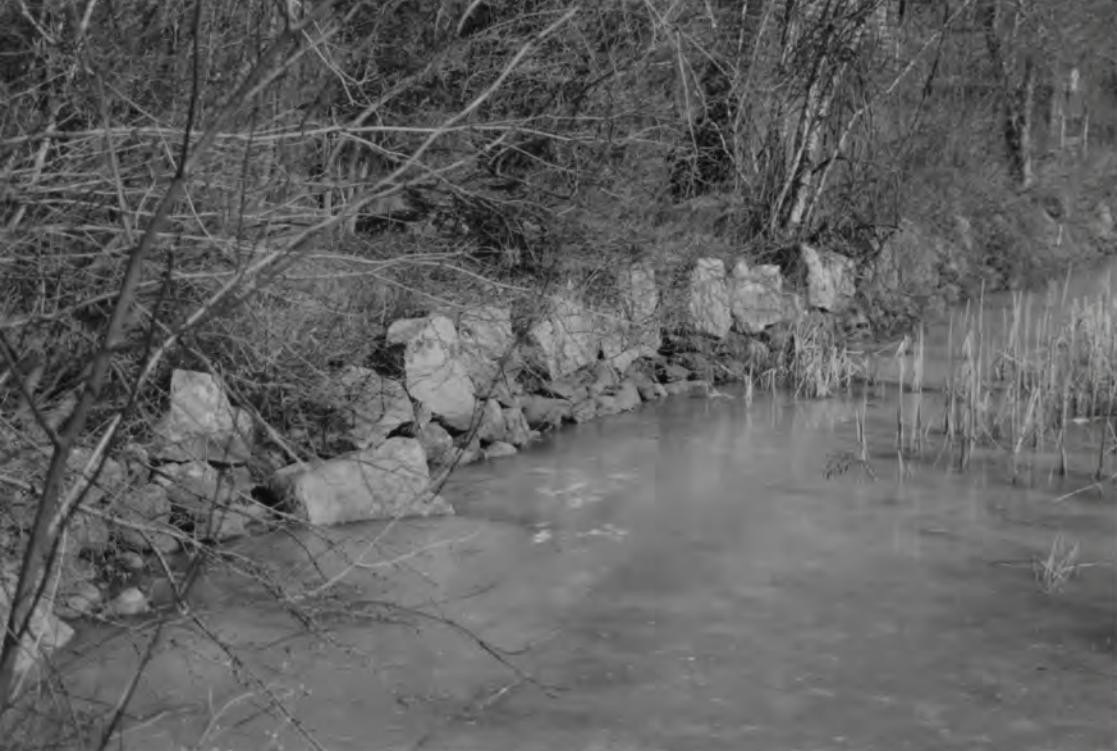
Hatch Mill
Plymouth County
Marshfield, MA
Photo 6 of 21

VIEW NE SHOWING SOUTH FACE OF DAM.

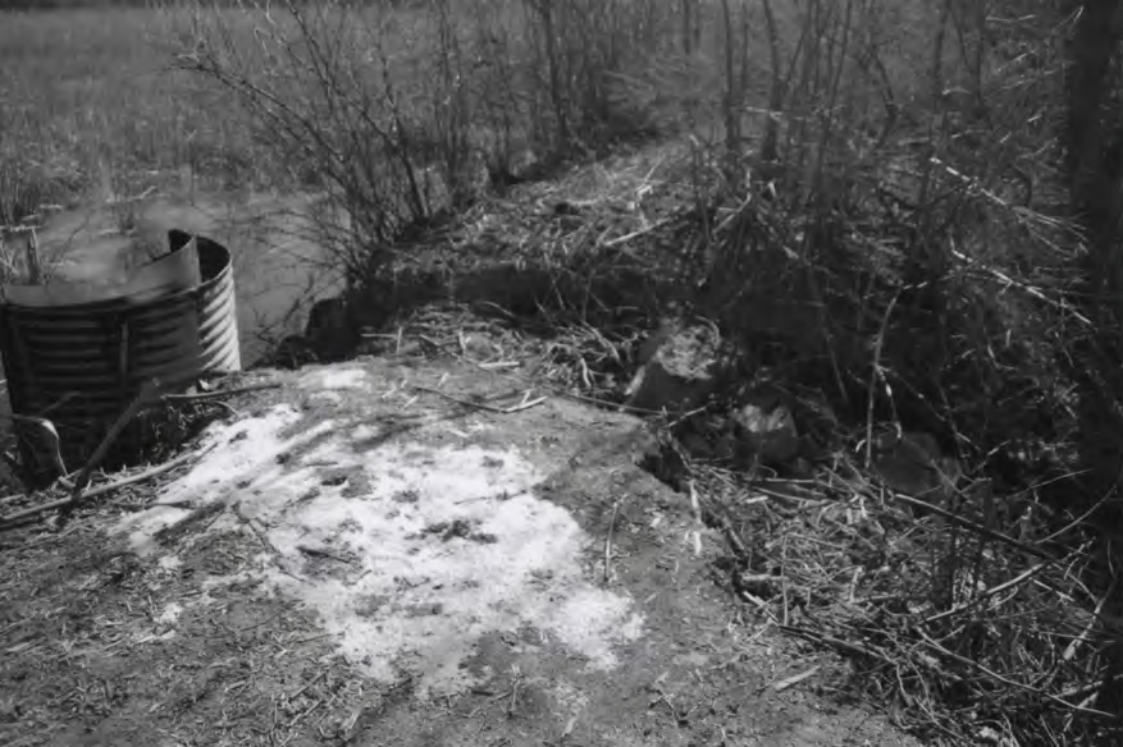
Hatch Mill
Plymouth County
Marshfield, MA
Photo 7 of 21

VIEW S SHOWING SPILLWAY

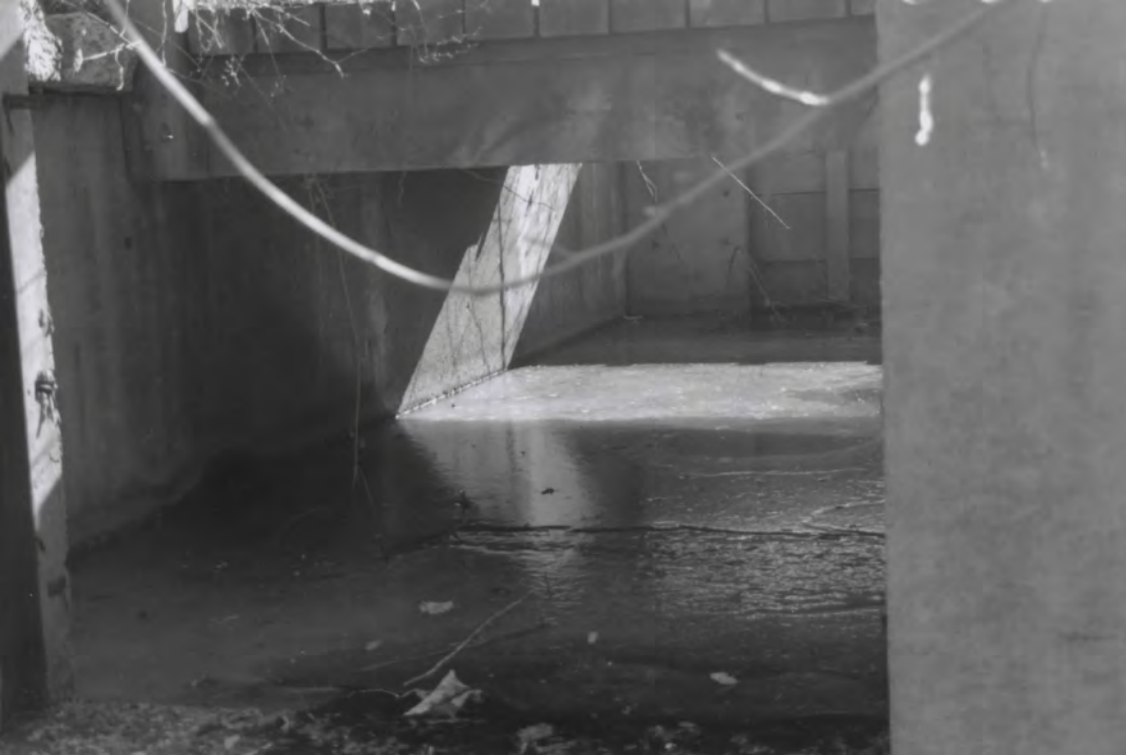
Hatch Mill
Plymouth County
Marshfield, MA
Photo 9 of 21

VIEW S IN FROM FRONT LOWER LEVEL OF BOX
MILL SHOWING HEADRACE FLUME.

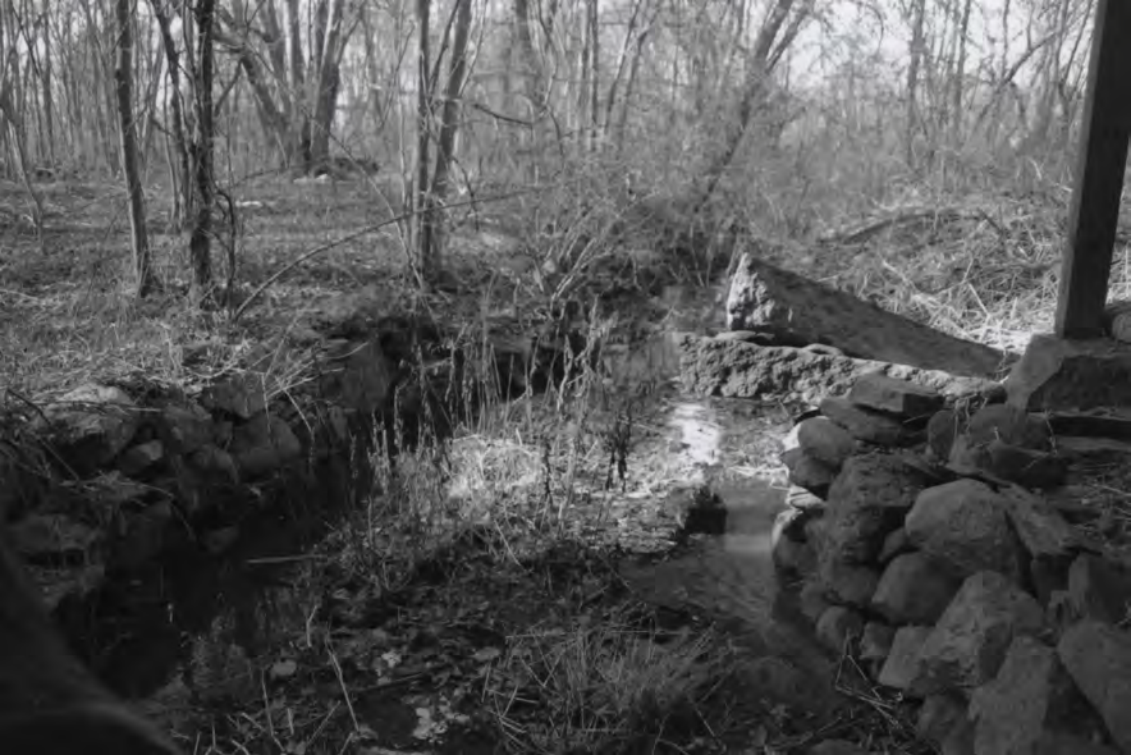
Hatch Mill
Plymouth County
Marshfield, MA
Photo 10 of 21

VIEW N SHOWING TAILRACE

The Tailrace, which diverted spent water from the mill, exits the lower level of the mill from the north side (Mill Photo 10). The banks of the tailrace channel are formed by fieldstone retaining walls that extend approximately 12 feet from the mill and vary in height from about two to three feet. The tailrace is roughly seven feet wide. The retaining walls of the tailrace terminate in the location of a former footbridge; remnants of its foundation and framing remain (Mill Photo 11).

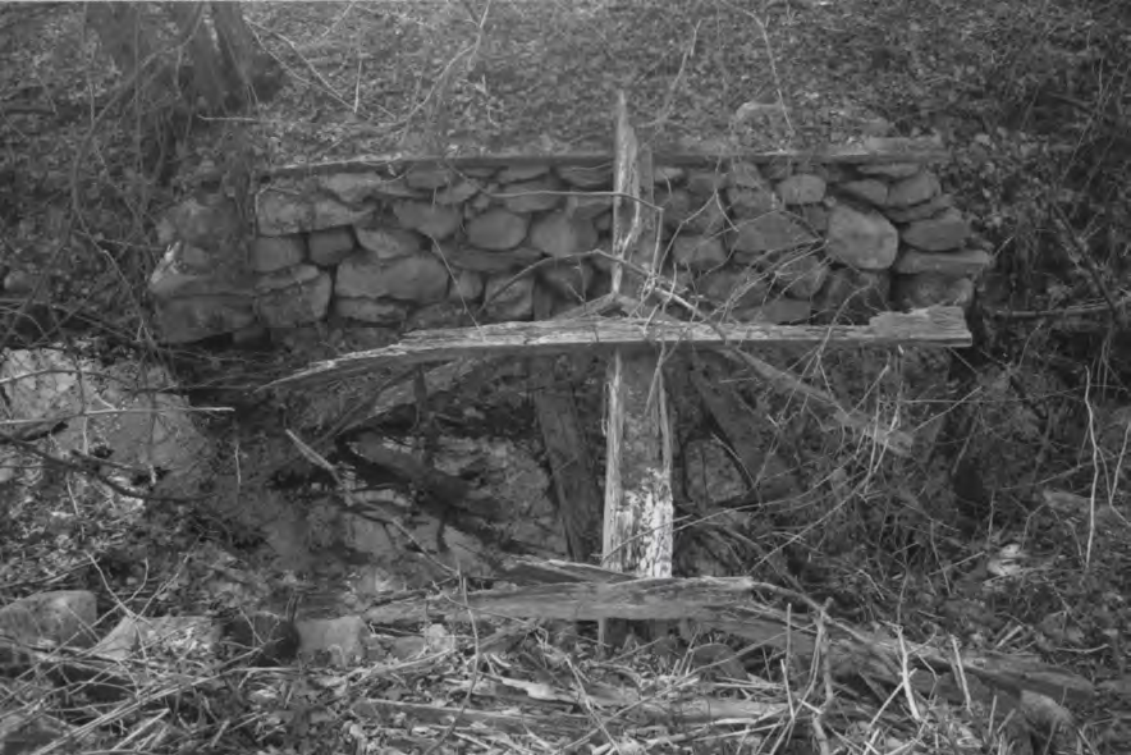
Hatch Mill
Plymouth County
Marshfield, MA
Photo 11 of 21

VIEW N SHOWING REMAINS OF FOOTBRIDGE
MA MARSHFIELD (PLYMOUTH COUNTY) - HATCHMILL 011.tif

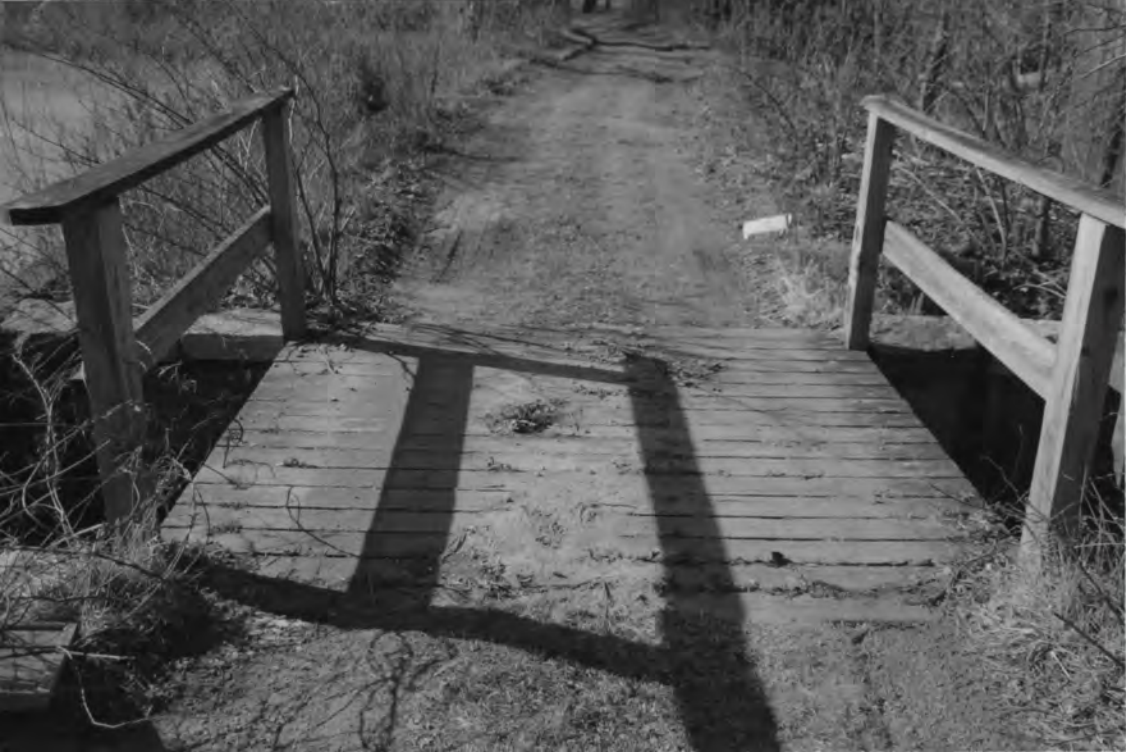
Hatch Mill
Plymouth County
Marshfield, MA
Photo 14 of 21

VIEW W SHOWING BRIDGE OVER HEADRACE
MA - MARSHFIELD (PLYMOUTH COUNTY) - HATCHMILL 014. tif

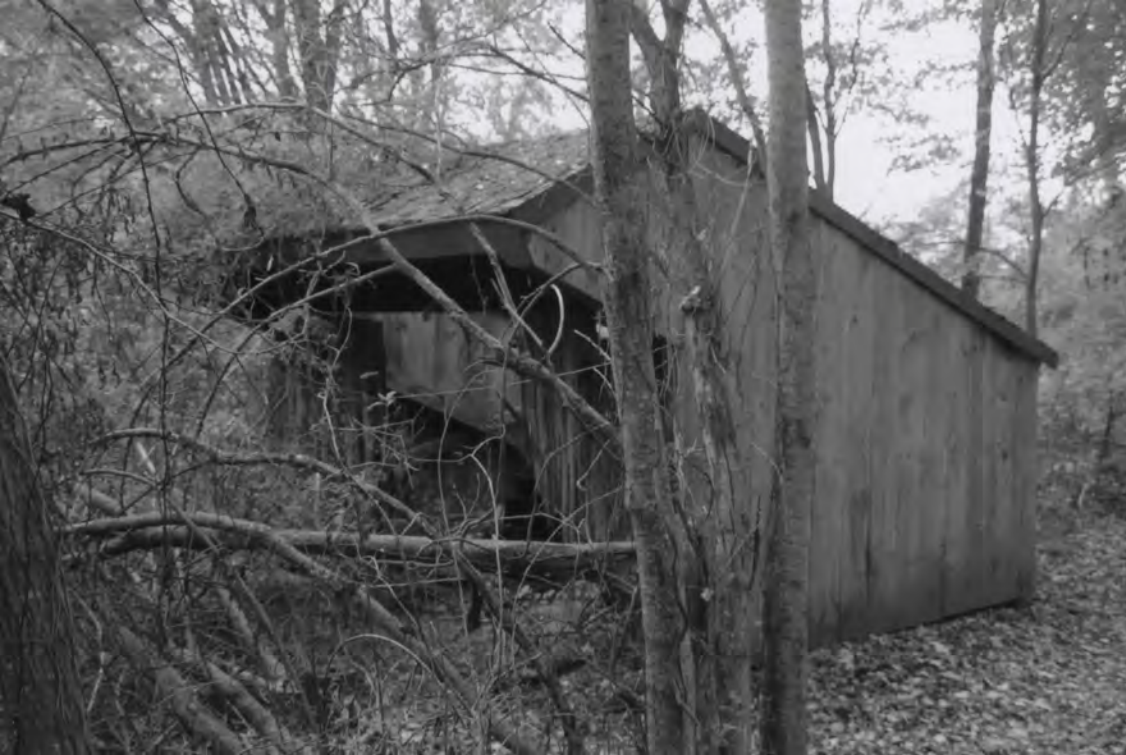
Hatch Mill
Plymouth County
Marshfield, MA
Photo 15 of 21

VIEW NW SHOWING SOUTH, EAST ELEVATIONS
OF SHED.

A small wooden shed (ca. 1970s) stands in a wooded area in the northeast corner of the lot (Mill Photo 15). This modern shed has a large hole in the roof and is in very poor condition.

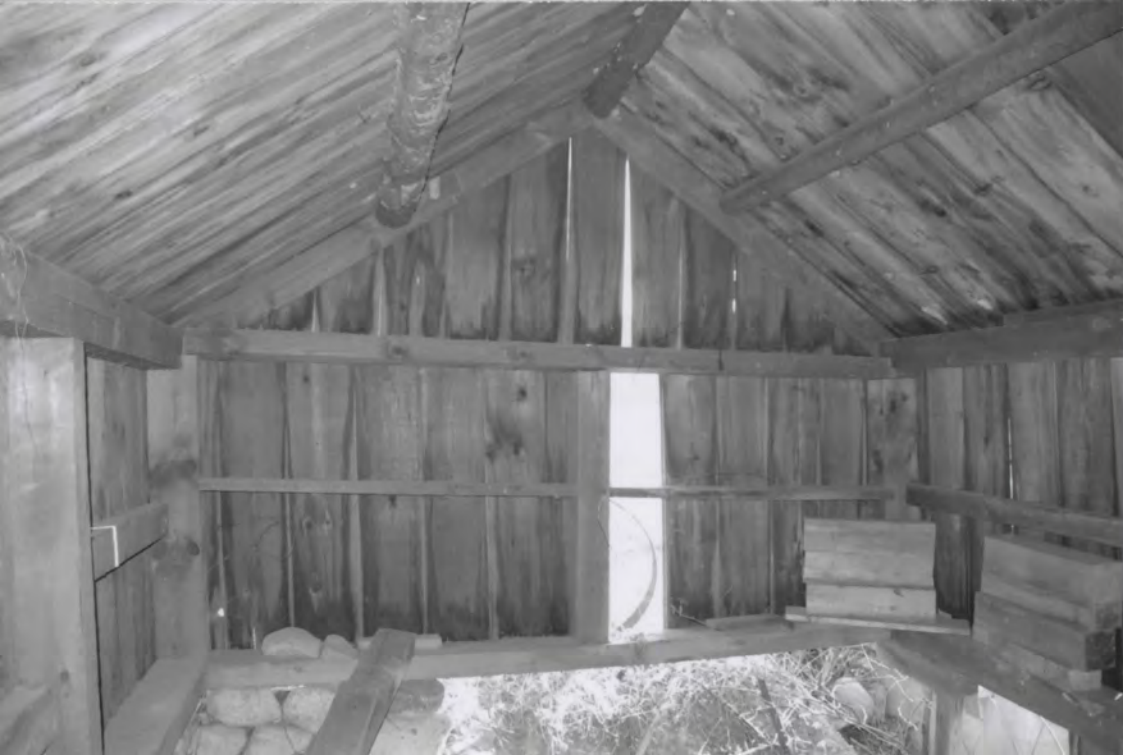
Hatch Mill
Plymouth County
Marshfield, MA
Photo 16 of 21

VIEW S MAIN LEVEL OF SAW MILL SECTION
SHOWING SOUTHERNMOST BAY.

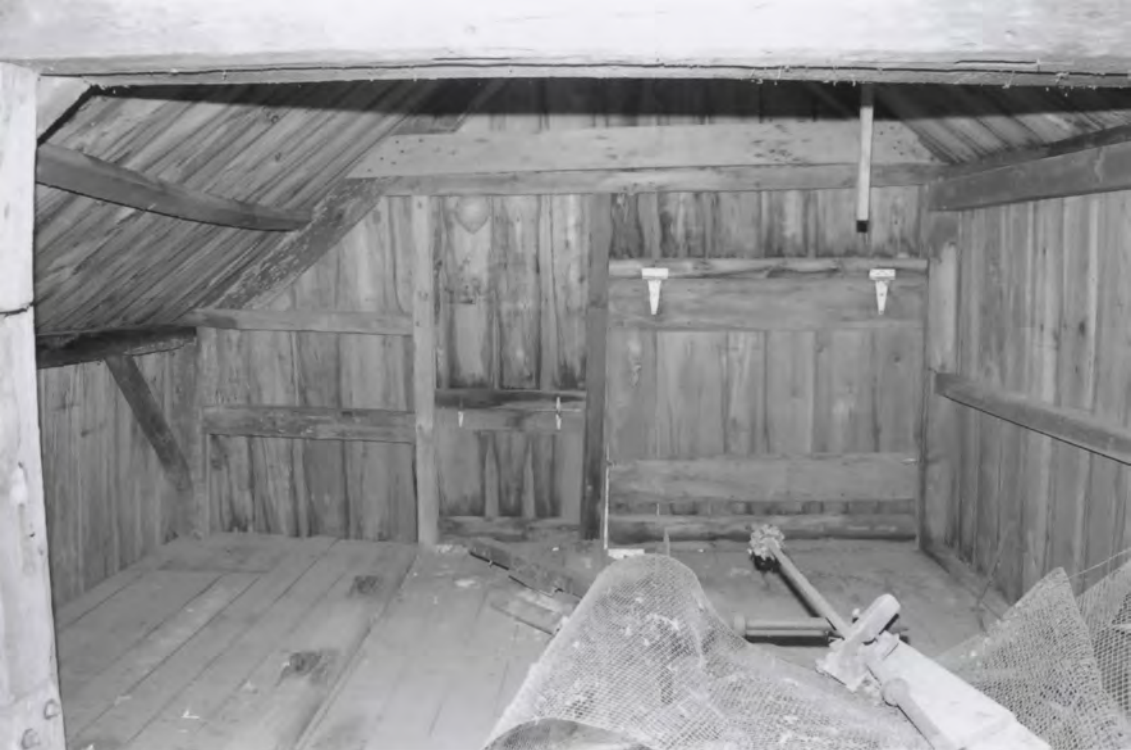
Hatch Mill
Plymouth County
Marshfield, MA
Photo 17 of 21

VIEW N ON MAIN LEVEL OF SAW MILL SECTION
SHOWING NORTHERNMOST BAY

and joists of the main level were replaced in 1974. (Mill Photo 17) The south and east sills were replaced at the same time. In the southeast corner of the main level, an opening in the floor (roughly measuring five feet by ten feet) marks the former location of the waterwheel. The opening is currently framed by a temporary wood railing as a safety precaution. When the mill was operational, lumber was cut on the main level, where today much of the floor area is occupied by the large circular saw and its long carriage. Two open stairs in the northeast corner provide access to the lower and upper levels.

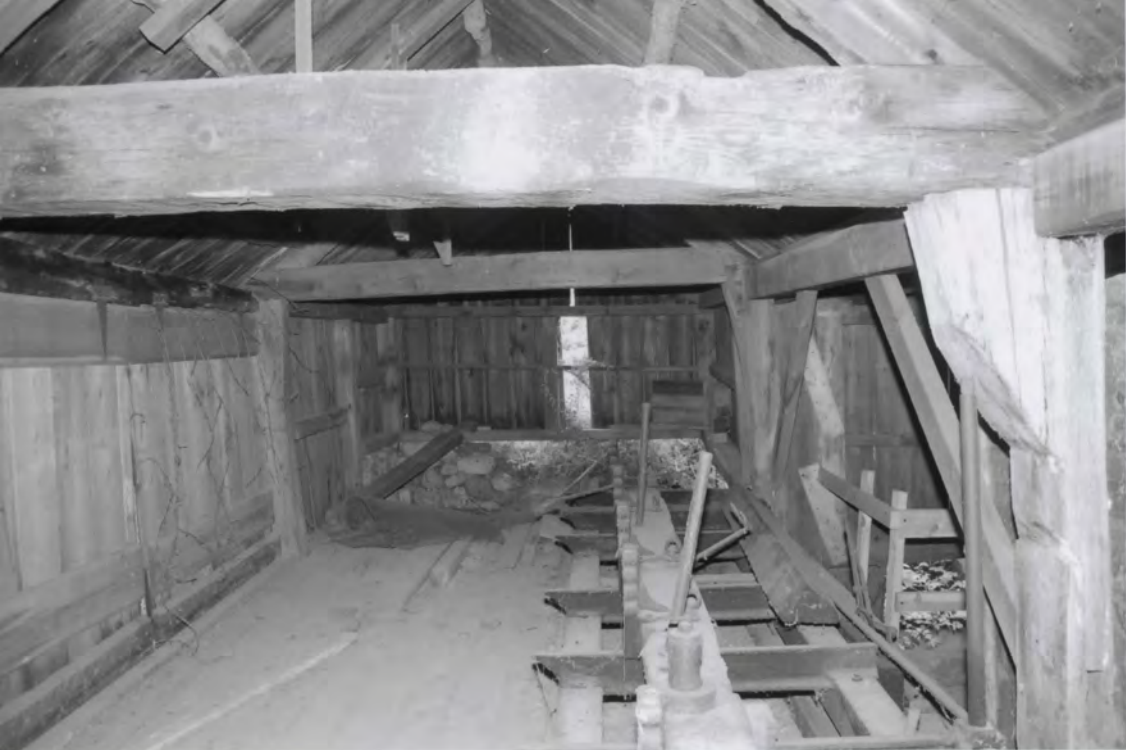
Hatch Mill
Plymouth County
Marshfield, MA
Photo 18 of 21

VIEW S ON MAIN LEVEL OF SAW MILL SECTION
SHOWING ORIGINAL FRAMING OF THE CENTRAL
BAYS (FOREGROUND) AND SOUTHERNMOST BAY
(BACKGROUND)

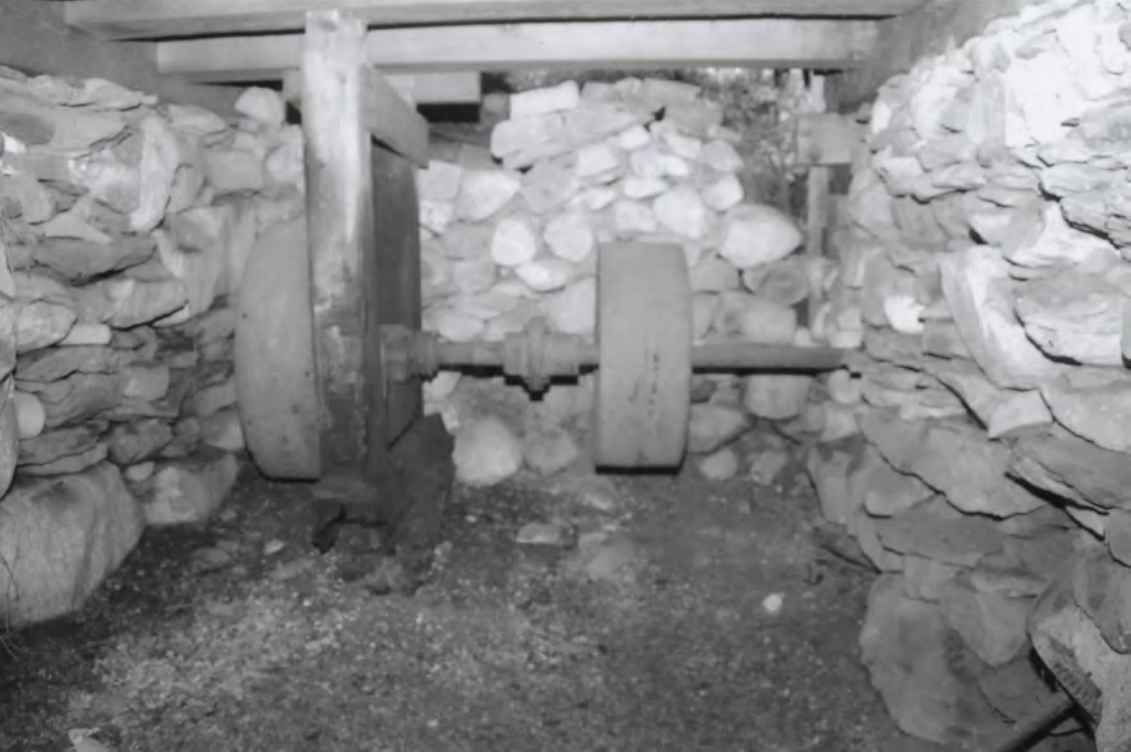
Hatch Mill
Plymouth County
Marshfield, MA
Photo 19 of 21

VIEW S IN LOWER LEVEL OF SAW MILL
SECTION SHOWING SHAFT AND WHEELS
IN SOUTHERNMOST BAY.

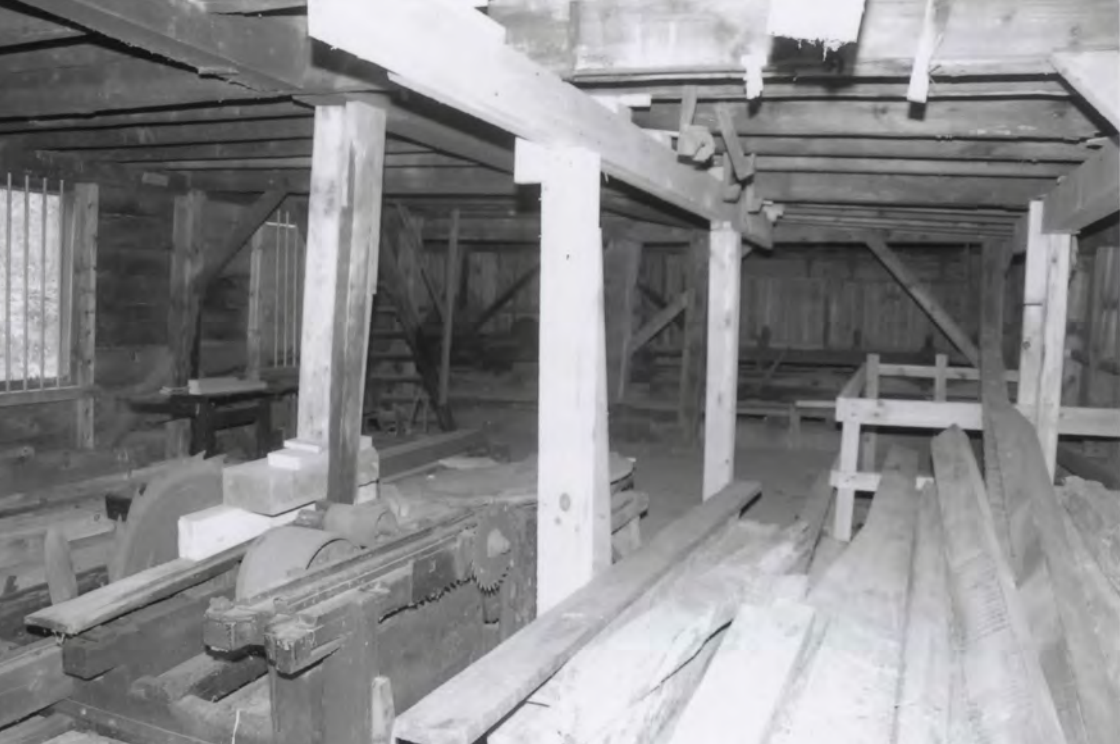
Photo 20 of 21

VIEW NE IN MAIN LEVEL OF BOX MILL
SECTION SHOWING HISTORIC FRAMING AND
RECENT TEMPORARY SUPPORTS.

The interior of the box mill is divided into three levels, none of which have partitions. (Mill Photo 20). The original braced framing is exposed throughout and generally remains in sound condition. The framing was recently supplemented by temporary supports, which were needed to shore up the building after the south roof slope collapsed and the south wall began to bow outward. The main and upper levels have unfinished wood plank flooring. Flooring

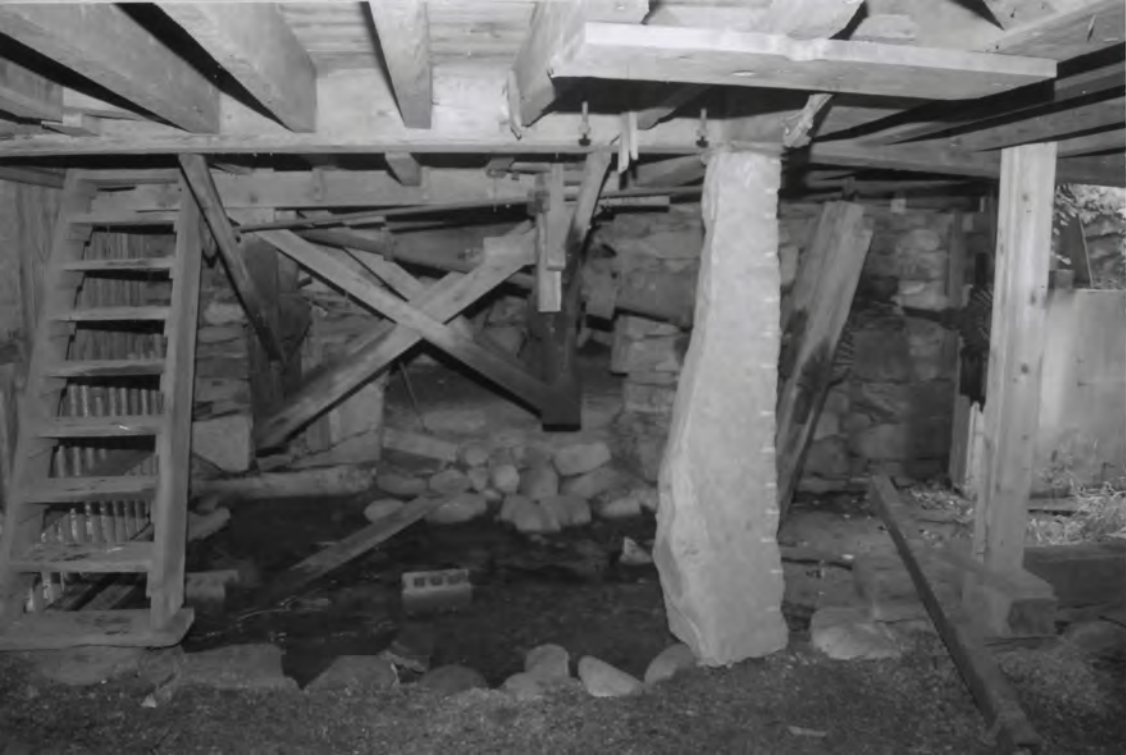
Hatch Mill
Plymouth County
Marshfield, MA
Photo 21 of 21

VIEW E IN LOWER LEVEL OF BOX MILL SECTION
SHOWING TAILRACE CROSSING IN FRONT OF
FOUNDATION OF SAW MILL SECTION.

The lower level has a packed gravel floor from 1983, along with exposed stone foundation walls (Mill Photo 21). An opening in the east wall measuring roughly six feet in width provides access into the lower level of the saw mill. Two large, rough-cut granite piers near the center serve as support for the girts. The mill's tailrace is located at the east end of the lower level. The tailrace varies in width from about seven to ten feet and sits roughly two feet lower than floor level. Sides of the channel are lined with random-laid fieldstone. Above the tailrace, the two principal gears and shafts that operated the saws remain in place. An early wooden gear is also stored in the building.
