# National Register of Historic Places Registration Form

Historic name: Fall River Entrance Historic District (Amendment and Boundary Increase)

Other names/site number: Fall River Entrance / Bighorn Ranger Station / 5LR.1184

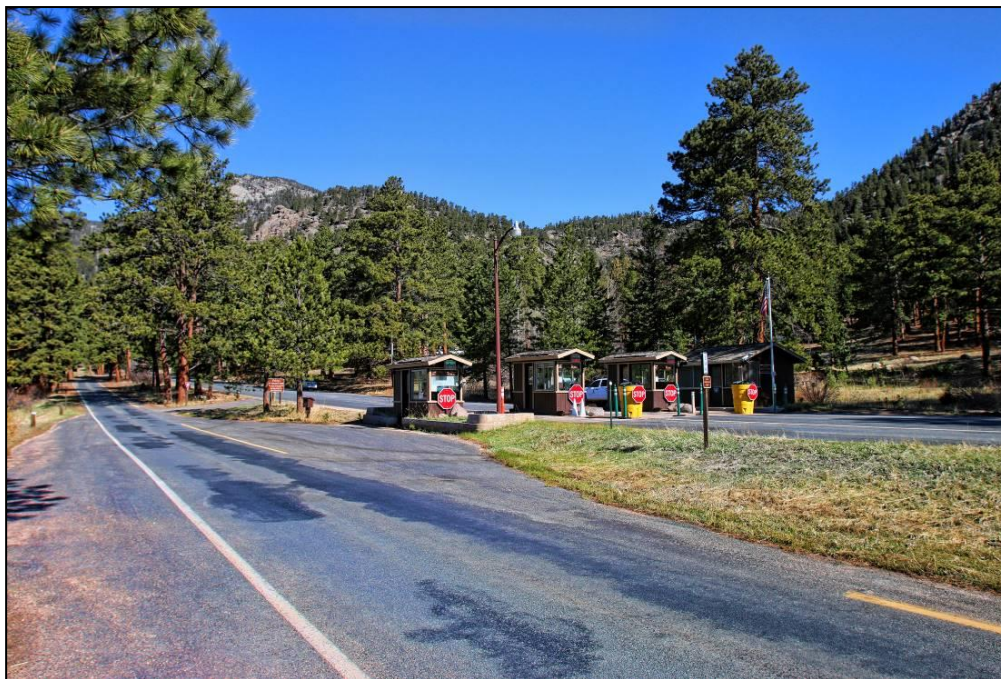
Photograph 4. View of the checking station (Building 353) and kiosks (Buildings 669-671) from the outbound lane, facing north-northwest.

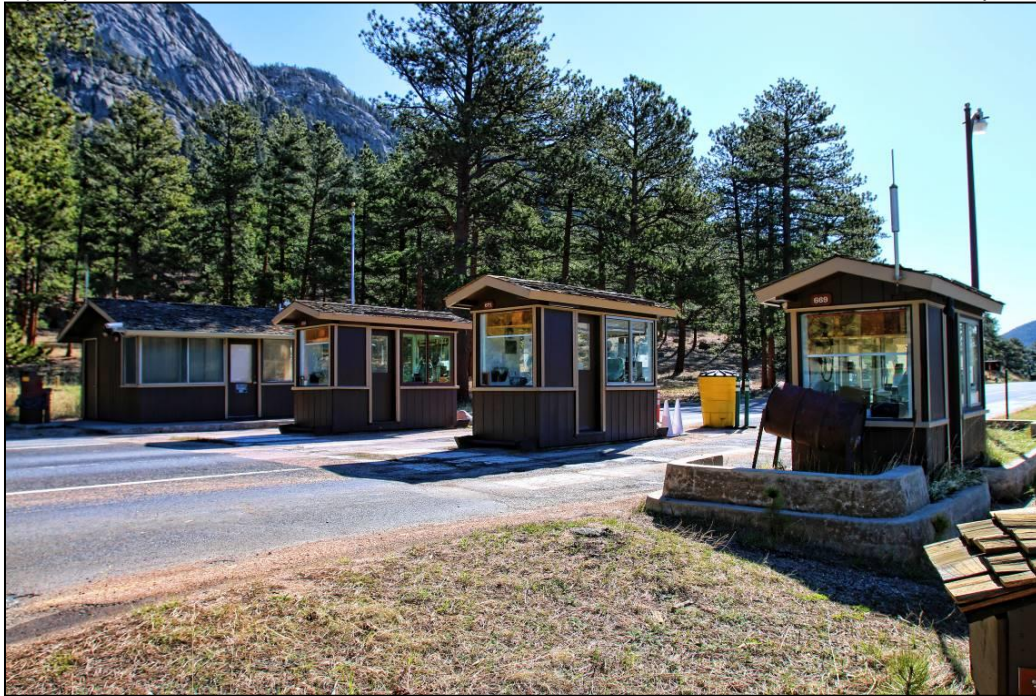
Photograph 5. View of the checking station (Building 353) and kiosks (Buildings 669-671) from the outbound lane, facing east-northeast.

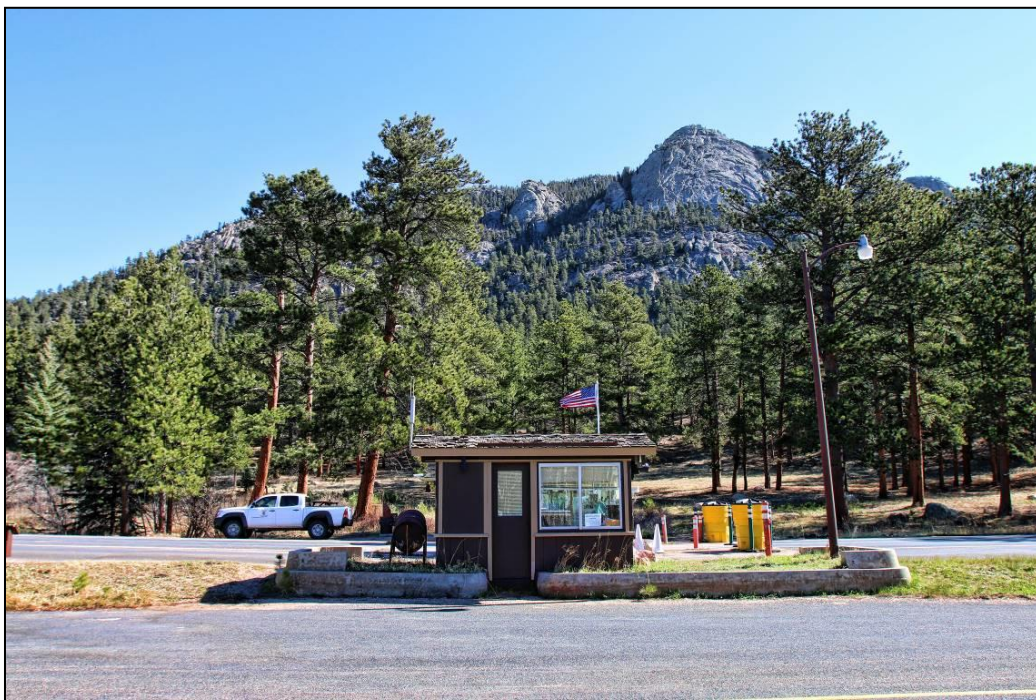
Photograph 6. Overview of the checking station (Building 353) and kiosks (Buildings 669-671) from the outbound lane with McGregor Mountain in the background, facing northeast.

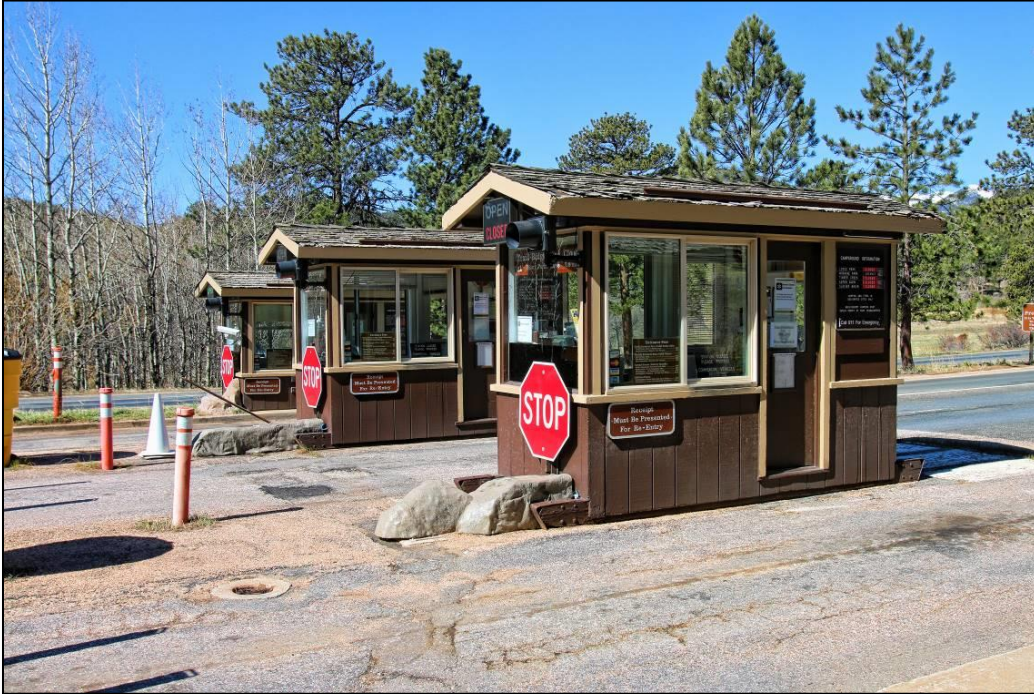
Photograph 7. Close-up of the entrance kiosks (Buildings 669-671), facing southwest.

Unlike the central two kiosks, the outermost (southern) kiosk (Building 669) (**contributing building**) was designed to be fixed and is founded on a poured concrete base, with battered concrete curbing extending well beyond the footprint of the kiosk to the north and south, 16' and 9' respectively (Photos 4, 5, and 6; Figure H15). The total overall dimensions of the kiosk, including curbing, is 36' x 6'. The curbing was originally designed to frame plantings, but these areas are presently only maintained as turf. The kiosk itself is otherwise undistinguished from the other two kiosks (Buildings 670 and 671).

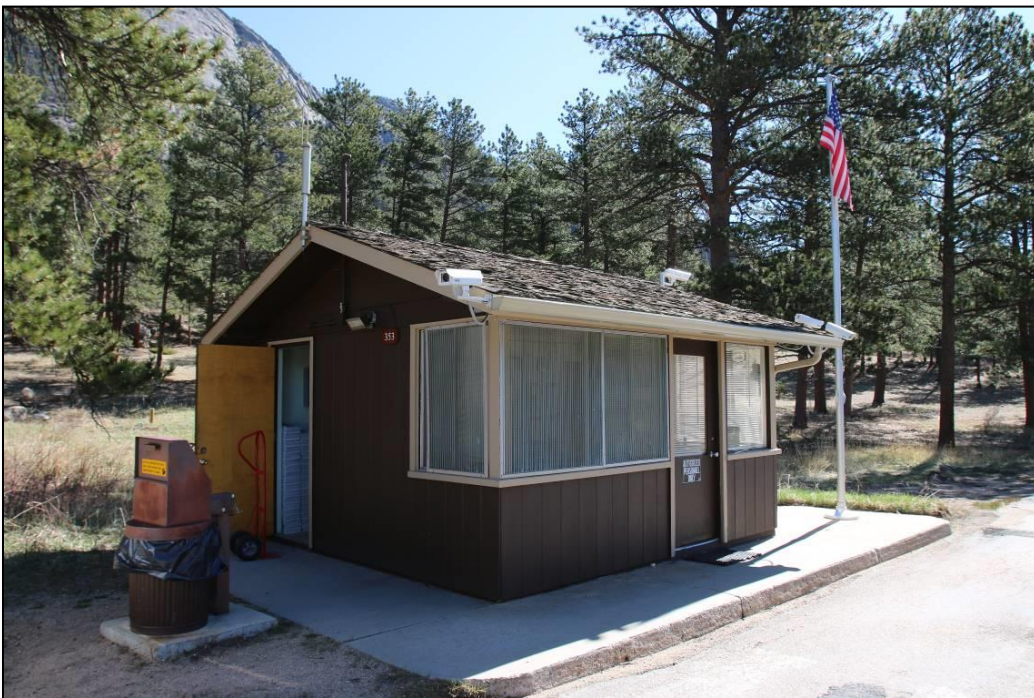
Photograph 8. Oblique view of the checking station (Building 353), facing east-northeast.

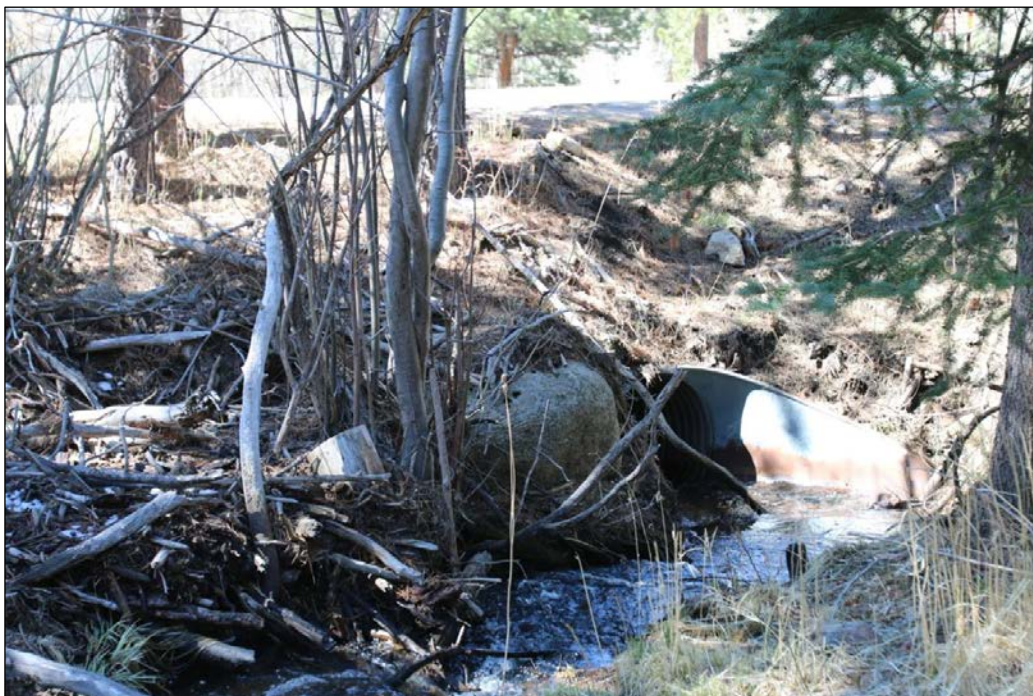
Photograph 10. Pipe culvert at Bighorn Creek north of U.S. 34, facing south.

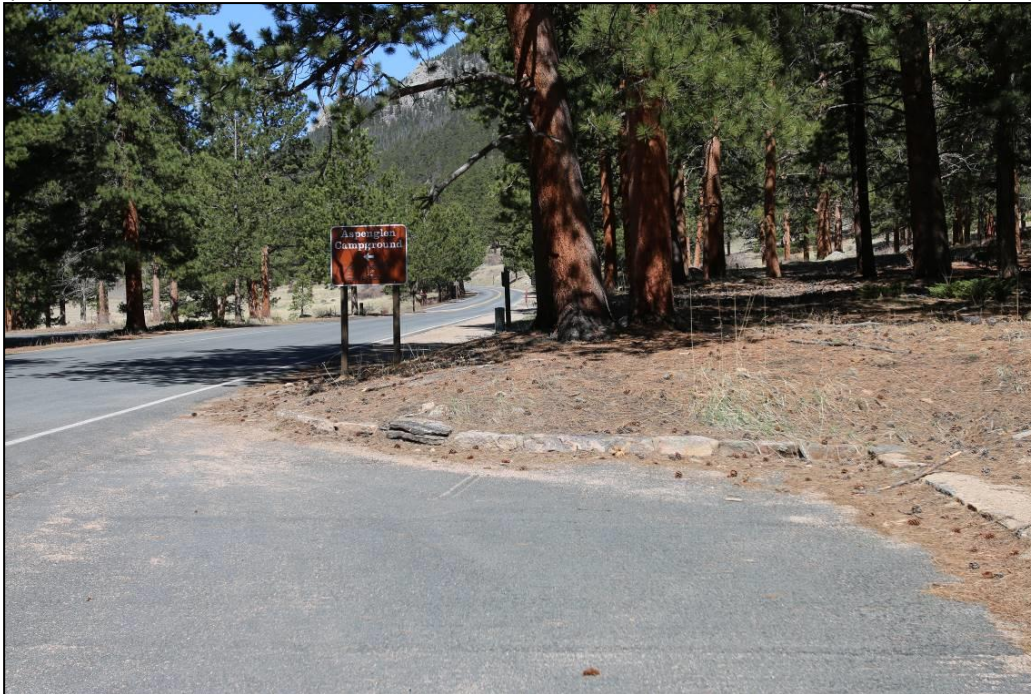
Photograph 11. Representative section of the masonry curbing at the 1933-1934 parking area at the site for the former checking station (Building 20), facing northwest.

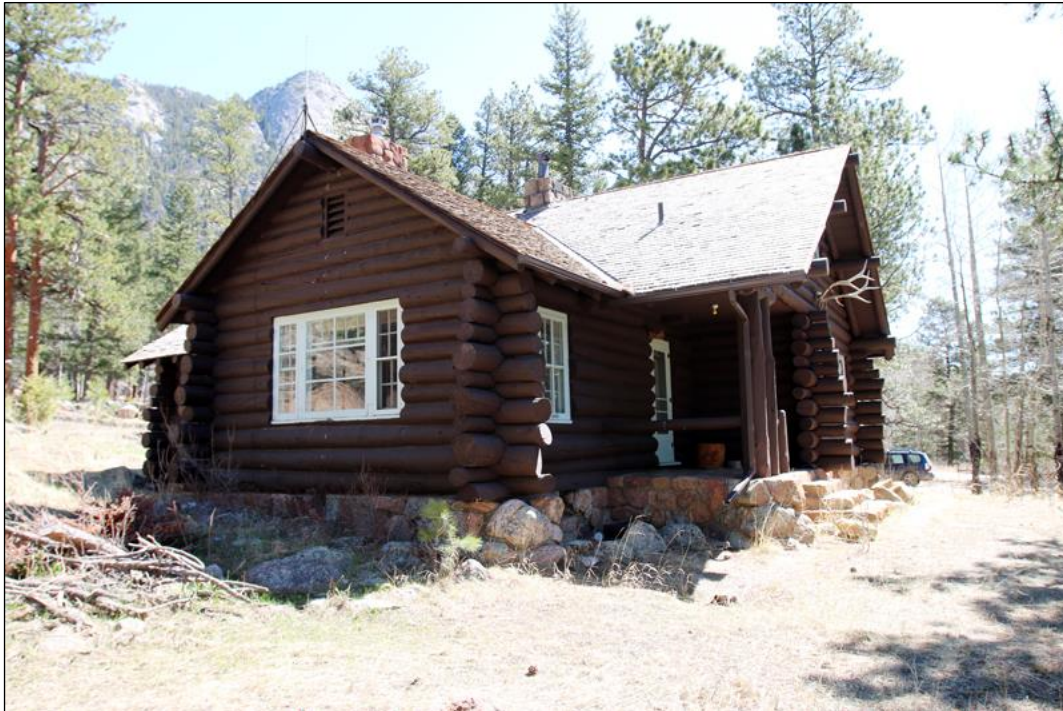
Photograph 15. Oblique view of the Bighorn Ranger Station (Building 44), facing northeast.

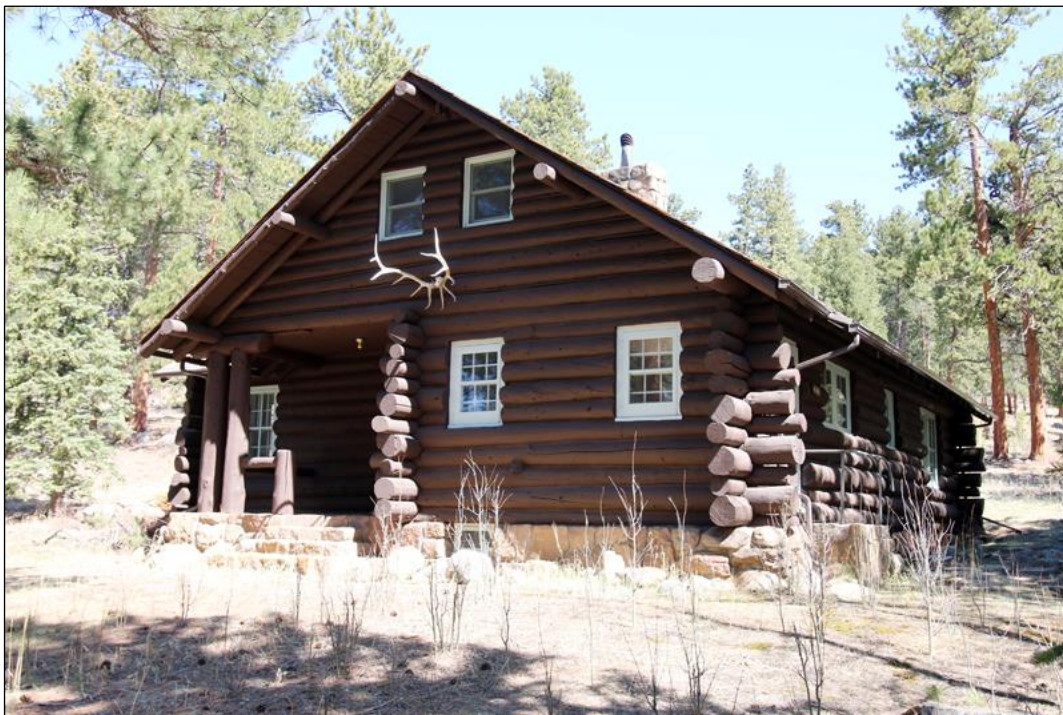
Photograph 16. Oblique view of the Bighorn Ranger Station (Building 44), facing north-northwest.

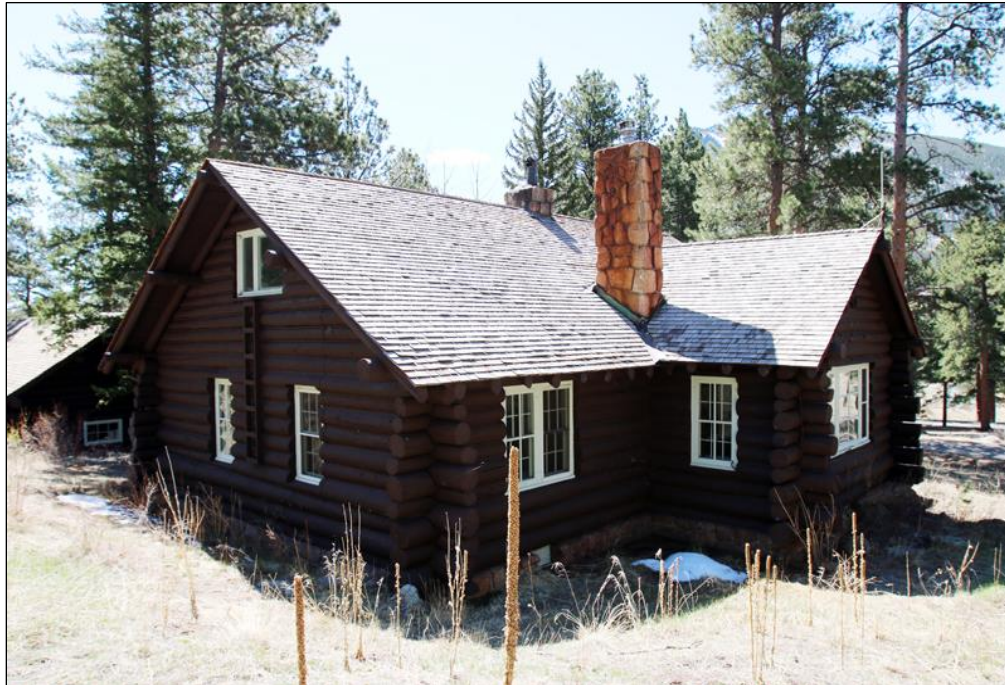
Photograph 17. Oblique view of the Bighorn Ranger Station (Building 44), facing south-southeast.

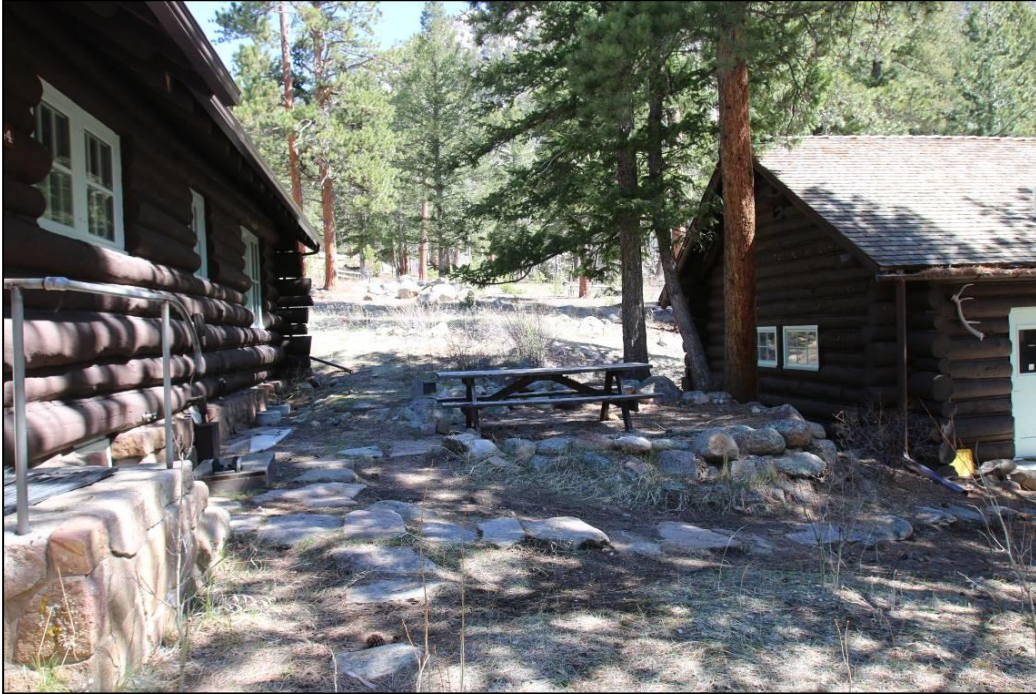
Photograph 19. Terraced platform and walkways between the Bighorn Ranger Station (Building 44) and the garage and woodshed (Building 169), facing northeast.

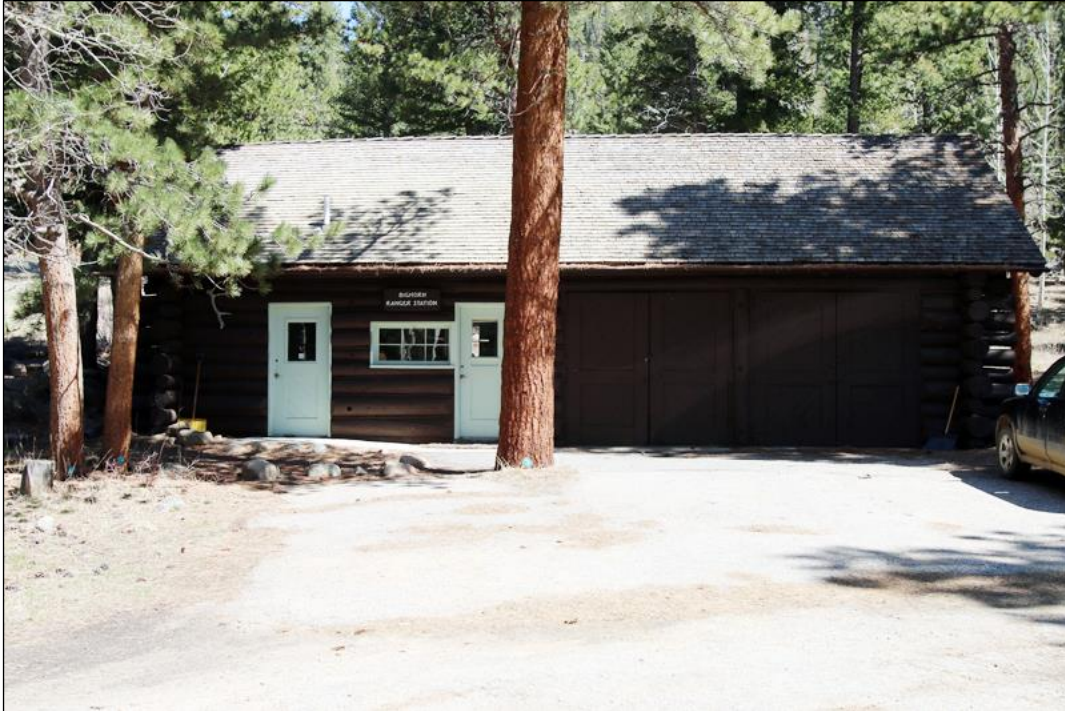
Photograph 21. Façade of the garage and woodshed (Building 169), facing northeast.

The garage and wood shed (Building 169) (**contributing building**) is located approximately 20' east of and slightly down slope from the Bighorn Ranger Station (Building 44). Constructed in 1935, the building was converted to a garage and office in 1946 (Photos 20 and 21; Figures H9 and H17). Measuring 40'-7" x 21'-11", the building is oriented to the southwest and characterized by a one-story, single-pile form, situated on a poured concrete foundation. The side-gabled roof is clad with wood shakes and features exposed rafter tails. Log walls are set with double saddle notching at the corners. The façade (southwest) exhibits two single-leaf pedestrian entries toward the western end; both are occupied by a solid-core wood door with upper light. Offset between the openings is a fixed six-light wood sash window. Both the window and eastern door were added during the 1946 conversion. The eastern half of the façade, fronting the garage, is characterized by two oversized double-leaf entries occupied by paired hinged doors comprised of diagonally-laid boards framed with battens. The end (northwest and southeast) sides are each punctuated by two six-light fixed sash wood windows, and the rear (northeast) side is fronted by four four-light fixed sash wood windows.

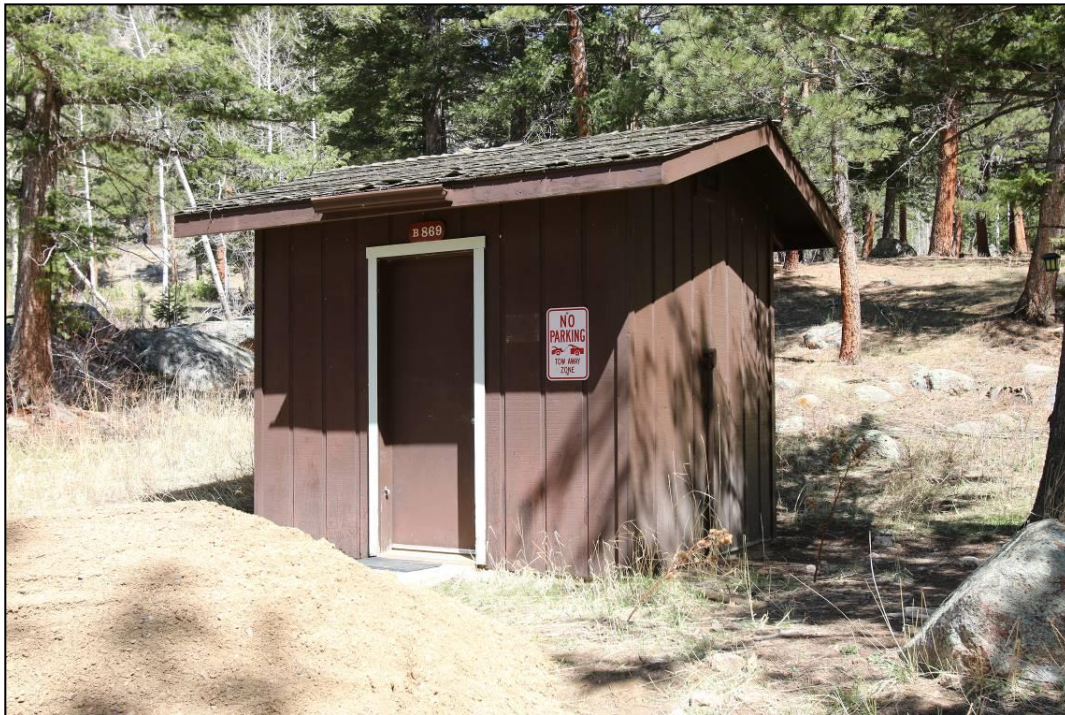
Photograph 22. Oblique view of the pump house (Building 869), facing northwest.

Located approximately 135' east of the garage and woodshed (Building 168), opposite Bighorn Creek, the pump house (Building 869) (**noncontributing building**) was constructed in 1983 (Photo 22). It is a small, one-story, single-bay frame building situated on a poured concrete foundation. The building is sheltered beneath a wood shake-clad side-gabled roof and clad in vertically-laid shiplap wood siding. The single-leaf pedestrian entry is centered on the southwest façade and occupied by an unglazed metal door.

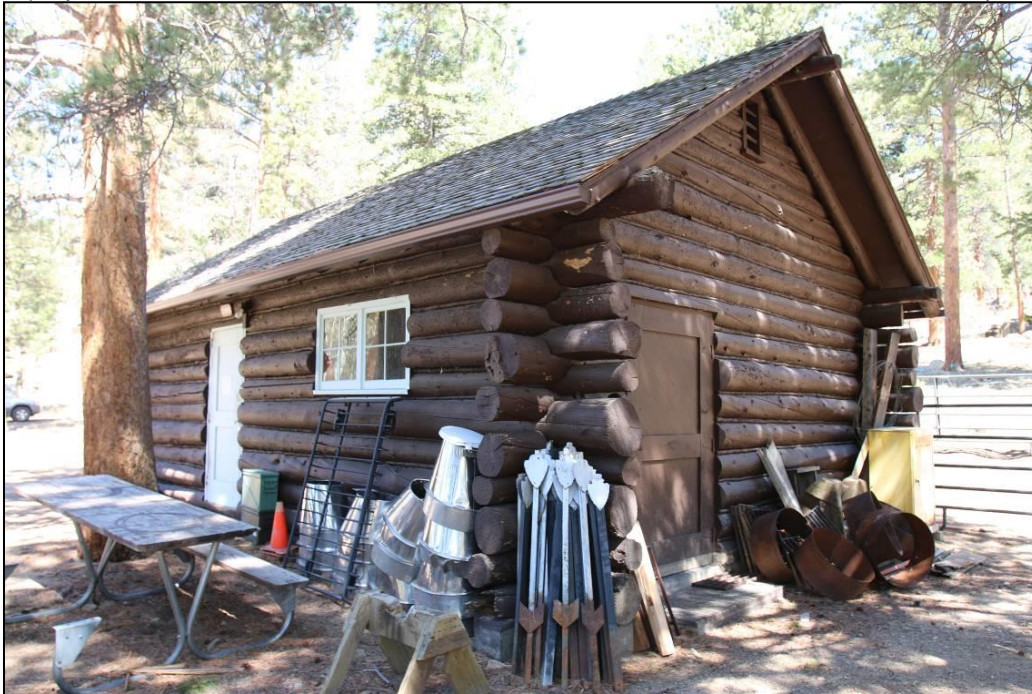
Photograph 23. Oblique view of the barn and stable (Building 168), facing northwest.

The barn and stable (Building 168) (**contributing building**), constructed in 1935 and later converted for storage, is located approximately 120' east of the pump house (Building 869) at the terminus of the Bighorn Ranger Station Area access road (Photo 23; Figure H18). Measuring 30' x 19'-4", the one-story, two-bay log building is situated on a low poured concrete foundation. The wood shake-clad side-gabled roof exhibits exposed rafter tails; louvered vents front the gable at each side (southeast and northwest) elevation. Log walls are set with double saddle notching at the corners. A single-leaf pedestrian entry is centered on the southwest façade, occupied by an unglazed door comprised of diagonal boards set with battens. To the east is a single window opening with four-light sliding wood sashes. A wide-set secondary pedestrian entry is located on the northeast side, and a single window opening with four-light wood sash window punctuates the rear (northwest) elevation. Hinged tubular metal gate sections form a corral around the rear of the shed.

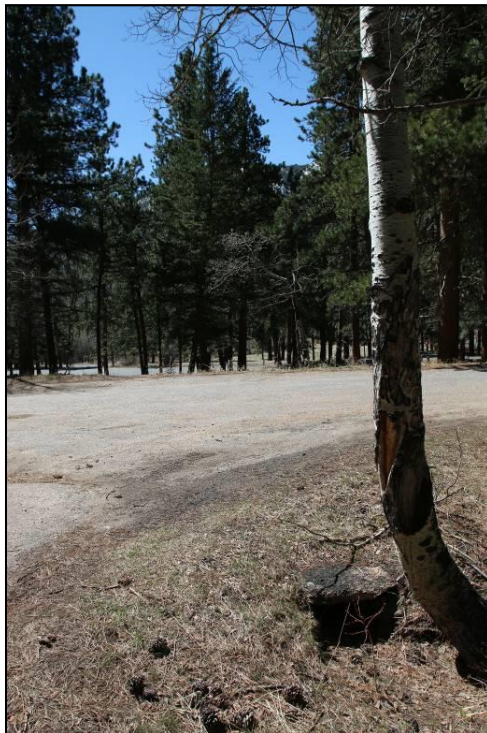
Photograph 24. View of the drainage culvert near the garage and woodshed (Building 169), facing southwest.

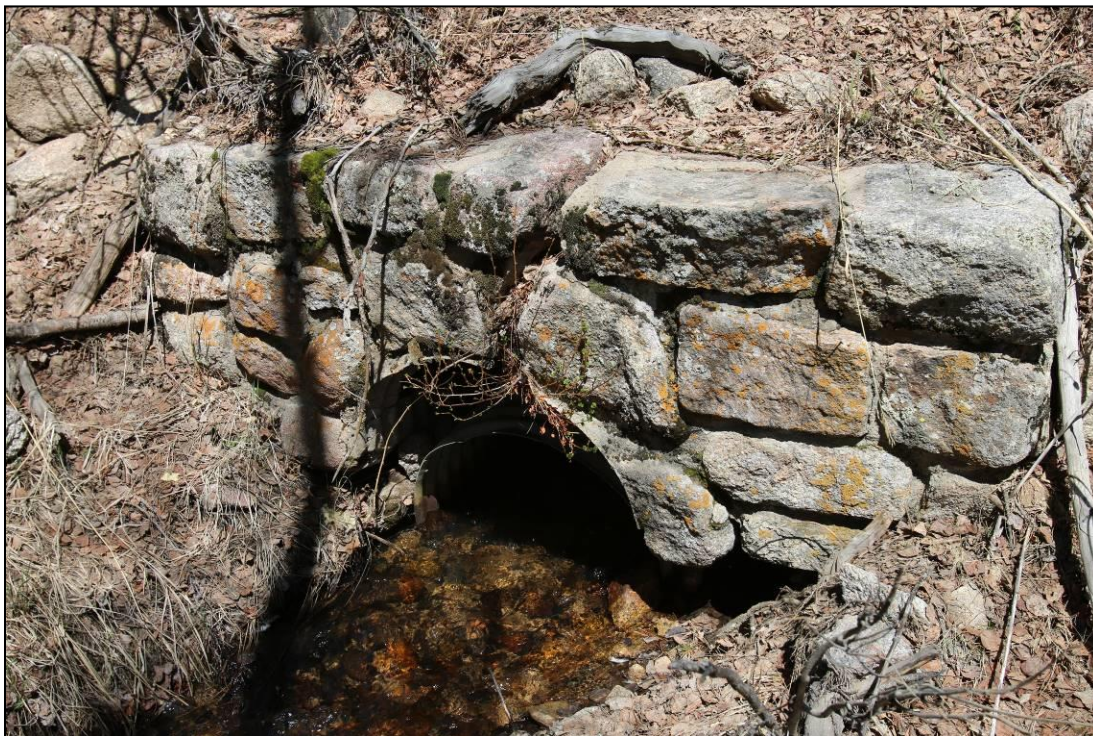
Photograph 25. View of the pipe culvert with stone headwalls on Bighorn Creek, facing south.

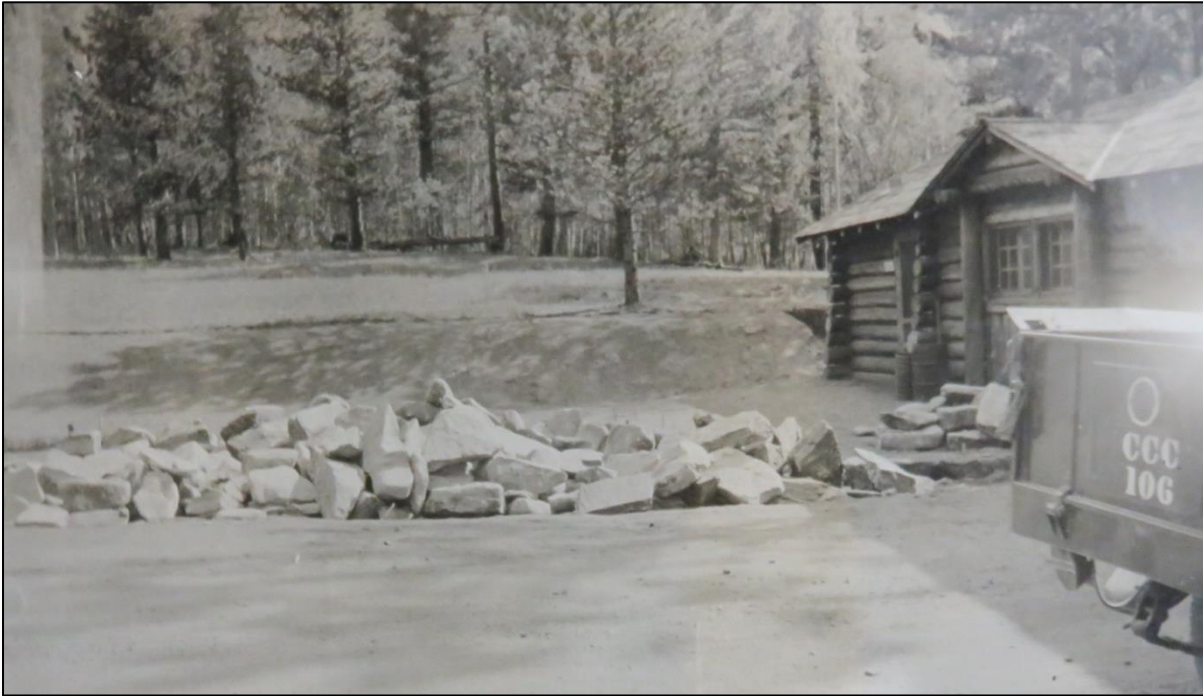
H5. June 1934 view of rocks for masonry curbing at the Fall River Entrance, by Roy Youngs. Located in the files of Rocky Mountain National Park Archives, Estes Park, Colorado, Civilian Conservation Corps Photograph Albums, photograph no. 3575.

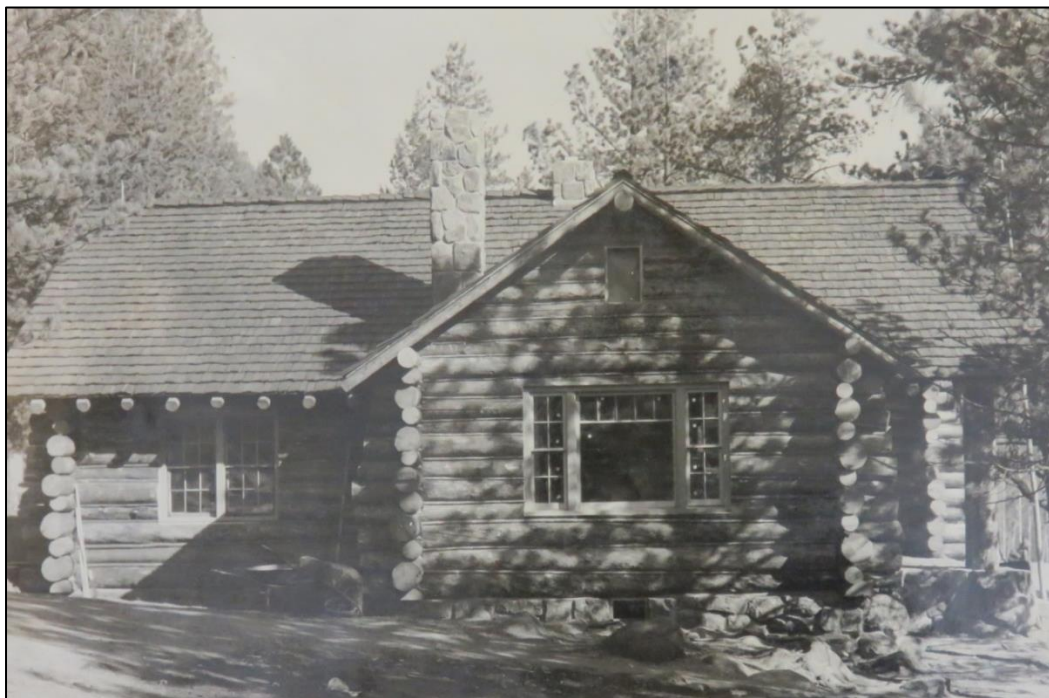
H8. March 1935 view of the Bighorn Ranger Station (Building 44). Located in the files of Rocky Mountain National Park Archives, Estes Park, Colorado, Civilian Conservation Corps Photograph Albums, photograph no. 3376.

- H8. March 1935 view of the Bighorn Ranger Station (Building 44). Located in the files of Rocky Mountain National Park Archives, Estes Park, Colorado, Civilian Conservation Corps Photograph Albums, photograph no. 3376.

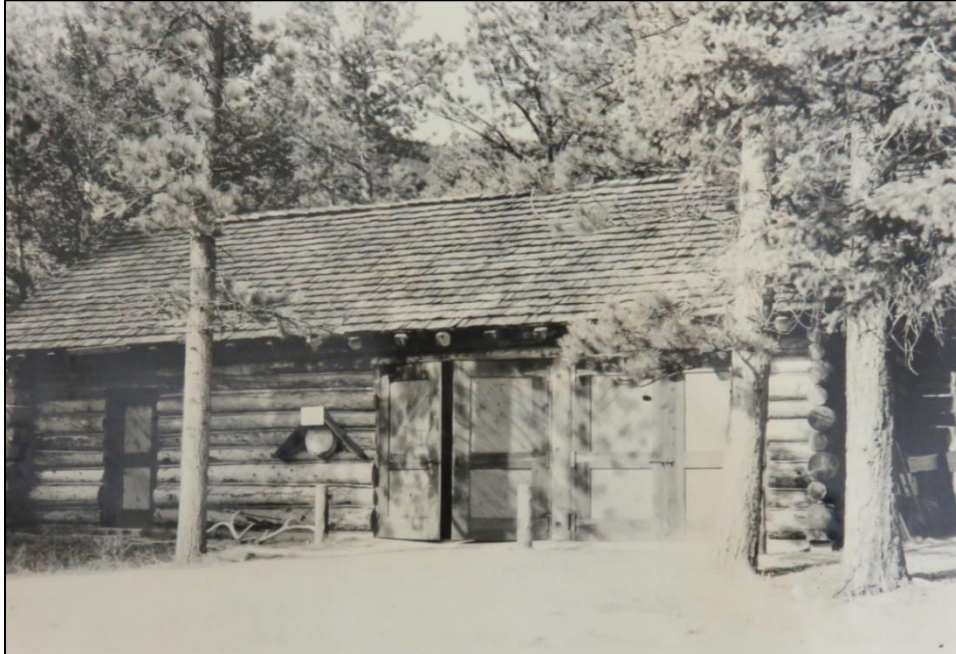
H9. March 1935 view of the garage and wood shed (Building 169). Located in the files of Rocky Mountain National Park Archives, Estes Park, Colorado, Civilian Conservation Corps Photograph Albums, photograph no. 4715.

- H9. March 1935 view of the garage and wood shed (Building 169). Located in the files of Rocky Mountain National Park Archives, Estes Park, Colorado, Civilian Conservation Corps Photograph Albums, photograph no. 4715.

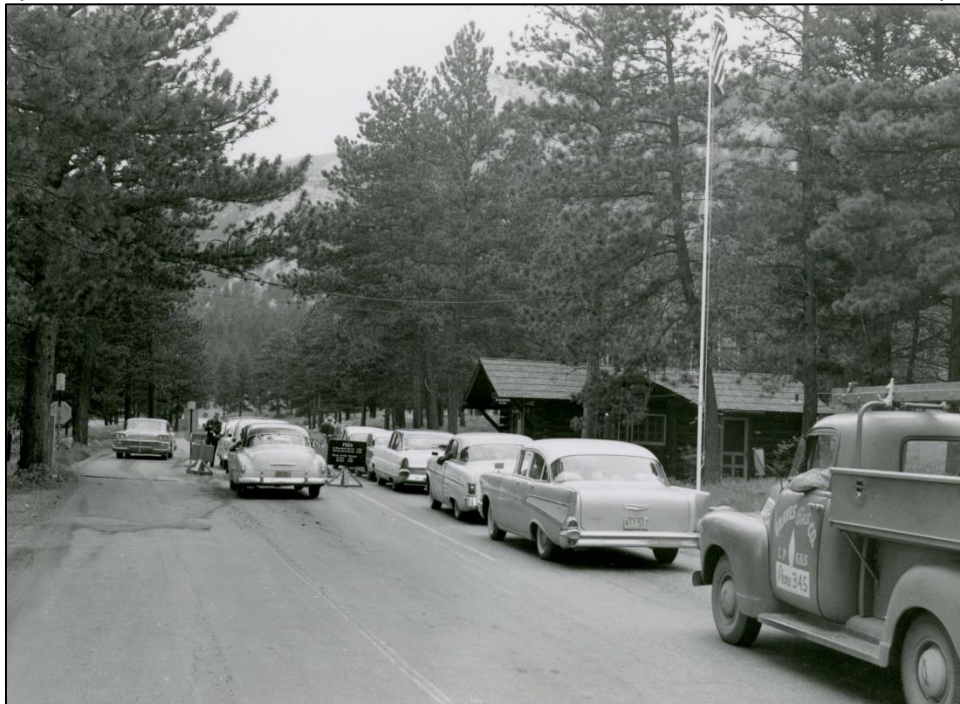
H11. July 1958 view of the Fall River Entrance with two inbound lanes and one outbound lane, by R.H. Boyer. Located in the files of Rocky Mountain National Park Archives, Estes Park, Colorado, Photograph Collection (11-Q-7), album no. 1, photograph no. 1376.

- H11. July 1958 view of the Fall River Entrance with two inbound and one outbound lane, by R.H. Boyer. Located in the files of Rocky Mountain National Park Archives, Estes Park, Colorado, Photograph Collection (11-Q-7), album no. 1, photograph no. 1376.

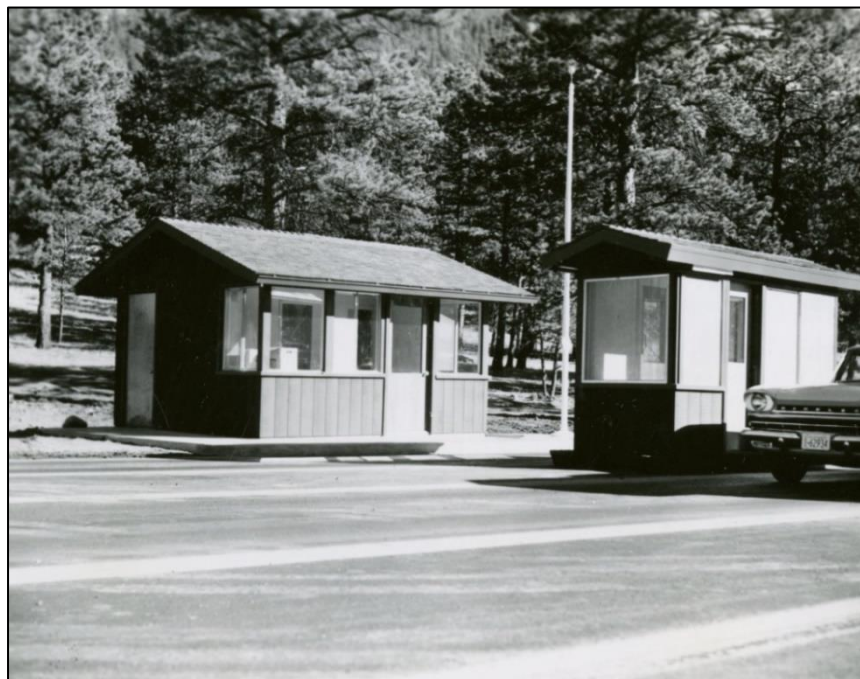
H14. December 1960 view of the checking station and kiosks at the redeveloped Fall River Entrance, by R.H. Boyer. Located in the files of Rocky Mountain National Park Archives, Estes Park, Colorado, Photograph Collection (11-Q-7), album no. 1, photograph no. 1374.

- H14. December 1960 view of the checking station (Building 353) and kiosks (Buildings 669-671) at the redeveloped Fall River Entrance, by R.H. Boyer. Located in the files of Rocky Mountain National Park Archives, Estes Park, Colorado, Photograph Collection (11-Q-7), album no. 1, photograph no. 1374.

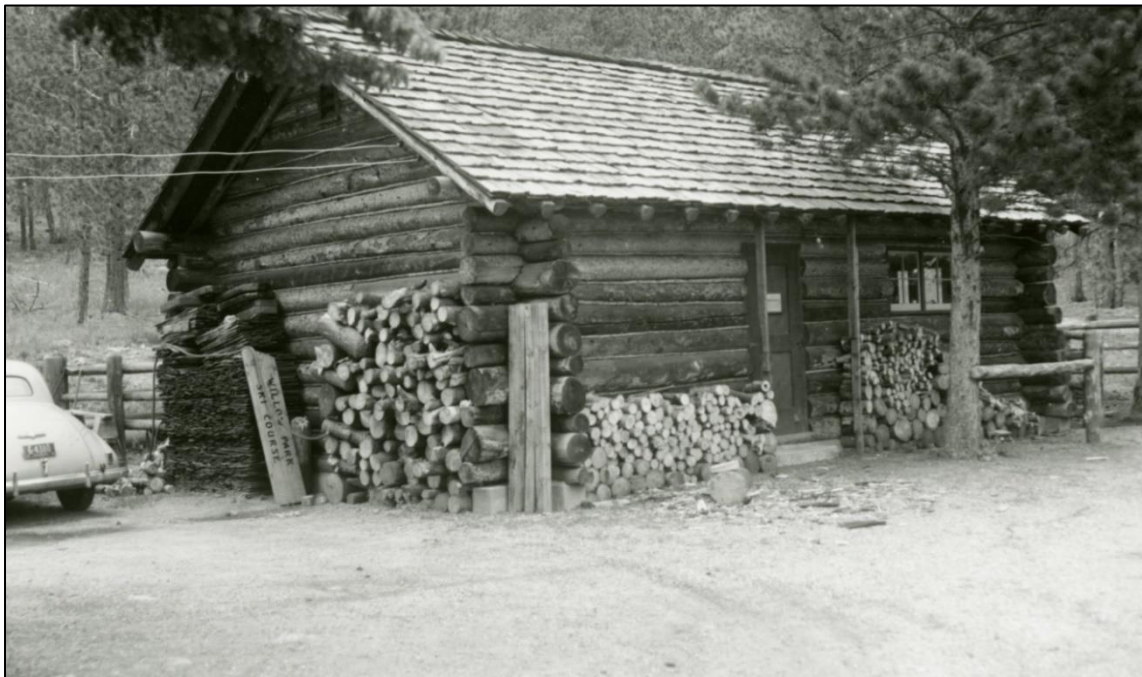
H18. Undated, c. 1960, view of the barn and stable (Building 168), by Ferrel Atkins. Located in the files of Rocky Mountain National Park Archives, Estes Park, Colorado, Ferrel Atkins Collection, Building Folder No. 168.
