**National Register of Historic Places
Inventory—Nomination Form**

historic Bank of Rogers Building

and/or common The Rogers Historical Museum

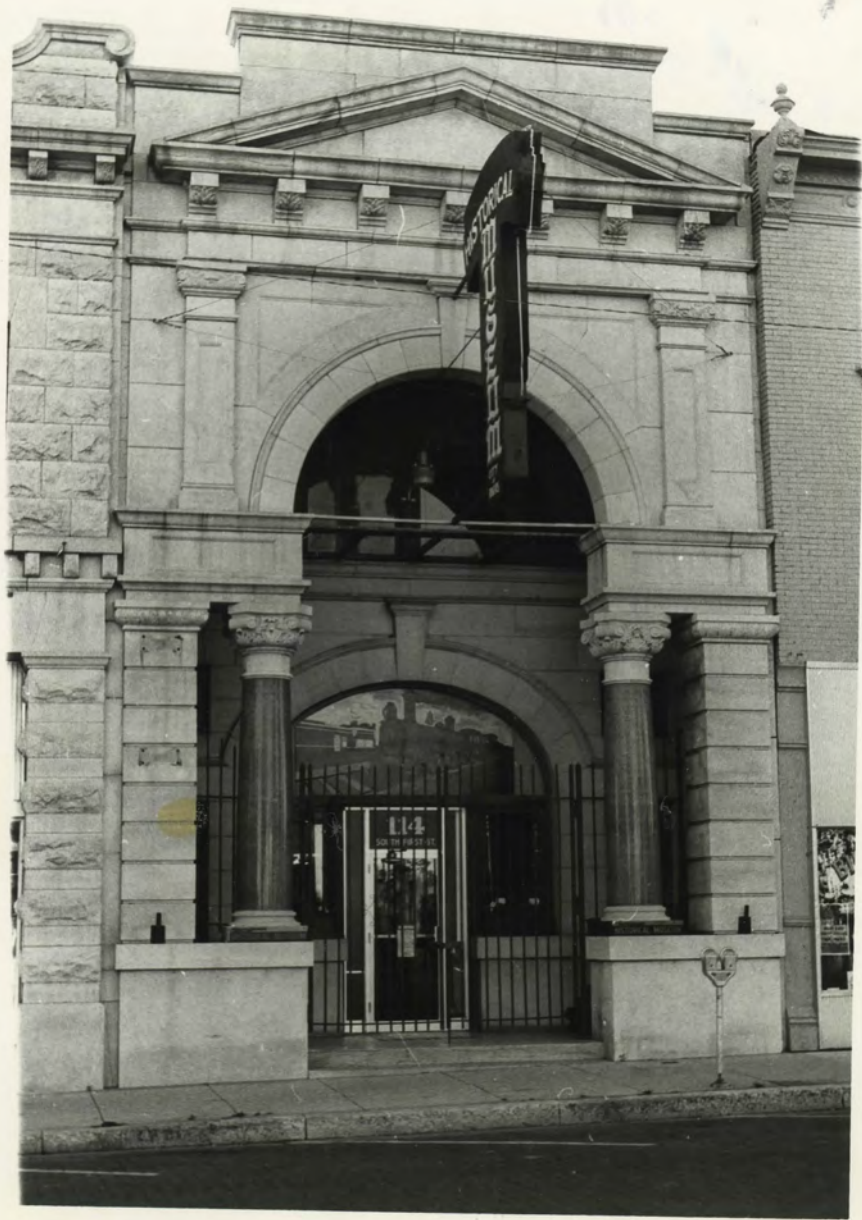
Arkansas Historic Preservation Program
Principal (east) facade viewed from the
the east
#1 of 4

The facade adjacent to the sidewalk resembles a triumphal arch; a large arched opening is centered in the wall. The opening is framed by polished marble columns and stone piers that equal the columns in height. The capitals of the marble columns are foliated while the piers are topped with roughly faced square capitals. The columns and piers support paneled imposts. A large semi-circular arch with articulated stone voussiors and keystone springs from the imposts. The arch is positioned in the lower part of the second story of the exterior facade. Two pilasters flank the arch and support an entablature and pediment that project from the wall. Above the pediment the outer facade terminates in a stepped parapet with ogee coping.

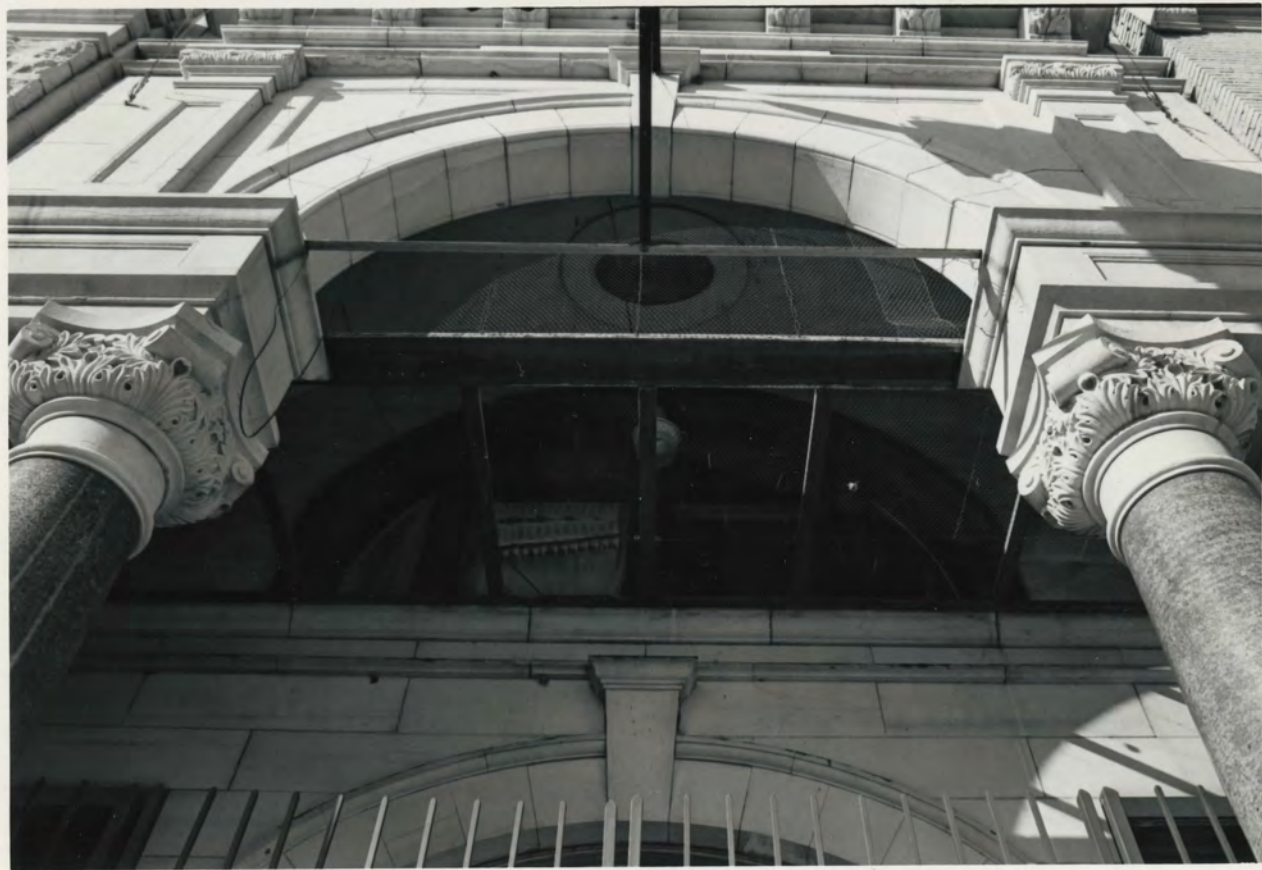
Arkansas Historic Preservation Program
Detail of the Principal (east) facade
viewed from the east
#2 of 4

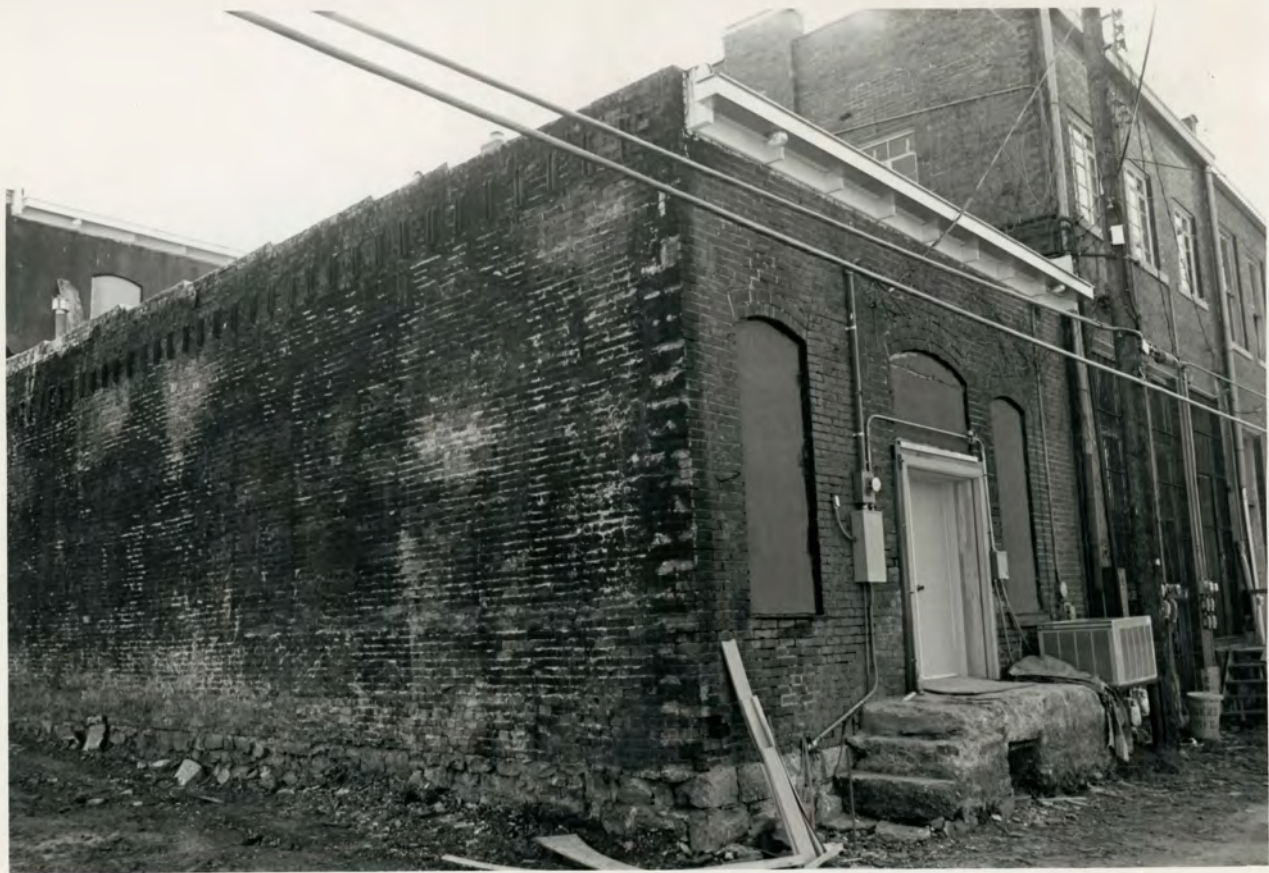
#3 of 4

Two story structure in right of photo
is the north and west elevations of
Bank of Rogers viewed from the north-
west

Since the Bank of Rogers is abutted on both its north and south elevations by adjoining buildings, very little of the structure other than the principal elevation is visible. The remaining exterior walls that are visible (west elevation and upper story of the rear of the north elevation) are of simple and unadorned brick construction. The windows on the north elevation are alterations. The significant principal elevation (east) has experienced few and only minor alterations.

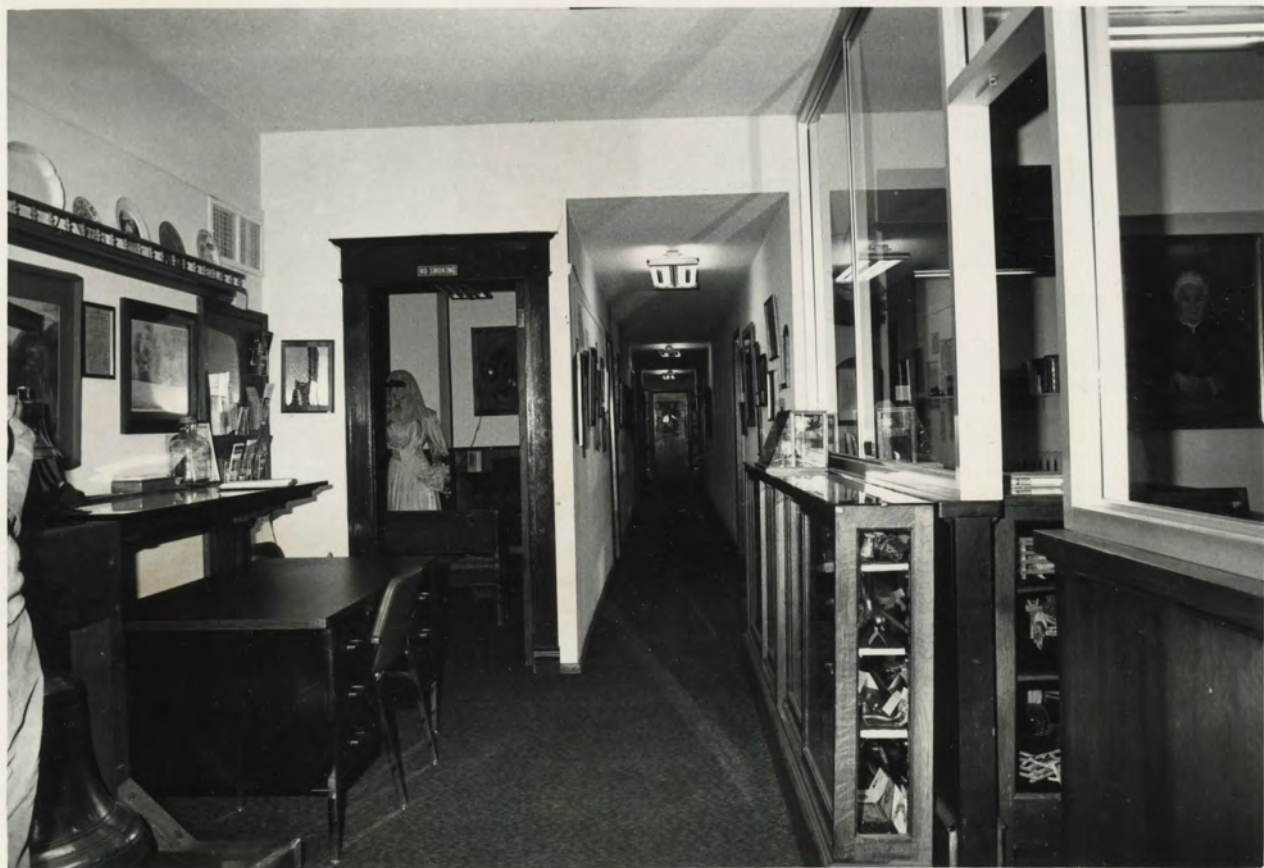
Bank of Rogers *Building*
Rogers, Arkansas
Ilike Shinn *Benton Co.*
1976
Arkansas Historic Preservation Program
First floor interior looking west
from the entrance
4 of 4
