# National Register of Historic Places Registration Form

Historic name: Champion Coated Paper Company  
Other names/site number: Champion Paper and Fibre Company; US Plywood-Champion Papers, Inc; Champion International Corporation; International Paper Company; SMART Papers  
Name of related multiple property listing: N/A

Street & number: 601 North B Street  
City or town: Hamilton State: Ohio County: Butler  
Not For Publication:  n/a Vicinity:  n/a

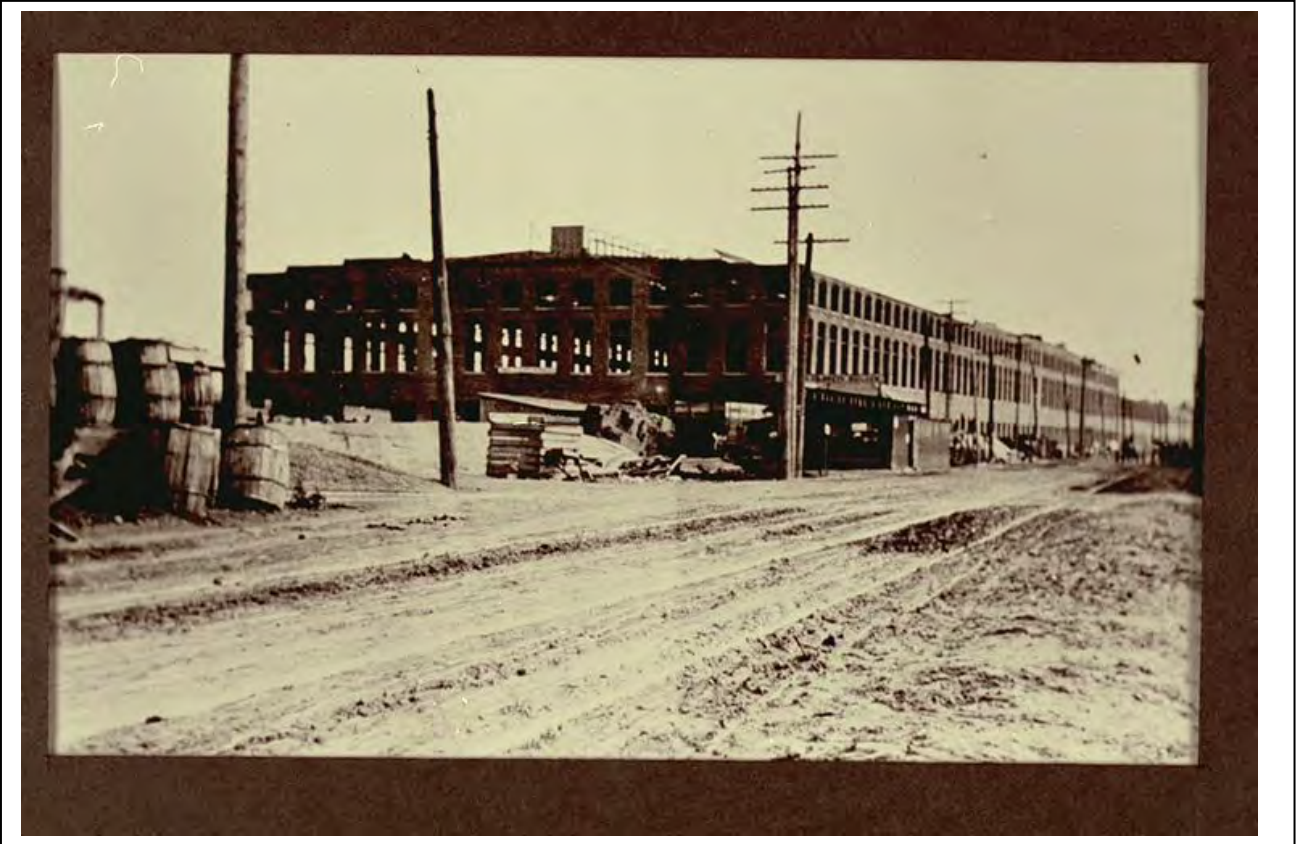
Figure 7: No. 2 Mill under construction, 1906, *Hamilton Lane Library*

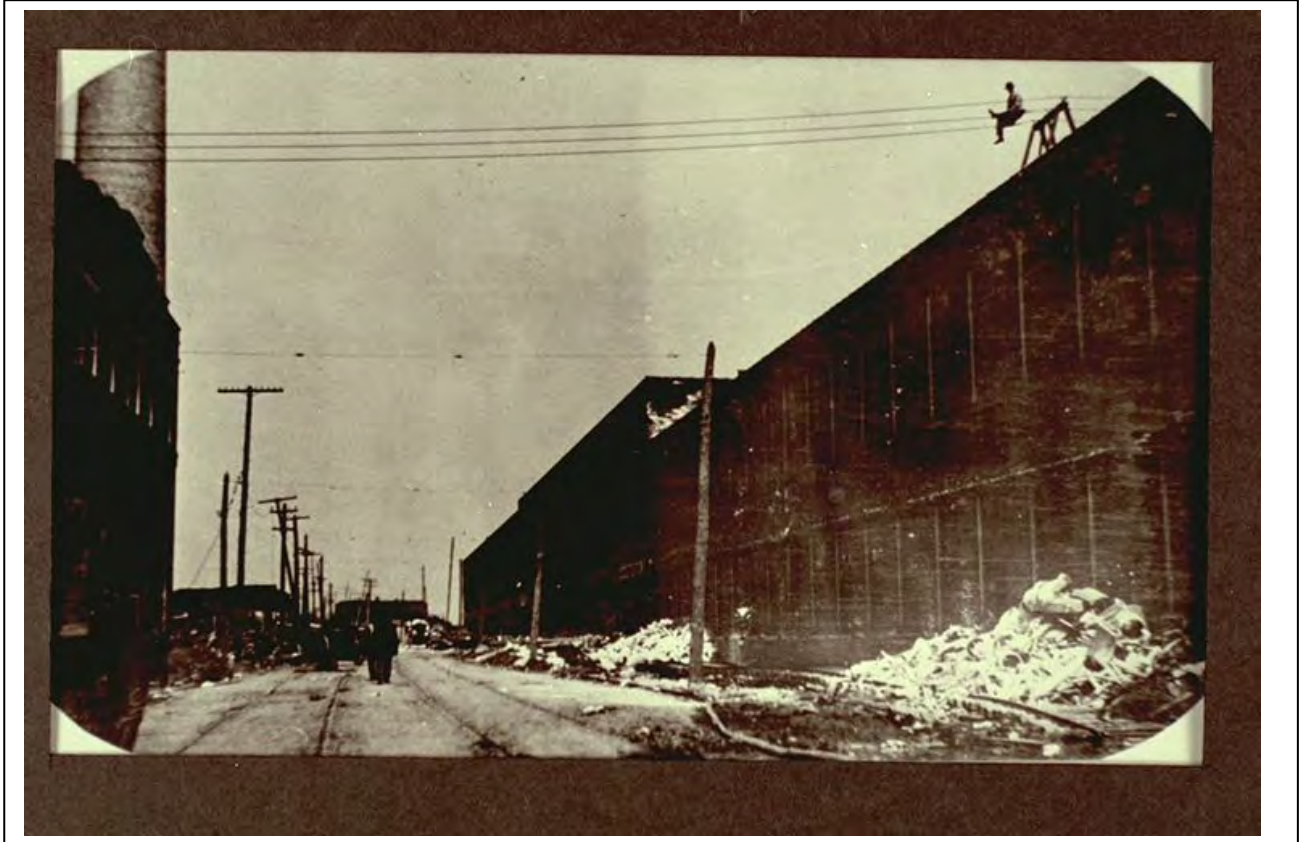
Figure 9: No. 1 Mill (left) and No. 2 Mill (right), following 1913 flood/fire, as seen from south, 1913, *Hamilton Lane Library*

In March 1913, another disaster struck Hamilton and Champion Paper, as the Great Miami River suffered a second massive flood that crested even 10 feet higher than the flood of 1898. The Champion plant was again almost fully submerged, and in the midst of the flood a major fire erupted in the No. 1 Mill, burning everything above the water line and supplanting the mill's earlier fire as the largest in Hamilton's history. Despite extensive damage to the plant and the entire region, Champion immediately set out to rebuild once again and was back in operation within 3 months. In the aftermath of the flood, Champion also provided water and electricity to Hamilton neighborhoods on the west side of the river, which had been cut off from their existing supply on the east side.<sup>18</sup>

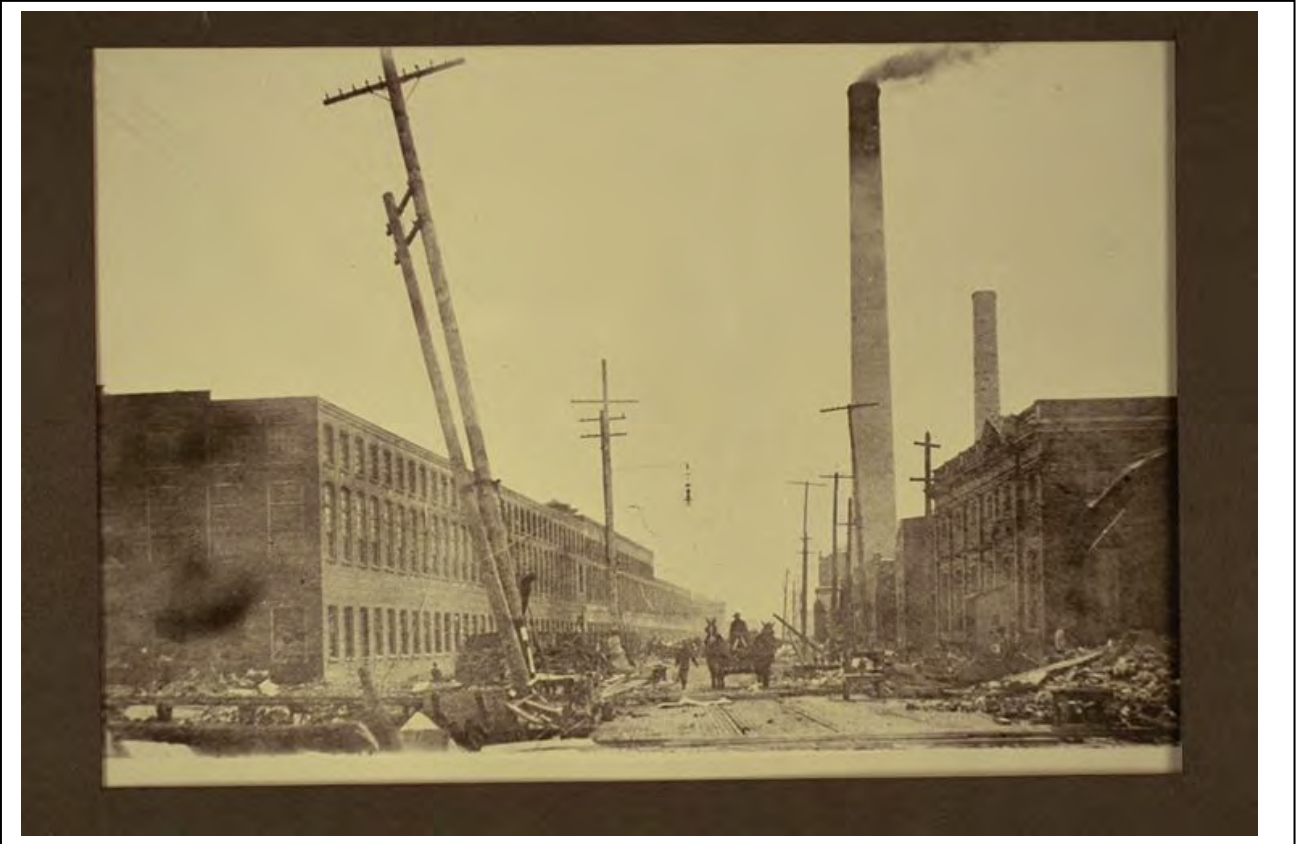
Figure 10: No. 1 Mill (right) and No. 2 Mill (left), following 1913 flood/fire, as seen from north, 1913, *Hamilton Lane Library*

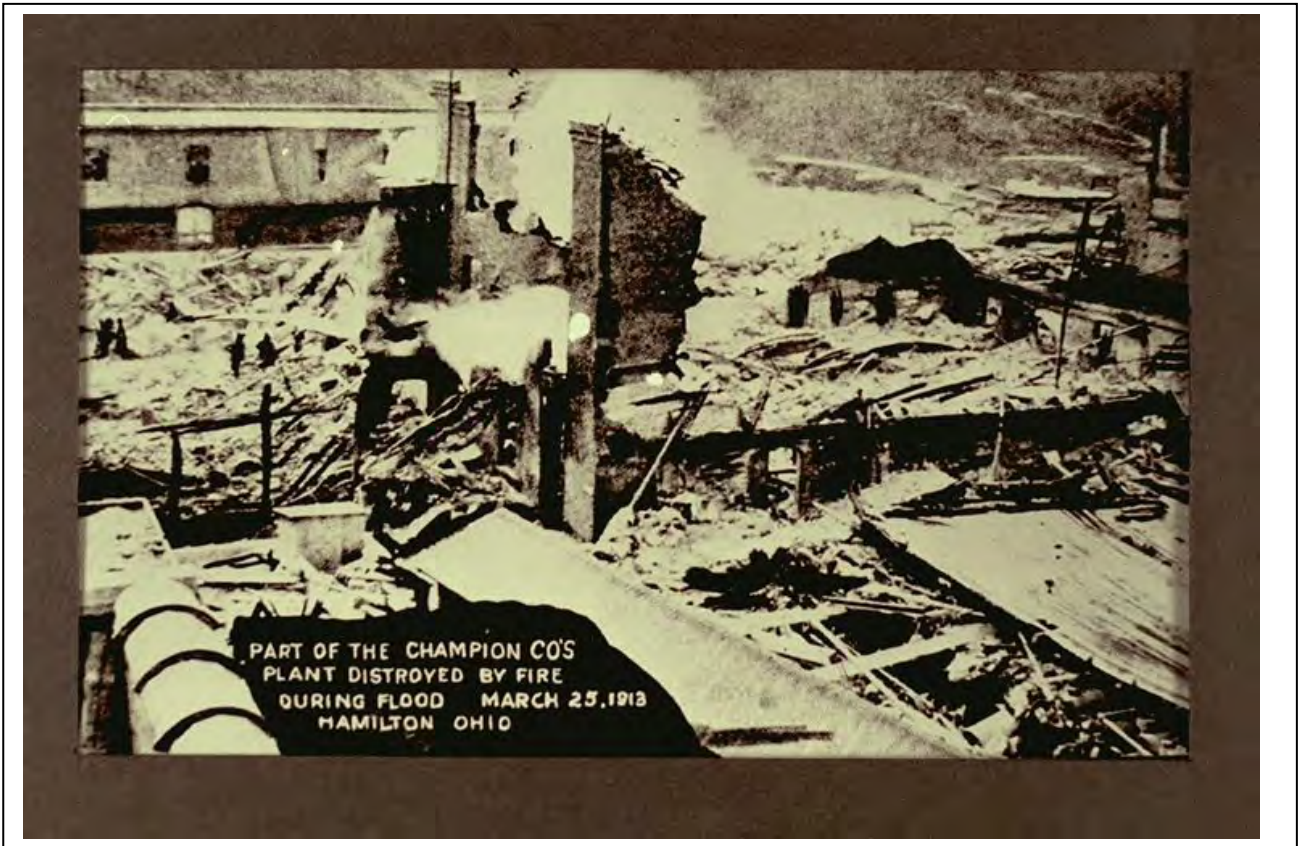
Figure 11: Extensive damage to No. 1 Mill from 1913 flood/fire, 1913,  
*Hamilton Lane Library*
