KENTUCKY HISTORIC RESOURCES INVENTORY

Site No. Sc 351

1. Historic Name(s) <u>Matthew Flounoy house</u>		22. ADD/County <u>Bluegrass State</u> <input type="checkbox"/> 105	
Original Owner <u>Matthew Flounoy</u>		23. U.S.G.S. Quadrant (15'/75') <u>Centerville Vic</u> <input type="checkbox"/> 047

2. Present Name <u>Bryan place</u>		24. UTM Reference	
3. Location <u>off E side Crumbrugh Pike and Johnson Mill Rd intersection W of N. Embury Cr.</u>		Zone <u>16</u> Easting <u>719760</u> Northing <u>4230360</u>

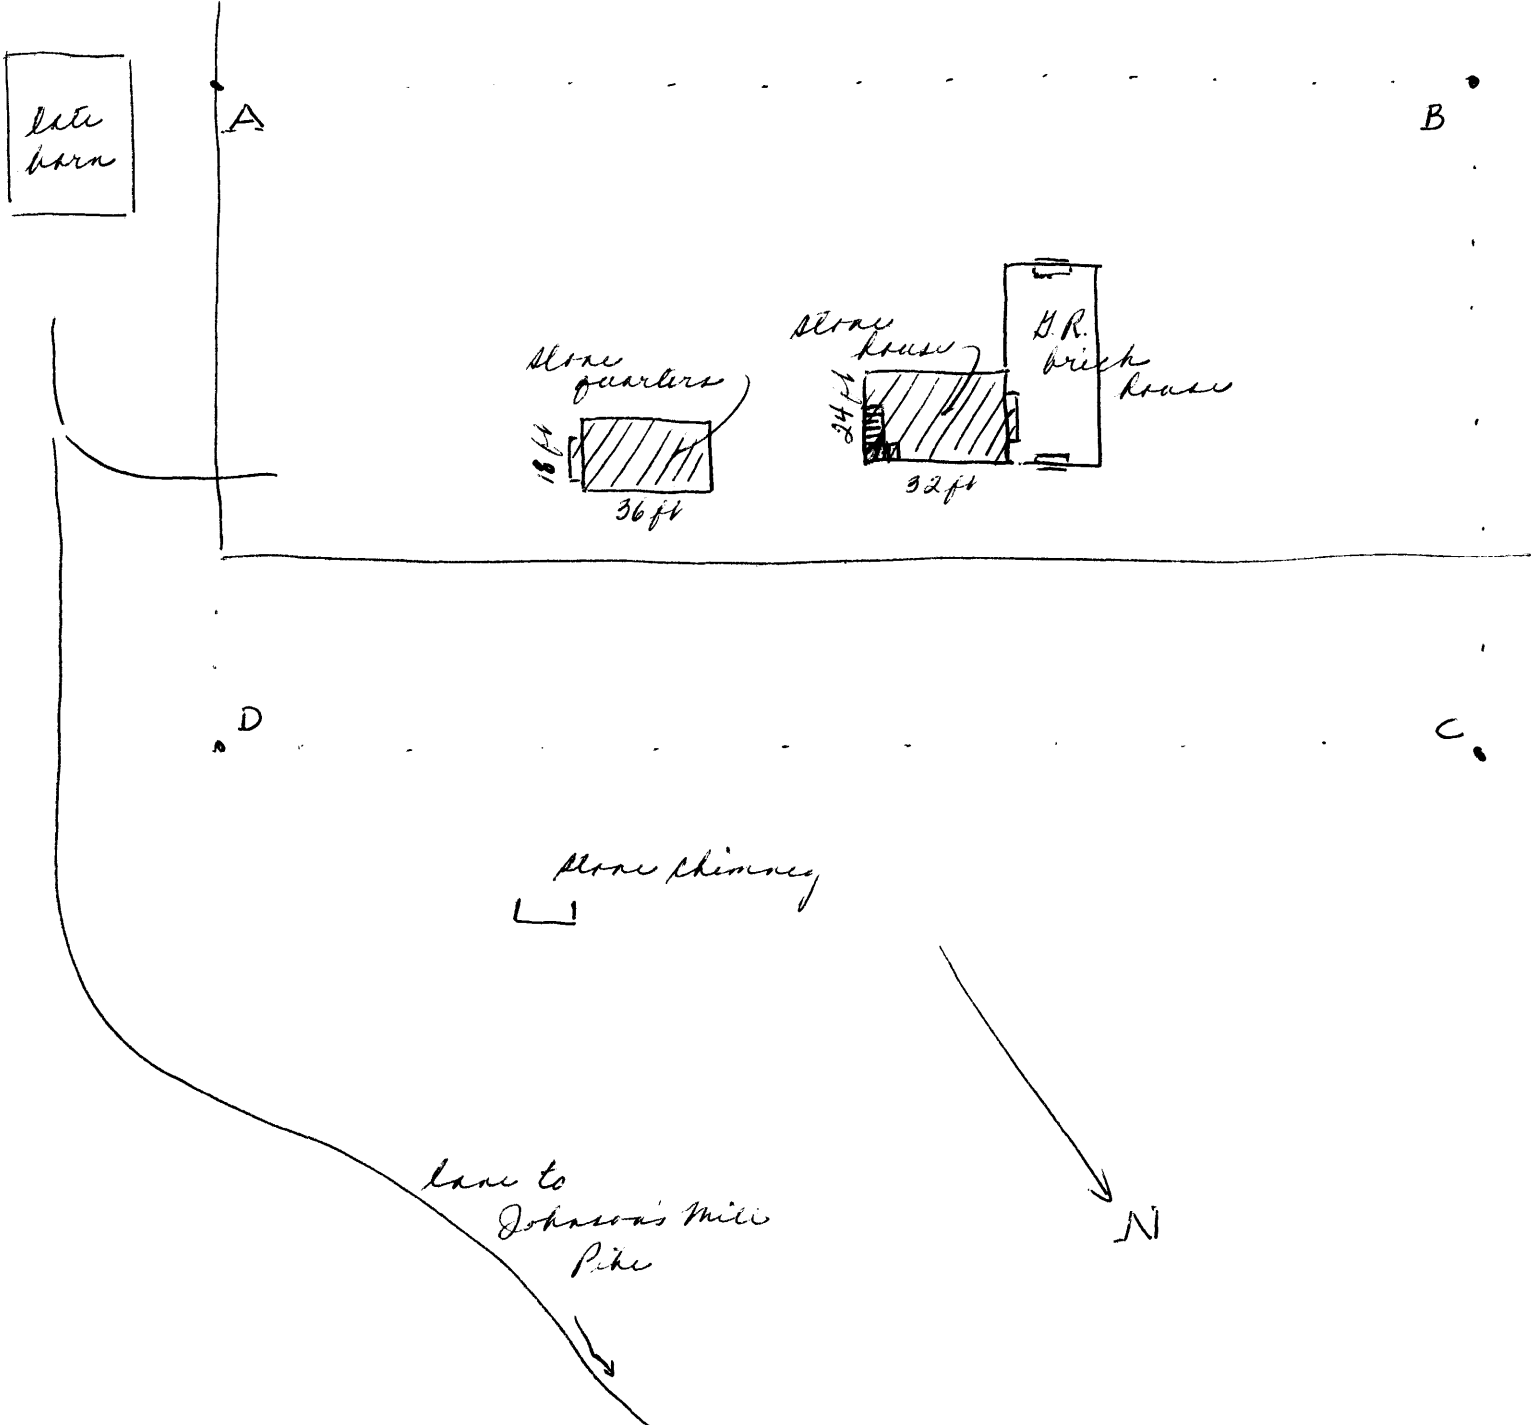
SKETCH MAP OF SITE SHOWING BOUNDARIES AND KEY BUILDINGS AND FEATURES WITH NORTH ARROW.

Beginning at A, 200 ft SW of a gate directly out from E corner of stone house, thence parallel to SW house wall 500 ft N W to B, thence at right angle 300 ft NE (crossing fence line) to C, thence parallel to A-B 500 ft SE to D, thence parallel to B-C 300 ft SW passing fence corner & with fence to the beginning, containing the stone house, brick house & stone quarters - about 3 1/2 acres.
