National Register of Historic Places
Registration Form

historic name Pope, Captain John S., Farm

Captain John S. Pope Farm
Orange County, North Carolina

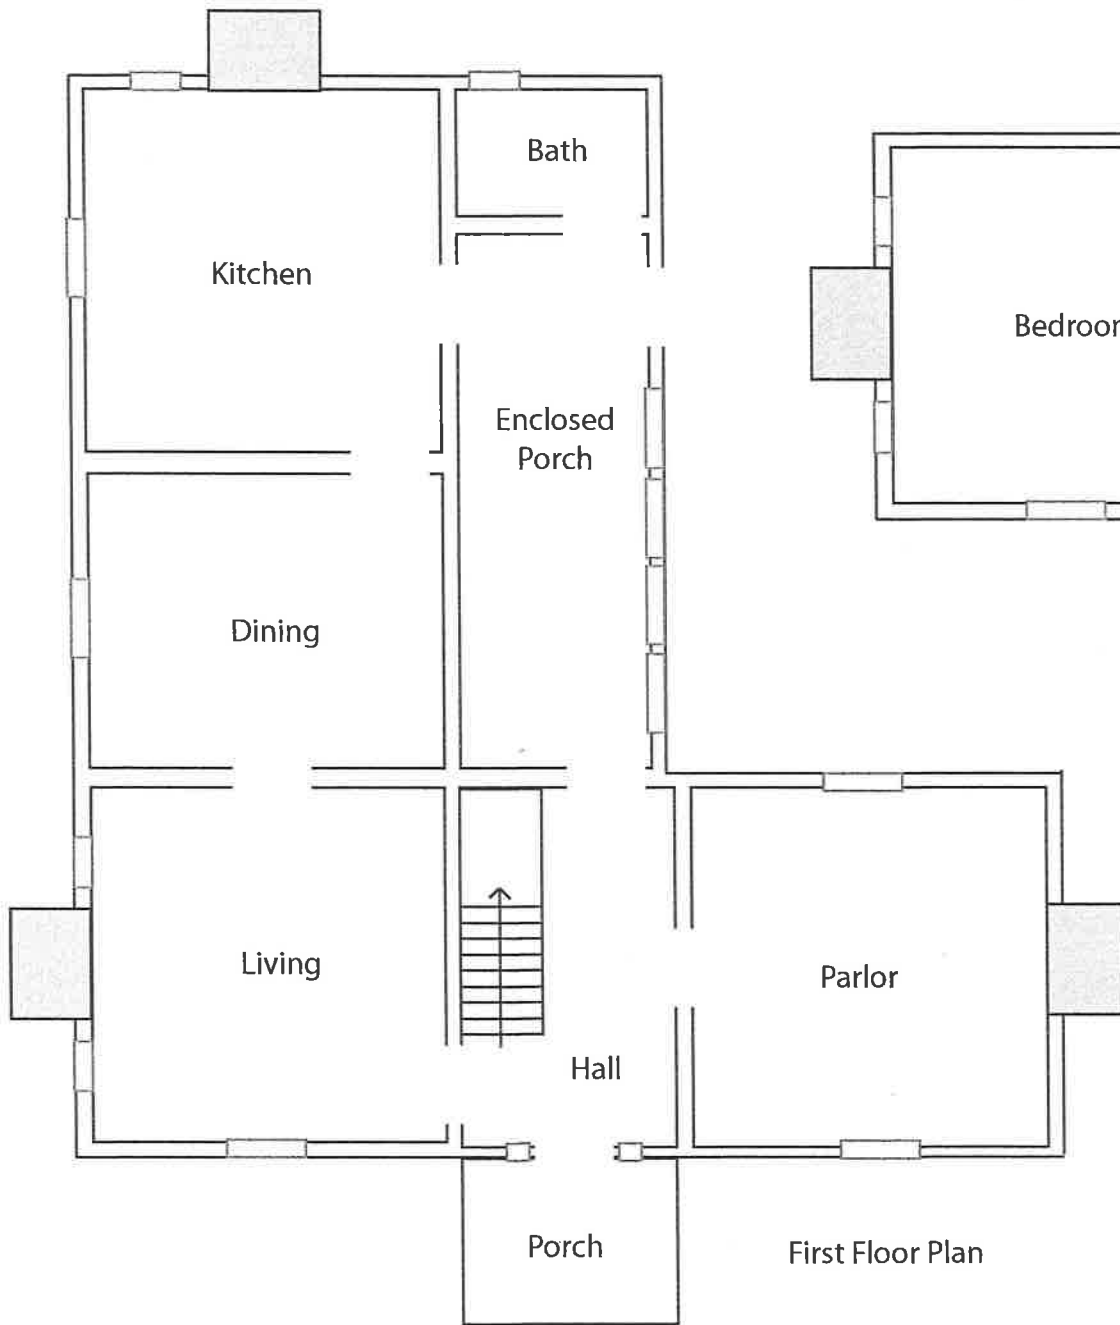
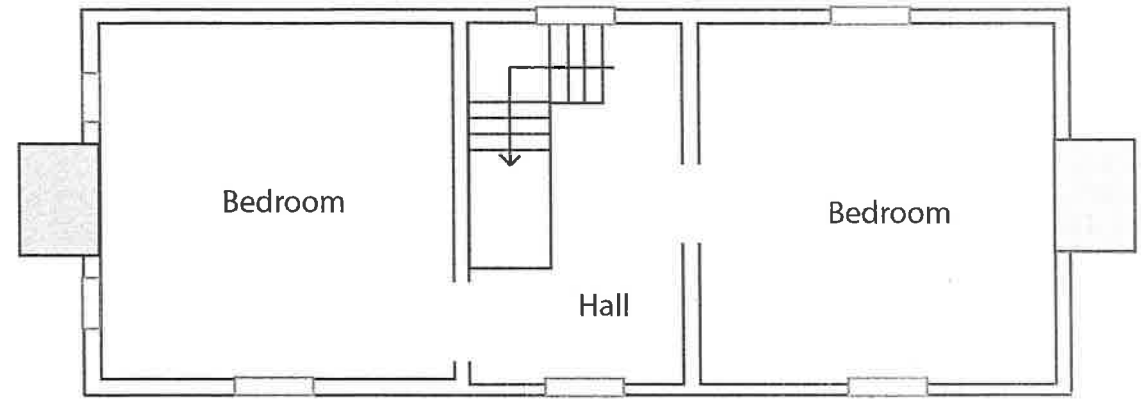
First Floor Plan

Second Floor Plan

Captain John S. Pope Farm
 6909 Efland-Cedar Grove Road
 Cedar Grove
 Orange County
 North Carolina

The front door opens to a center hall with a stair along the north wall and a door on the east wall that opens to the rear porch. There are living spaces on each side of the hall and two bedrooms flanking the hall at the second-floor level. There are eight-foot ceilings on the first floor and seven-foot ceilings on the second floor, all with painted, wide-plank horizontal sheathing on the walls and ceilings. Original wood floors are unpainted, medium-plank boards. There are eight-inch baseboards with a small trim detail at the top. Interior doors are two-panel, Greek Revival-style doors with box locks. Door and window surrounds are six-inch, flat-board surrounds with applied molding at the outer edge and no apron. Ductwork in the kitchen and second-floor rooms is enclosed with drywall.

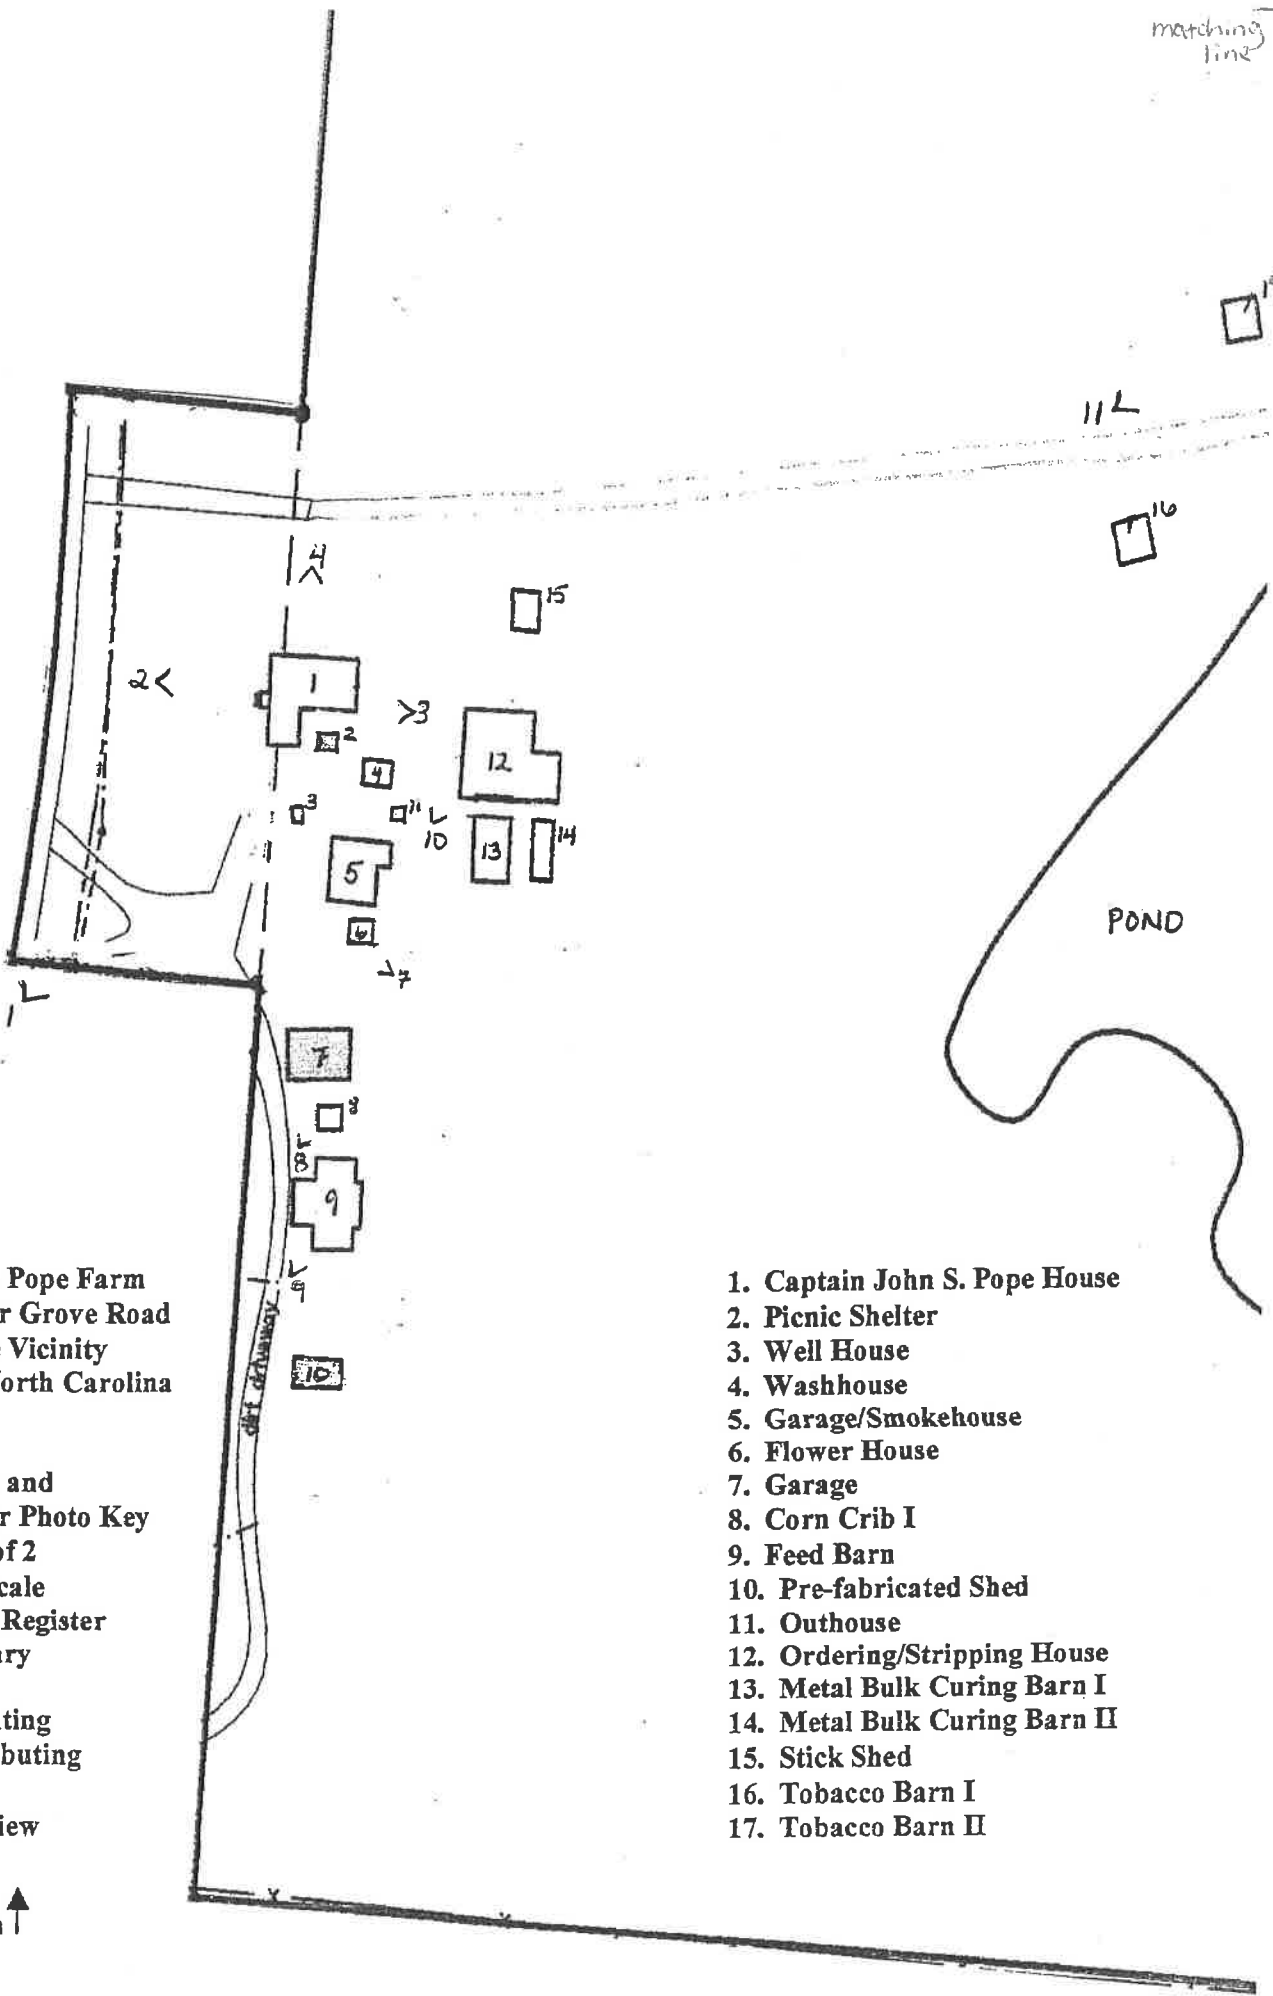
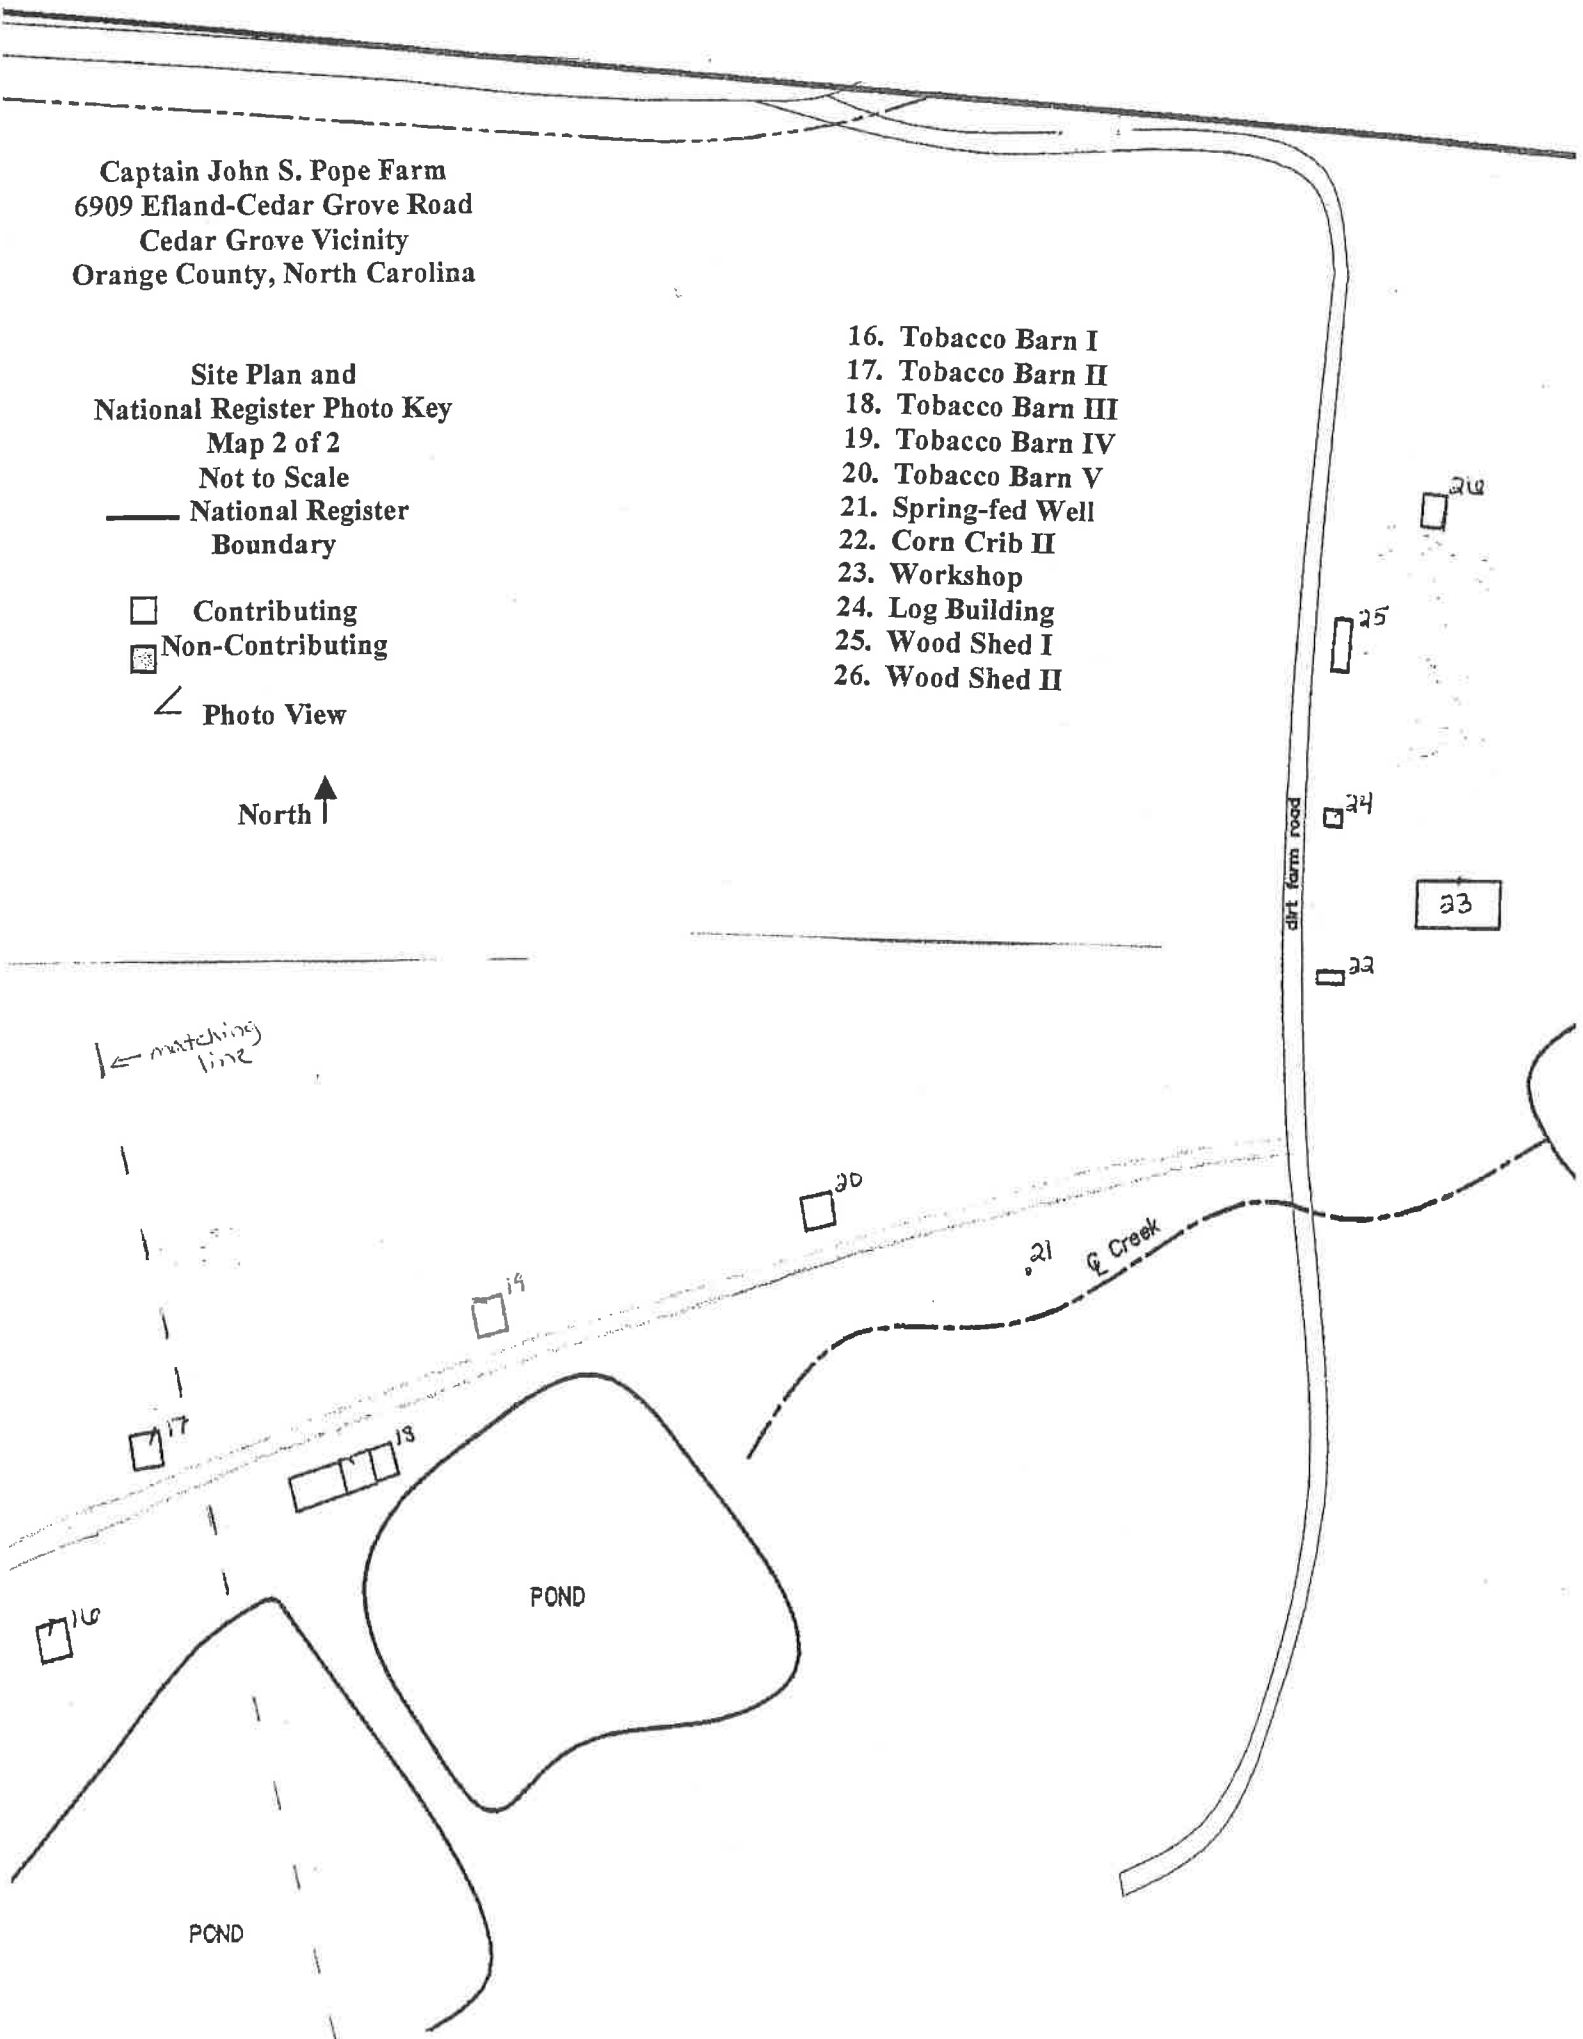
Site Plan and
 National Register Photo Key
 Map 1 of 2
 Not to Scale
 — National Register
 Boundary

Captain John S. Pope Farm
 6909 Efland-Cedar Grove Road
 Cedar Grove Vicinity
 Orange County, North Carolina

- 16. Tobacco Barn I
- 17. Tobacco Barn II
- 18. Tobacco Barn III
- 19. Tobacco Barn IV
- 20. Tobacco Barn V
- 21. Spring-fed Well
- 22. Corn Crib II
- 23. Workshop
- 24. Log Building
- 25. Wood Shed I
- 26. Wood Shed II

The inventory list is organized by location of building, moving from north to south along Efland-Cedar Grove Road and then from west to northeast along the farm road. Numbers assigned to the buildings in the inventory list correspond with the numbered buildings on the accompanying site maps. All of the buildings are one-story except where noted.

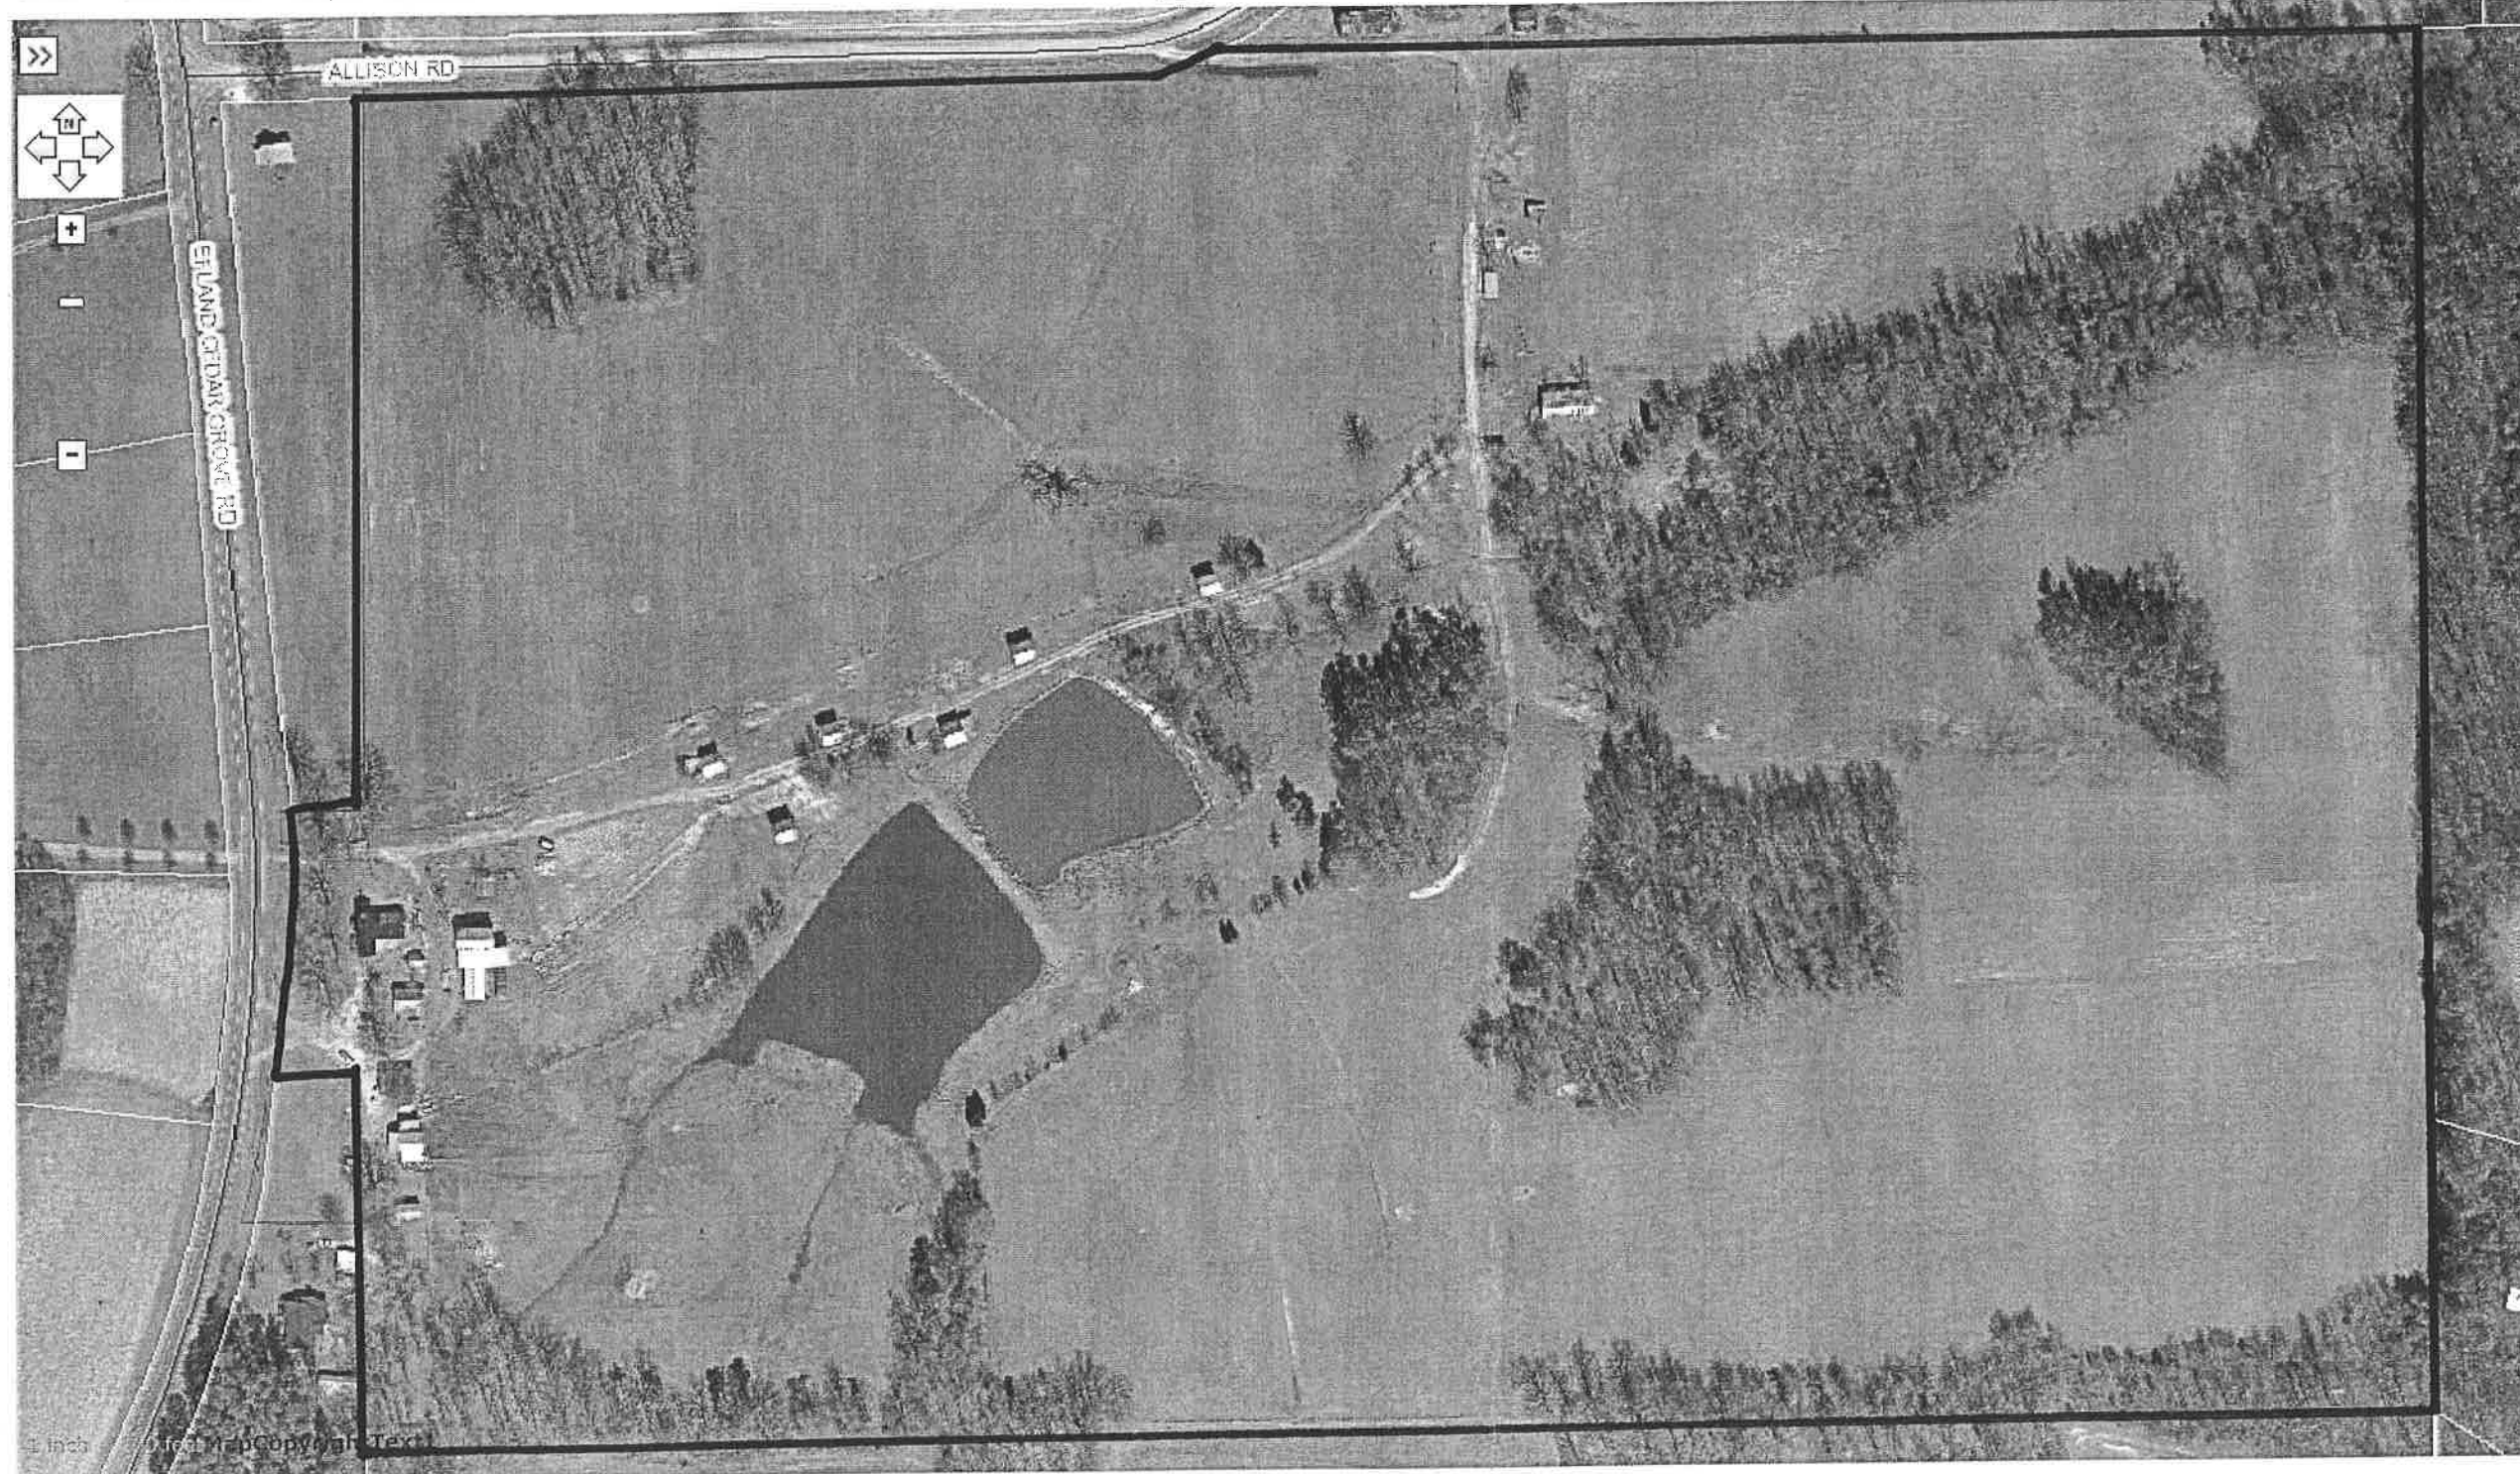
Captain John S.
 Pope Farm
 6909 Efland -
 Cedar Grove Rd.
 Cedar Grove vic.
 Orange County,
 North Carolina
 Tax Map with
 National
 Register Boundary
