National Register of Historic Places  
Registration Form

historic name Martin, William P. and Rosa Lee, Farm

other names/site number SE0372

state Arkansas code AR county Searcy code 129 zip code 72650

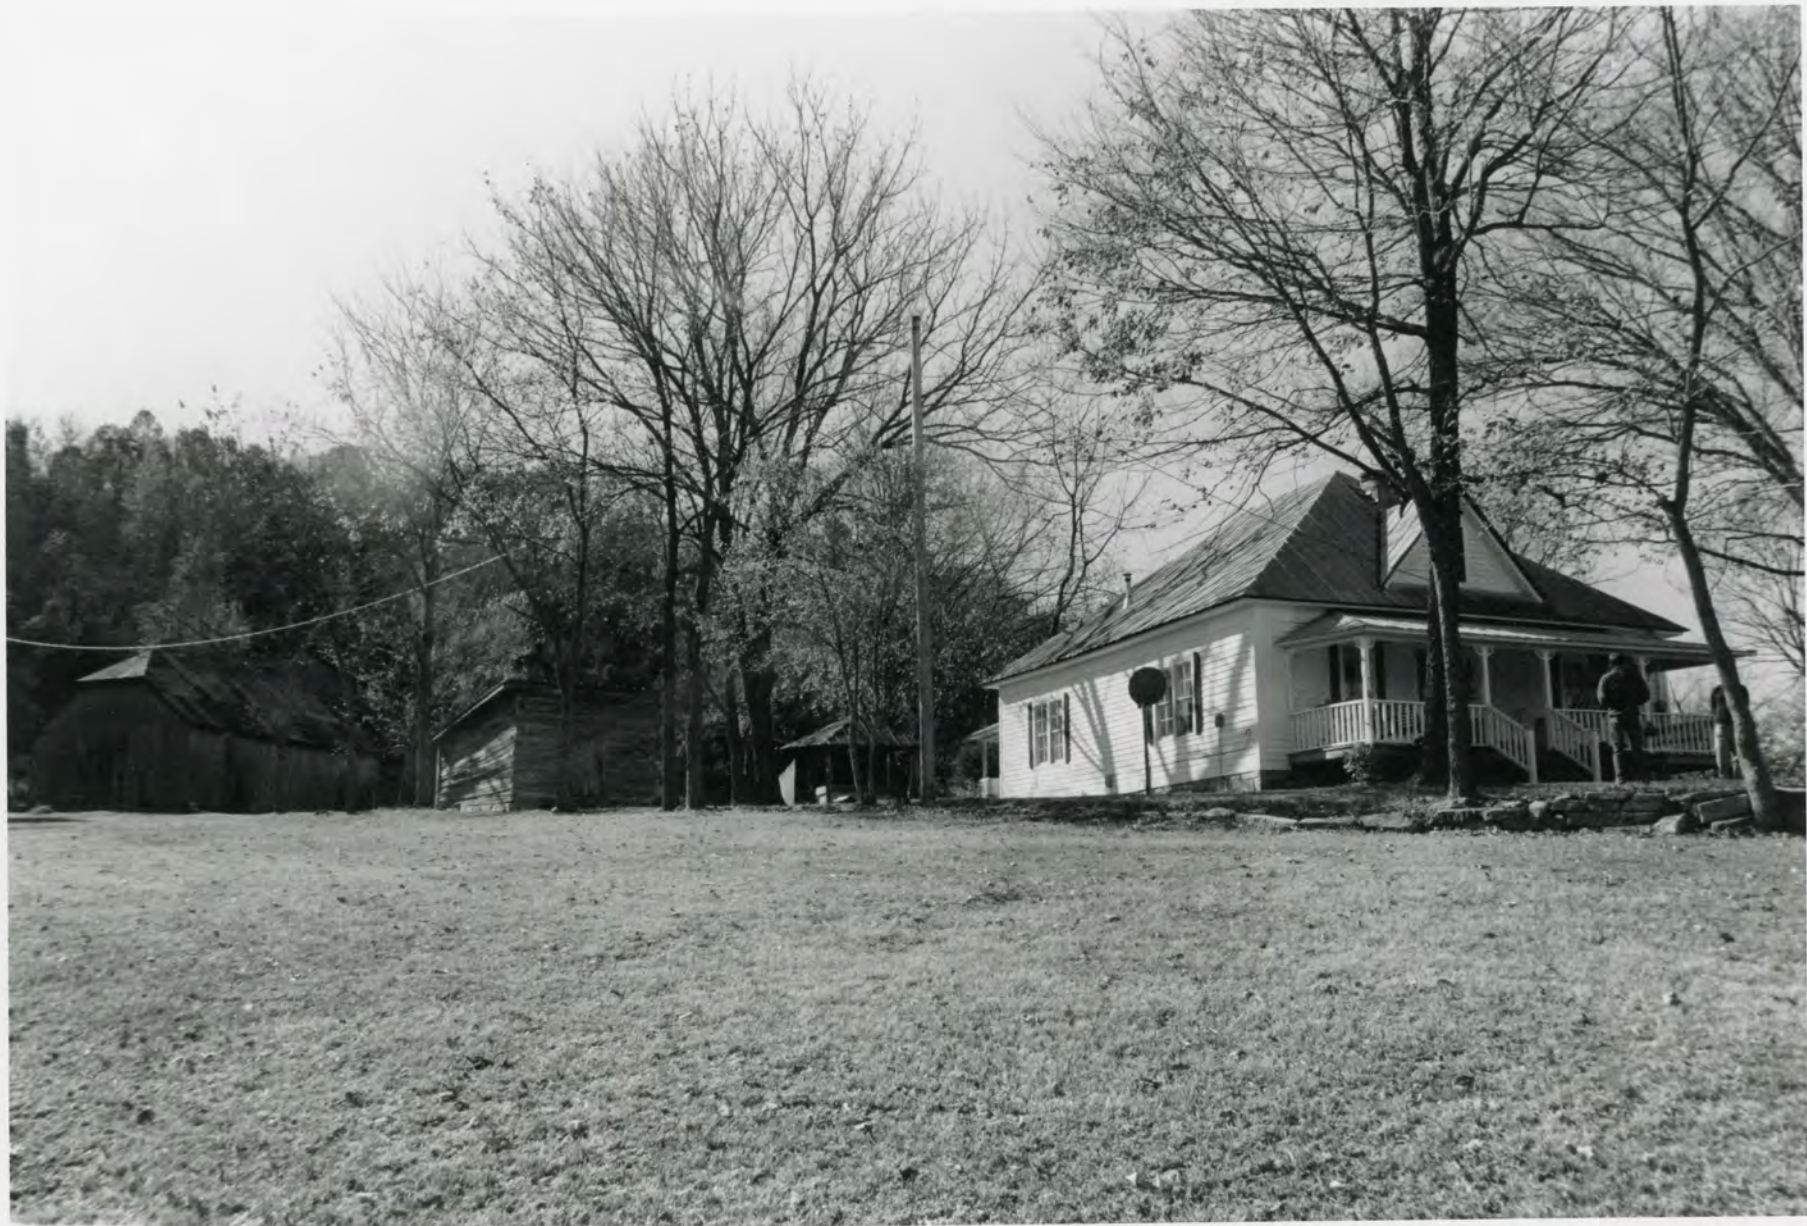
1. William P. and Rosa Lee Martin Farm
2. Searcy Co., AR
3. Ralph Wilcox
4. November 4, 2010
5. Arkansas Historic Preservation Program, Little Rock, AR
6. Looking southwest towards farm buildings
7. #1

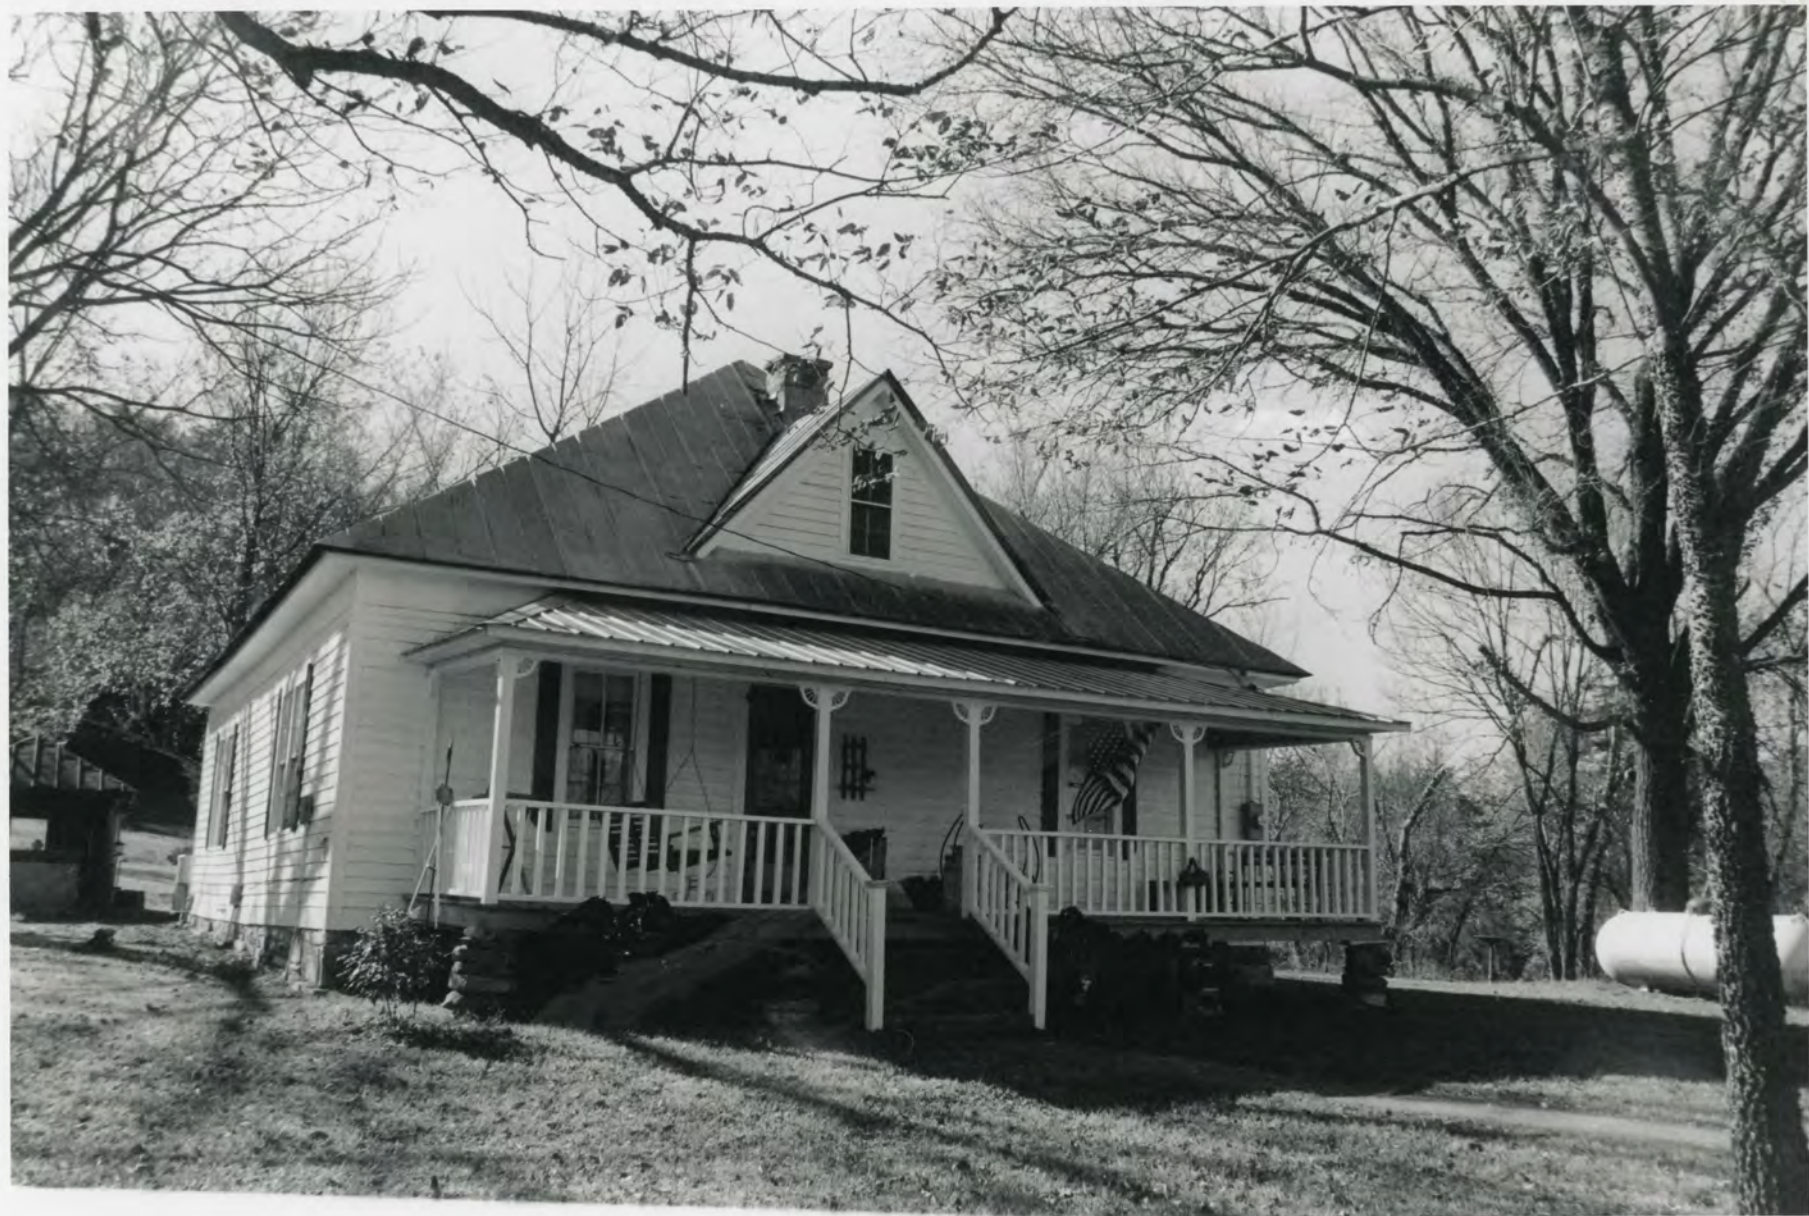
1. William P. and Russell Lee Martin Farm
2. Searcy Co., AR
3. Ralph Wilcox
4. November 4, 2010
5. Arkansas Historic Preservation Program, Little Rock, AR
6. north elevation of farmhouse, looking south
7. #3

### Front/North Façade

The north, or front façade of the Martin Farmhouse is fronted by a full, front porch with a hipped roof supported by square wooden posts. The porch floor, which is supported by a native stone pier foundation, is bordered by a simple wooden railing. Concrete steps lead to the front door, which is slightly offset to the left and is flanked by two four-over-four double-hung windows. To the left and right of the windows are simple red wooden shutters with rounded corners. The hipped roof is broken by a central gabled dormer and a native stone chimney located between the dormer and the roof peak. The front porch extends to the north.

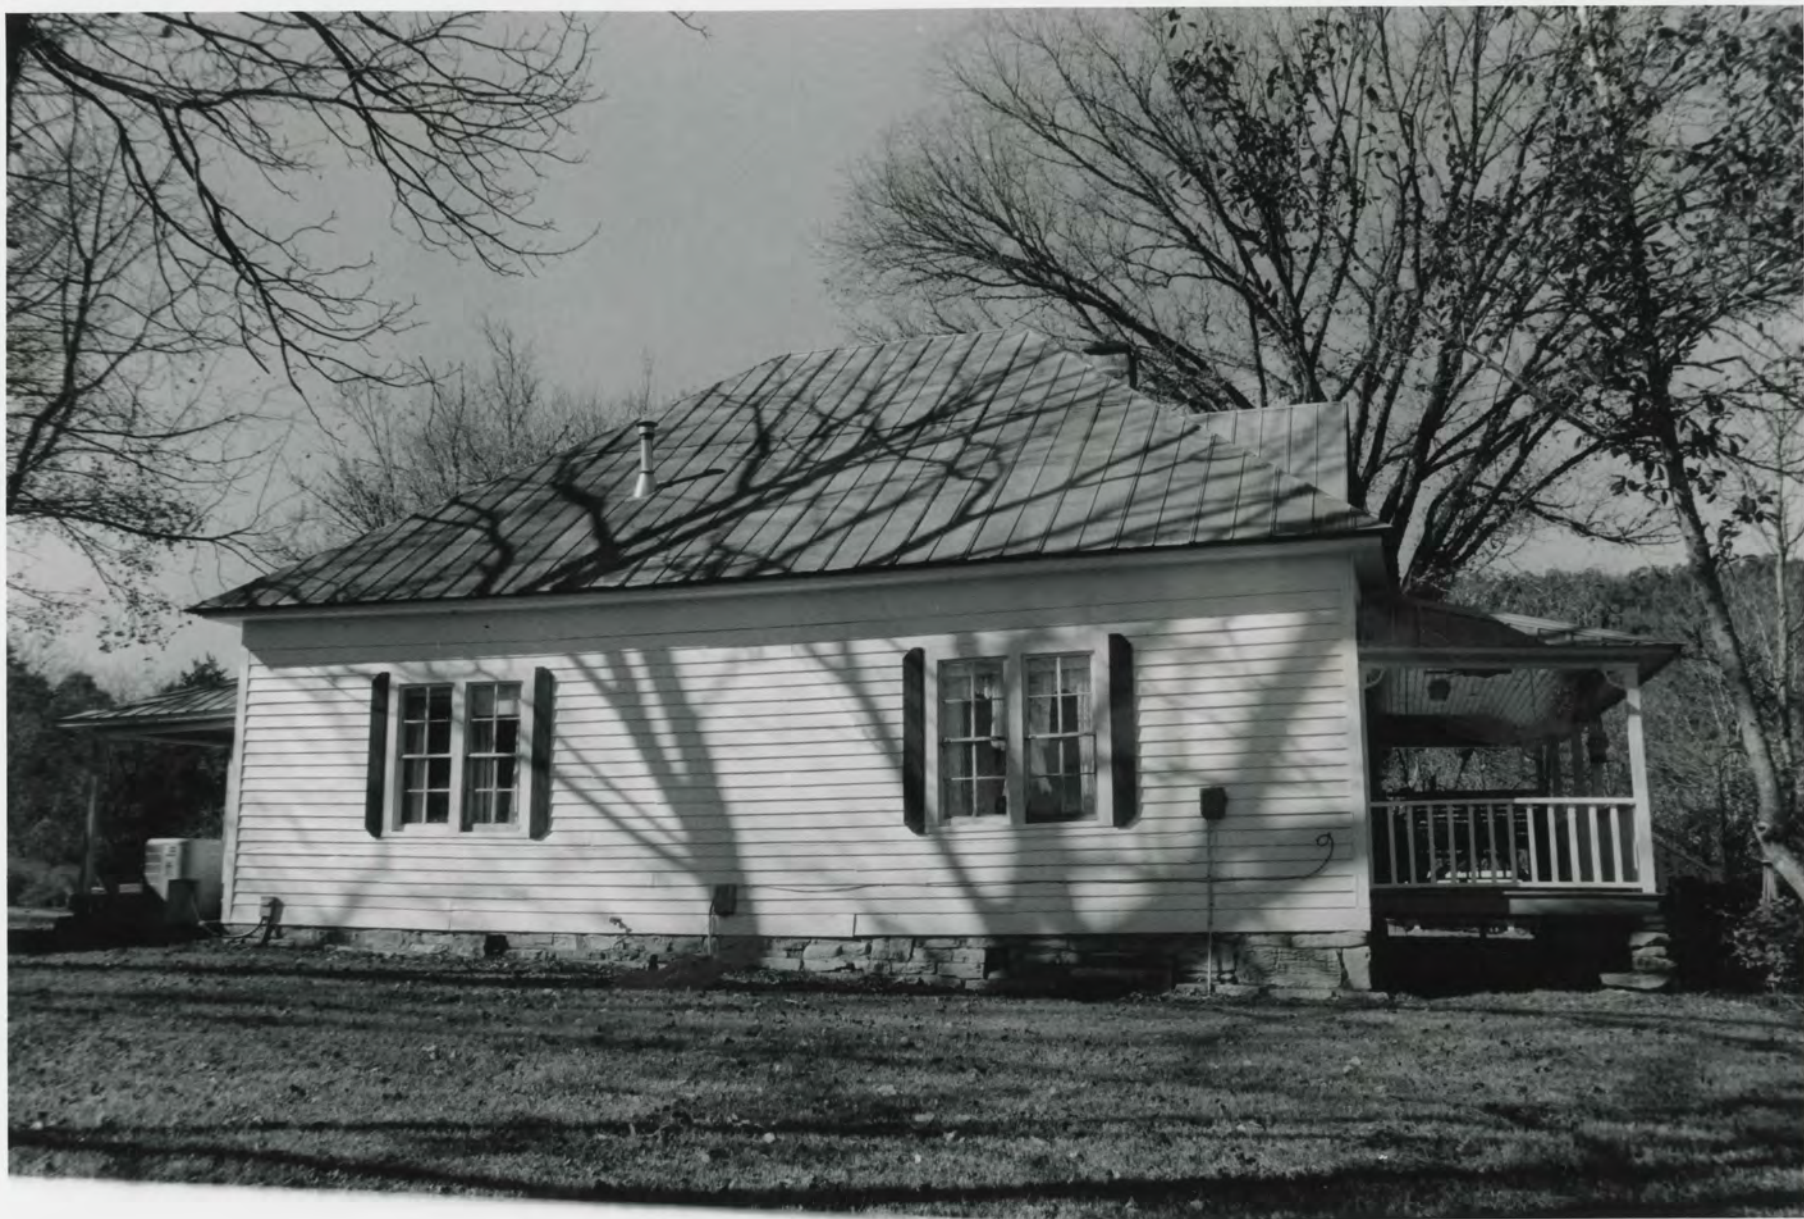
7. #4

6. east elevation of farmhouse, looking west

### East Façade

The main mass of the east elevation features a pair of four-over-four double-hung windows located slightly to the right of center. To the north of this window is a single four-over-four double-hung window, and to the south is another pair of four-over-four double-hung windows. To the left and right of the single window and the window pairs are simple red wooden shutters with rounded corners. On the roof just above the south window pair is a thin, native stone chimney. The side of the sunroom, which is at the south end of this elevation, has a pair of single-pane stationary windows just under the roofline. The front porch extends to the north.

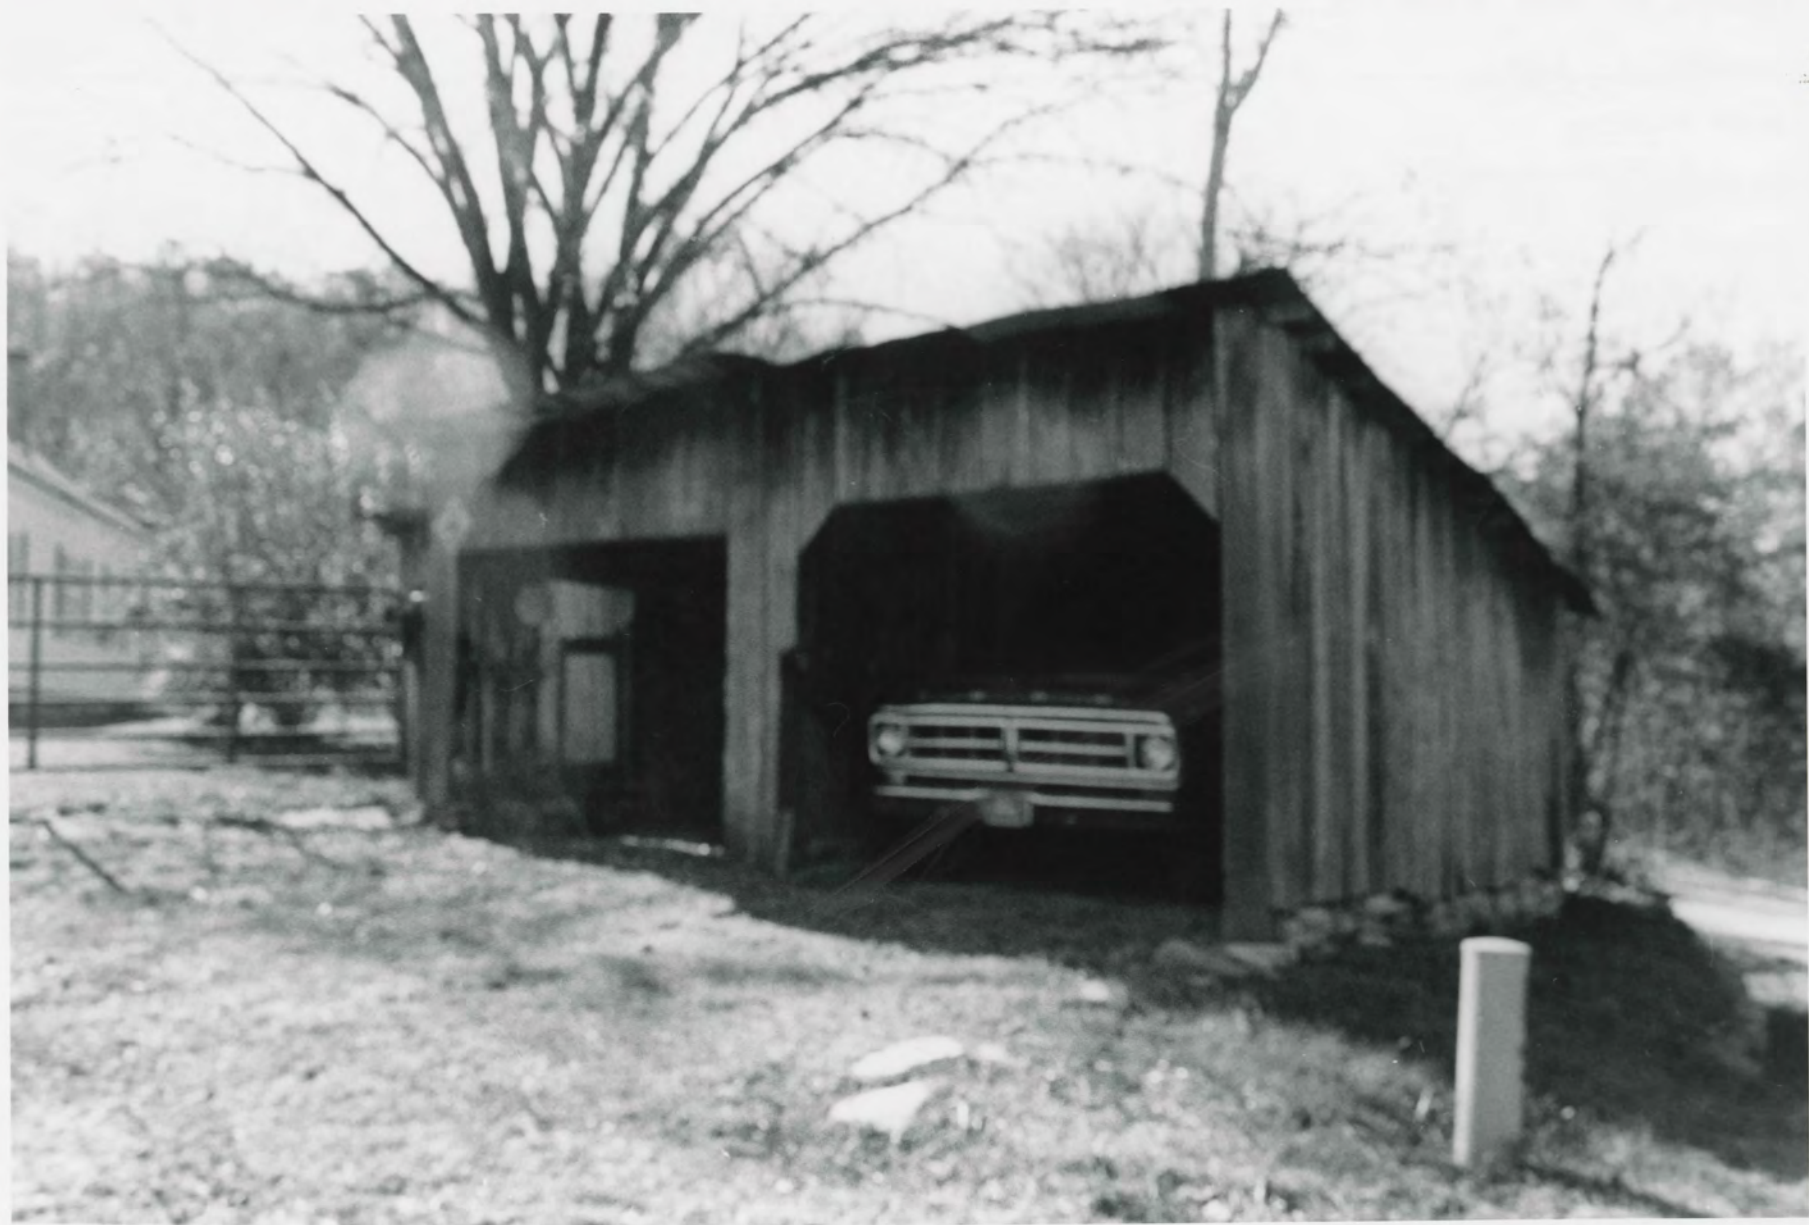
1. William P. and Rosa Lee Martin Farm
2. Searcy Co., AR
3. Ralph Wilcox
4. November 4<sup>th</sup>, 2010
5. Arkansas Historic Preservation Program, Little Rock, AR
6. northeast elevation of garage, looking southwest
7. #5

### Outbuilding: Garage/Workshop

This three bay structure is located approximately 30 feet northwest of the house. Its foundation consists of native stone and mortar topped with heavy, hand hewn logs. The three bay carport faces northeast and consists of two open front bays for use as a garage and an enclosed bay for use as a workshop or for storage. The northwest end of the building was significantly damaged by two trees that were allowed to grow into the structure. In 2007 the trees were removed and repairs were made using boards similar to the ones damaged by the trees. The remainder of the siding consists of rough cut hardwood boards and they remain intact. The original wood shake shed roof on this structure was removed due to deterioration and has been replaced with corrugated galvanized metal roofing.

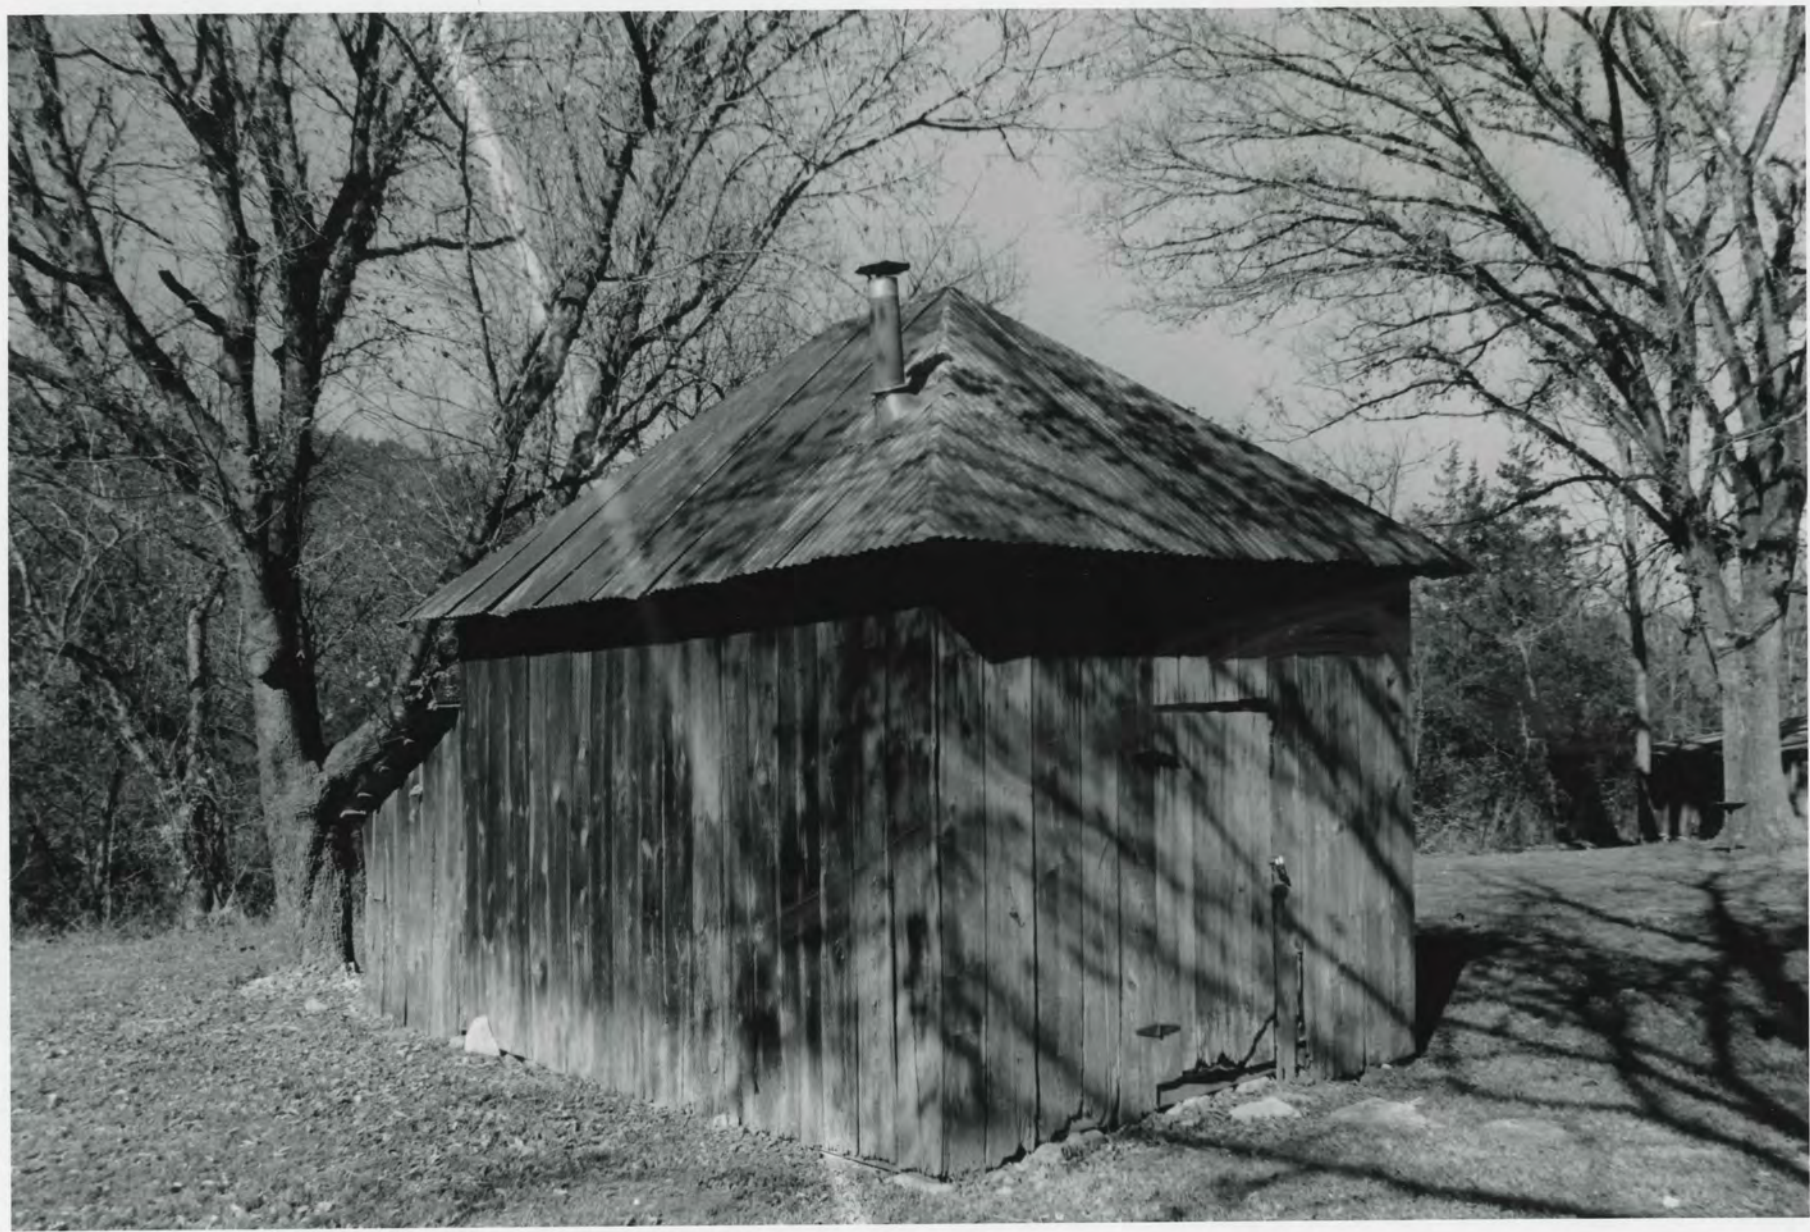
7. #6

6. north-east elevations of smokehouse, looking southwest

### Outbuilding: Smokehouse

This structure is located approximately 15 feet from the southwest corner of the house. Its foundation consists of stacked native stone topped with hewn logs, and it retains the original vertical rough-cut hardwood siding. The building was converted into a craft house by adding sheetrock, shelving, and insulation to the interior walls. The hip roof is covered with galvanized corrugated metal. A skylight was added to the roof on the north side. A small lean-to with a metal shed roof is attached to the west side.

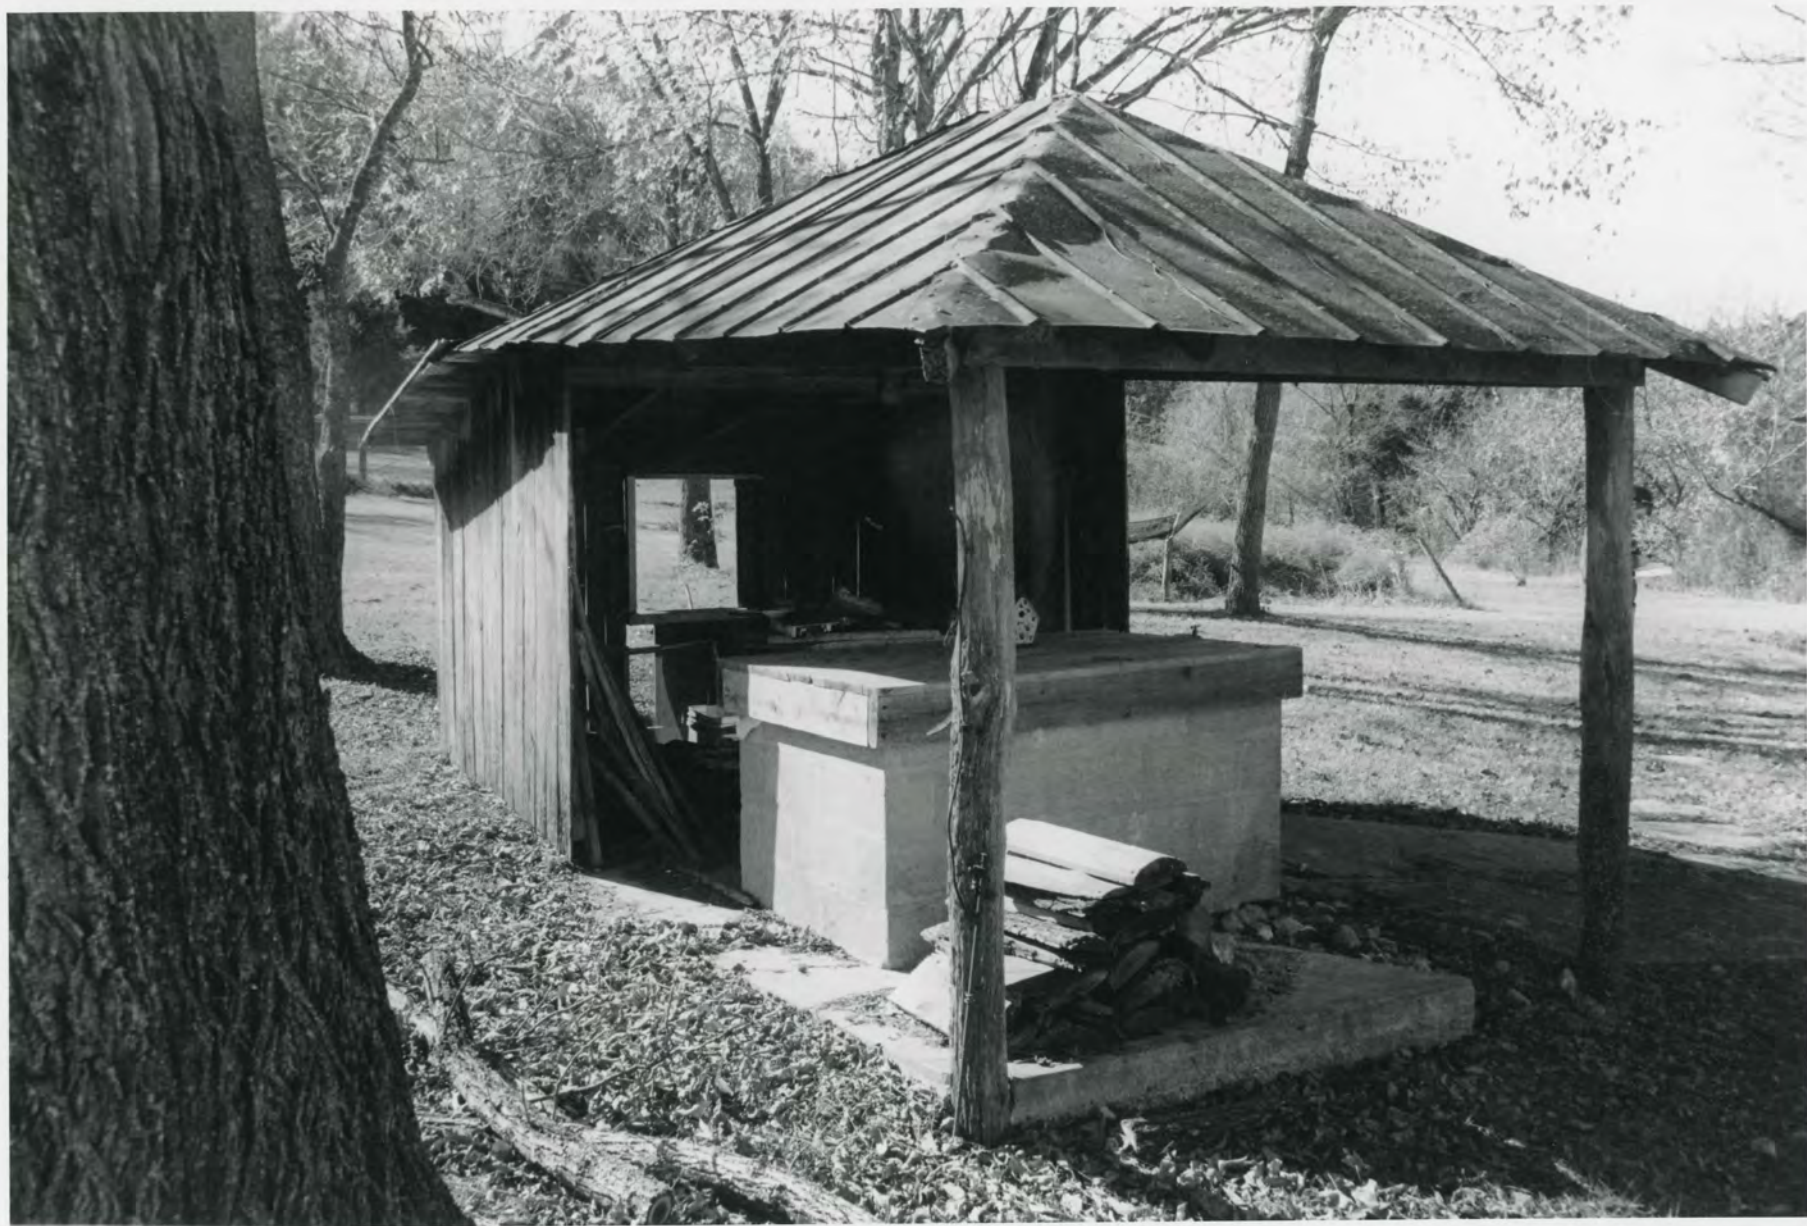
7. #7

6. north + east elevations of well, looking southwest

### Outbuilding: Well House

The well house is located about two steps from the southeast corner of the back porch of the house and has a concrete foundation and floor. The front two thirds of the structure is open, covered by a metal hipped roof supported with round log posts. The rear section is enclosed with hardwood barn boards and topped with a metal shed roof. A concrete block encasement was built inside the well house to protect the pump and exposed pipes. This addition was likely made around 1946 when electricity came to the area.

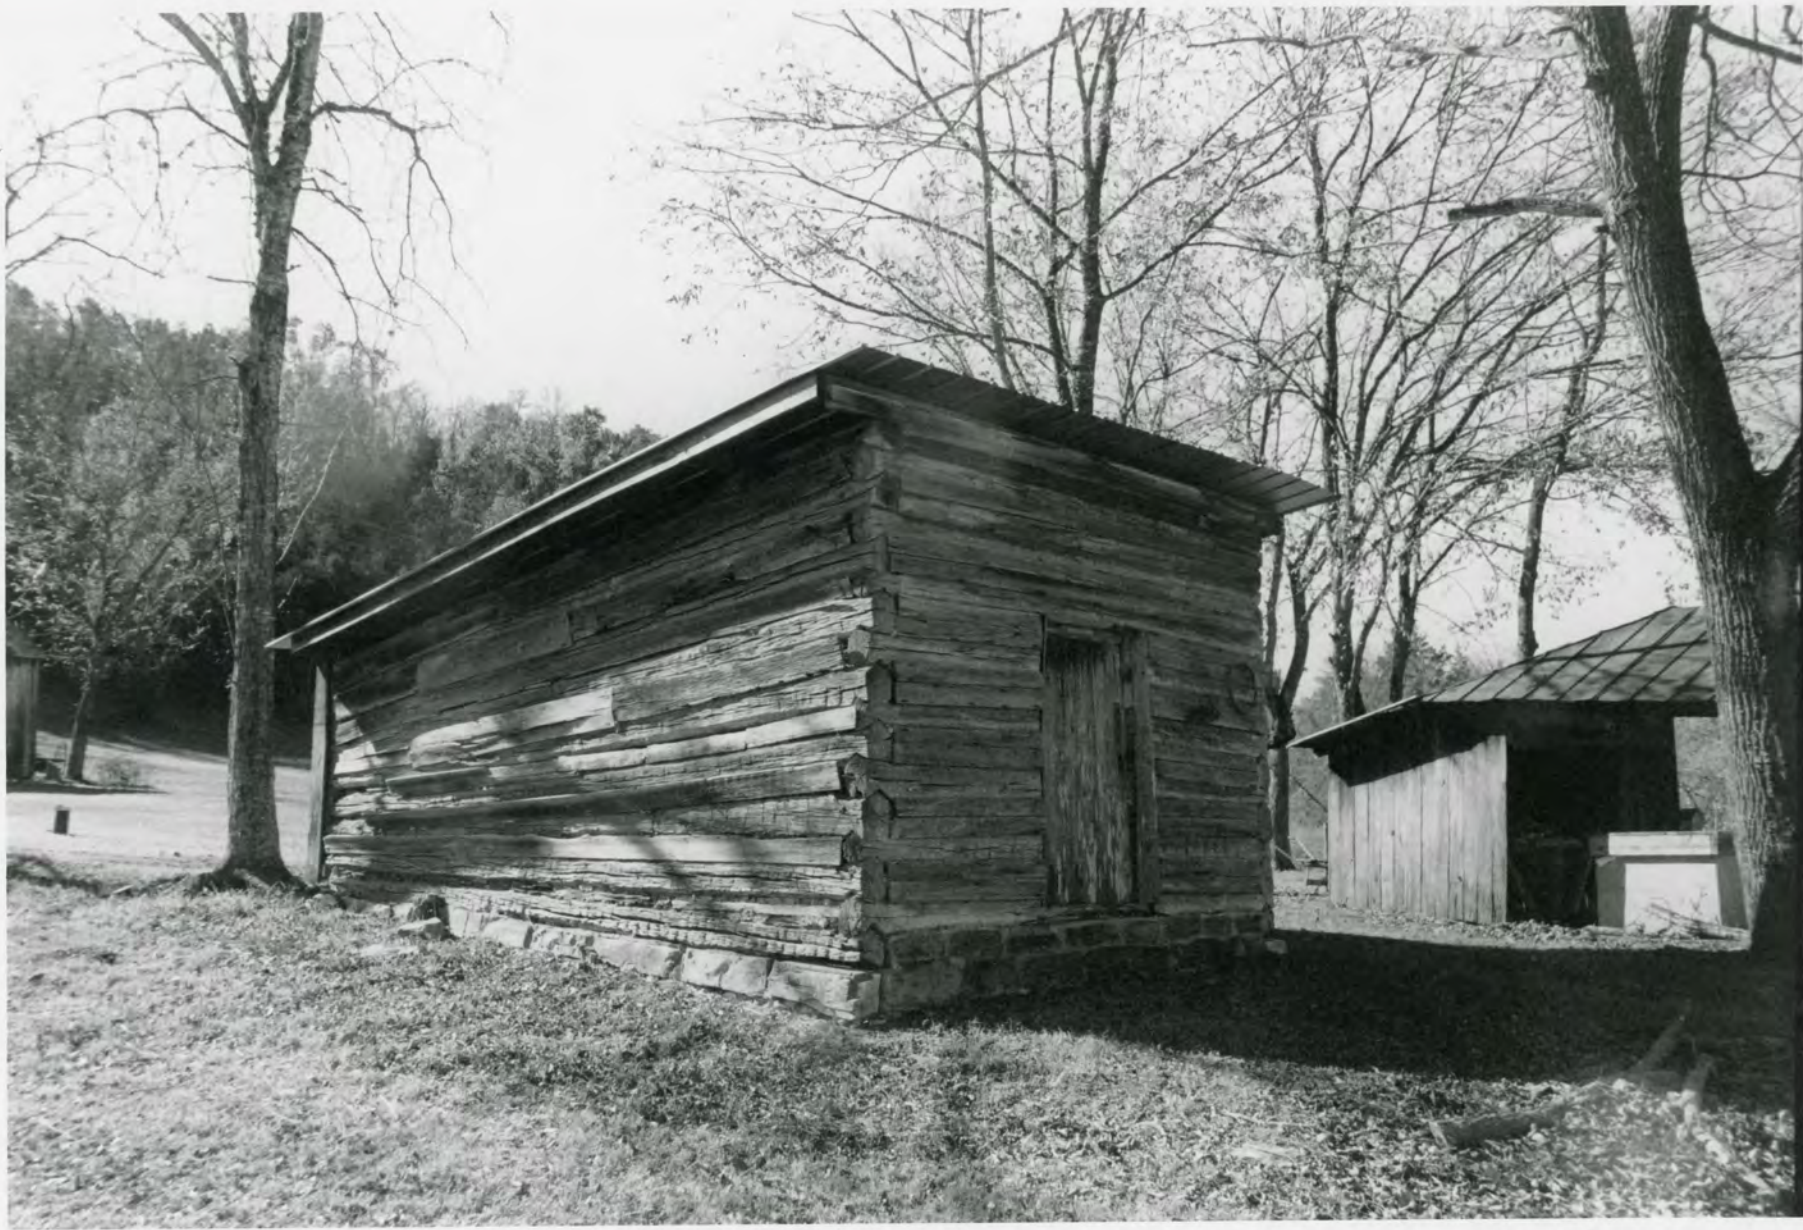
1. William P. and Rosa Lee Martin Farm
2. Searcy Co., AR
3. Ralph Wilcox
4. November 4, 2010
5. Arkansas Historic Preservation Program, Little Rock, AR
6. north-east elevations of potato house, looking southwest
7. #8

### Outbuilding: Potato House

The potato house is located approximately 10 feet east of the well house and its foundation consists of native stone and mortar topped with hand hewn logs. The walls are horizontal rough cut timbers sealed with chinking. There is one window on the back, or south side of the building. The structure remains intact except for the addition of a new metal shed roof similar to the roofing on the house. This new roof was added to the potato house just before the current owners purchased the property in 2006.

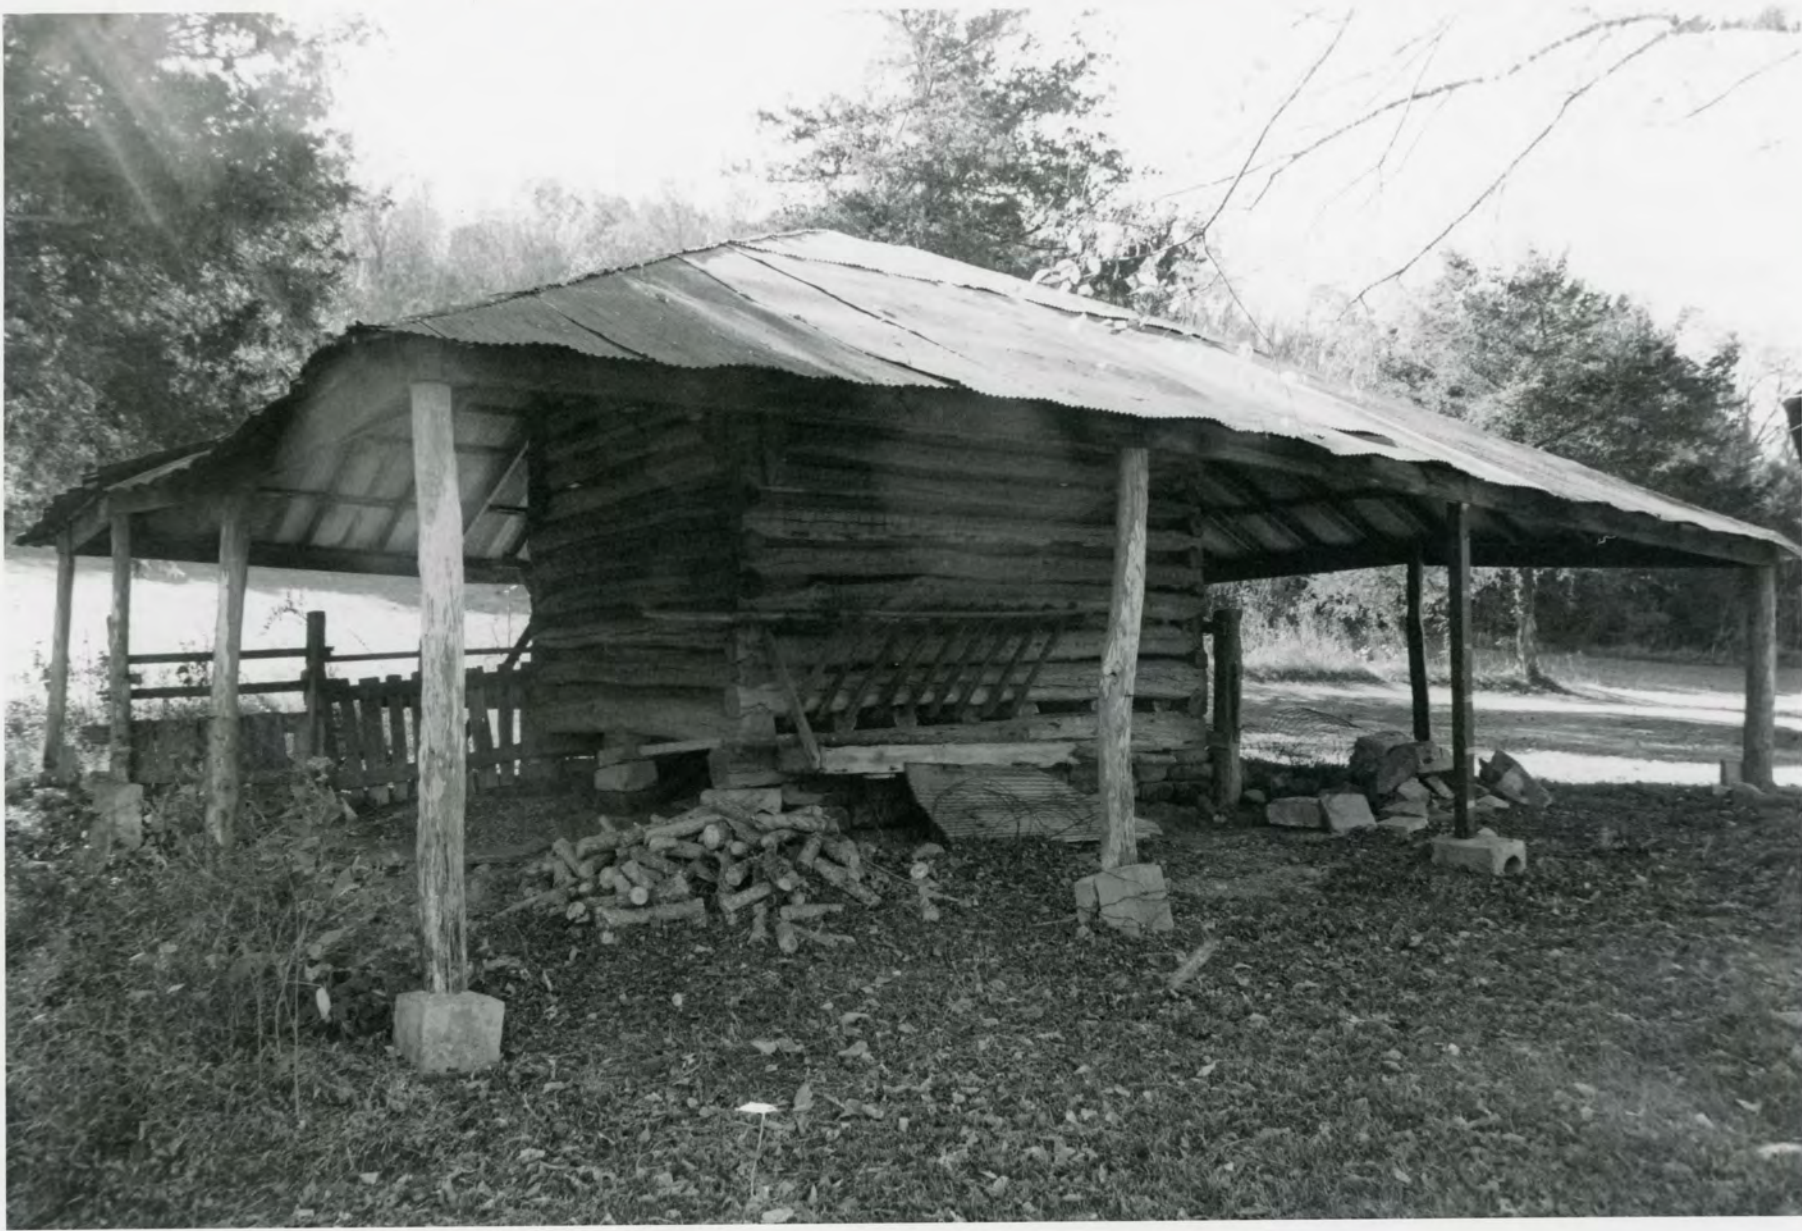
1. William P. and Rosa Lee Martin Farm
2. Searcy Co., AR
3. Ralph Wilcox
4. November 4, 2010
5. Arkansas Historic Preservation Program, Little Rock, AR
6. northwest + northeast elevations of corn crib, looking south
7. Hq

### Outbuilding: Corn Crib

The corn crib is a pole building located approximately 25 feet east of the backside of the barn. The crib is constructed of hand hewn logs with a rough cut board floor in the center of the structure. The door to the crib has the original sliding wood latch. The hip roof is made of corrugated galvanized tin and expands beyond the crib on all four sides.

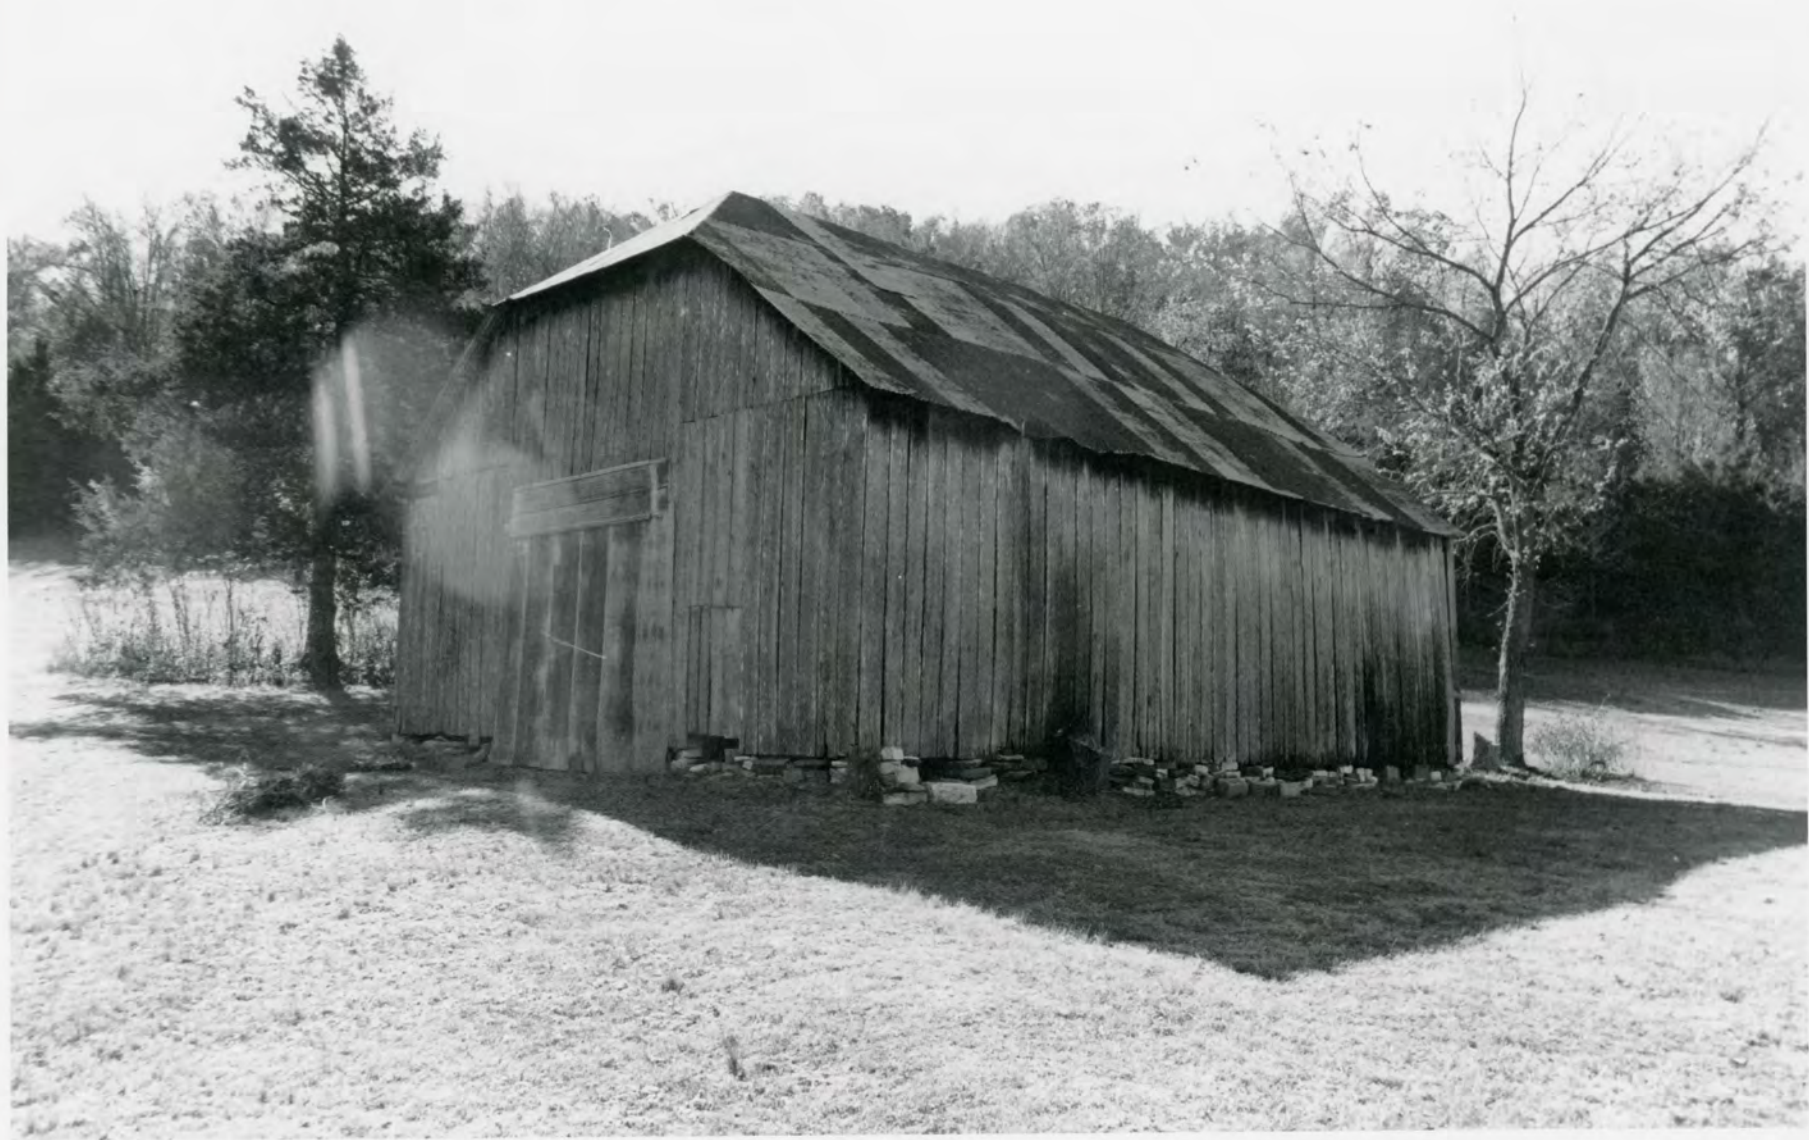
1. William P. and Rosa Lee Martin Farm
2. Searcy Co, AR
3. Ralph Wilcox
4. November 4<sup>th</sup>, 2010
5. Arkansas Historic Preservation Program, Little Rock, AR
6. northwest + northeast elevations of barn, looking south
7. #10

### Outbuilding: Barn

The barn, located approximately 150 feet south of the southeast corner of the house, sits on a foundation of stacked native stone. A few years ago the barn was damaged due to high winds and shifted slightly on its foundation. The foundation damage was repaired with concrete blocks in a few places. The walls are covered with vertical, rough cut hardwood boards and are topped with a corrugated metal, clipped gable roof.

The front, or southwest façade of the barn has a pair of large doors constructed of vertical, rough cut hardwood boards. The wind blew out part of the rear, or northeast wall and approximately one third of it was replaced with roofing tin. The northwest and southeast elevations are unadorned.

The interior is laid out like a transverse crib barn with four compartments on either side of a 15-foot-wide hallway running the length of the barn. Upstairs is an open loft that covers approximately two-thirds of the total inside area of the structure. As mentioned above, the barn suffered some damage due to the high winds, but it was salvaged by straightening it up and adding new timber braces on both the lower level and in the loft. Each door to the eight interior compartments has the old wooden sliding latches or wooden hook latches. Electric service to the barn was added in 2007.
