National Register of Historic Places Registration Form

historic name George (Jr.) and Sarah Morgan House

street & number 208 Egg Harbor Road

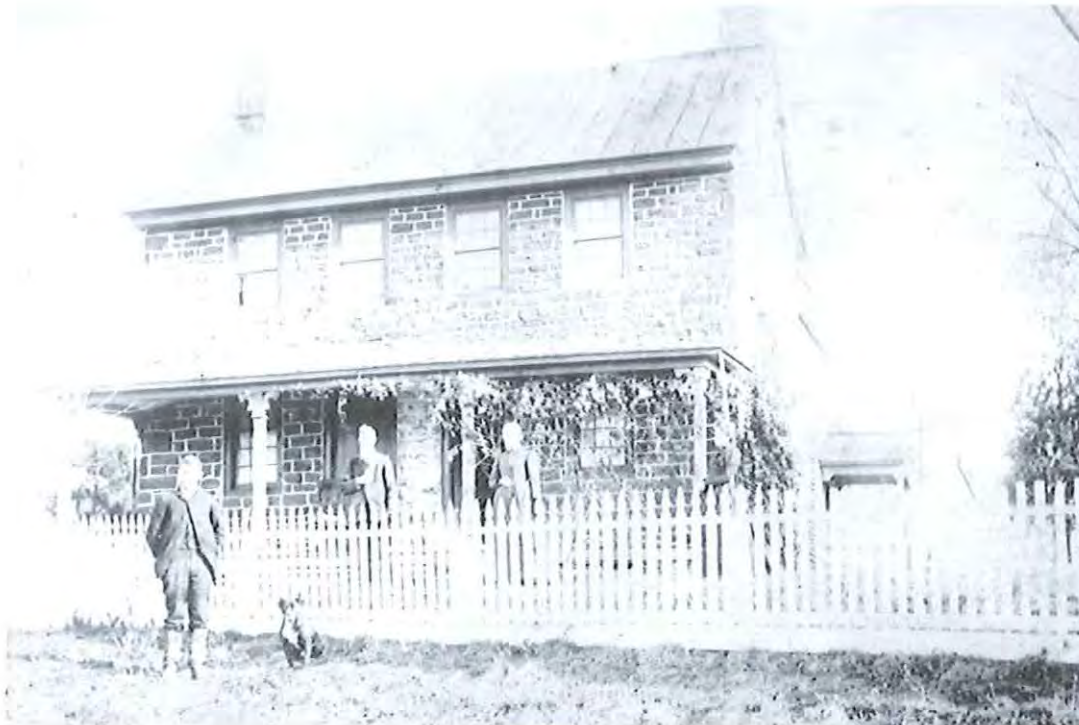
Figure 5: Photograph taken in 1894 showing several members of the Paulin family standing in front of the house. View northwest. The beehive oven is not seen on the exterior and the easternmost front door has not yet been removed and stoned over. The winder stair may still be intact because the small window lighting it on the east side wall appears to be extant.

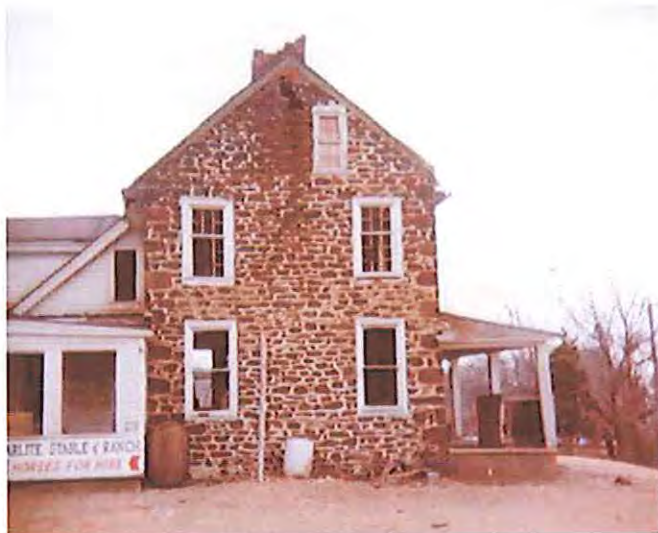
Figure 6: ca. 1975 photograph of the house, view east.

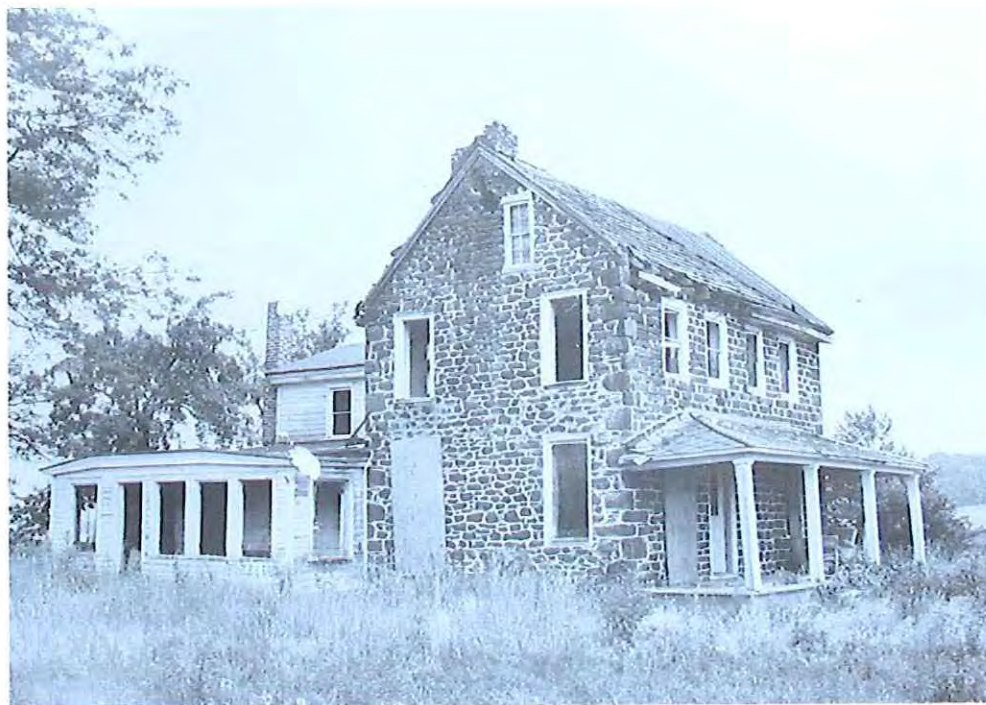
Figure 7: Ca. 1980
view of the house
before the fire in
December of that year.
View northeast.
(courtesy of the
Washington Township
Historic Preservation
Commission)

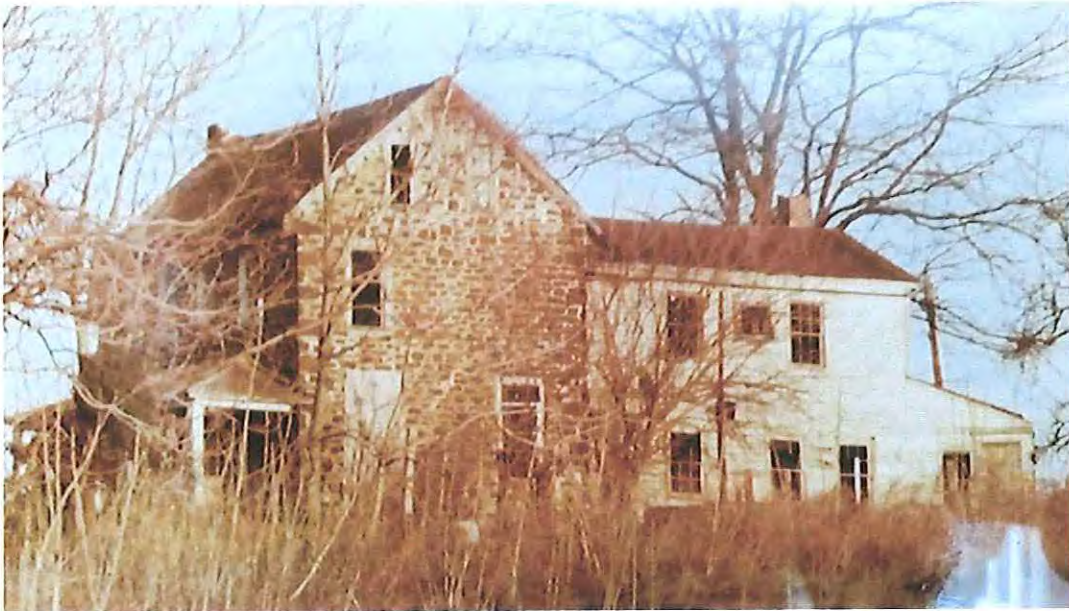
Figure 8: ca. 1980 view of the east side elevation (courtesy of the Washington Township Historic Preservation Commission)

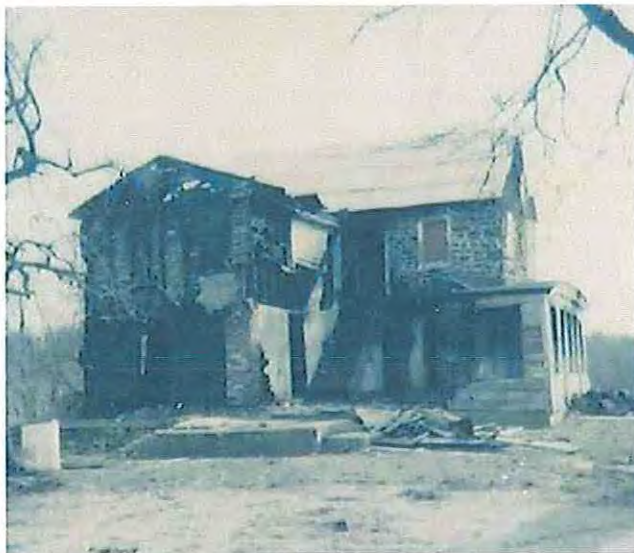
Figure 9: rear of the house after the December 1980 fire. (courtesy of the Washington Township Historic Preservation Commission)

In December, barely three months later, the house suffered a devastating fire that began in the frame additions to the rear and spread to the attic of the stone main block, destroying the roof and attic floor (figure 9). In 1981, the Township authorized repairs to the building that included rebuilding/restoring the roof and chimneys. The Washington Township Historical Society also began a volunteer effort that year to restore the house to its ca. 1765 appearance. The ca. 1765 date was chosen because the later rear additions, too heavily burned to be restored, had to be demolished, leaving only the ca. 1765 main block still standing. With no access to the second floor (the original stairs had been removed in the early 20th century and second floor access relocated to a stair in the later rear additions), the Historical Society determined that restoring the original winder stair and adjacent cooking fireplace in the main block was needed to reestablish functionality to the house and depict the house's original appearance. To ensure

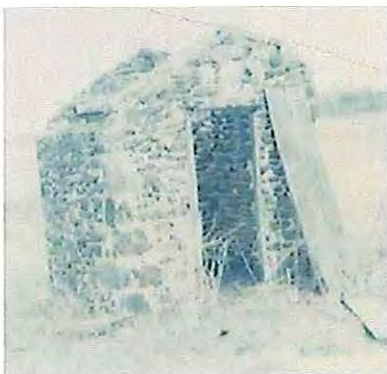
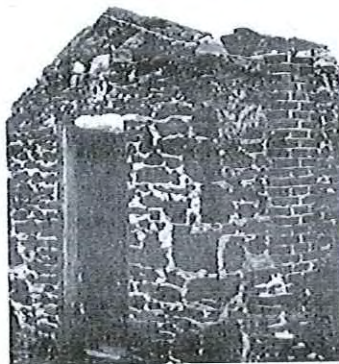
Figure 10a (left) and 10b (right): two views, both taken in the early 1980s, of the stone outbuilding. (courtesy of the Washington Township Historic Preservation Commission)

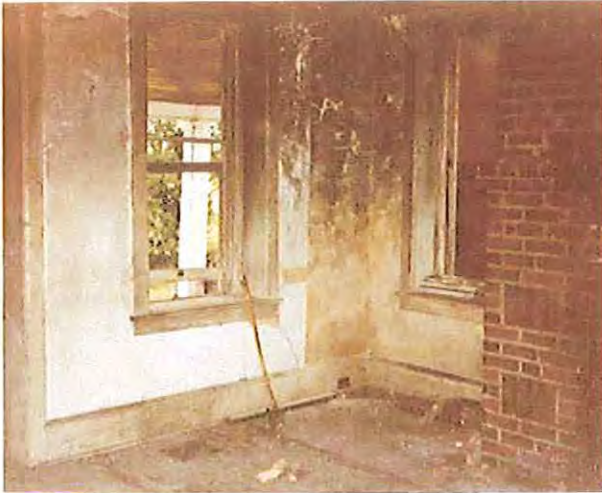
Figure 11: southwest corner of the parlor, ca. 1981 before restoration. Note the mid-20th century appearance of the fireplace, seen at right in the photo.

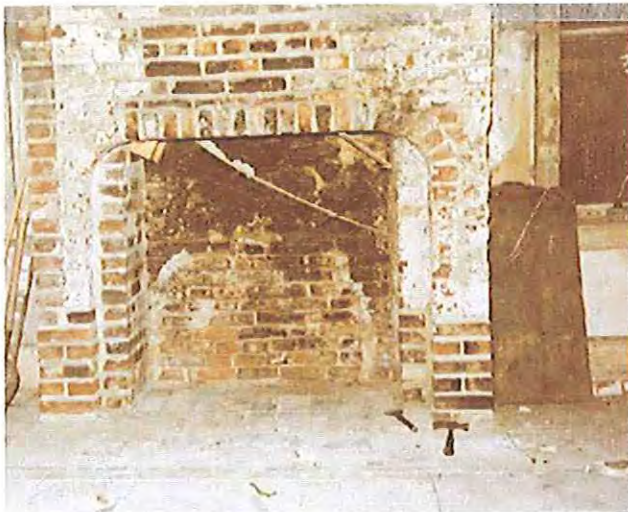
Figure 12: parlor fireplace exposed after later brickwork was removed. Photo taken in 1981.

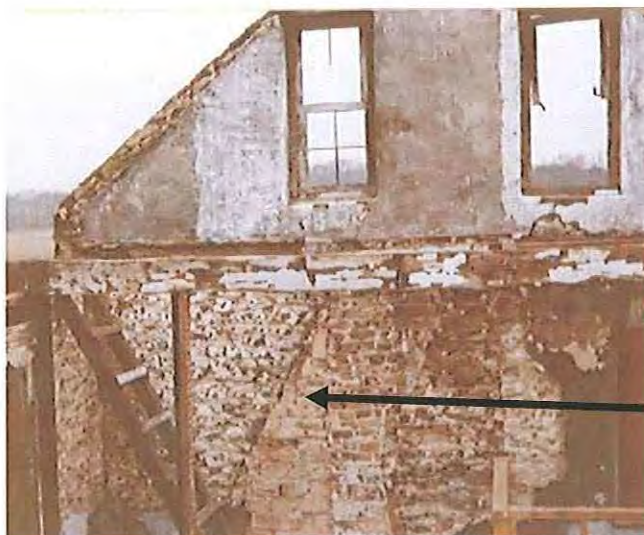
Figure 13: east side wall of the gable end exposed during restoration, ca. 1981. Note the ghost in the stonework showing the angle of the kitchen fireplace chimney in the chamber above the kitchen.

Based on evidence found in the east side wall, the kitchen fireplace was rebuilt, as was the winder stair [figures 13 and 14]. The beehive oven was rebuilt to match the original opening that had been revealed when the plaster wall covering the stones was removed in the kitchen. The 6/6 double-hung wood window on the east side wall was removed and replaced with a 4/4 double-hung wood sash window that provided light to the stairway. Windows on the first and second story of the west side wall were removed, and their openings infilled with stone to match. A late 19th-century front porch was removed [figure 7]. Floorboards recycled from the fire-damaged, demolished rear additions were laid in the garret and the west end chimney was rebuilt from the garret level to above the roof line. All window sashes were repaired, reglazed, reinstalled, and given new sills and frames.¹

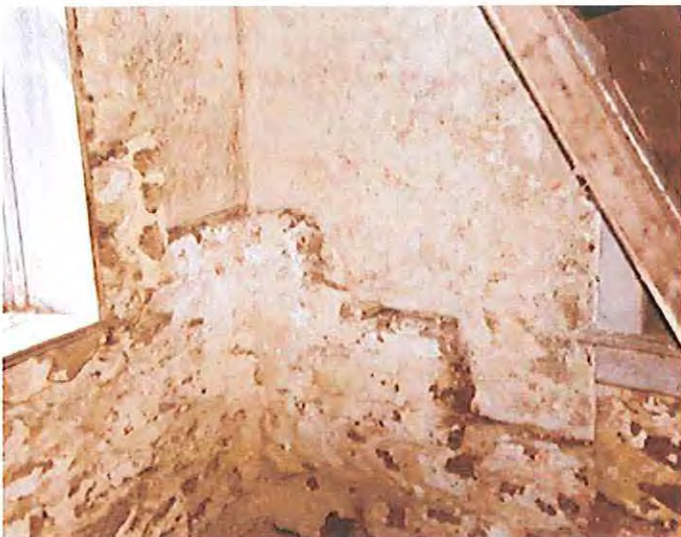
Figure 14: view southeast showing the southeast corner of the interior at the first story level with the stonework showing the configuration of the original winder stair.

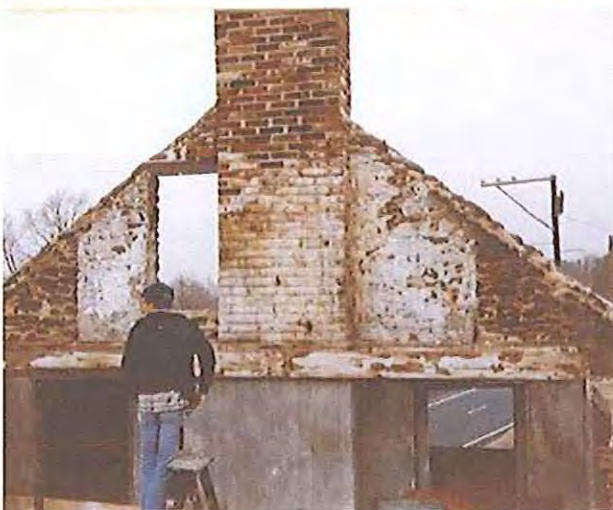
Figure 15 (left): west gable end, showing the chamber (its fireplace plastered over) and the chimney in the attic being repaired.

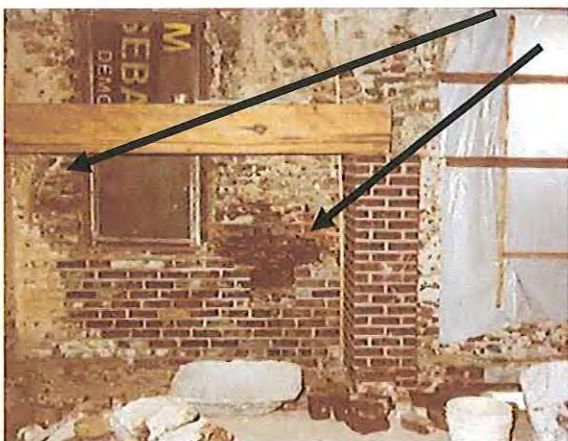
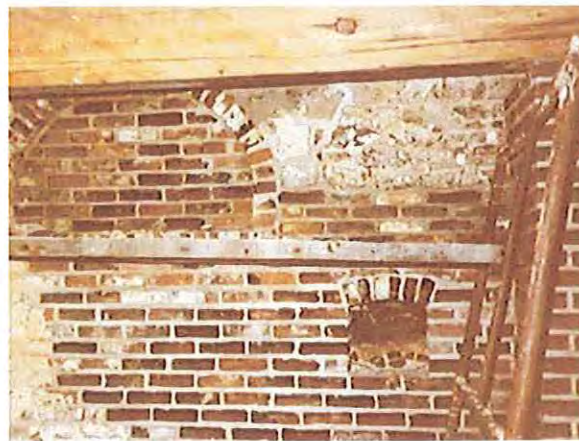
Below: Figure 16a (left) and 16b (right) showing the outline of the beehive oven and niche (16a) which had been plastered over when the cooking fireplace was removed, and their restoration in the 1980s (16b). The beehive oven opening was bricked over until the exterior portion could be re-built. It is fully operational today.

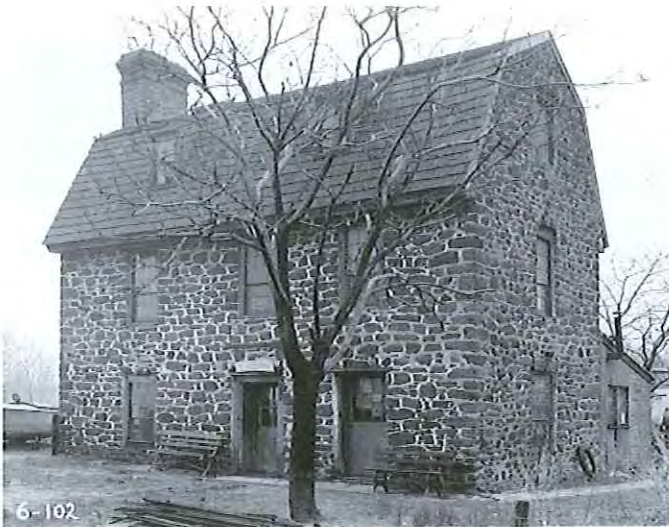
Figure 17: Joseph Nicholson House, located on Admiral Wilson Blvd. in Camden County and demolished in 1948. Reportedly built ca. 1699, thus making it the earliest stone residences in the area. HABS-NJ-102.

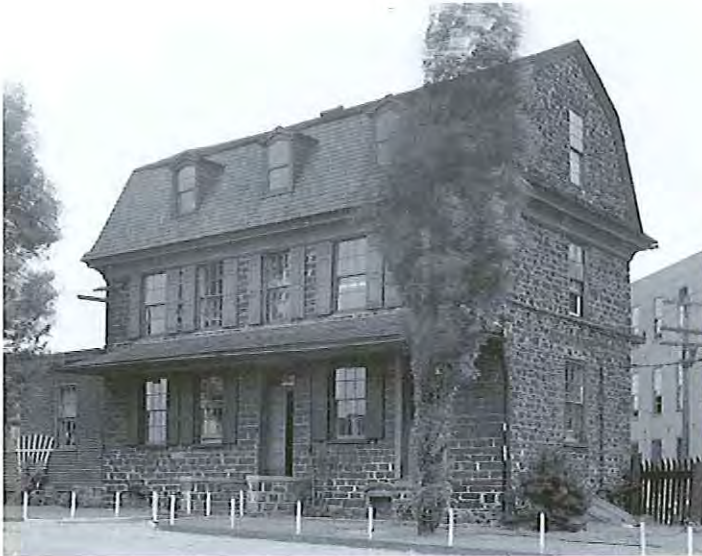
Figure 18: Benjamin Cooper House, built in 1734, is the earliest known example of a coursed ashlar façade in southwestern New Jersey (extant). It stands in Camden City. HABS-NJ-304.

Of these, the earliest with a definitive date is located in the City of Camden and it predates the 1760s by several decades, foreshadowing the popularity that would come later. Still standing but damaged by fire in 2012, the 2½-story, gambrel-roofed Benjamin Cooper House (figure 18) has a pent roof along its

coursed ashlar façade between the first and second stories. Initials of the original owners and the date of 1734 are found in a gable-end datestone.

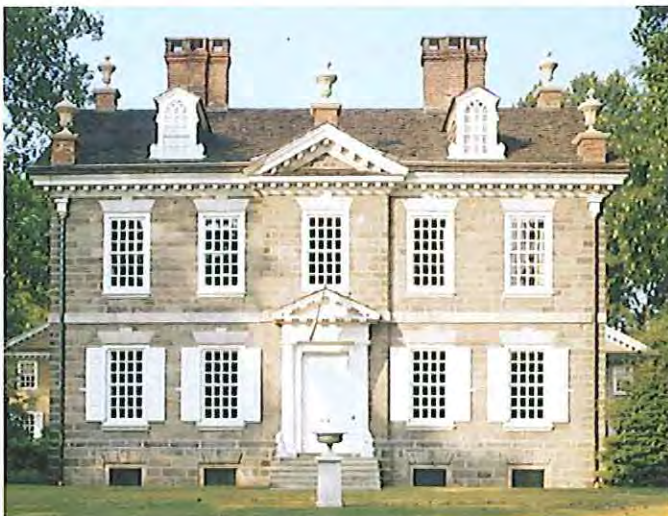
Figure 19: Cliveden (Benjamin Chew House), built between 1763 and 1767 and located in Germantown, Pennsylvania. It is a National Historic Landmark, significant for its Georgian style architecture.

The best known and most architecturally sophisticated example of a coursed ashlar façade in the greater Philadelphia area is the high style Georgian example of Cliveden (Benjamin Chew House, figure 19, extant) built 1763-1767 in Germantown, Philadelphia County, Pennsylvania. Also in Germantown is the extant 1768 John Johnson House, a much more restrained example (probably because Johnson was a Quaker) that features a pent roof, pedimented dormers, and a simple four-light transom over the center door.

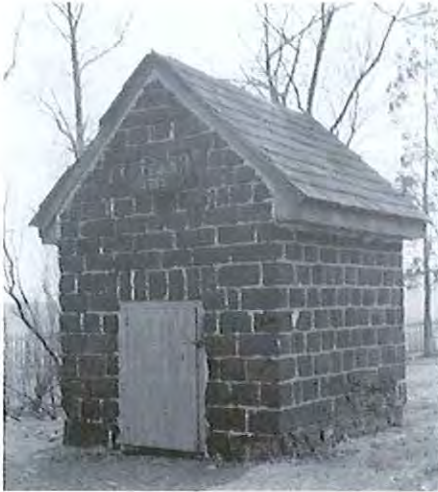
Figure 20: John Black's smokehouse, built in 1786, has all elevations made of coursed ashlar. It is located near Jobstown, Burlington County. HABS-NJ-263.

HABS also documented several stone outbuildings in southwestern New Jersey. John Black, a farmer who lived east of Jobstown in Burlington County, built a substantial smoke house with coursed ashlar not only on the façade, but on the rear and side elevations as well (figure 20, fate unknown). Its datestone proclaims a 1786 construction date.⁴⁵ HABS also documented the Tallman Smokehouse (demolished), built in 1757 in Burlington County of uncoursed ironstone.⁴⁶ The Gloucester County cultural resources survey identified several stone outbuildings, among them a potato house (#0816-21) and a storage building (#0816-25), both in South Harrison Township, an ice house and smoke house on the same property in E. Greenwich Township (#0803-12), and a 17' x 17' cool storage building (#0824-20) in Woolwich Township. It is not known how many of these still stand.

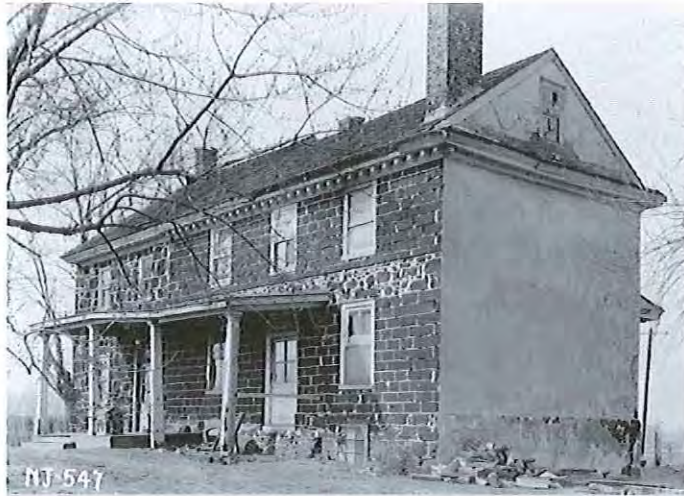
Figure 21: Joseph Hewlings House. The oldest section has the coursed ashlar façade and dates to 1767. It was located in Mt. Laurel, Burlington County and no longer stands.

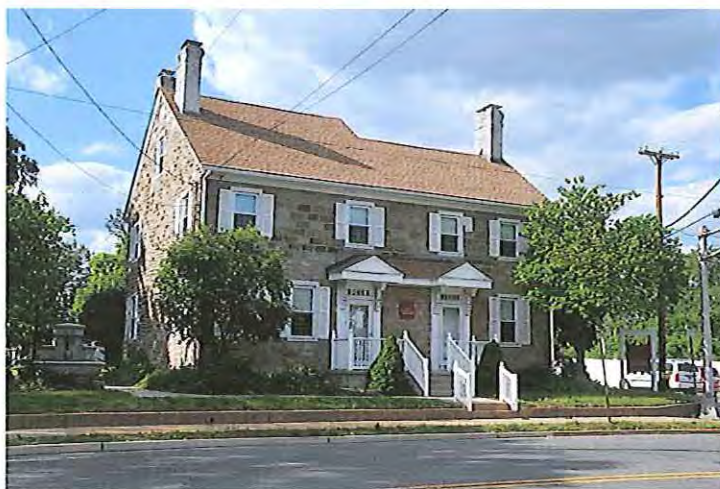
Figure 22: The Gill House, located in Paulsboro, Gloucester County, New Jersey, is said to have been built ca. 1800.

Gloucester County's four known examples of domestic buildings with coursed ashlar facades range in date from ca. 1765 to 1819. The earliest is the ca. 1765 George (Jr.) and Sarah Morgan House, subject of this nomination. The two-story Gill House in Paulsboro (extant, figure 22) was reportedly built about 1800.⁴² The most noteworthy among all southwestern New Jersey examples is the two-story Bodo Otto House located on Kings Highway in Mickleton (East Greenwich Township), Gloucester County (figure 23, extant). The rear half of the house, built of uncoursed stone and called "new" in a newspaper ad dated 1771, had a two-room wide floor plan with a large cooking fireplace (extant) in one of the rooms. In 1819, the house was doubled in size with a full-width addition creating a nearly-square footprint. The new front features a coursed ashlar façade notable for its heavy wood lintels broken with a keystone over the windows and center door.⁴³ The Otto House has a 1½-story stone "twin" (extant, figure 24) with the same heavy lintels. Probably built about the same time, the Dawson House is located a few miles away at 358 Union Road in East Greenwich Township.⁴⁴

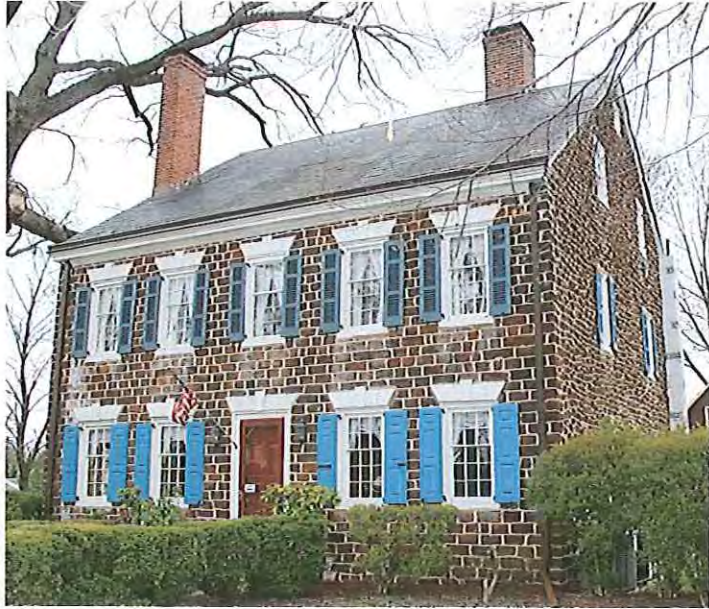
Figure 23: Bodo Otto House, Mickleton, Gloucester County. The rear half was built with a 2-room wide plan about 1770. In 1819, an addition to the front doubled the size of the house.

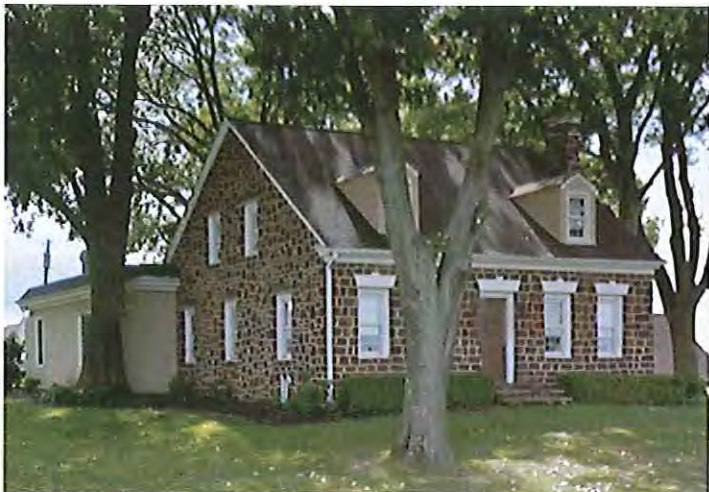
Figure 24: W.A. Dawson House (named for the owner on the 1869 map) at 358 Union Road, Mickleton vicinity, Gloucester County. It was probably built about 1820 and is identical on the exterior to the Dr. Bodo Otto House.

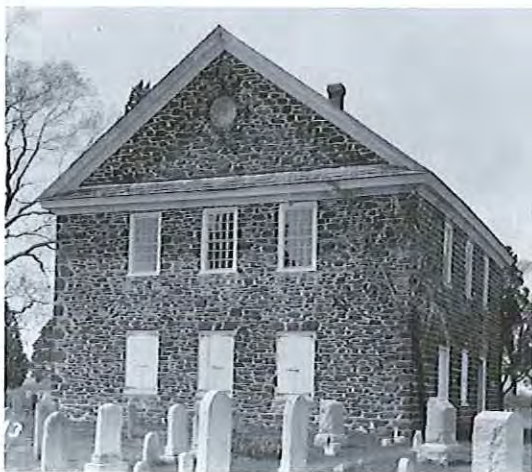
Figure 25: Fairfield Presbyterian Church, Cumberland County, New Jersey, built in 1780-81 with a coursed ashlar façade seen at right. HABS-NJ-273.

Salem County has only a “small handful of [extant] colonial stone houses” and Cumberland County has a similar number of stone buildings, but one of them, the Fairfield Presbyterian Church built 1780-81 (figure 25), has a coursed ashlar facade.⁴⁷

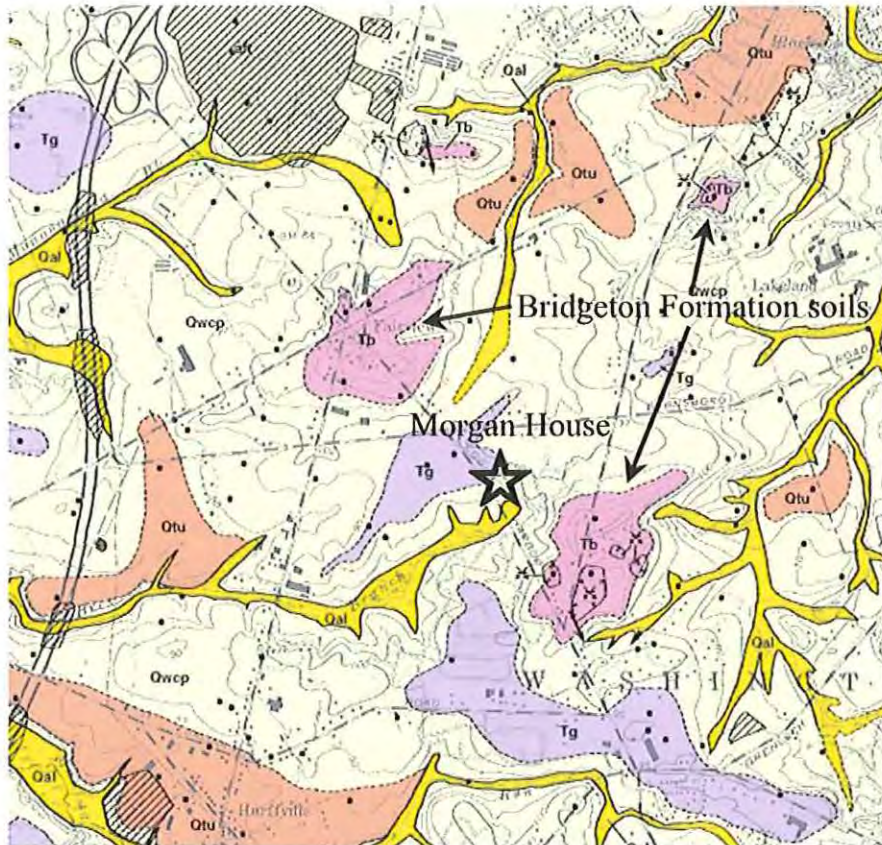
partial selection showing the Morgan House
and three areas containing Bridgeton Formation soils that might
have provided the ironstone used in its construction

Figure 27:
geology map
annotated to
show the Morgan
House and
Bridgeton
Formation soils

Local lore claims the stones used in the Morgan House were obtained locally and that seems logical given the high cost to transport heavy stones from a great distance. The map titled “Surficial Geology of the Runnemede Quadrangle, Camden and Gloucester Counties, New Jersey,” prepared in 2003, identifies two areas containing Bridgeton Formation soils that are within one-half mile of the Morgan House (figure 27). Bridgeton Formation soils, found in New Jersey’s coastal plain, have the potential to yield ironstone. Shaded in pink and identified as “Tb” on the map, they are located to the northwest and southeast of the house. Another, smaller deposit is located one mile to the northeast. Of the three, the one to the southeast was located on the 200 acres George Morgan Jr. inherited from his father and may have been the source of the stone used in the Morgan House.

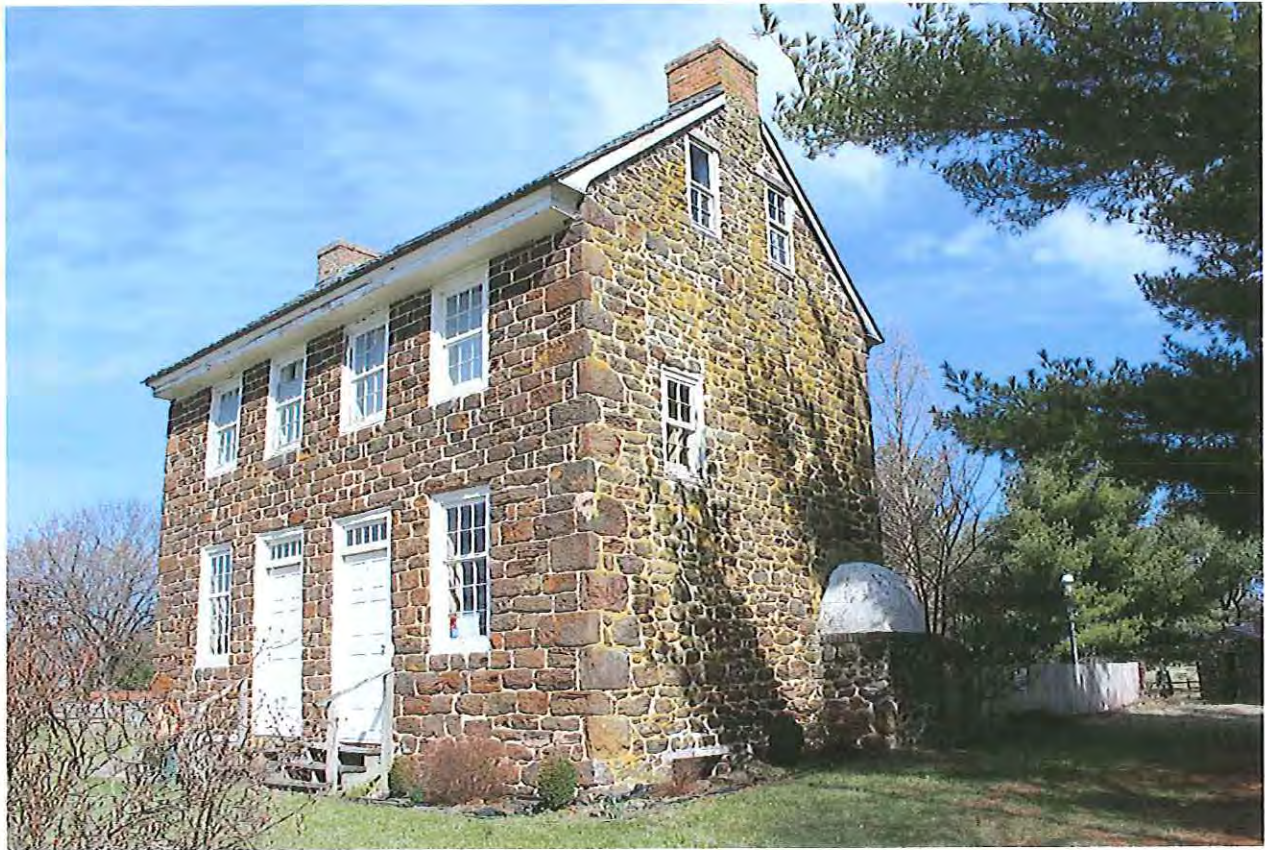
Photograph 2: view northwest showing the façade (south elevation) and east side elevation; note the beehive oven.

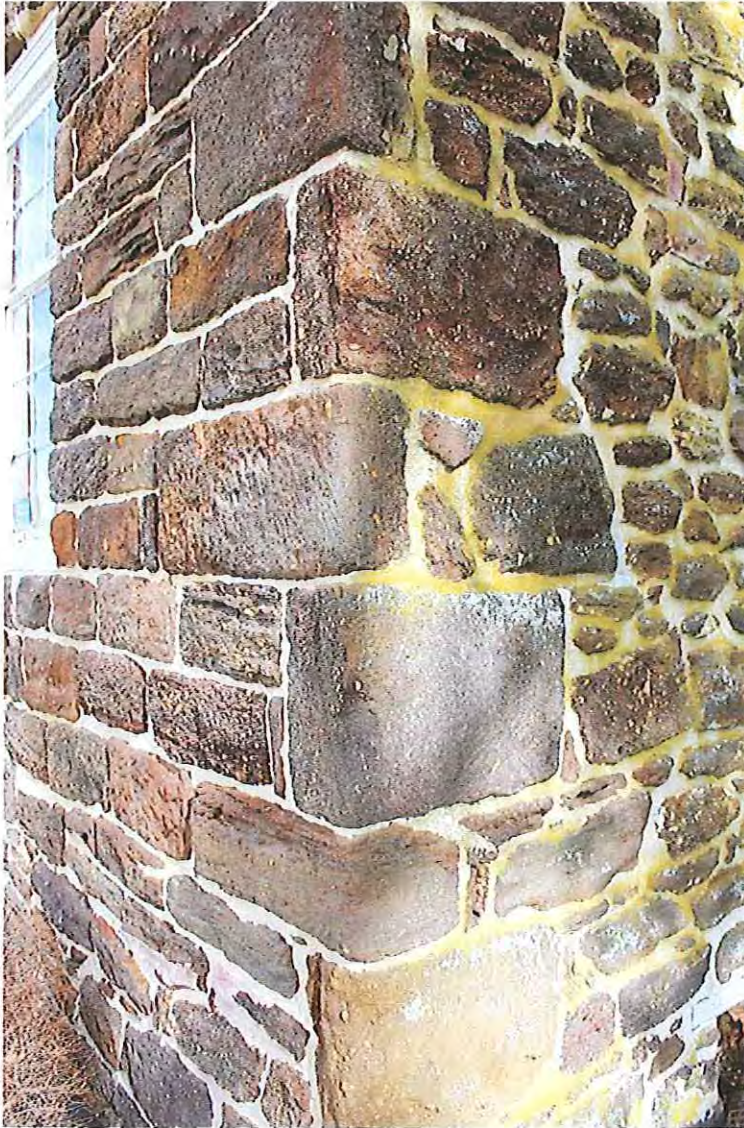
Photograph 3: view of the house's southeast corner showing the quoins, the ashlar ironstone blocks on the façade, and the uncoursed ironstone on the east side elevation.

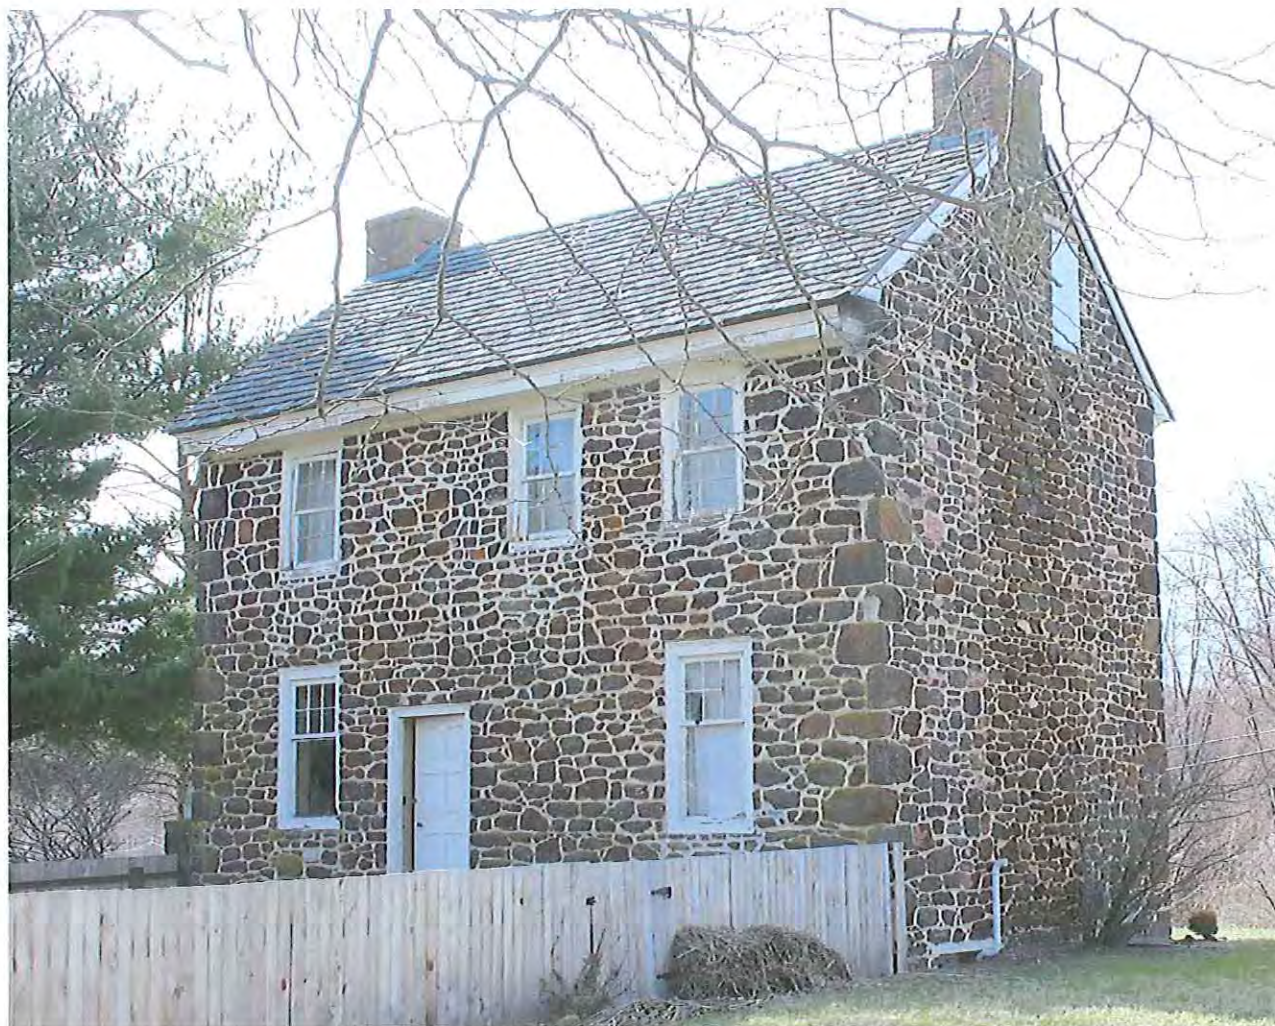
Photograph 4: view southeast showing the west (side) elevation and the rear (north) elevation.

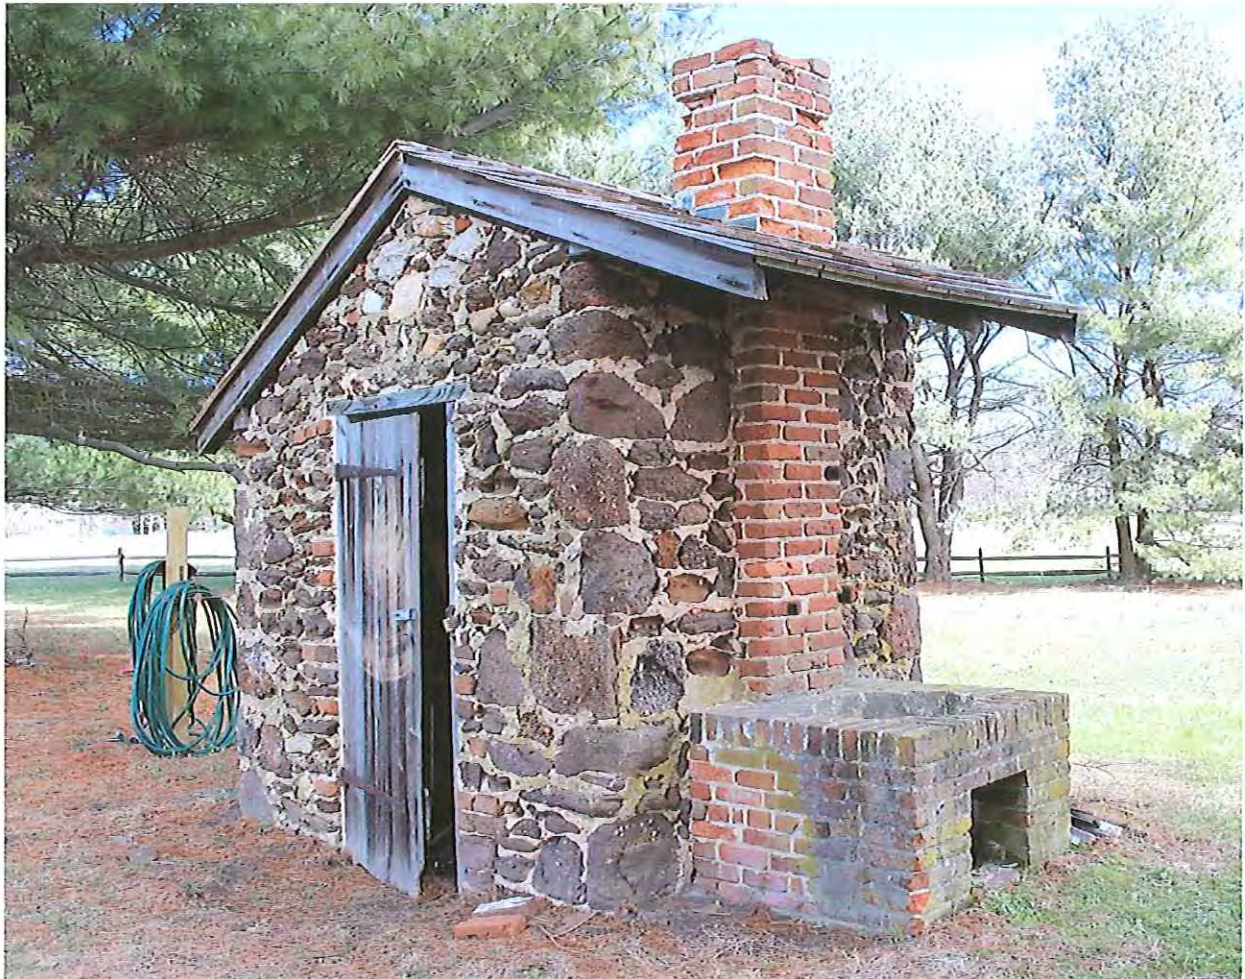
Photograph 6: outbuilding, view northwest showing the façade (south elevation) and the east side elevation.

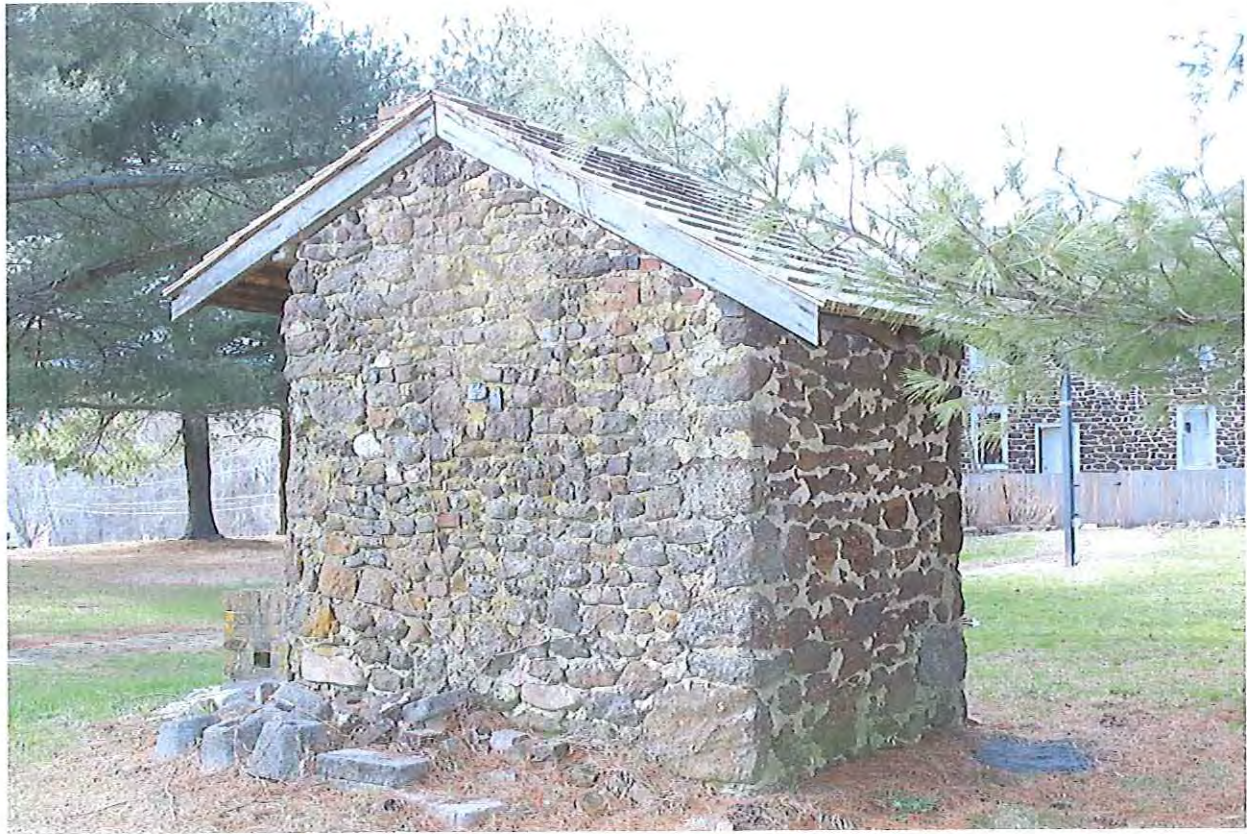
Photograph 7: outbuilding, view southeast, showing the rear (north) elevation and the west side elevation.

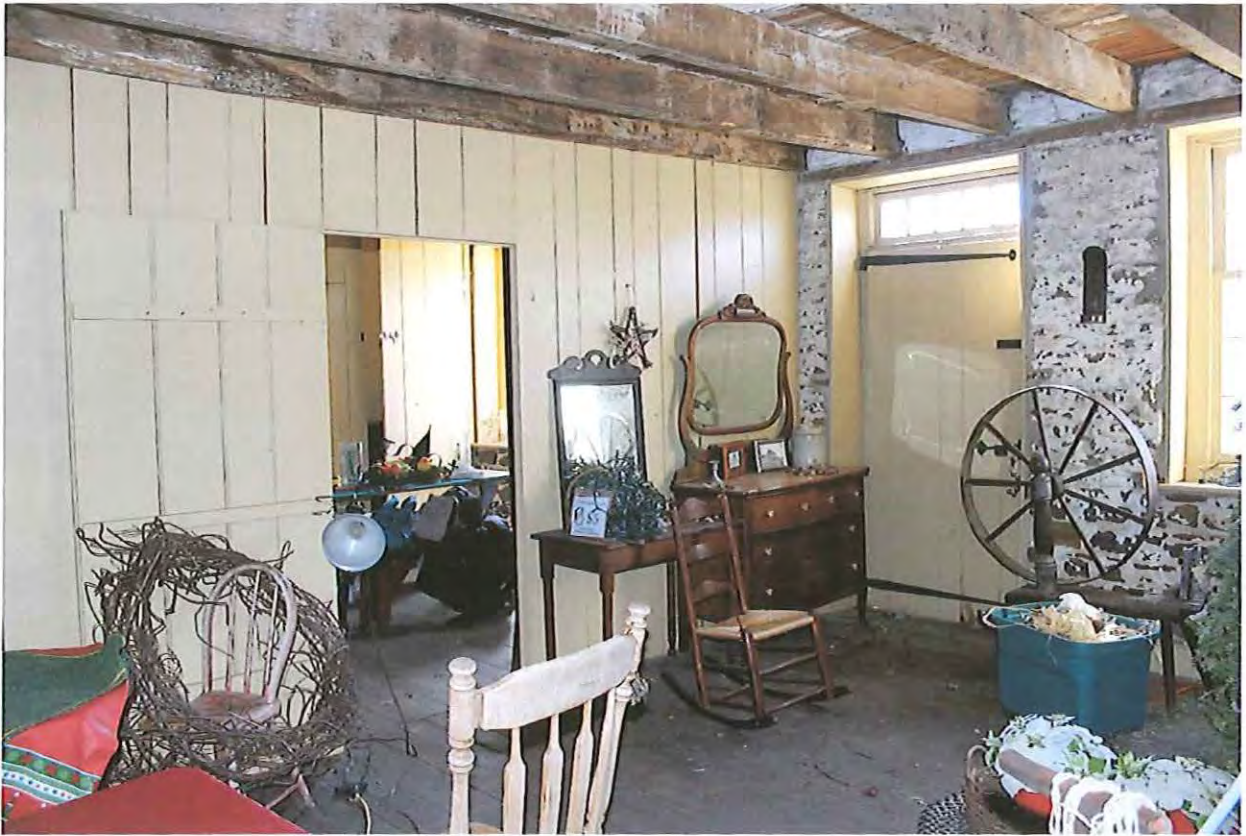
Photograph 9: parlor, view southeast showing the front door and vertical board partition wall.

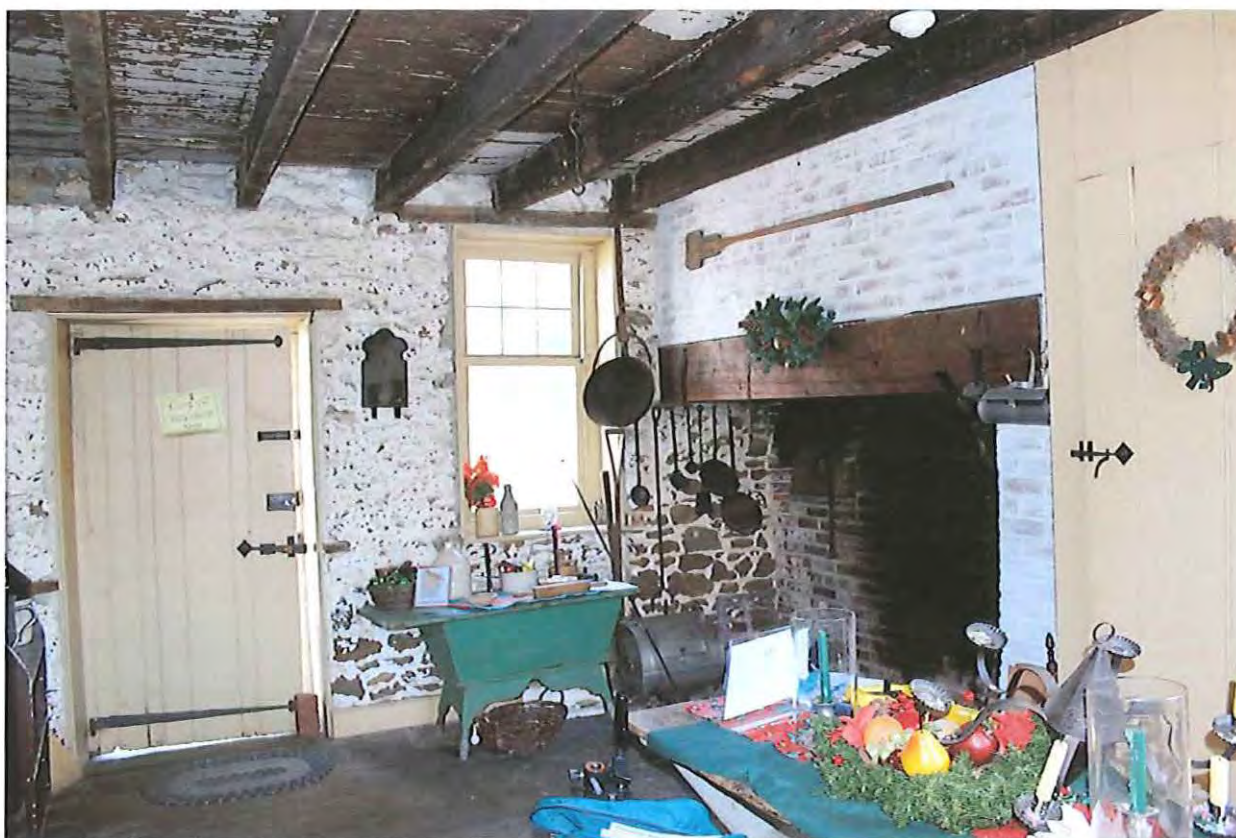
Photograph 10: kitchen, view northeast showing the back door and the cooking fireplace.

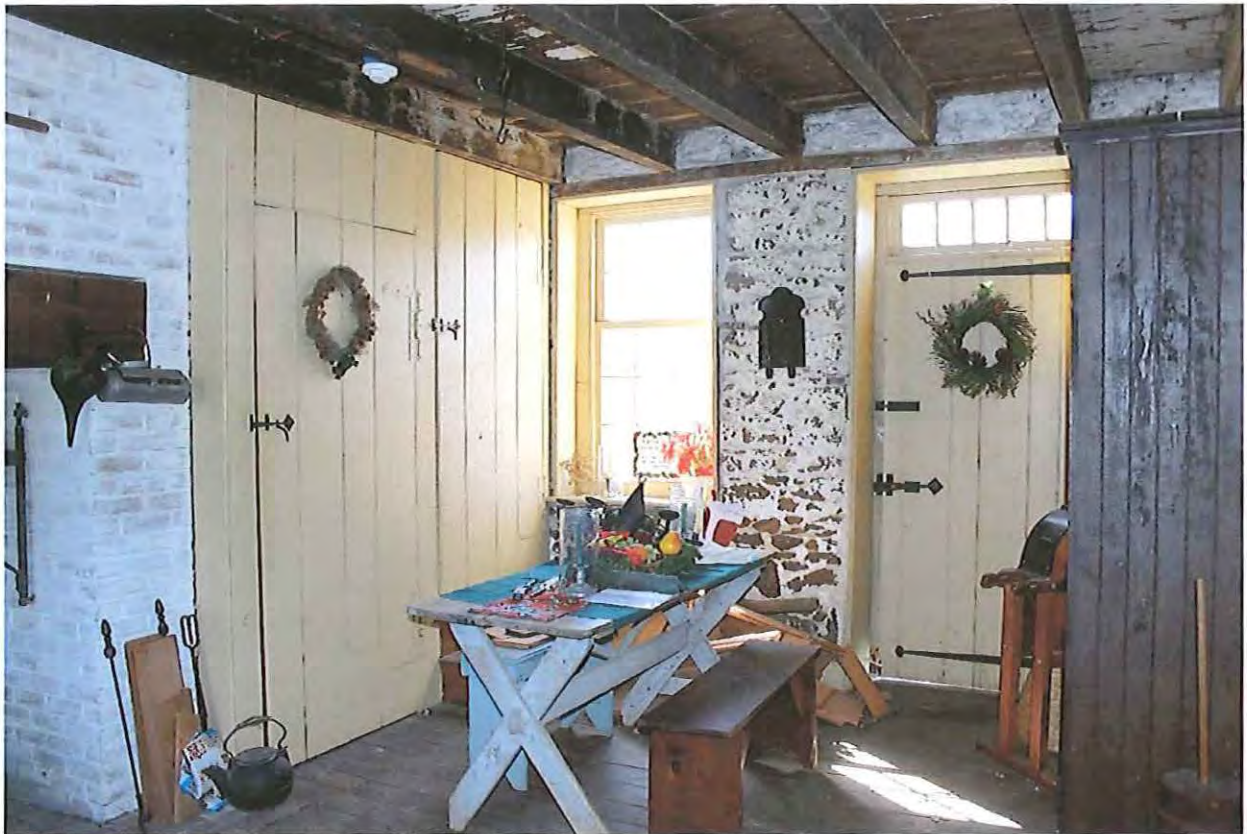
Photograph 11: kitchen, view southeast showing the front door and doors to the winder stair.

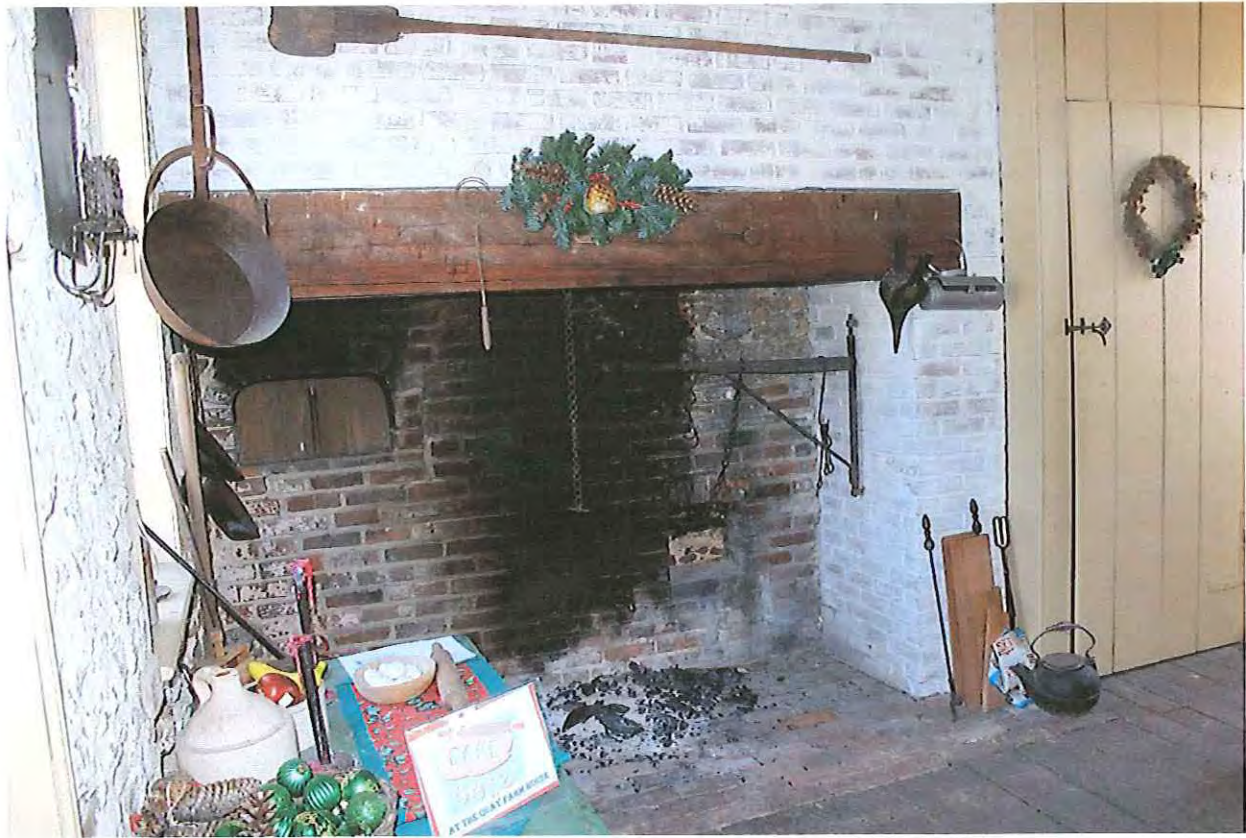
Photograph 12: kitchen, view almost east showing the cooking fireplace.

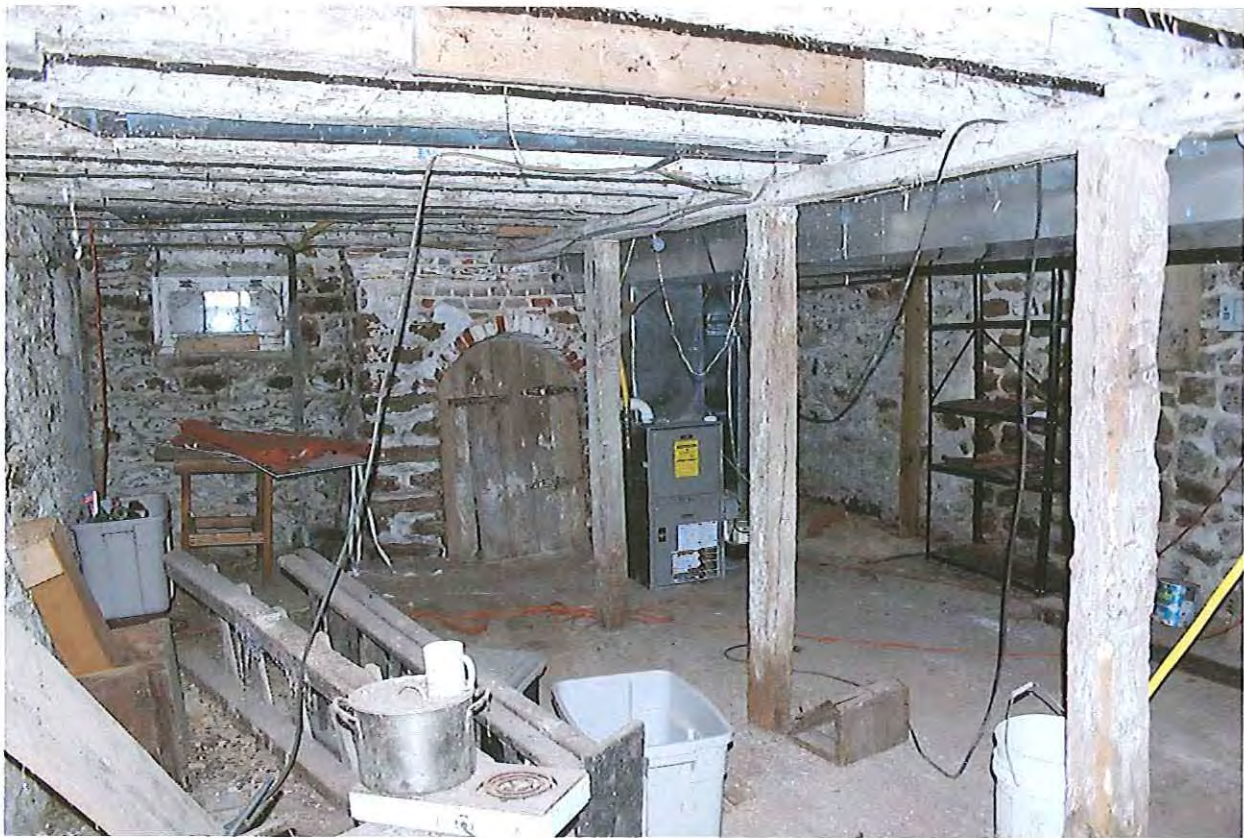
Photograph 16: basement, view northwest showing brick chimney support for parlor and chamber fireplace.
