National Register of Historic Places Registration Form

historic name George (Jr.) and Sarah Morgan House

street & number 208 Egg Harbor Road

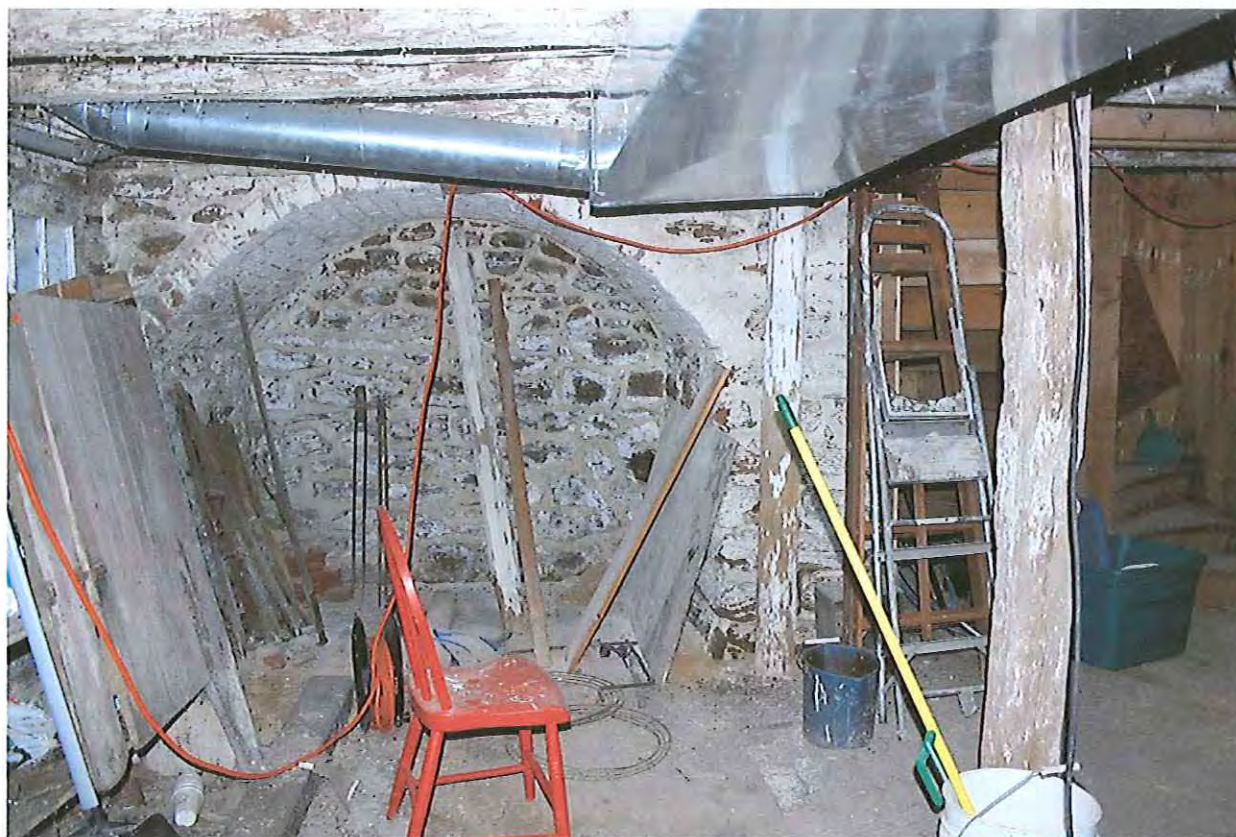
Photograph 17: basement, view east showing chimney support for kitchen fireplace.

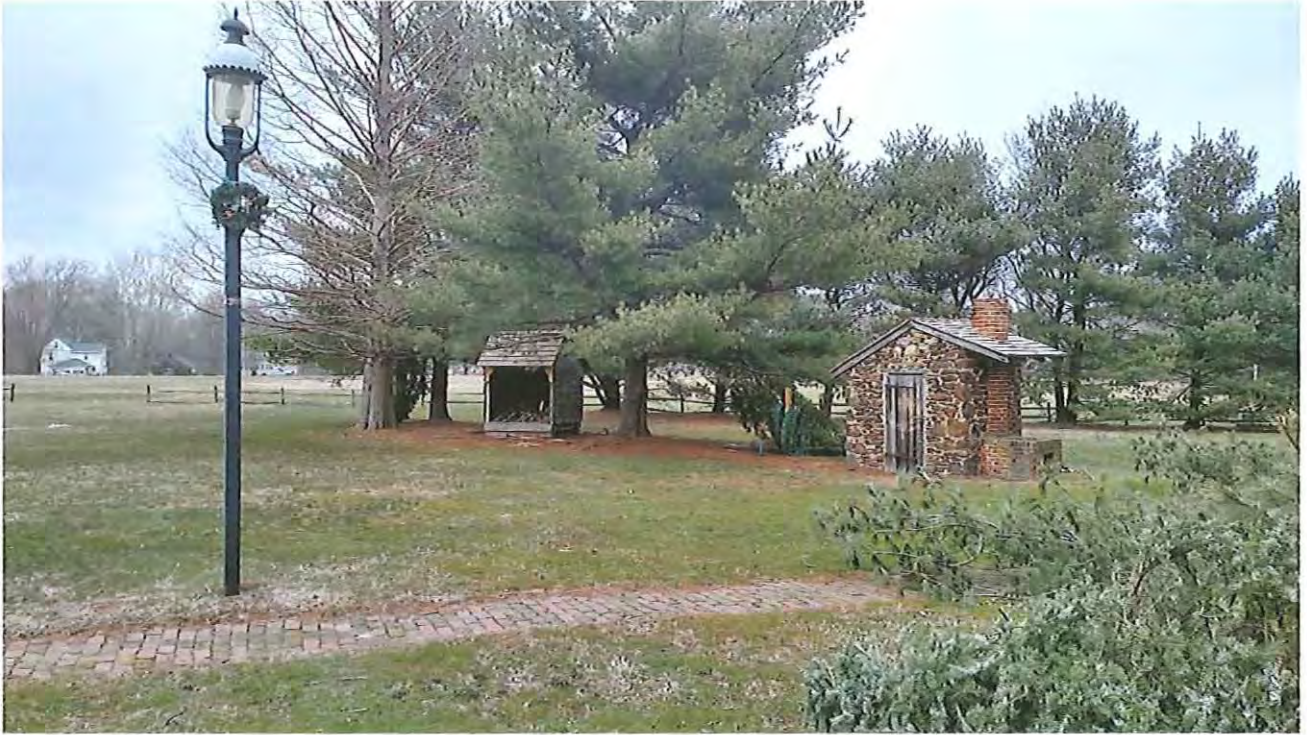
Photograph 18: lamp post (non-contributing) with the ca. 2015 storage shed (center, not within the boundaries) and the stone outbuilding (contributing) at the right. View northwest.

Approximately eight-feet tall, the electrified lamp post consists of a square metal pole supporting a fixture with two metal arms under a milk glass globe that caps a clear glass shade [photo 18].

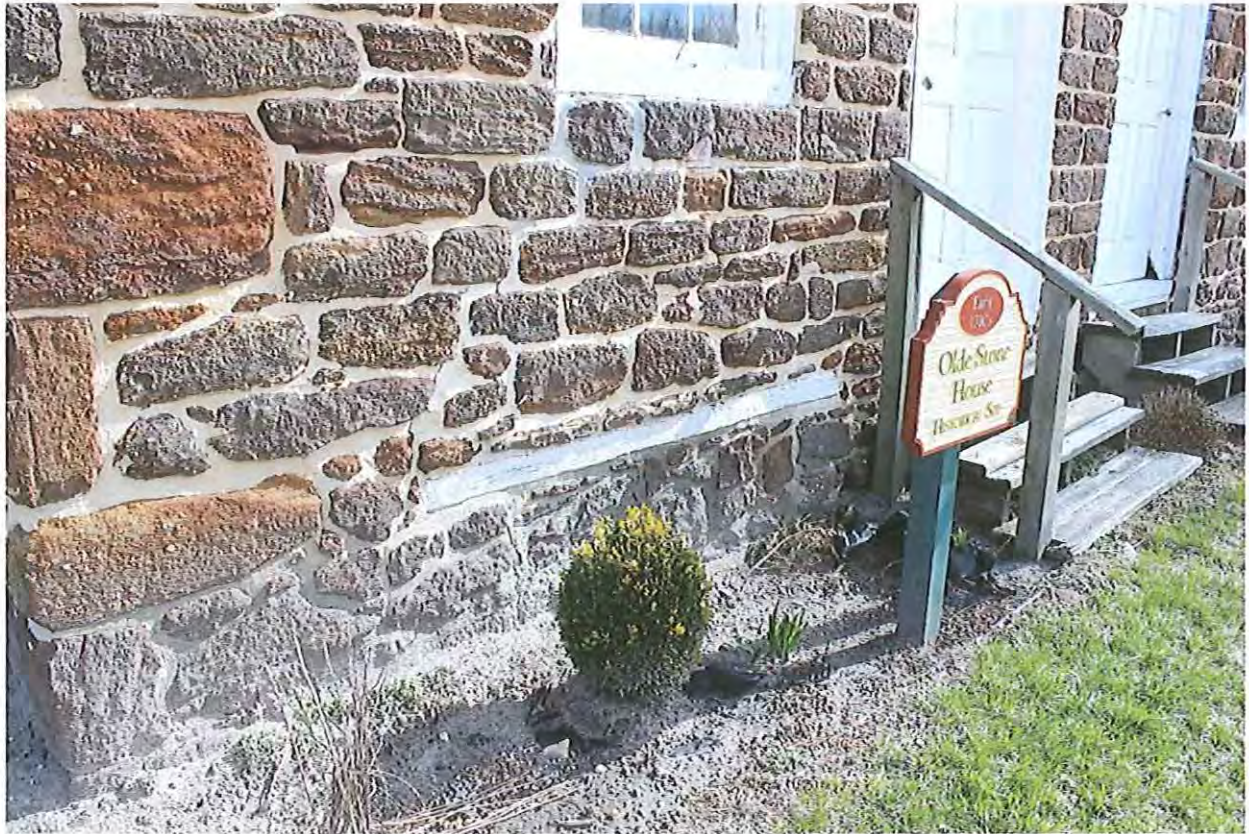
Photo 19: view of the façade (south elevation) showing the header for exterior basement steps at the foundation level in the southwest corner.
