National Register of Historic Places Registration Form

historic name Hoodoo Ridge Lookout

other names/site number Hoodoo Ridge Lookout Historic District

street & number Umatilla National Forest, Walla Walla Ranger District not for publication

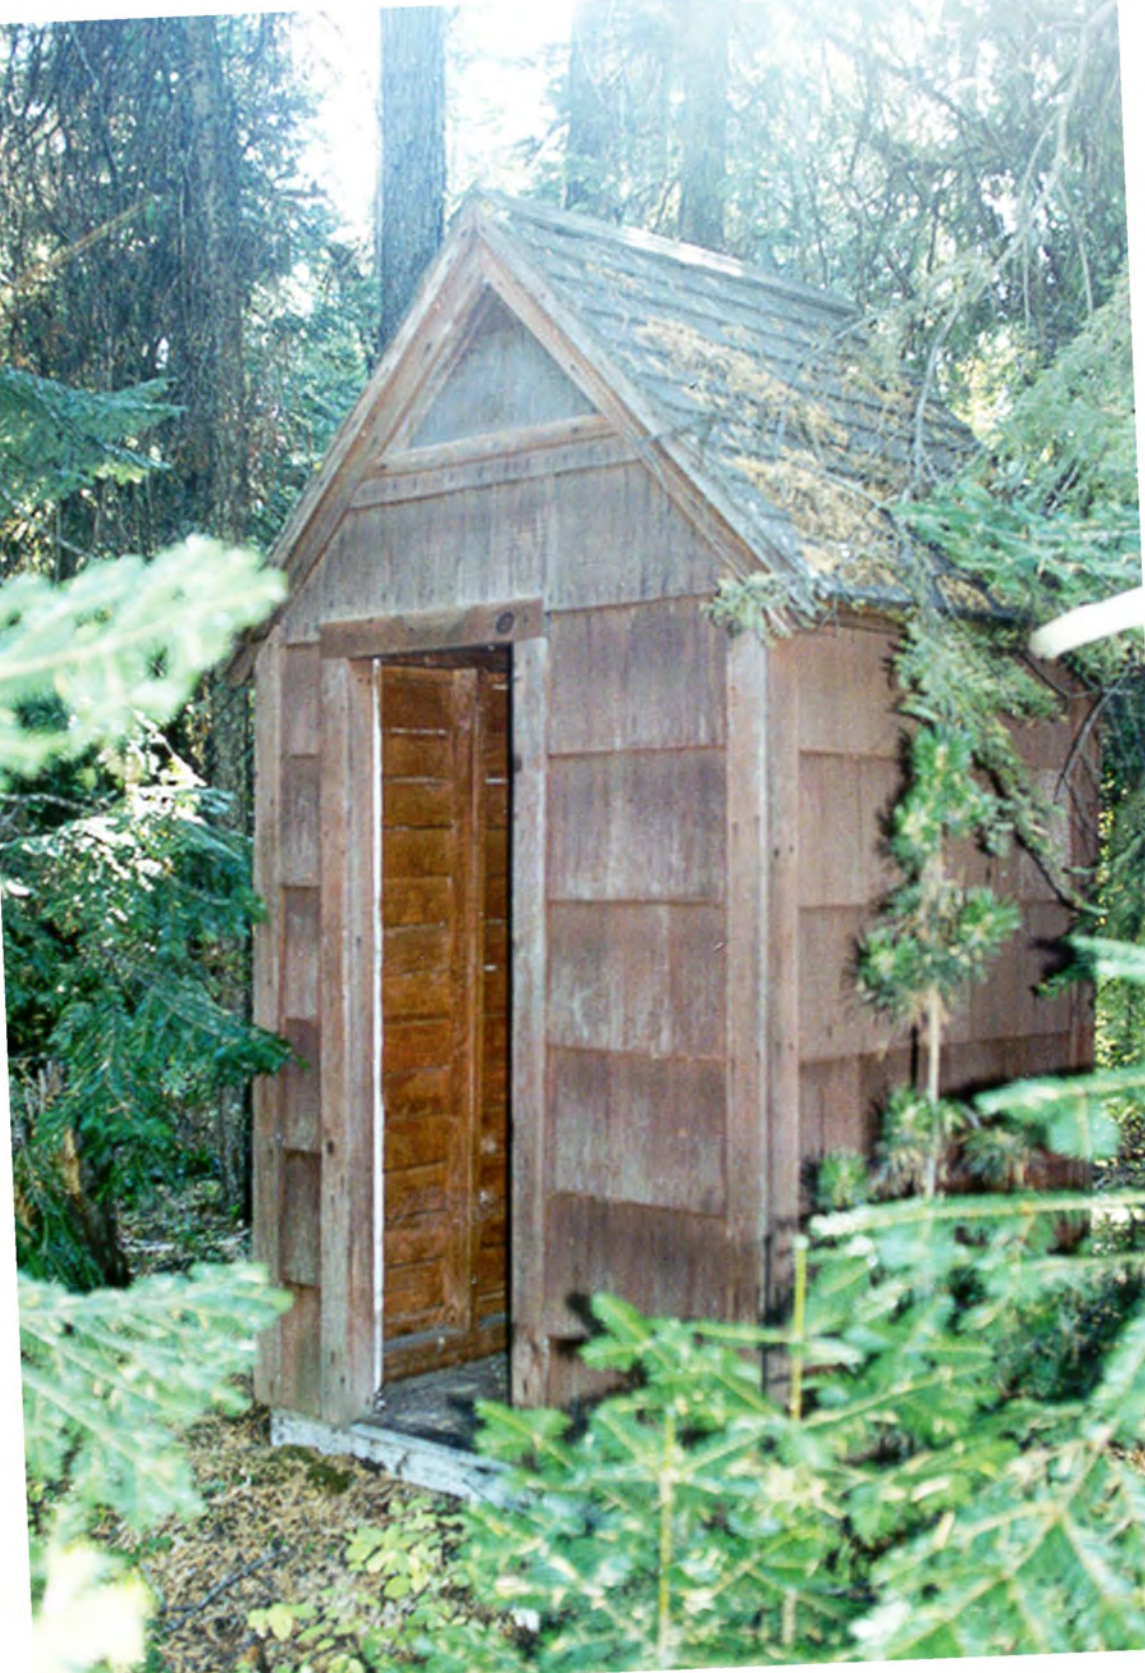
Though its age cannot be determined, the outhouse is known to be constructed sometime before 1953. The newer foundation and split-cedar siding suggest that the outhouse post-dates the other structures or had renovations around the early mid-century. The building is in very good condition and maintains its integrity as no real alterations have occurred. See Photos 11 and 12.

- Photo 10 of 12:** OR_WallowaCounty_HoodooRidgeLookout_0010
Western and southern elevations of the Hoodoo Ridge garage after the Passport In Time restoration project. (2002)
- Photo 11 of 12:** OR_WallowaCounty_HoodooRidgeLookout_0011
Eastern and northern elevations of the Hoodoo Ridge outhouse.
- Photo 12 of 12:** OR_WallowaCounty_HoodooRidgeLookout_0012
Western and southern elevations of the Hoodoo Ridge outhouse.
