NATIONAL REGISTER OF HISTORIC PLACES  
REGISTRATION FORM

Historic name -- Kelso Depot, Restaurant and Employees Hotel

**1. KELSO DEPOT (See attached site and building plans for depot from Historic American Buildings Survey, *Union Pacific Railroad Depot, CA-2679, 1997*)**

**SITE [CONSISTING OF 13 CULTURAL LANDSCAPE CHARACTERISTIC FEATURES] (See attached existing conditions site plan from Draft *National Park Service Cultural Landscapes Inventory, Kelso Depot, Mojave National Preserve, April 2000*)**

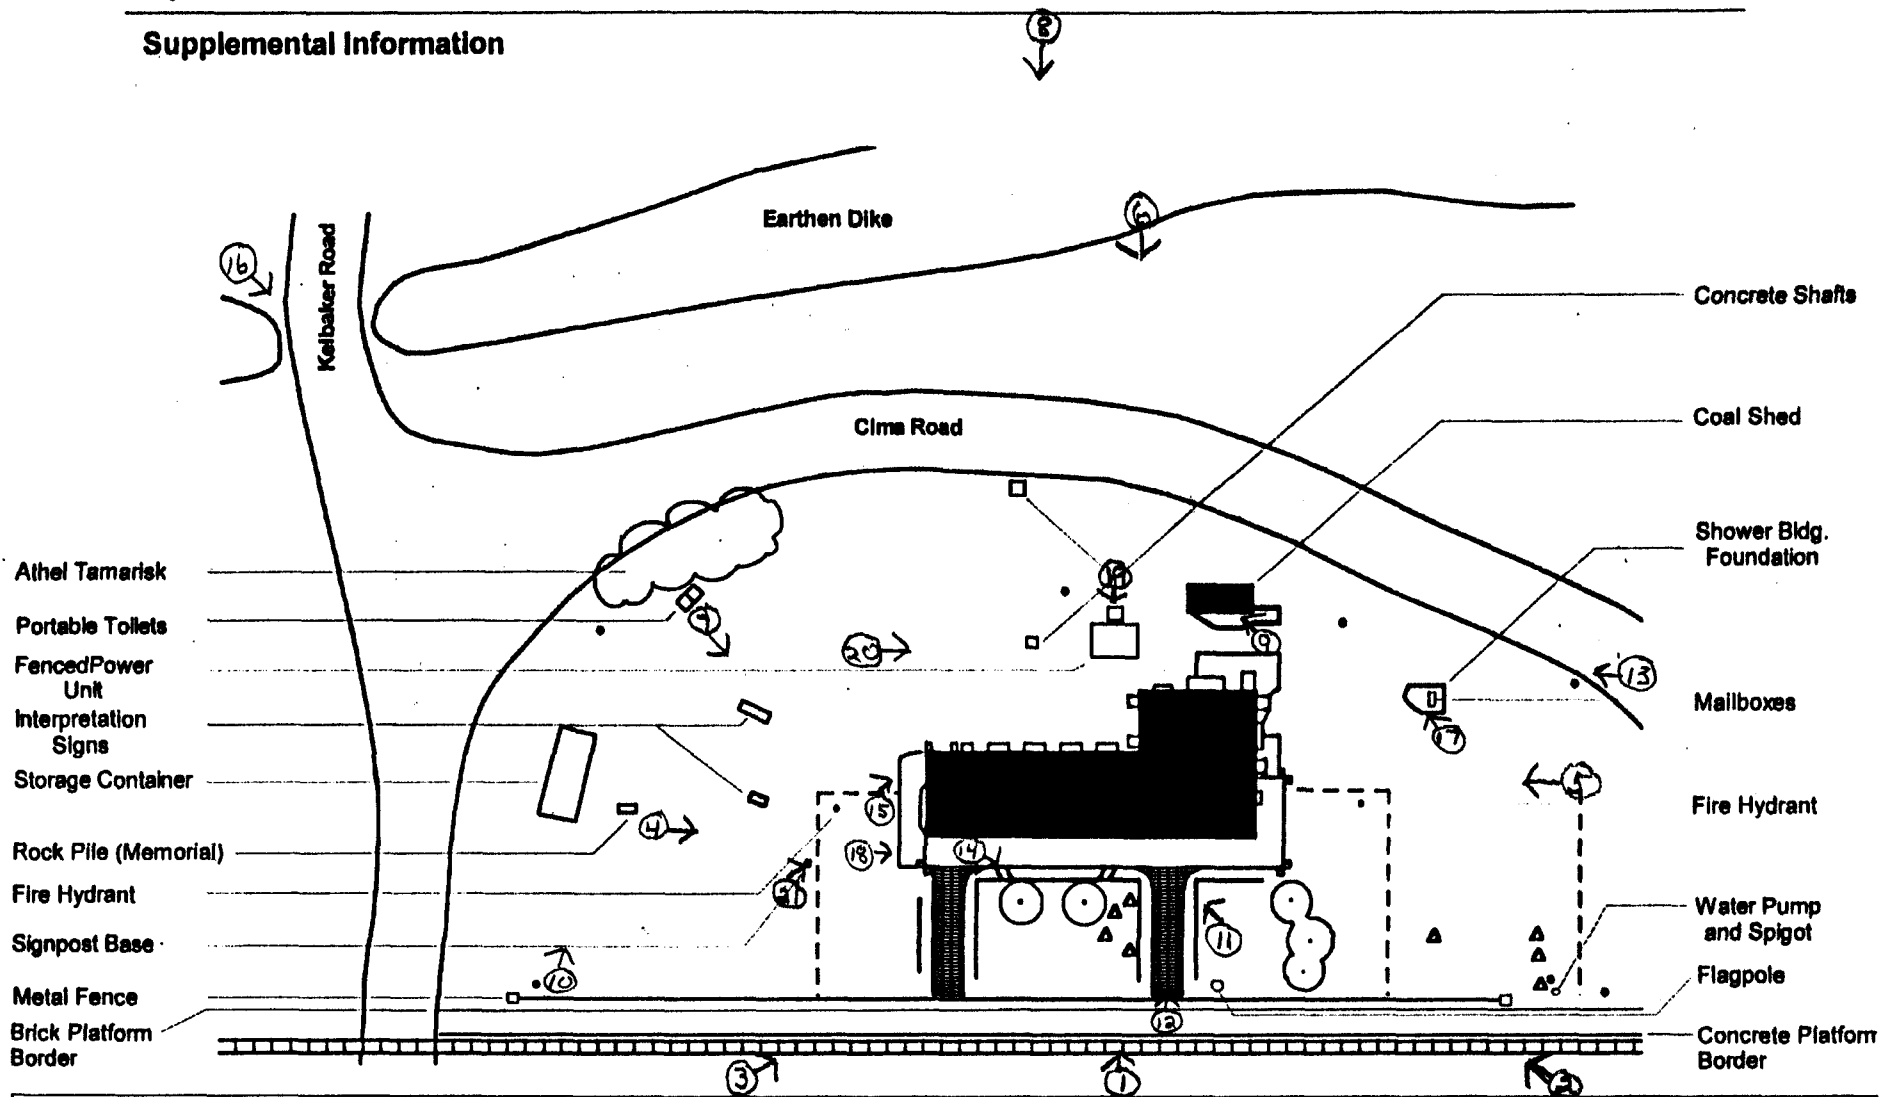
**SITE PLAN, KELSO DEPOT EXISTING CONDITIONS, IN DRAFT *NATIONAL PARK SERVICE*  
*CULTURAL LANDSCAPES INVENTORY, KELSO DEPOT, MOJAVE NATIONAL PRESERVE,*  
APRIL 2000**

**Kelso Depot**  
**Existing Conditions**  
 Cultural Landscape Inventory  
 Pacific Great Basin Support Office  
 January 7, 2000

The condition of the individual landscape features varies from poor to good. However, as a whole, the historic landscape at the Kelso Depot is in poor condition. This is a direct result of decisions made during the 1992 land transfer from the Union Pacific Railroad to the Bureau of Land Management (BLM). Following its acquisition of the site, the BLM stopped irrigating and maintaining the depot grounds. This action resulted in the eventual elimination of most of the vegetation at the site. The elms, cottonwoods, shrubs, and lawn that had created the image of the oasis in the desert either sickened or died and were then removed. Only five Canary Island date palms, and perhaps three *Athel tamarisk*, have survived from the district's period of significance. Other important features, such as the loading platform brick surface, were also removed by the BLM. After the bricks were removed, a metal fence was installed to prevent the public from approaching the railroad tracks.

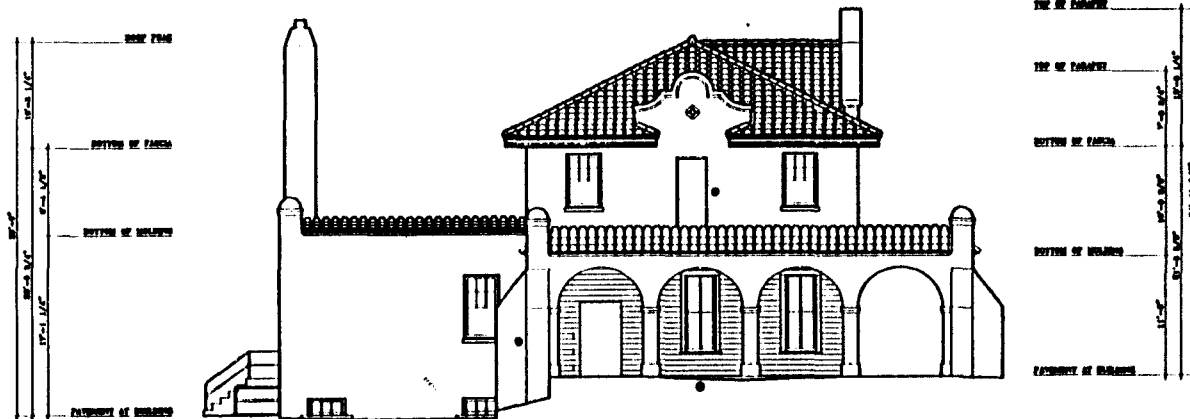
**SOUTHWEST ELEVATION**  
1/4"=1'-0"

- NOTES
- 1 ARCHES INSTALLED IN 1940
  - 2 DOOR INSTALLED IN ORIGINAL WINDOW OPENING IN 1940
  - 3 DOOR INSTALLED IN ORIGINAL WINDOW OPENING IN 1940
  - 4 ORIGINAL CASING NOT INSTALLED
  - 5 DOOR INSTALLED IN ORIGINAL WINDOW OPENING IN 1940
  - 6 ORIGINAL WINDOW OPENING IN 1940

The east and west elevations of the two-story portion of the depot are similar except for the frame infill of the west arcade, an alteration that was made in 1942 to form an added baggage room. After the depot was closed in 1964, the west end of the arcade was converted for storage and workshop use by Bridge & Building/Signal Maintenance laborers. Behind the infill, there was originally a two-leaf door in the north bay and a typical transomed casement on the south. The center bay was blind. The espadaña parapet tops the center of the three bays. Within the parapet is a quatrefoil vent segmented with sections of barrel tiles. On the west end, the fenestration pattern of the façade was continued on the second floor. The center window, however, has been changed into a door to which a fire escape once was attached. The arcade wraps around the full width of the west elevation and terminates in a buttressed pier topped with a hemisphere on a molded base.
