National Register of Historic Places Registration Form

historic name Horner-Terrill House
other names/site number Horner House

street & number 410 South Emerson Ave. not for publication
city or town Indianapolis vicinity
state Indiana code IN county Marion code 097 zip code 46219

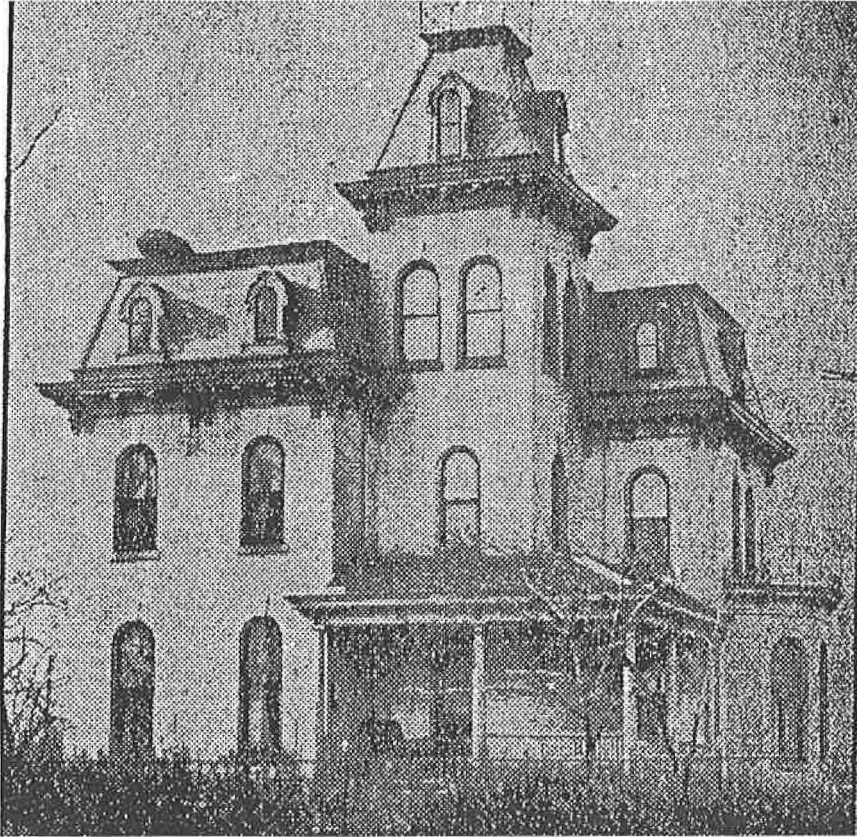
Agnes McCulloch Hanna's article "Old Houses with Towers Examples of Dignified Style of Architecture," *Indianapolis Star*, February 14, 1933

The tower section rises three full stories beside the south section, and is set back into a corner formed by the intersection of the two main blocks of the house. A concrete stoop with block foundation fills the corner. As it appeared in the 1932 photo, it is believed that the porch wrapped around the tower from the east to the north. The porch, added c. 1900, had three round wood columns and a wood railing, a narrow frieze with exposed rafters or modillions and a cornice or box gutter. By 1975, the porch had been enclosed with stone veneer knee walls and vertical board siding. Circa 1990, the porch was removed entirely. The current stoop has various scroll-shaped limestone blocks flanking its short set of steps. The scroll stones are likely salvaged from another site and are not original to this property. The blank side wall of the south section and the walls of the tower section and north block still show joist pockets from the porch. The front door entry faces east and has a stone threshold and two-row header segmental arch with stone keystone. The doorway has a plain rectangular transom, with a shaped wood piece at the top to follow the arch. The door appears to be original; the lower one-third has a molding outlining a raised rectangular panel with scalloped corners (it is visible on the interior, since the opening is currently boarded shut). The single light above it has scalloped corners and a raised molding around the glazed area. The second floor has a single one-over-one double-hung window detailed like the others on the front. The third floor has two round arched windows. Because of the positioning of the tower, these two openings do not align on center like the openings below. The tower has its own set of paired brackets at each corner, and an overhanging cornice, topped by a shallow pitched pyramidal hip roof. The tower originally had a Mansard roof with dormer window both matching the main roof and its dormers, and high iron crest work at the top of the tower (visible in the 1932 photo) (photo

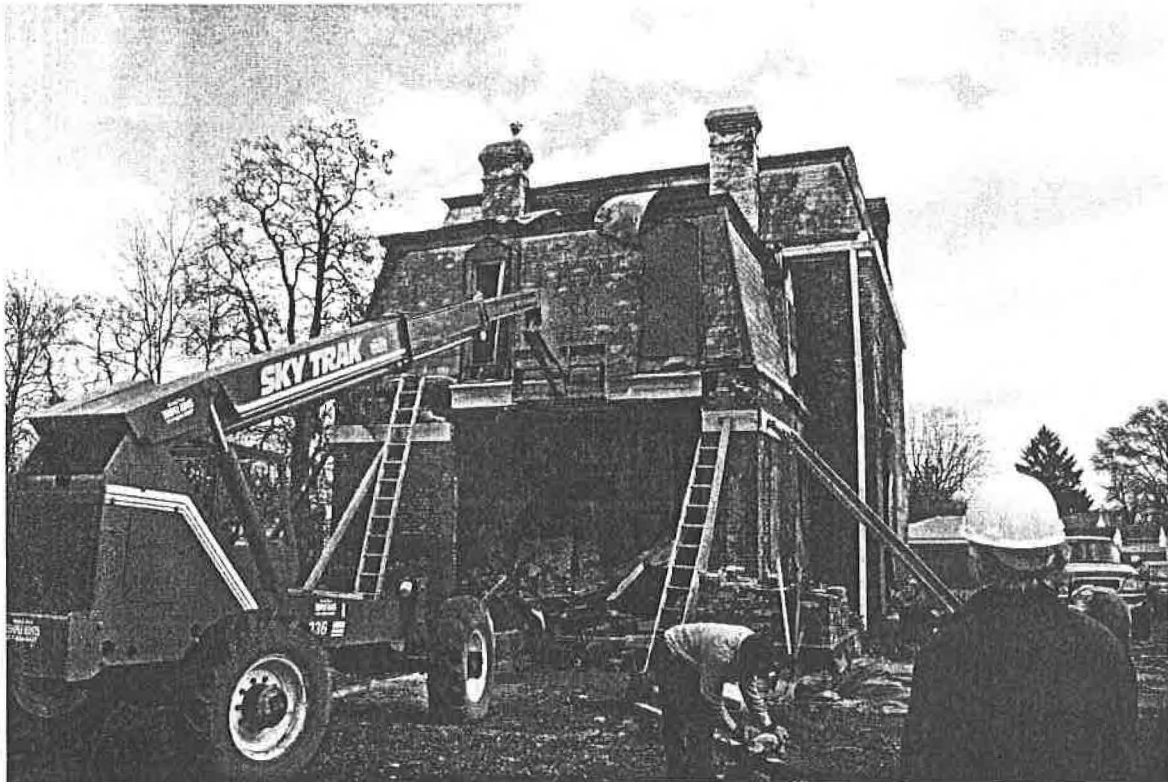
November 10, 2011 installation of support beam

A one and one-half story section stands west of the two story portion of the house (photo 0004). This rectangular section is not as wide as the front section, and so its walls are set back about four feet. Window openings have two course thick segmental arches instead of the round arches seen elsewhere. There are two window openings on the south face of the addition, two on the north face, and two doorways on the west face. Above them, the Mansard roof of the addition is punctured by gabled dormers. There is one dormer on the south face, aligning with the window closest to the main block of the house, two aligning with the west doorways, and one on the north face. The Mansard roof retains its slate on its vertical faces, which is patterned like the main roof, and also, is coated in paint, like the main roof as previously described. The main Mansard roof is visible behind the addition. Its outer corners retain some slate. There are two symmetrically placed massive chimneys on the west roofline, each with recessed panels and corbelling, matching the chimney in the south elevation. The north chimney has a recent stovepipe vent with angled cap projecting from one of its two flues. Between the chimneys, the Mansard roof has rolled or asphalt roofing. Currently the masonry wall below the mansard roof line of the west elevation collapsed between and above the two former doorways leaving a large void (photo 0004). The current owner has installed a laminated wood support beam in order to stabilize the wall from further deterioration.
