Coshocton Main Street Historic District

National Register of Historic Places Registration Form

Historic name: Coshocton Main Street Historic District

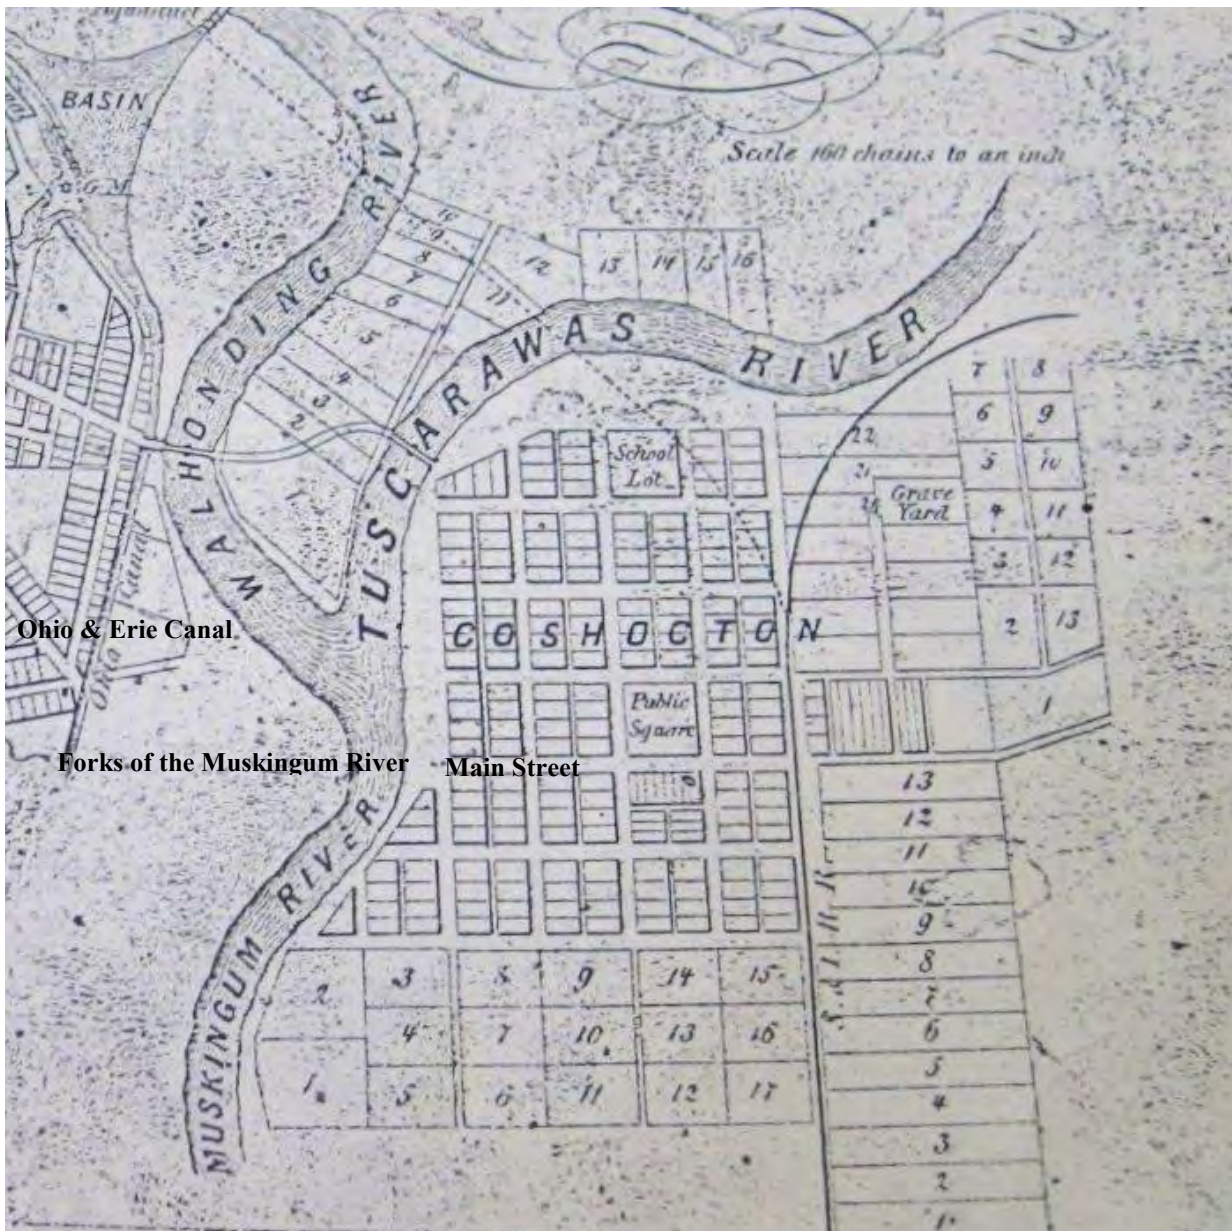
Figure 1. Plat Map of Coshocton County Ohio, ca. 1860

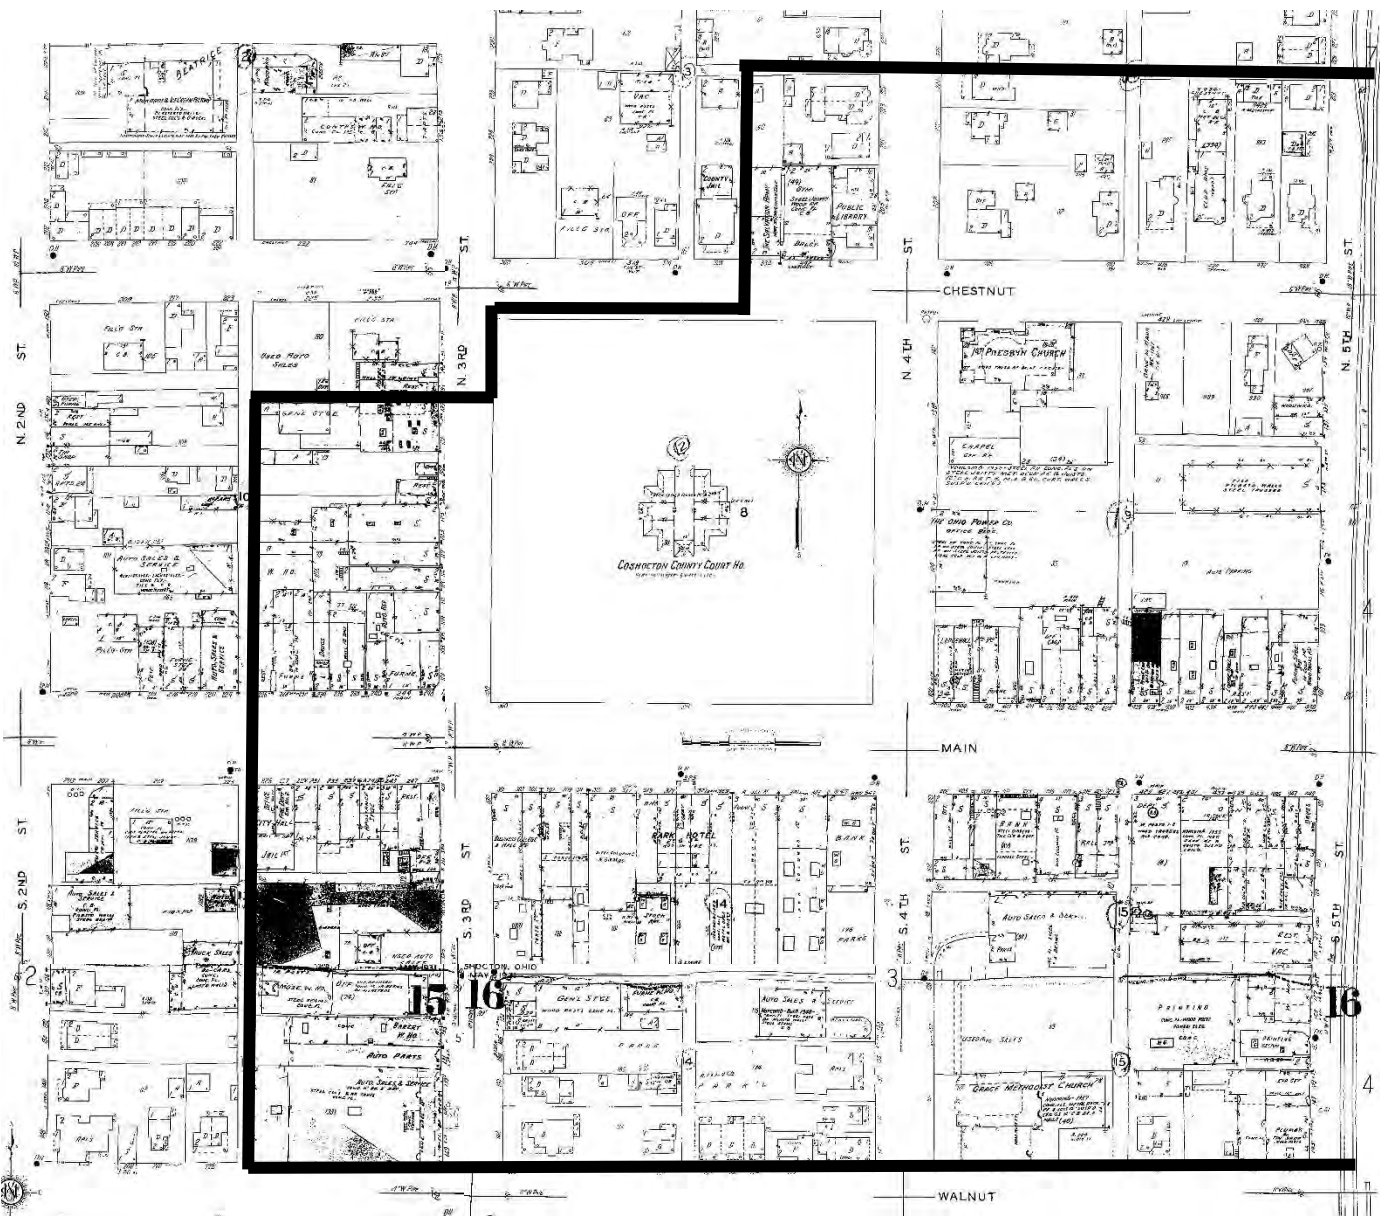
Figure 6. Map of Coshocton, 1962, 3rd to 5th Street - Historic District outlined in black

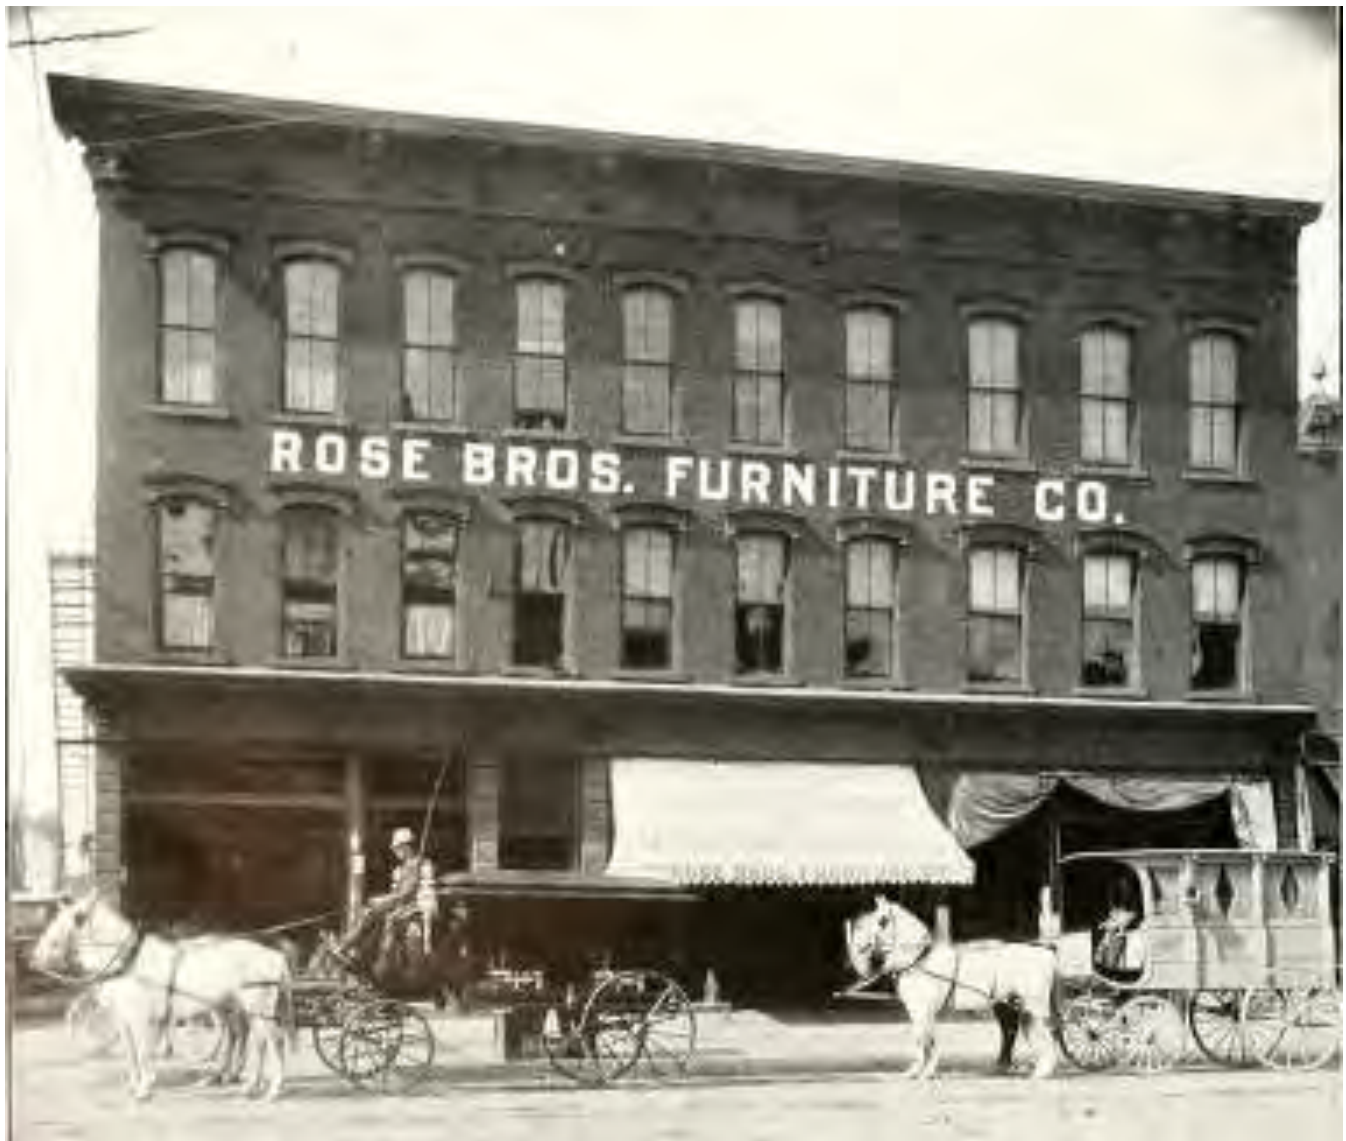
Figure 19. Rose Brothers. Building, 226-230 Main Street (#1), Photo 1911

The ca. 1880 Italianate style two-part commercial three-story brick building is partially concealed with corrugated metal siding at the second floor. Painted quoined stone piers define the first floor which support a painted stone string course supported by paired scrolled brackets. The western storefront configuration is slightly altered from the original with two pane picture window and transom above with recessed entry. Stairs lead to the basement with guardrail at the sidewalk. The remaining first floor has replacement metal and glass storefront systems with recessed entrance and a barrel canvas awning. The 10-bay symmetrical second and third floor double hung 2/2 windows were replaced with double hung 1/1 windows or infilled with painted plywood. The second and third floor of the existing building are obscured from bays 6-10 by corrugated metal siding. The bracketed cornice at the parapet has been removed. The west elevation exhibits infilled picture and double hung 1/1 replacement windows at the second floor. A metal fire escape descends from the center third floor window bay. The Lee Building, 232 Main Street (#2) is adjacent to the east.
