National Register of Historic Places Nomination Form

historic name Bricker-Price Block
other names/site number C.D. Bricker Building (115 S. Chestnut) and W.J. Price Building (105 S. Chestnut)

street & number 105-115 S. Chestnut Ave. not for publication N/A
city or town Earlham vicinity N/A
state Iowa code IA county Madison code 121 zip code 50072

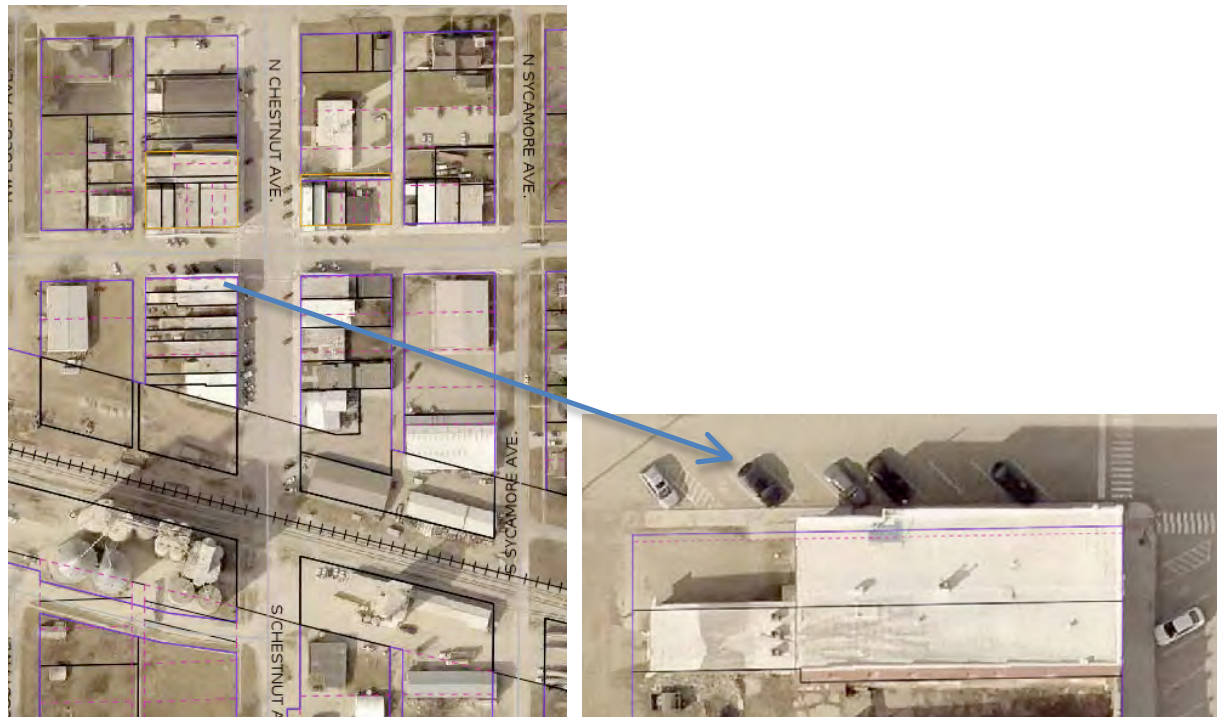
Figure 3: Parcel map of Earlham commercial district, with enlarged detail of Bricker-Price. (Madison County Assessor's Office, 2015 aerial photograph)

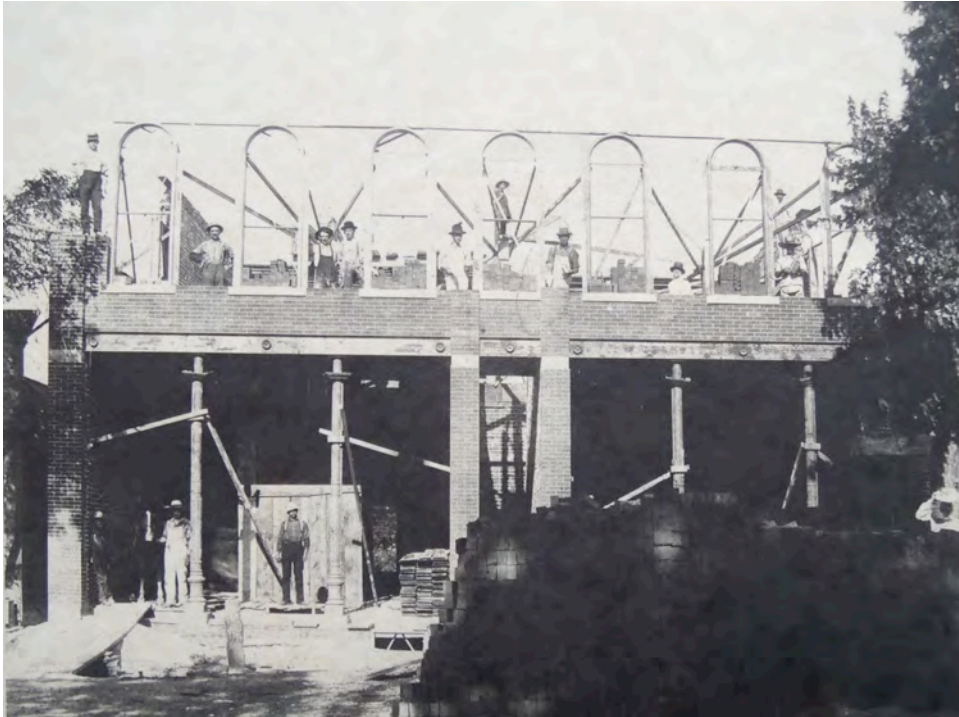
Figure 4: Construction of the Bricker-Price Block as recorded in a photo dated 1900. It shows that the block was constructed all at one time with unified façade including shared central staircase. (Courtesy Earlham Historical Society Museum)

Local contractor J.E. Walton, noted in the Earlham centennial history as building more Earlham structures than any other (as will be explored below), constructed the nearly symmetrical Bricker-Price Block. (Myers: "Early Business Ventures") A 1900 photograph (Figure 4) captures the construction, showing that the unified façade was built all at one time.

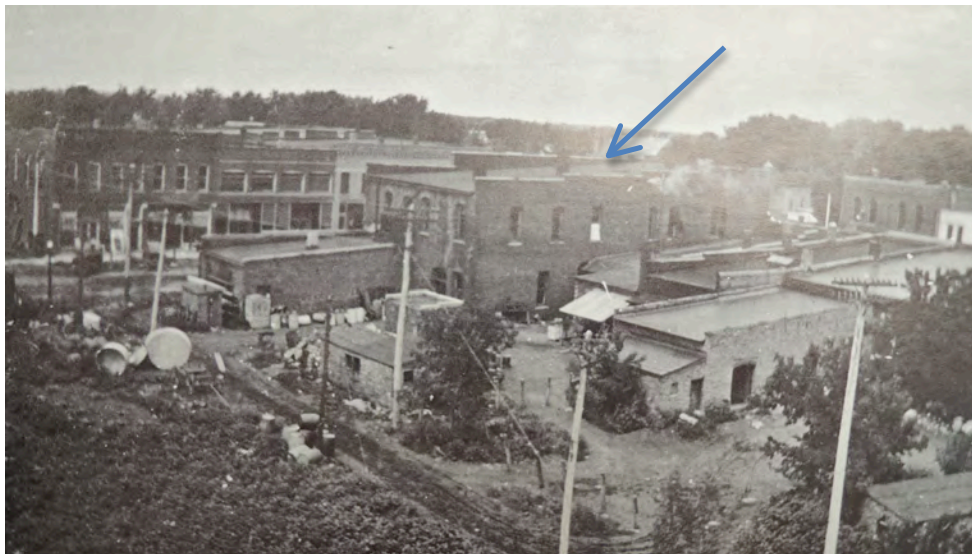
Figure 6: Bird's eye view of downtown taken from the top of the grain elevator, looking northeast toward First Street and Chestnut Avenue. The Bricker-Price Block (indicated by the arrow) is shown from the rear, before the rear south addition was built to the Bricker Building, pre 1919. (Myers: "Early Photos...")

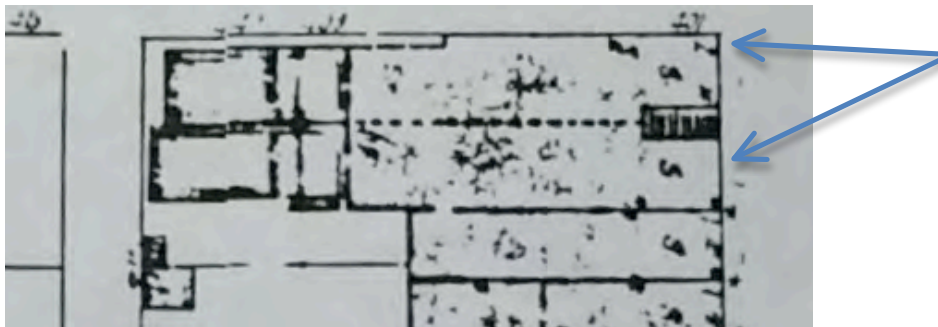
Figure 8: 1933 Sanborn map, showing rear south addition built to Bricker Building.

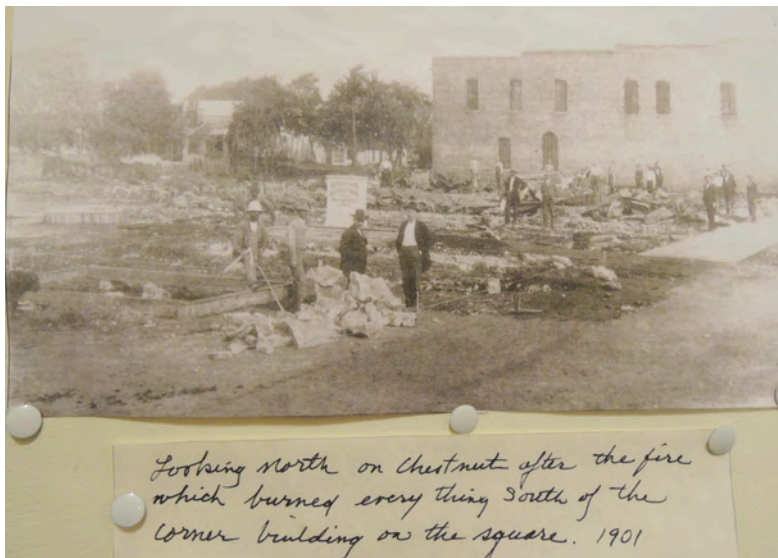
Figure 9: Photograph from 1901 showing Bricker-Price Block (arrow) still standing after destructive fire burned all commercial buildings to the south. (Courtesy Earlham Historical Society Museum)

1901: Bricker-Price Block stops the great fire from spreading north to the rest of Earlham. The fire caused "great damage to stock and all wood trimming." (Byrne)

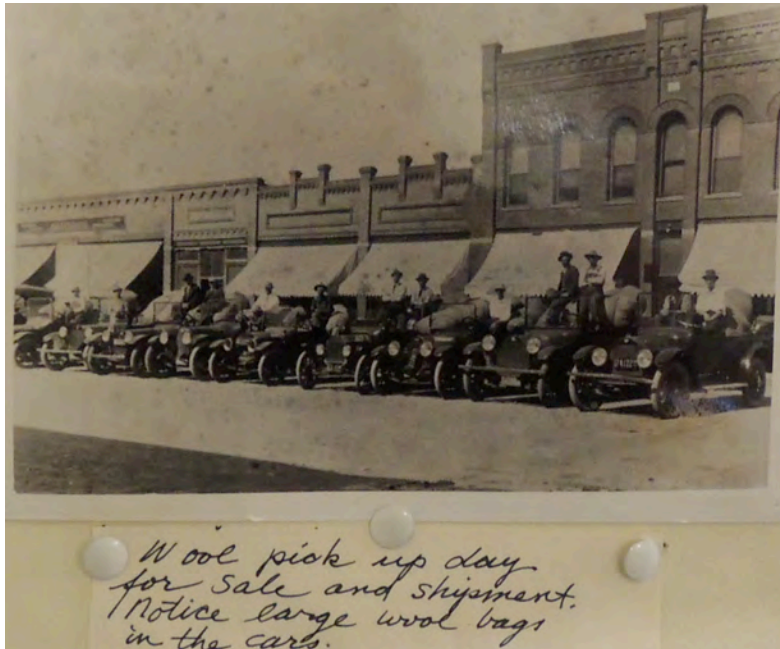
Figure 10: Undated photograph from early 1900s showing Bricker-Price Block (arrow) and post-fire brick commercial buildings to the south. (Courtesy Earlham Historical Society Museum)

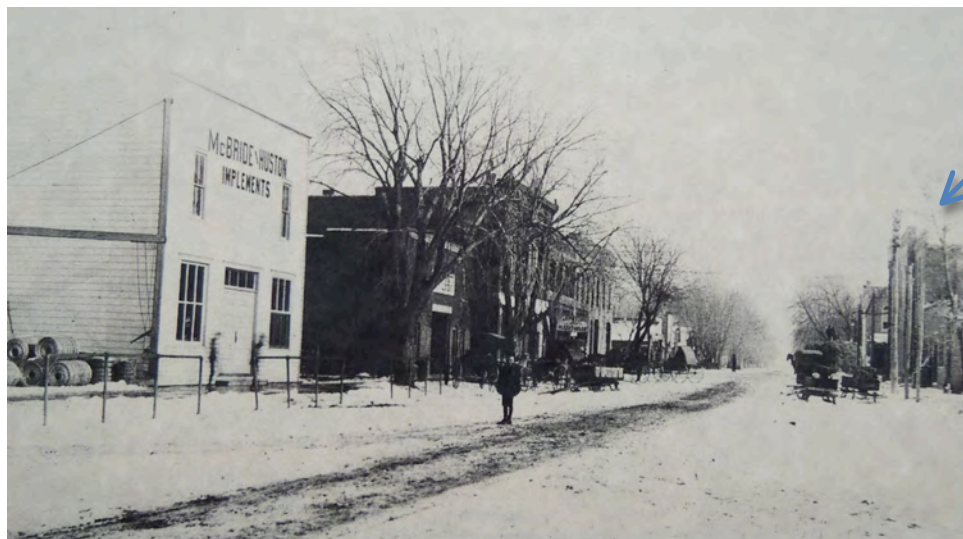
Figure 15: This early 1900s view of First Street (then Main Street) looking east shows the north wall of the Bricker-Price Block with a telephone pole planted next to the sidewalk (arrow points). (Courtesy Earlham Historical Society Museum)

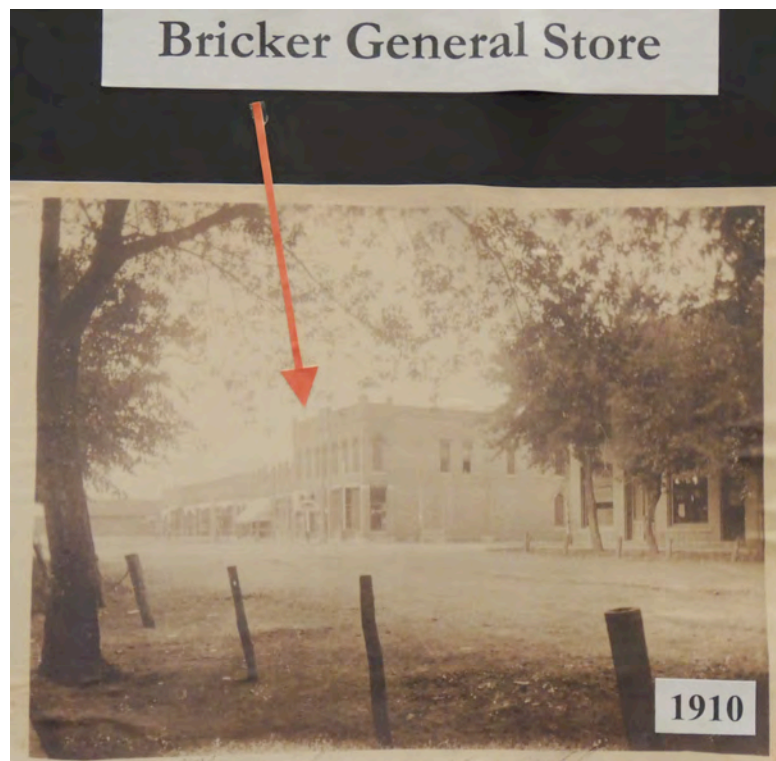
Figure 17: Bricker-Price Block in 1910, look SW. (Courtesy Earlham Historical Society museum)

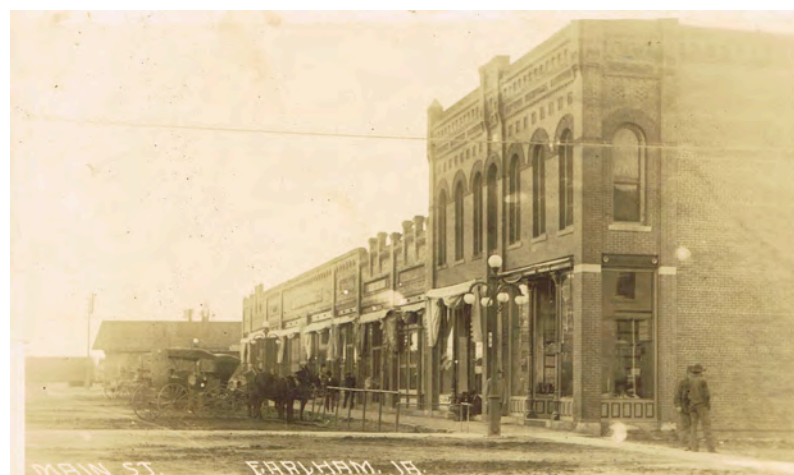
Figure 18: Bricker-Price Block in circa 1922, look SW. (Courtesy Ben Price and family)

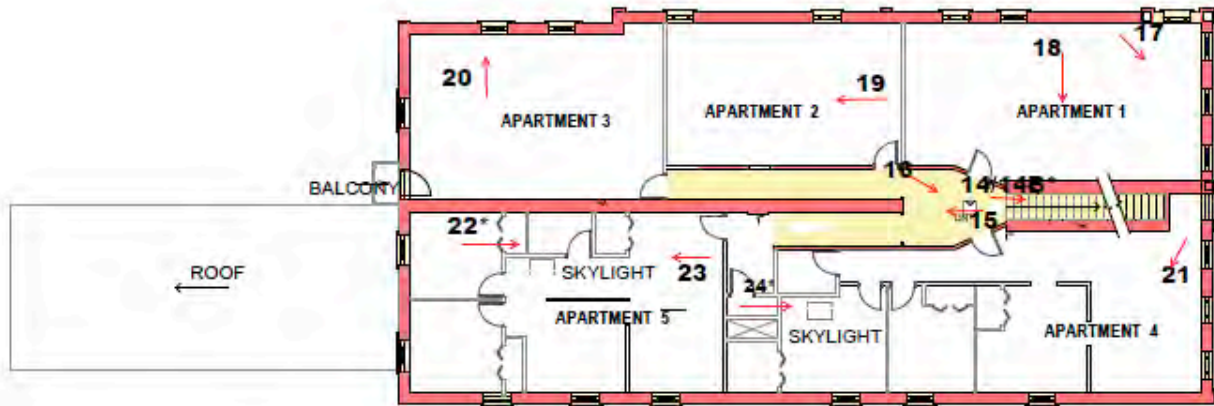
Second-floor Plan Sketch Map and Photo Key – Existing Conditions, 2016

* = photo taken above modern dropped ceiling to show original height ceiling

2 SECOND FLOOR - EXISTING
1/8" = 1'-0"
