NATIONAL REGISTER OF HISTORIC PLACES
PROPERTY PHOTOGRAPH FORM

1 NAME Leonis Adobe

CITY, TOWN Calabasas

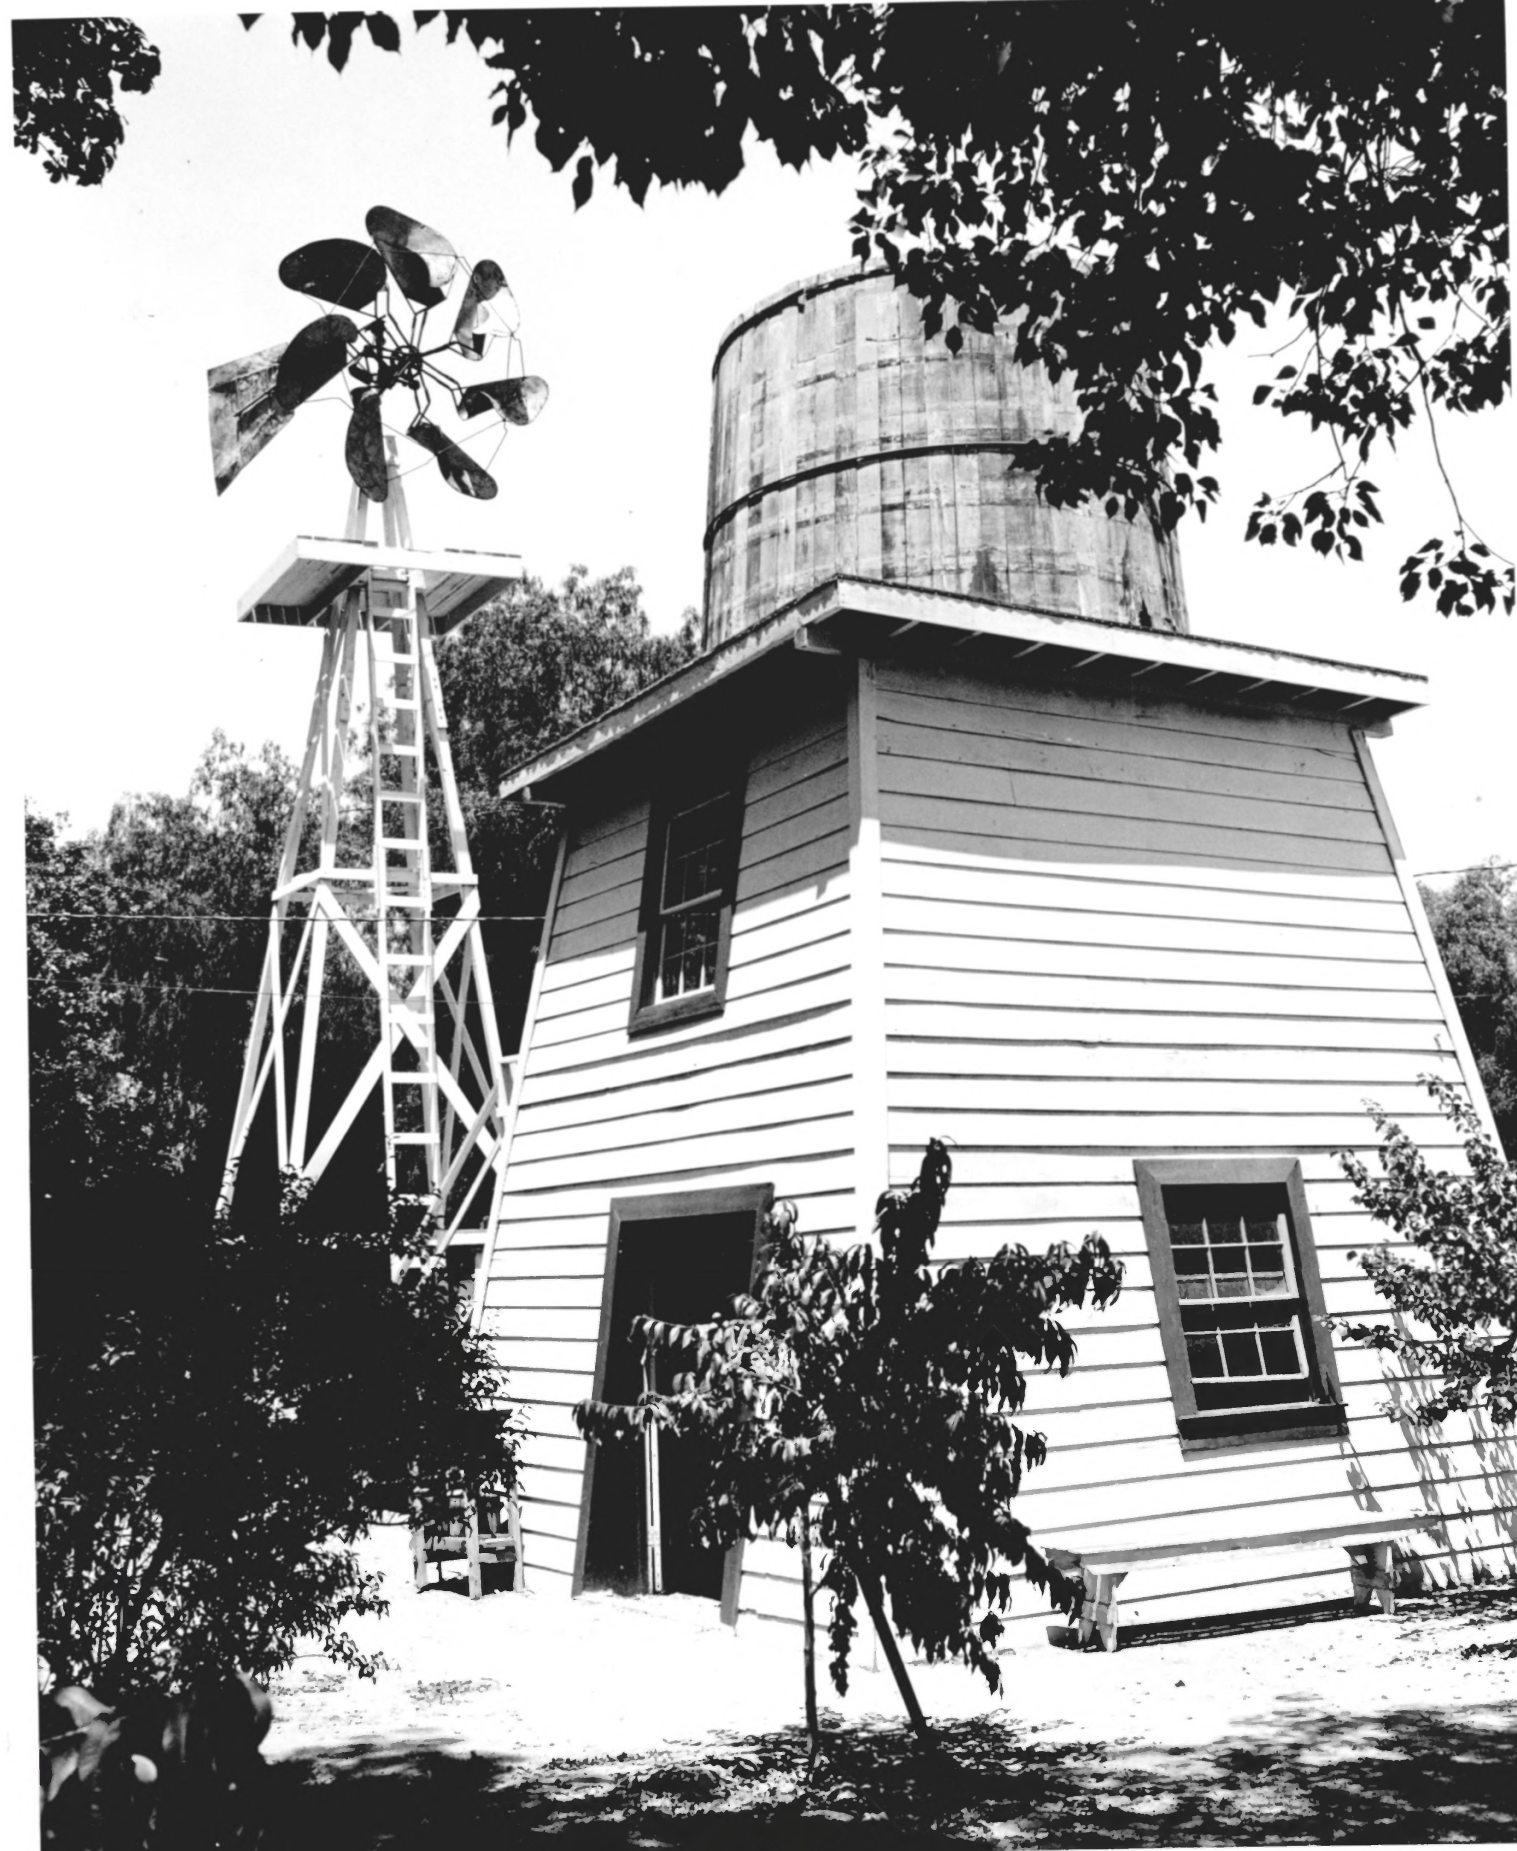
When the Association obtained the Adobe this area was an asphalt paved parking lot. We knew from tradition and the 1905 photograph that a well with windmill and a tank house had been here. Excavation found the redwood lining of the well and 16 foot square mud sill of the tank house under 2 feet of fill dirt.

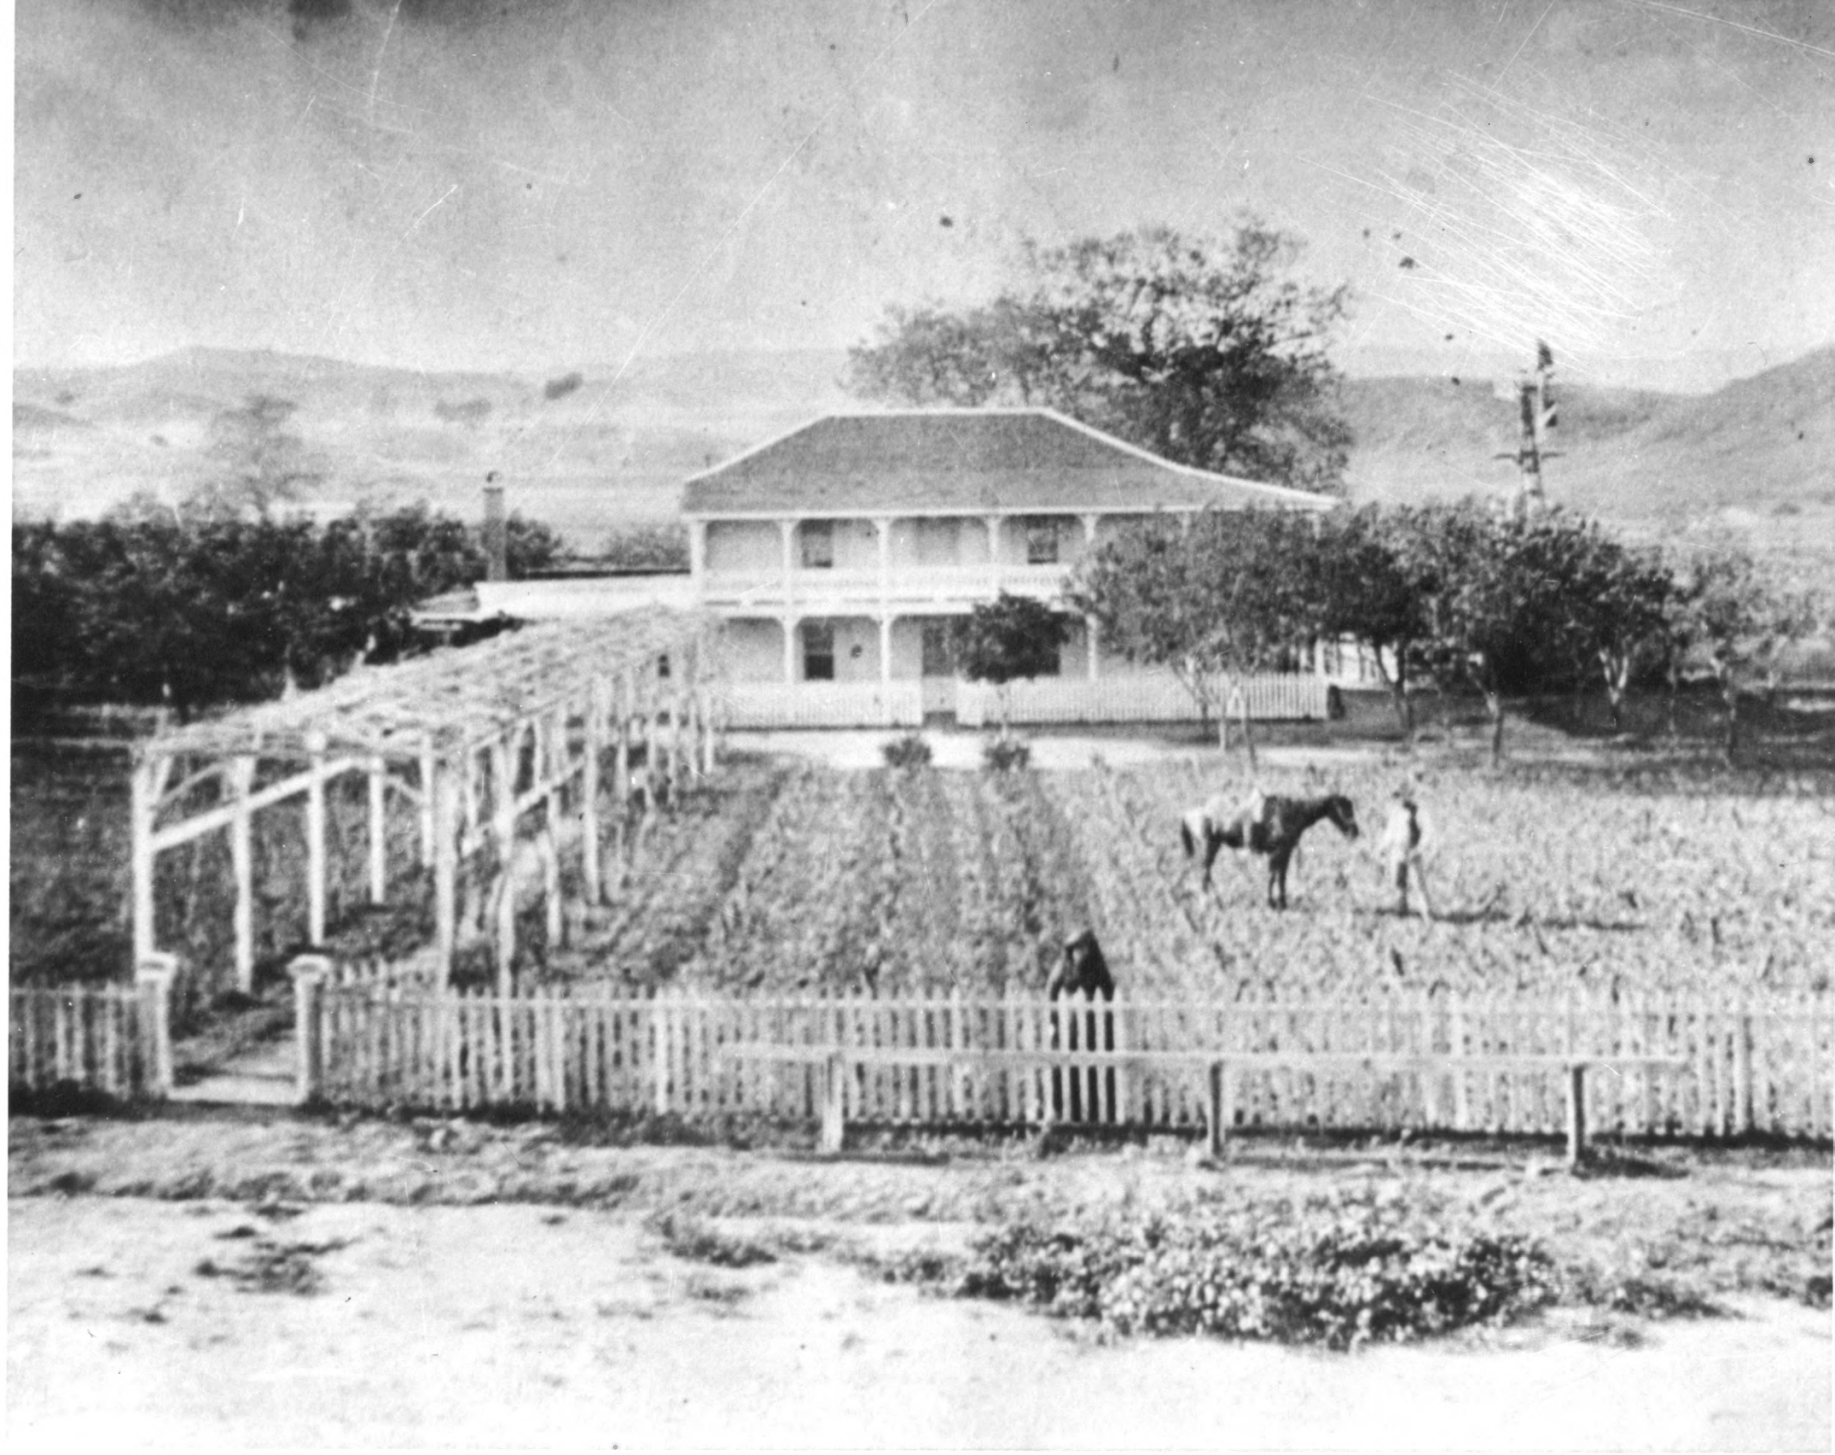
4 IDENTIFICATION
DESCRIBE VIEW, DIRECTION, ETC. IF DISTRICT, GIVE BUILDING NAME & STREET
Earliest known photo-1905. Mrs. Leonis at fence. Juan Menendez her son, with horse.
Notice original windmill, vineyard, grape arbor, fruit trees all of which
disappeared and have been replaced as part of the restoration. PHOTO NO.

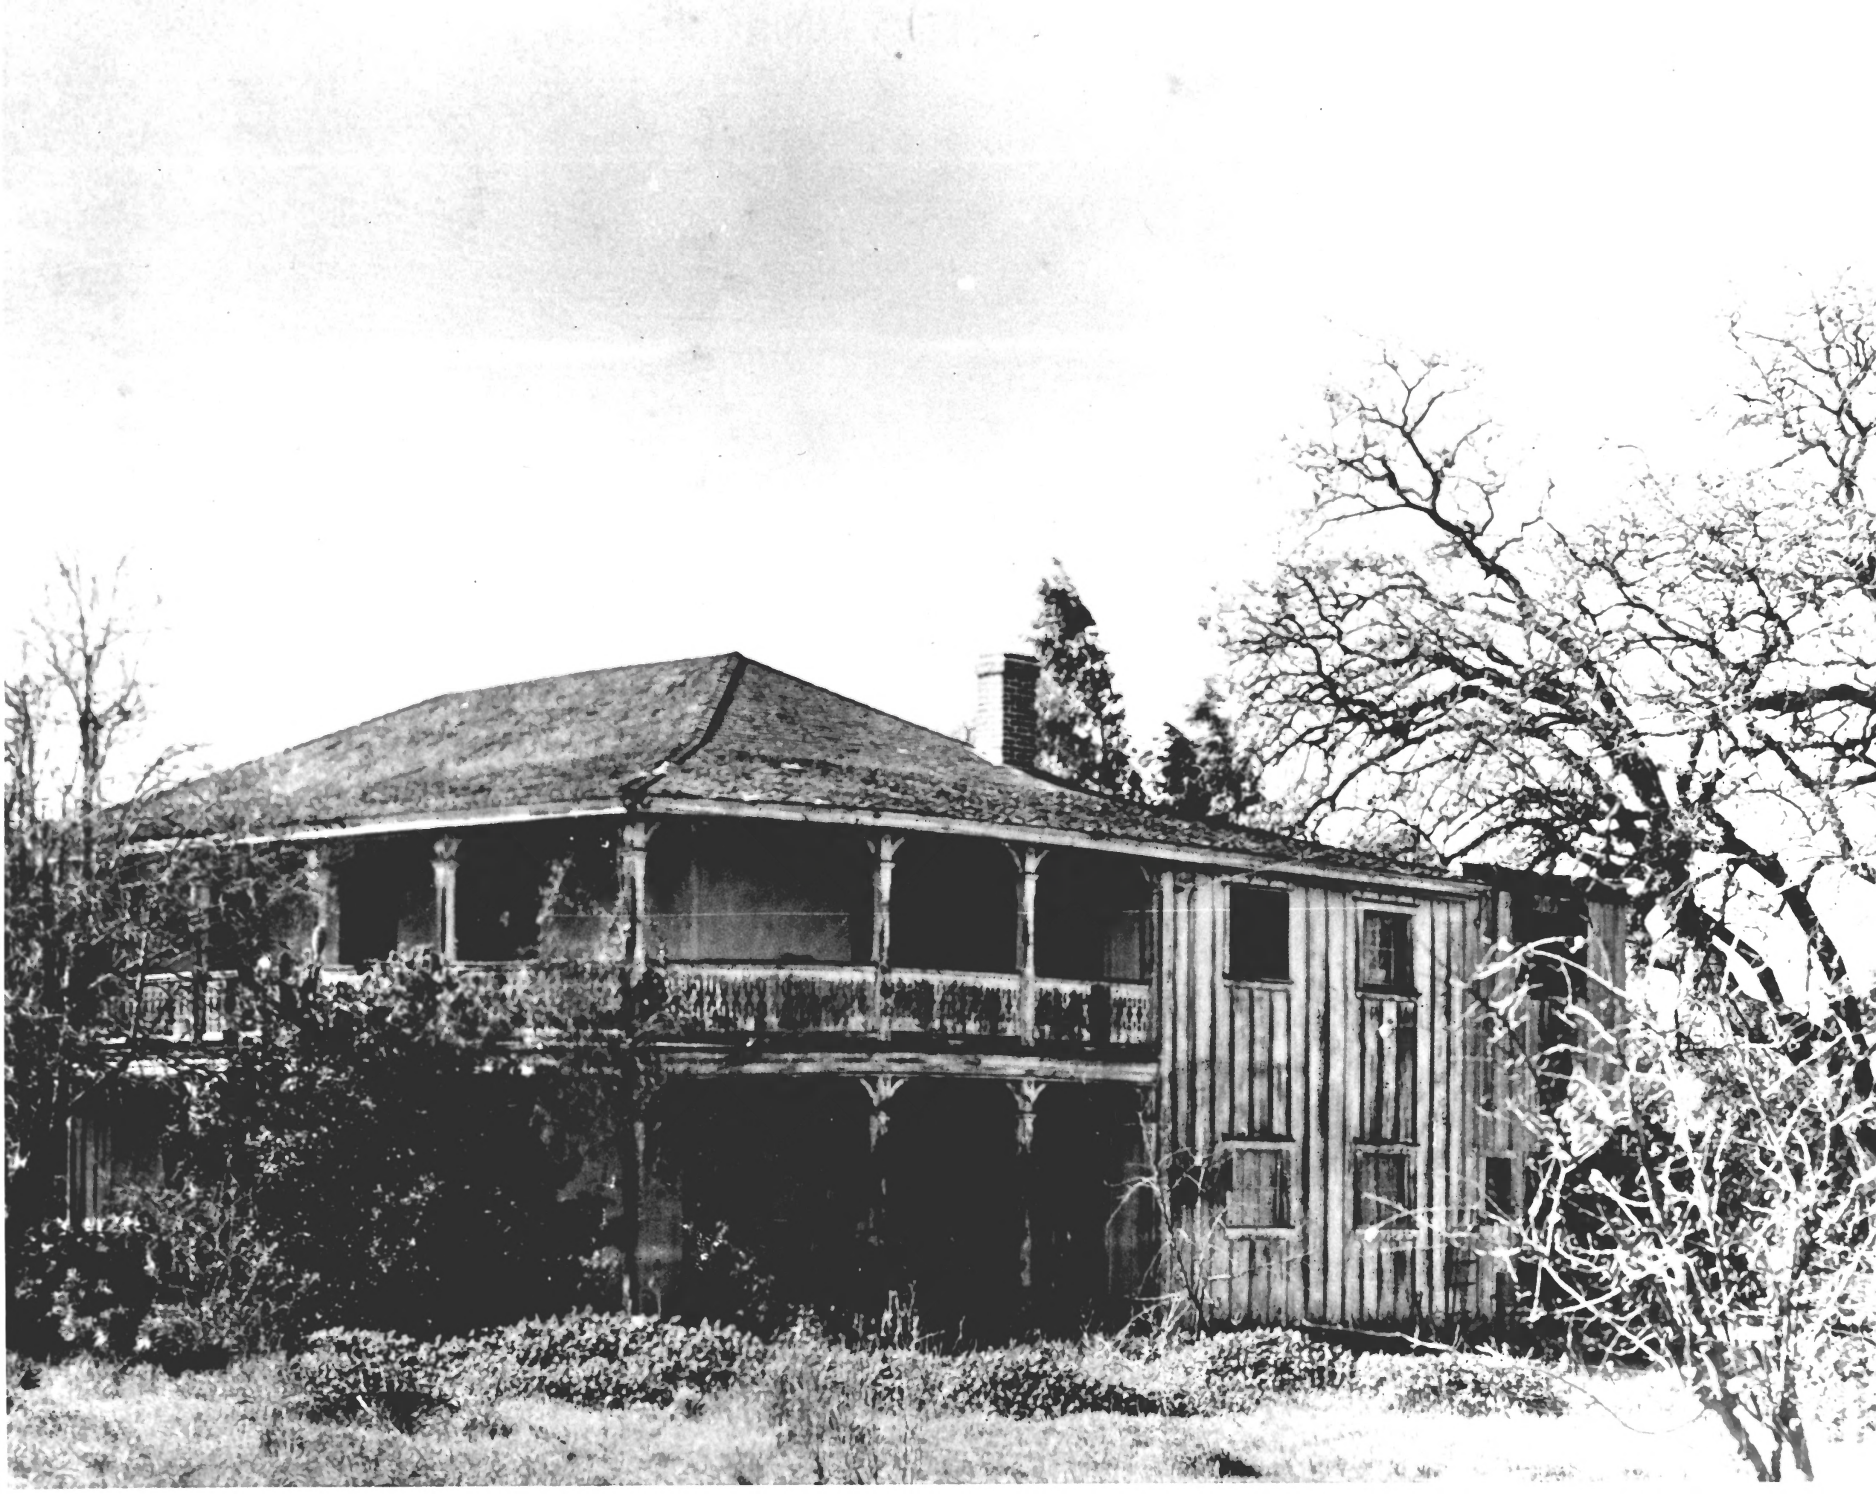
South and Southwest side of Adobe in the mid 1930's. Note that living room fireplace (see chimney) has been added and the Agroure addition (last window on right on both floor. These were done circa 1925-27 and were removed in restoring the house to it's late 1870's period.

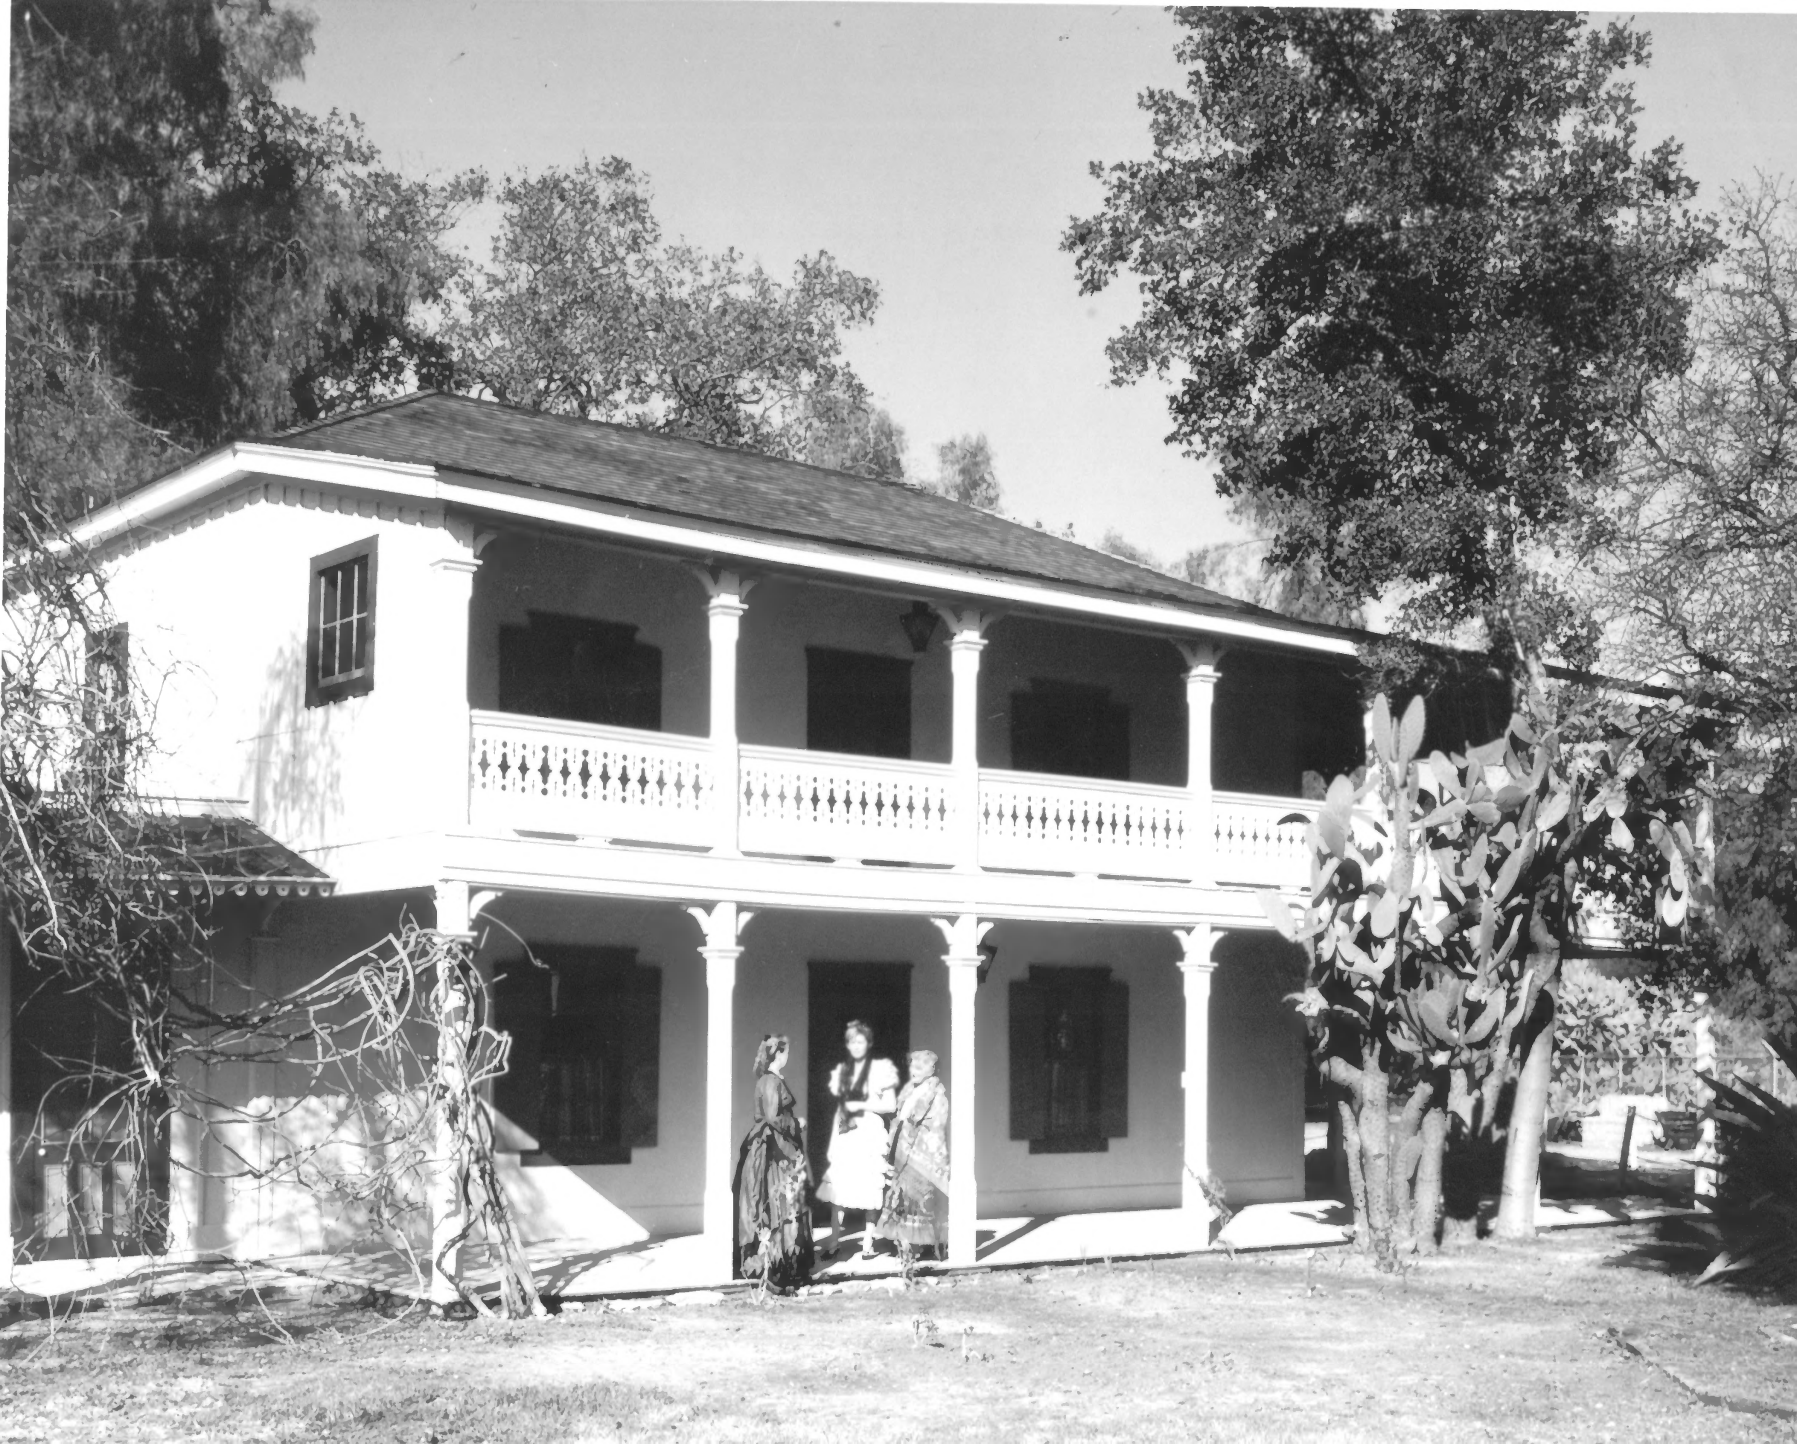
The Leonis Adobe, 1966. Restoration of the building to its appearance of the late 1870's, when the Miguel Leonis family lived there, has been completed. Since the photograph the front yard has been re-planted with ancient wine-grape vines, secured from an abandoned vineyard.

Restoration of the Leonis Adobe to its appearance of the late 1870's, when the Miguel Leonis family lived there. Since the photograph the yard has been replanted with ancient wine-grape vines and pepper trees making it impossible to get a view of the house for a photograph.
