United States Department of the Interior
National Park Service
National Register of Historic Places Registration Form

Historic Name: King-Woods Farmstead
Other name/site number: King-Woods Farmstead
Name of related multiple property listing: NA

Street & number: 920 E Court Street
City or town: Seguin State: Texas County: Guadalupe
Not for publication: Vicinity:

Architectural Classification: LATE 19TH CENTURY / Folk Victorian; LATE 19TH AND 20TH CENTURY
 REVIVALS / Classical Revival/ Neo-Classical

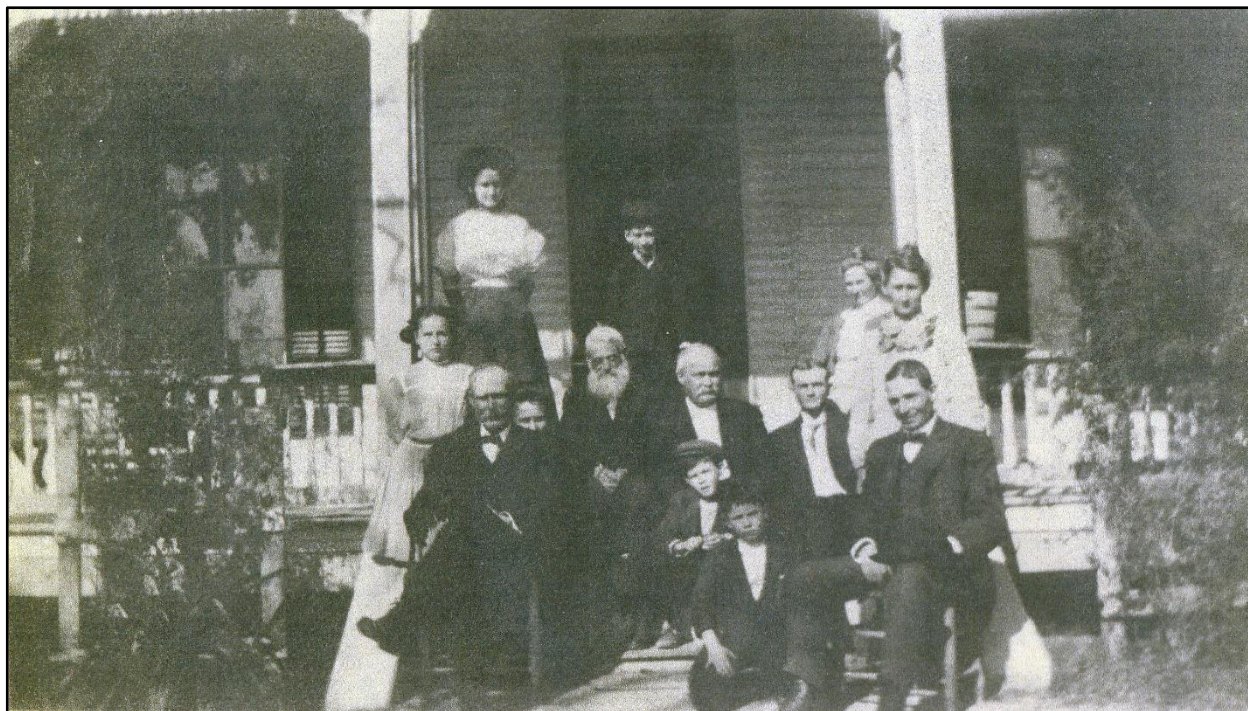
FIGURE 7: King and Moss family on porch of Henry and Bettie King's Folk Victorian style house with central hall as completed in 1887. Photo c. 1892 (Provided by Janice Woods Windle).

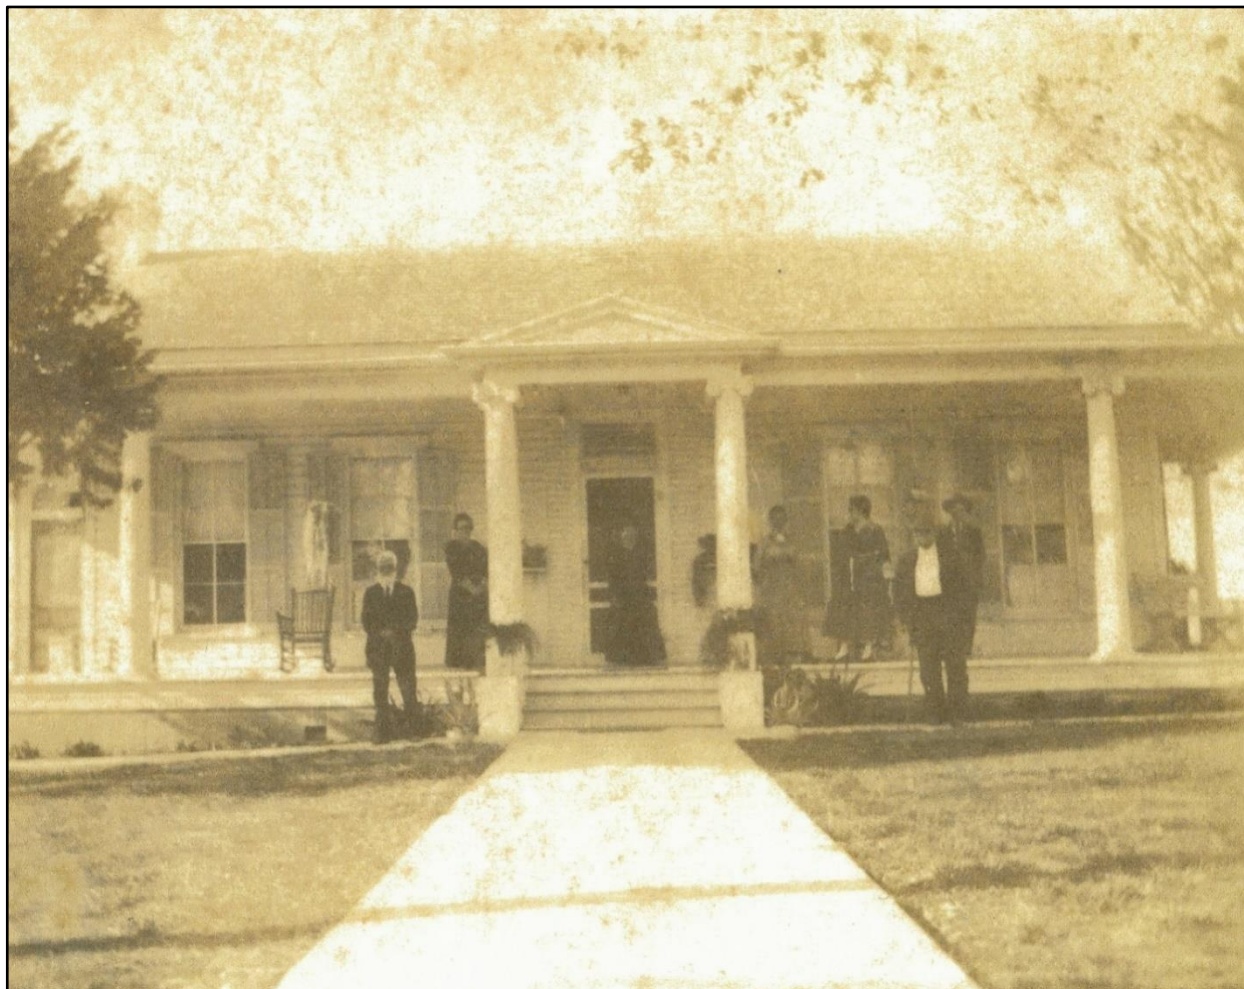
FIGURE 8: King-Woods House. Members of the Moss and King family in front of the King-Woods House as remodeled in 1893. Photo c. 1902 (Provided by Janice Woods Windle).

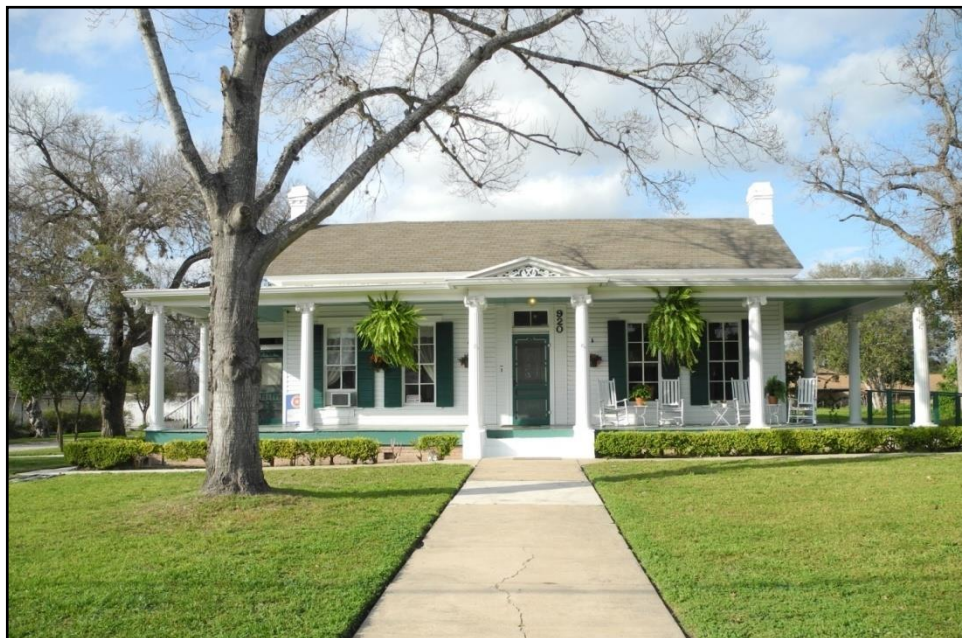
PHOTO 1: King-Woods House, south elevation, facing north (February 1, 2017).

The front façade has a symmetrical AABAA arrangement with a central entrance flanked by two window openings on each side. The entrance contains a single entry door topped by a two-light transom window. Vertical bead board panels used as infill are found to either side of the door, suggesting that the door opening was reduced in size—likely in 1893 when the house was remodeled to its Neoclassical appearance. The door and transom openings are framed with flat trim. The door itself is highly elaborate, with a bottom panel containing a decorative intaglio carving and a large window with etched glass in its center and leaded and stained glass lights in a 3” rectangular border around its edges (Photo 10). On either side of the window and bottom panel are carved spindles with alternating cylindrical and blocky shapes. Delicate sawtooth trim underlies the window, and the knob backplate is cast iron with carved floral motifs. A plain, historic-age wood screen door is attached to the exterior. The four window openings on this primary façade have tall, narrow, 4/4 double hung wood windows, louvered shutters, and wide wood trim with a molded strip along the top. The siding on the front elevation is wood drop siding with a thin decorative bead between each lap.

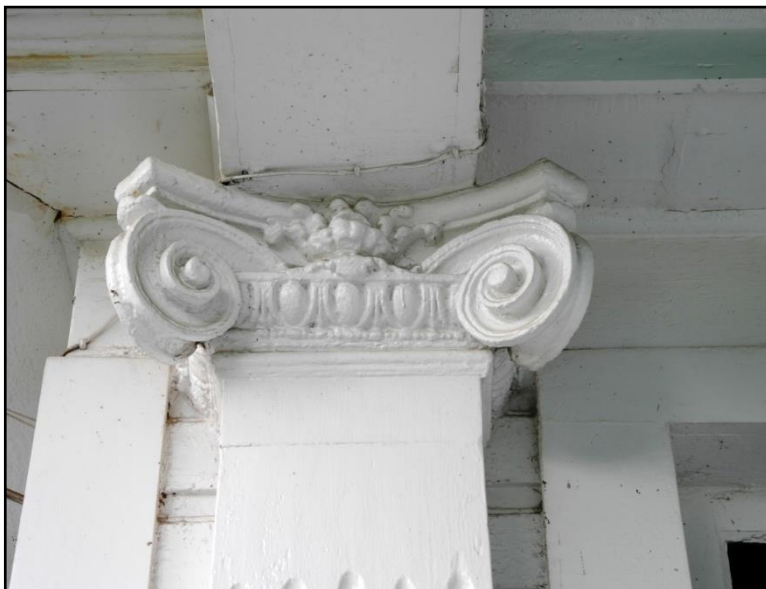
PHOTO 8: King-Woods House, capital on pilaster (west elevation), facing east (February 1, 2017).

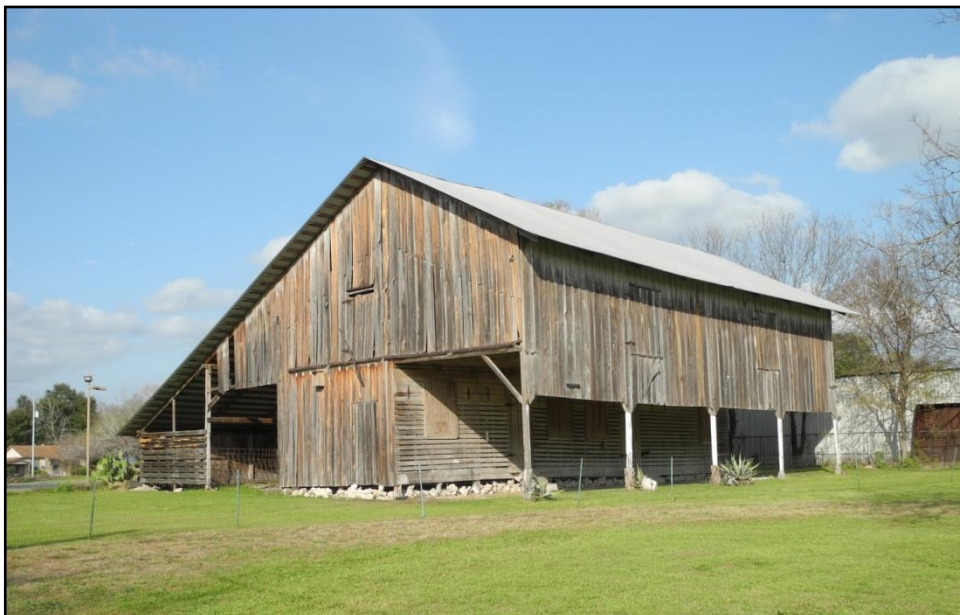
PHOTO 11: King-Woods Multi-purpose Barn, c. 1895, west and south elevations, facing northeast (December 10, 2016).

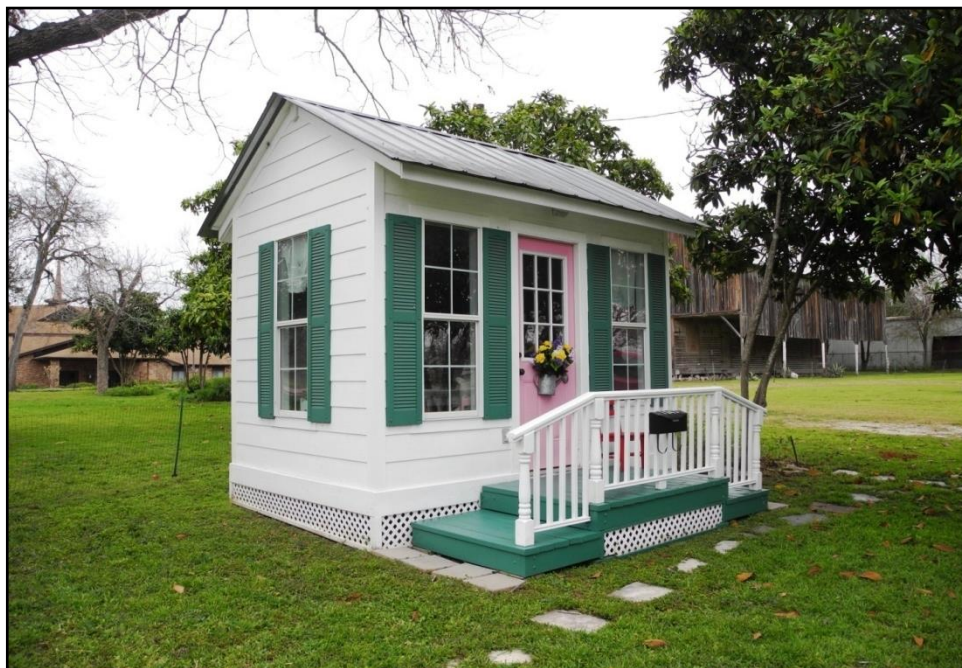
PHOTO 18: King-Woods Playhouse, 1947, west and south elevations, facing northeast (April 23, 2017).

The playhouse is located approximately 35 feet east of the house near the yard's decorative kumquat trees. It is a small wood frame side-gabled building with a footprint measuring approximately 10 by 8 feet (Photo 18). Its siding is asbestos and its roof is standing seam metal. Exterior walls have plain fascia and corner boards and flat window and door trim. The narrow bargeboards on the gabled side elevations have small wood "keystone" details. The building sits on a slightly raised foundation and its front elevation has a "Charleston" porch with wide, low steps accessing both sides. Along the front of the porch is a balustrade with turned and square banisters. The foundation is skirted with lattice.

The front elevation is symmetrical, with a central door flanked by two windows. The door is a non-historic replacement with two panels in the lower section and nine rectangular lights in the upper section. The west side elevation has a single window opening. All three windows have fixed wood shutters, replacement vinyl sash, and metal screens. The east side elevation and rear are windowless. Inside, the playhouse has a single room with a vaulted ceiling that follows the roof form. The floor is wood and the walls are smooth and painted.

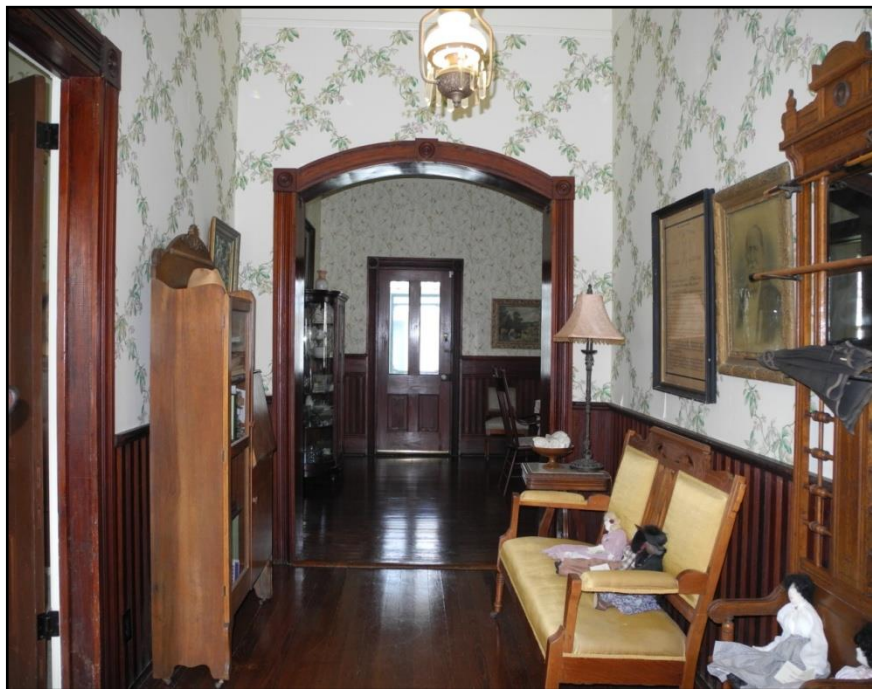
PHOTO 20: King-Woods House, from central hall (1887) to back door (1893) (April 23, 2017).

The interior of the house retains excellent integrity. The front door opens into the central hall (Photos 19-20), which has a door opening to either side—the east door leads into the parlor and the west door to the front bedroom. At the north end of the hall is an arched opening that leads into the dining room (Photo 20). The hall, parlor, and dining room have dark stained oak floors. The hall and dining room both have stained wood wainscoting, and the trim around all door and window openings is stained wood with bullseye blocks in the corners (Photos 19-20, 24-25). Wide painted crown molding is found underneath the high ceilings of all rooms. Between the parlor and dining room is a set of wide, dark stained pocket doors. At the west end of the dining room is a door to the rear bedroom (Photo 22). From the rear bedroom, doors lead south into the front bedroom (Photo 23) and west into the bathroom. The bathroom has painted bead board wainscot walls. Both bedrooms currently have carpet covering the floors. At the northern, or rear, wall of the dining room are two doors—one leads to the kitchen at the building's northeast corner and the other is the exterior door that leads onto the rear porch (Photo 20).
