# National Register of Historic Places Registration Form

Historic name: Wilkins Farm

Other names/site number: VDHR File No. 085-0216

City or town: Edinburg State: Virginia County: Shenandoah

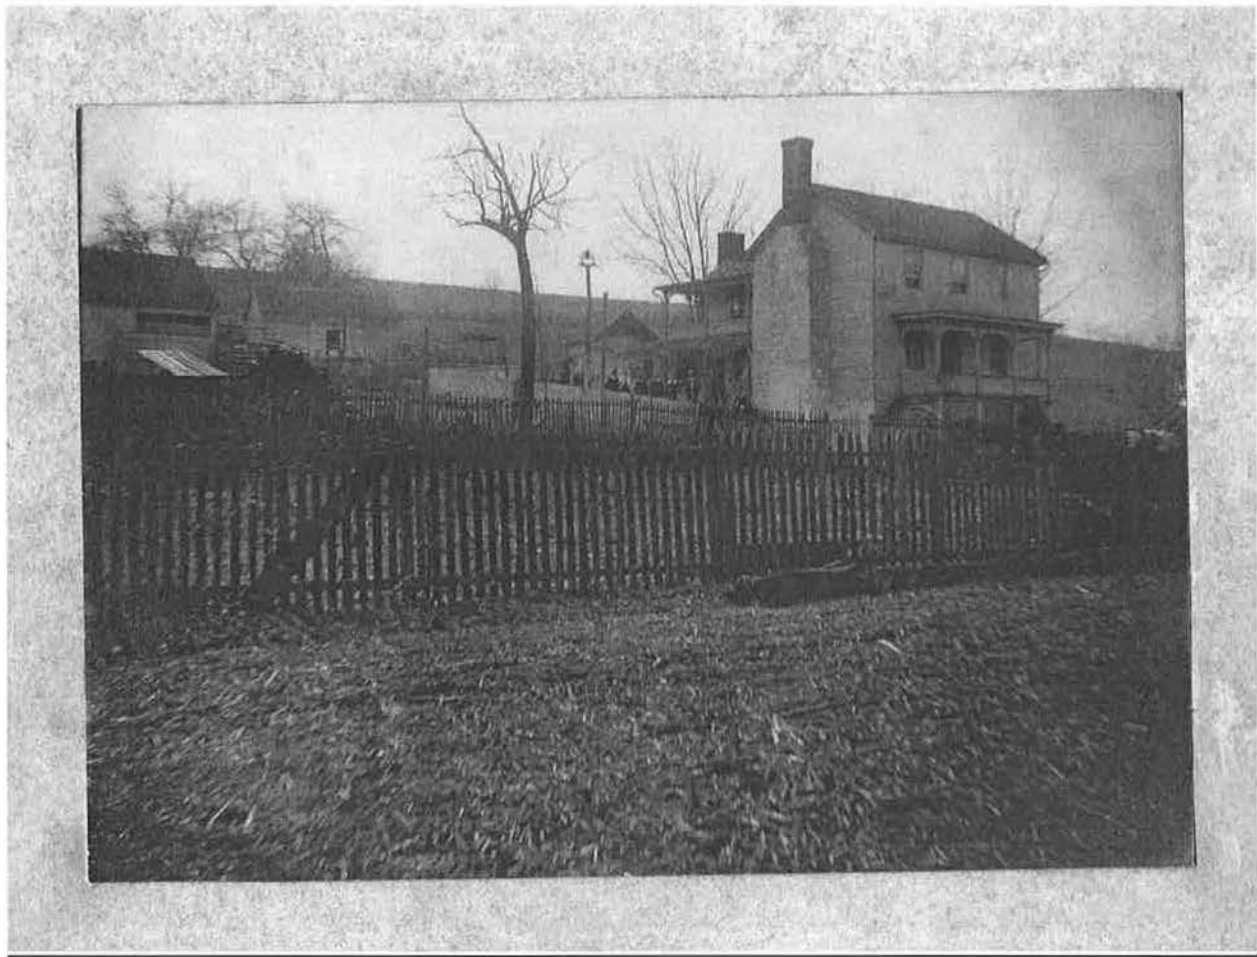
Wilkins Farm, Shenandoah County, Virginia, 1913.

area is limited, any potential for archaeology appears to be confined to an elongated 50-foot by 300-foot area. A 1913 photo reveals additional small outbuildings east of the main house. Irregular land forms in the current pasture suggest the possibility of a larger on-ground log barn. A possible foundation base of limestone rubble fashioned into a 24-inch-wide platform with an undetermined length was found 50 feet east of the main house. Potentially this area might explain the source of the reused logs in the summer kitchen. West of the granary, a barrow pit was found that may have been used to build the ca.1776 fireplace. The mortar seems to be made of local gritty clay which was repointed at a later date. It was back filled with limestone rubble and flakes from the chimney construction. The exterior dimensions are unknown. Two non-diagnostic aboriginal surface finds were a fire reddened low-grade jasper end-scraper and a fired quartzite preform. Large quantities of historic pottery shards have been found and include ca. 1750, English cream-ware, pearl-ware, transfer-ware, buff to red-bodied earthen-ware with lead-glaze and salt-glaze stoneware, and white-ware. A lot of the red-ware shard rims indicate dairy pots and pans. A single piece of an English pipe stem from the mid-19<sup>th</sup> century and an 18<sup>th</sup>-century bone button were found.

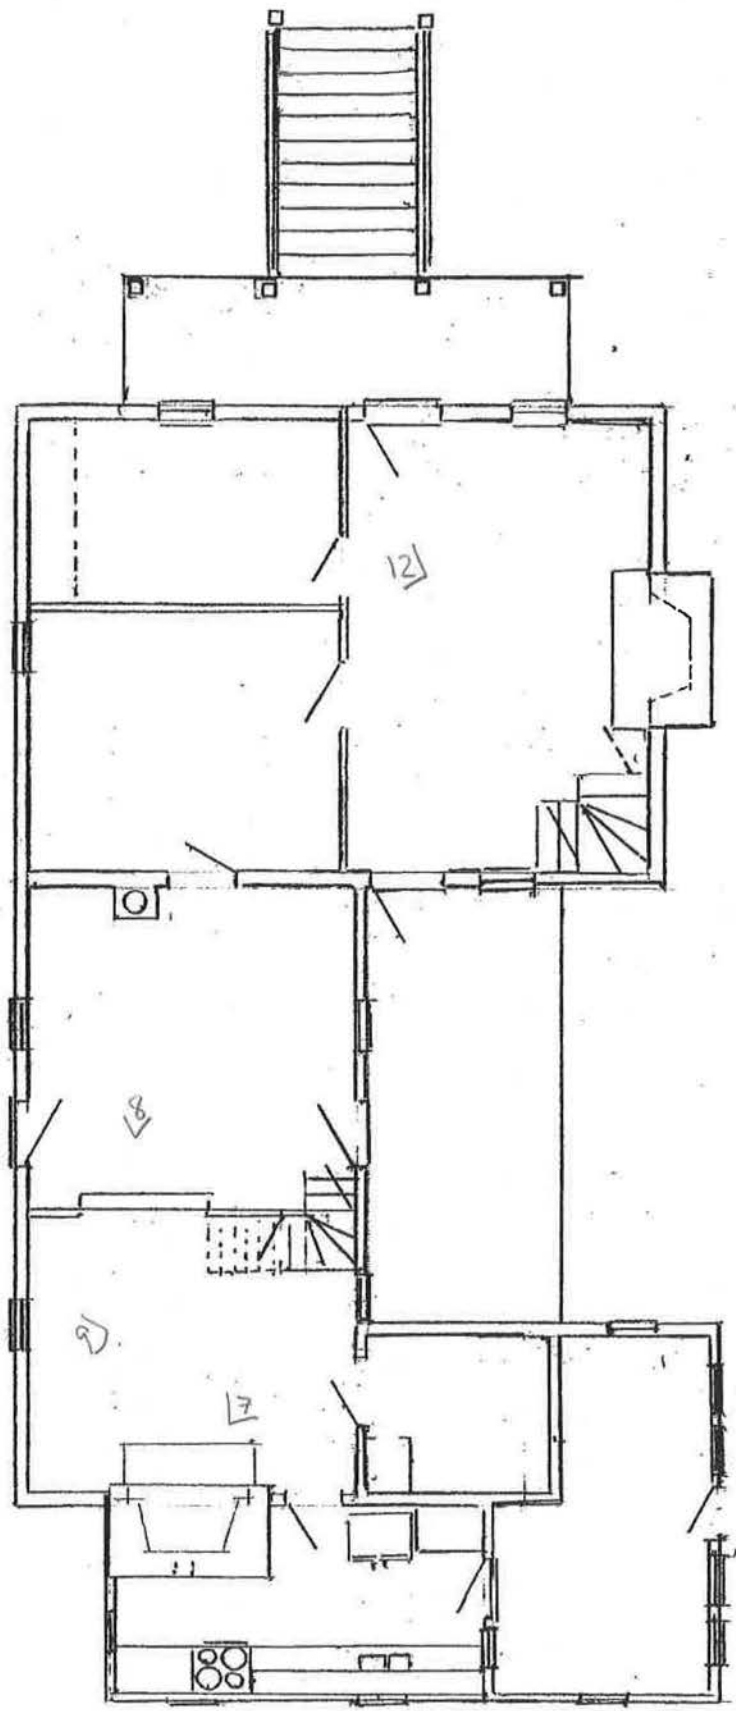
WILKINS FARM  
SHENANDOAH COUNTY, VA  
VDHR FILE NO. 085-0216  
PHOTO KEY/SITEPLAN
