KENTUCKY HISTORIC RESOURCES
Individual Inventory Form

Resource # 20
Shelby County

1. Name of Resource: Fullenwider House

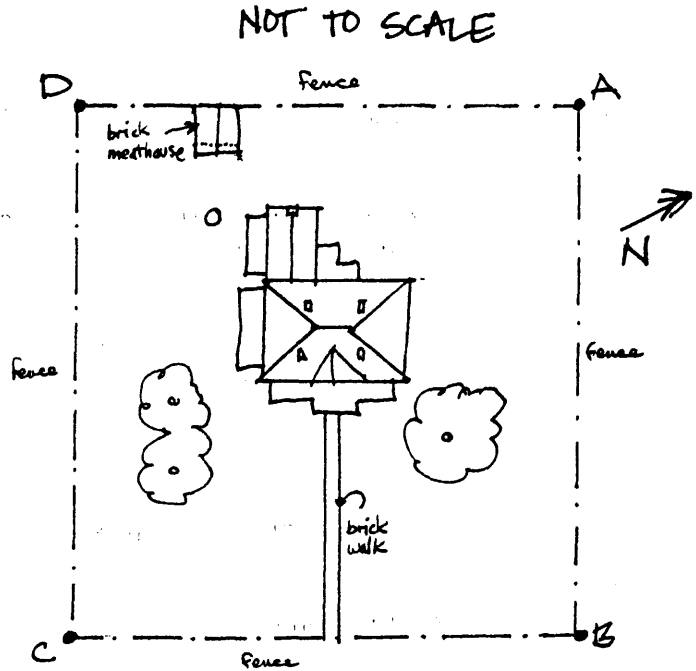
44. Site Plan (and boundary description and justification for N.R. sites):

Beginning at A, southeast 165' along a fence to B, thence 165' southwest along a fence to C, thence 165' northwest along a fence to D, thence 165' northeast along a fence to the point of origin. The boundaries were chosen to encompass the house and its domestic-related space and outbuildings enclosed by fences from the surrounding fields. Included is a contributing brick meat house.

Point A is at the intersection of two fences which define the northeastern and northwestern edges of the yard and is 113 feet northeast of the northern corner of the meathouse.

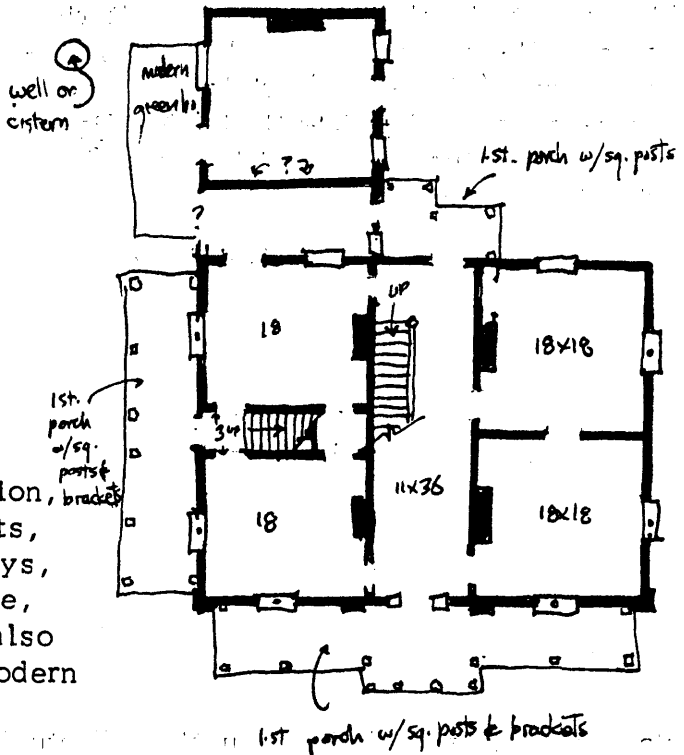
45. Description and House Plan:

2-story, 3-bay, brick, center-passage, double-pile plan, double-stretcher bond on principal (east) facade, pilasters divide bays, gabled pediment above central bay with round ventilator, paired 4/4 sash windows with stone lintels and sills at outer bays of east facade and in end walls, eared door surround with colored glass sidelights, transom, original 1-story wood porch with jig sawn railing, square columns and brackets on new concrete block foundation, deep cornice with dentils and paired brackets, hipped, standing seam roof, interior chimneys, south wall has off-center secondary entrance, 1-story wood porch similar to that on front also on new foundation, 1-story brick ell with modern

greenhouse (on south side), 1-story wood porch in angle of ell sheltering rear entrance to house and door into north wall of ell, 6/6 sash on rear of house.

Eared door and window surrounds except in passage, high molded baseboards, original metal mantel in southeast room, turn-of-the-century replacement mantels in both north rooms, southwest room has been converted into modern kitchen with plaster removed, secondary stair between southwest and southeast rooms leads to corresponding second floor chambers which originally did not open into passage, doors have been cut into passage by present owner and a bathroom inserted between these two rooms and at the west end of the passage on the second floor.

Sh-35 are the only two houses recorded in the county which exhibit the same variation on the standard double-pile plan - a secondary stair between the front and rear rooms on one side of the passage giving access to the second floor chambers which did not originally open onto the center passage. Both houses appear to have been built at approximately the same time and exhibit similar stylistic elements.
