historic name Englar-Schweigart-Rinehart Farm
other names CARR-389

street & number 47 Rockland Road not for publication
city or town Westminster vicinity
state Maryland code MD county Carroll code 013 zip code 21158

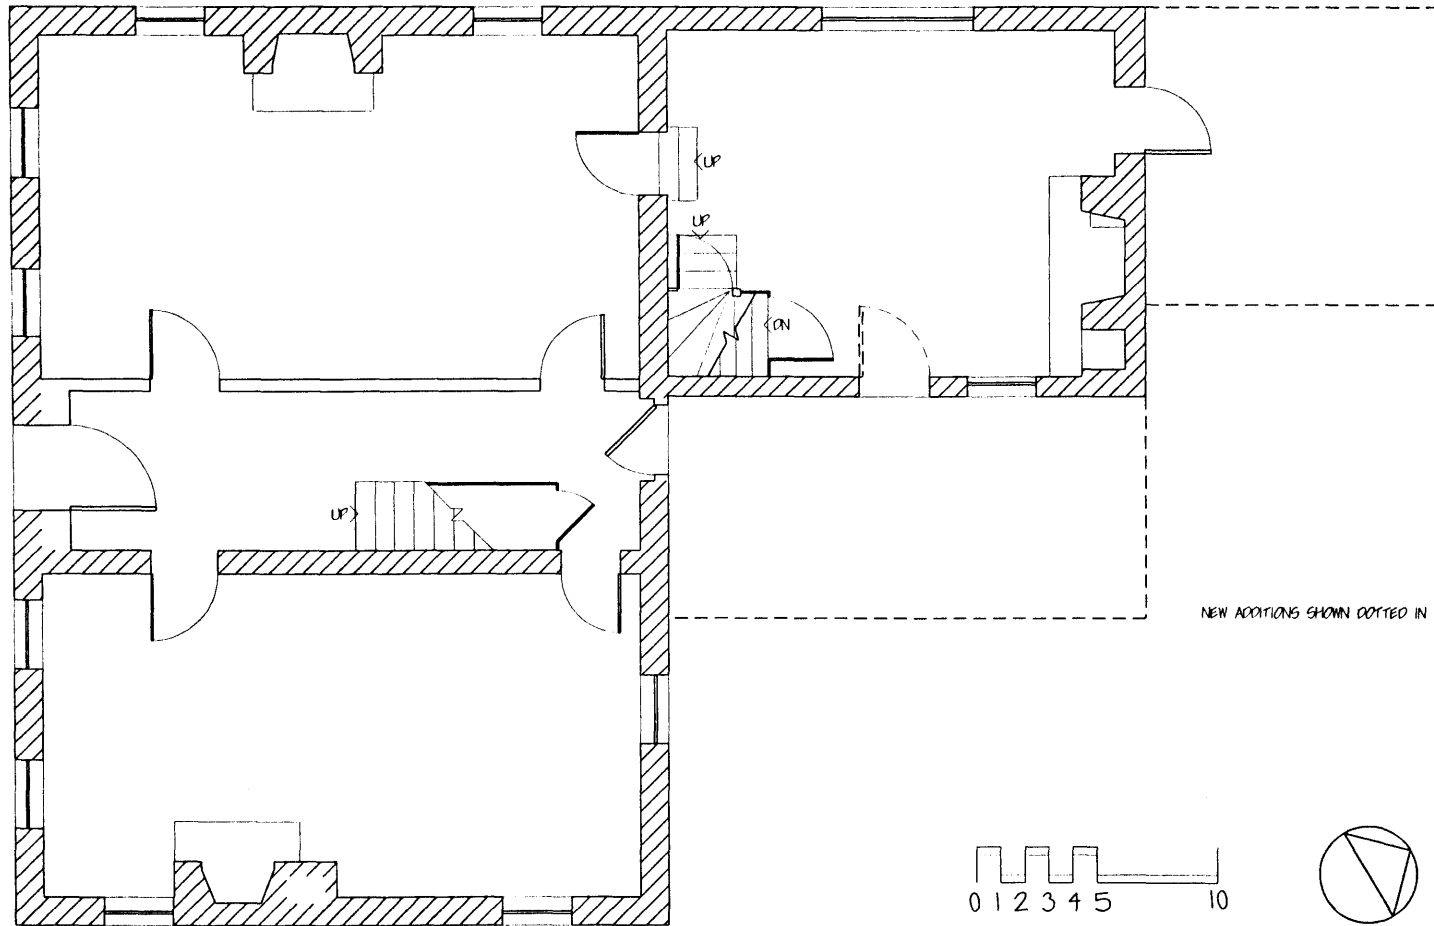
CARR-389 ENGLAR-SCHWEIGART-RINEHART FARM 47 ROCKLAND ROAD
 FIRST FLOOR PLAN MEASURED BY KEN SHORT, ALLISON SHORT, MONICA SHORT, & BECKY HERRICK DRAWN BY KEN SHORT JULY 2002

The first story has a center-passage, single-pile plan with a single room in the rear ell. The passage floor runs north-south, is random width between 4 ½ and 7 ½ inches, and appears to be chestnut. It is face-nailed with T-heads. The baseboard has a beaded top edge and there is new chair rail with a beaded top edge. The walls and ceiling appear to have been sheetrocked over. The front door architrave has a broken field with a cavetto at the break and is mitered at the corners. The door has cast-iron foliate butt hinges with finials. The architrave on the south interior doors has an ovolo back band and a beaded interior edge. The interior doors have six panels with raised fields and ovolo panel moulds. The panels are hand-planed. The doors are hung on cast-iron butt hinges with two knuckles and have cast-iron rim locks. Most of these locks are plain, but the west room south door lock is labeled with "Norwalk L. Co.," and has a mineral knob. None of these locks are original, as there was a least one earlier lock on each door. There is a two-run stair on the east wall that ascends to the north, where there is a landing, then ascends to the south along the west wall. It has a closed stringer that is hand-planed and has a small bead near the bottom and a large bead at the bottom. Below the stringer are five tall panels that are sunk and flat, and are hand-planed. There are plain square newel posts, rectangular balusters, and a moulded handrail that is mortised and tenoned and pegged to the newel post. The rear door and the north
