Buck Camp Patrol Cabin
Property Name

National Register of Historic Places Registration Form

historic name Buck Camp Patrol Cabin
other names/site number Buck Camp Snow Survey Shelter, Buck Camp Ranger Station, Yosemite National Park Building No. BC4800

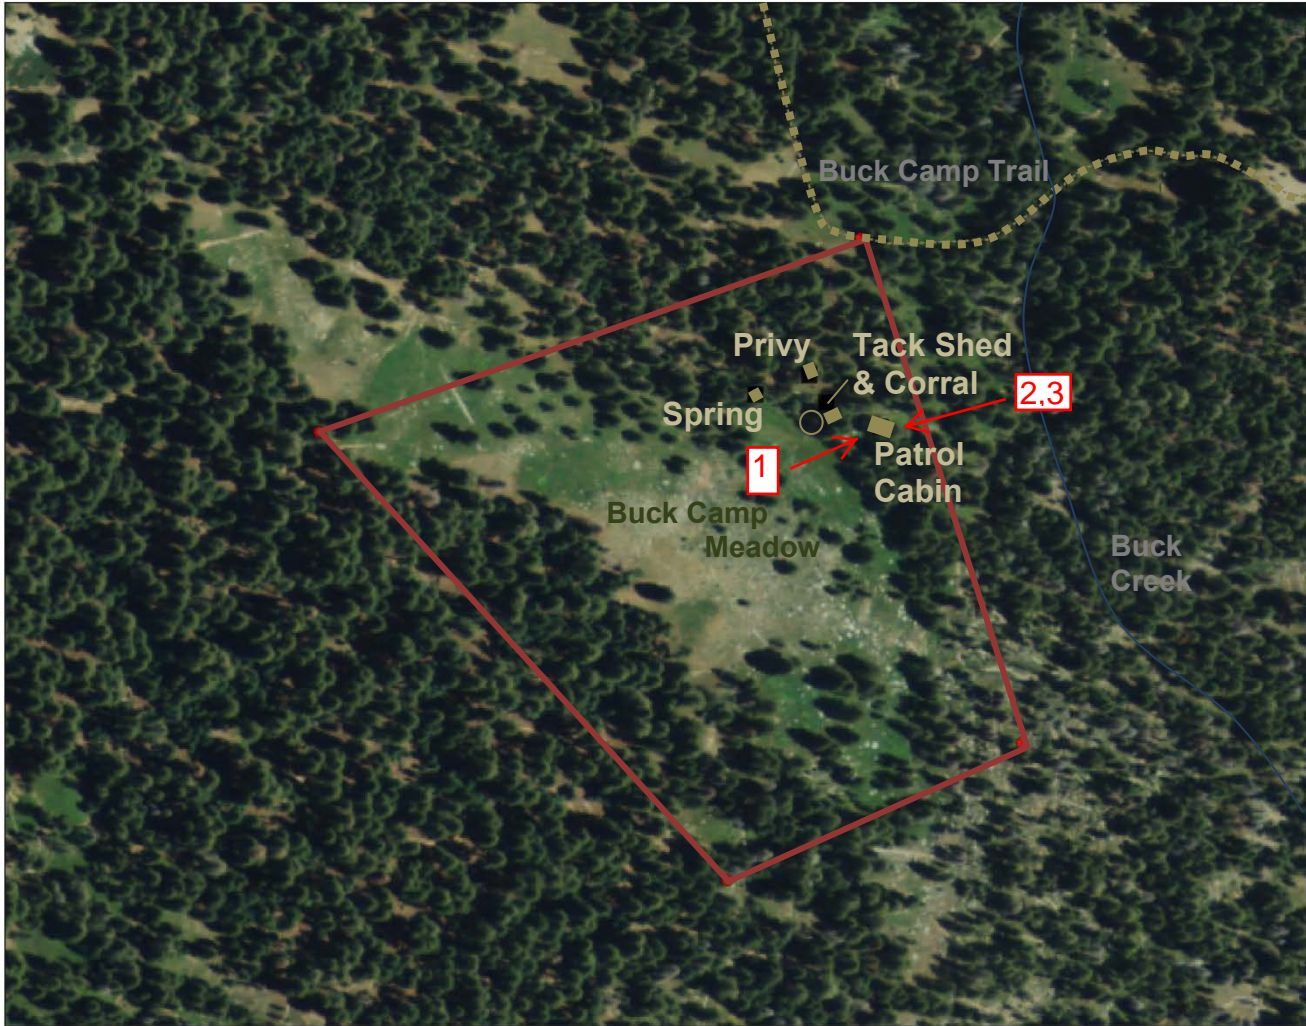
Buck Camp Patrol Cabin - Property Bounday

15.7 Acres

A property boundary of 15.7 acres for the Buck Camp Patrol Cabin has been determined by Yosemite National Park's Branch of History, Architecture and Landscapes for purposes of this nomination. This area encompasses all contributing and non-contributing resources associated with the historic and current operation of the property.

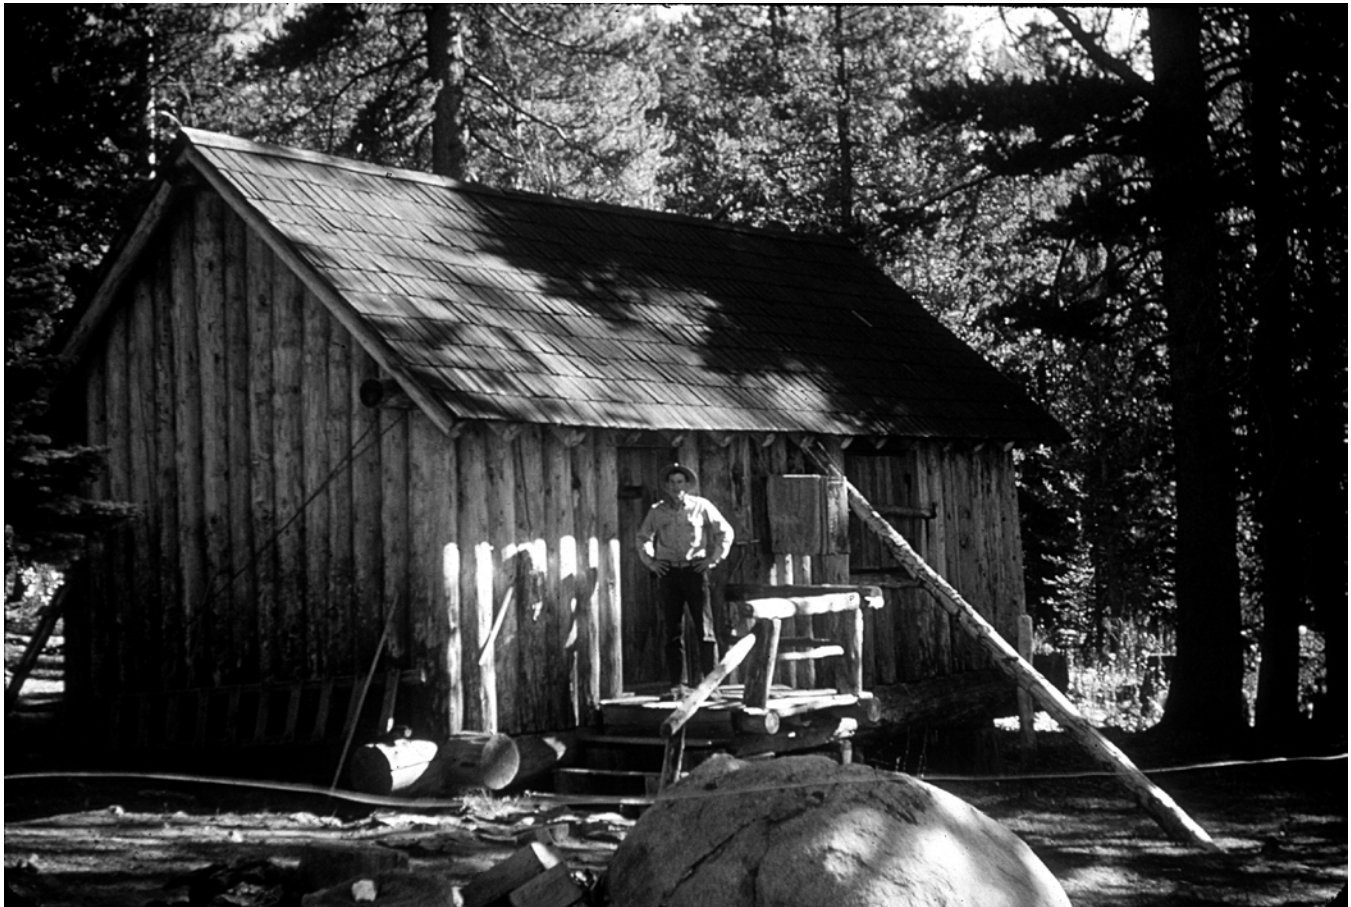
Historic Photo

"Ashley at Buck Camp Oct 5 1949"

round and placed at the western end of the porch. The porch configuration has changed multiple times throughout the history of the patrol cabin. The first known photographic documentation of the patrol cabin dates to 1949 and shows a much smaller elevated porch constructed of peeled logs and dimensional lumber deckboards. By 1964, a haphazard porch of log rounds and plywood was in place. From photographic documentation, it appears that the porch currently in place was constructed in 1986. Although the existing porch is not original to the building, it does possess rustic character and is in keeping with the overall style of the patrol cabin and uses comparable materials.
