THACKARA HOUSE

912 Eldridge Av., Collingswood, N. J.

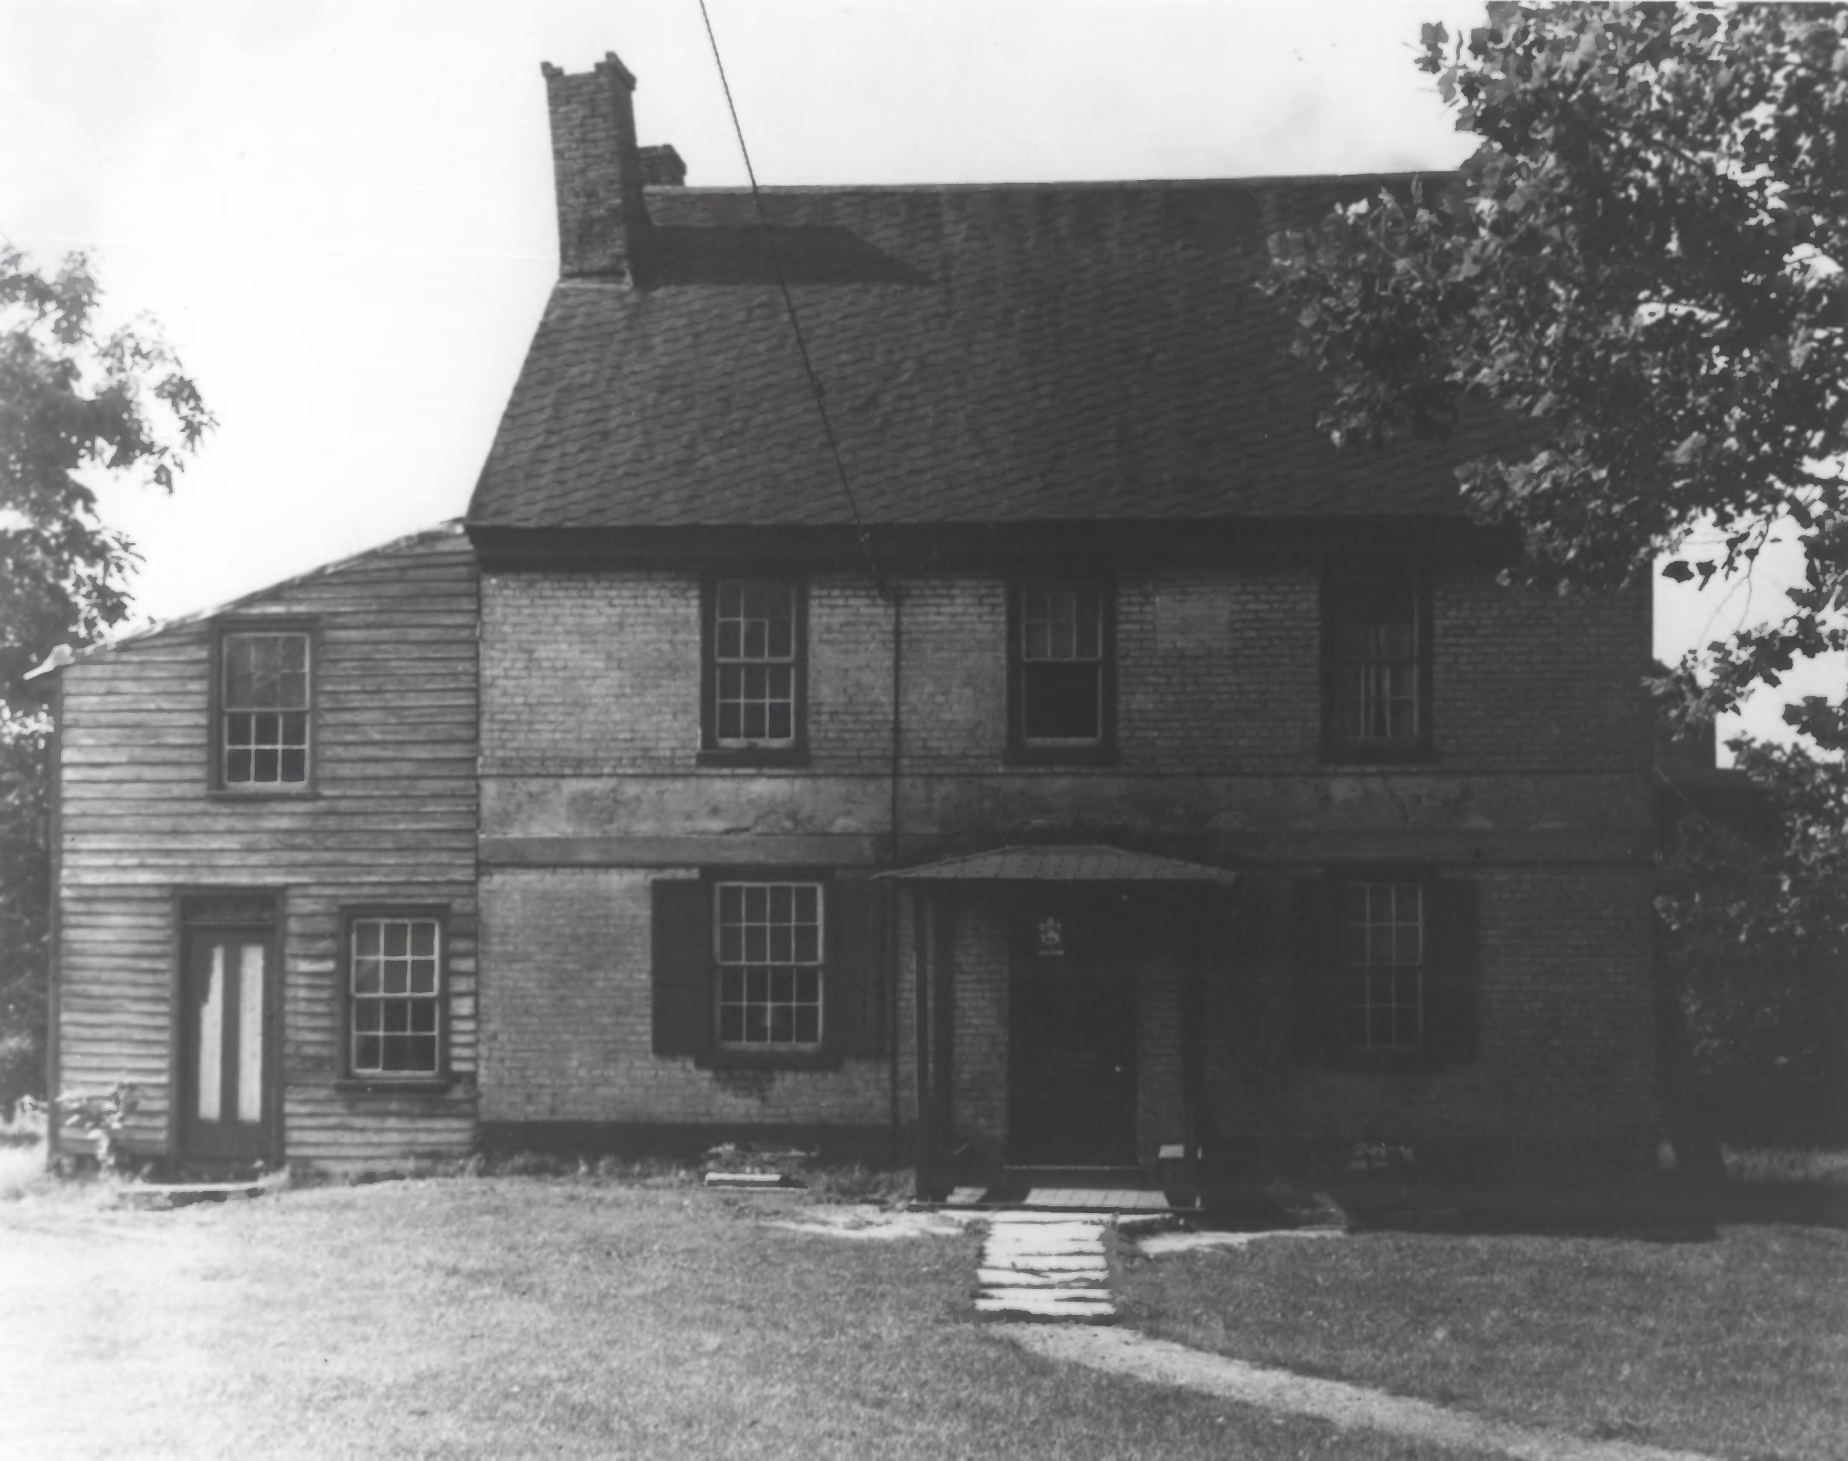
Photograph No. 1 of 13

View from Eldridge Avenue showing House
in use as Boy Scout Troop Headquarters,
Camera facing South.

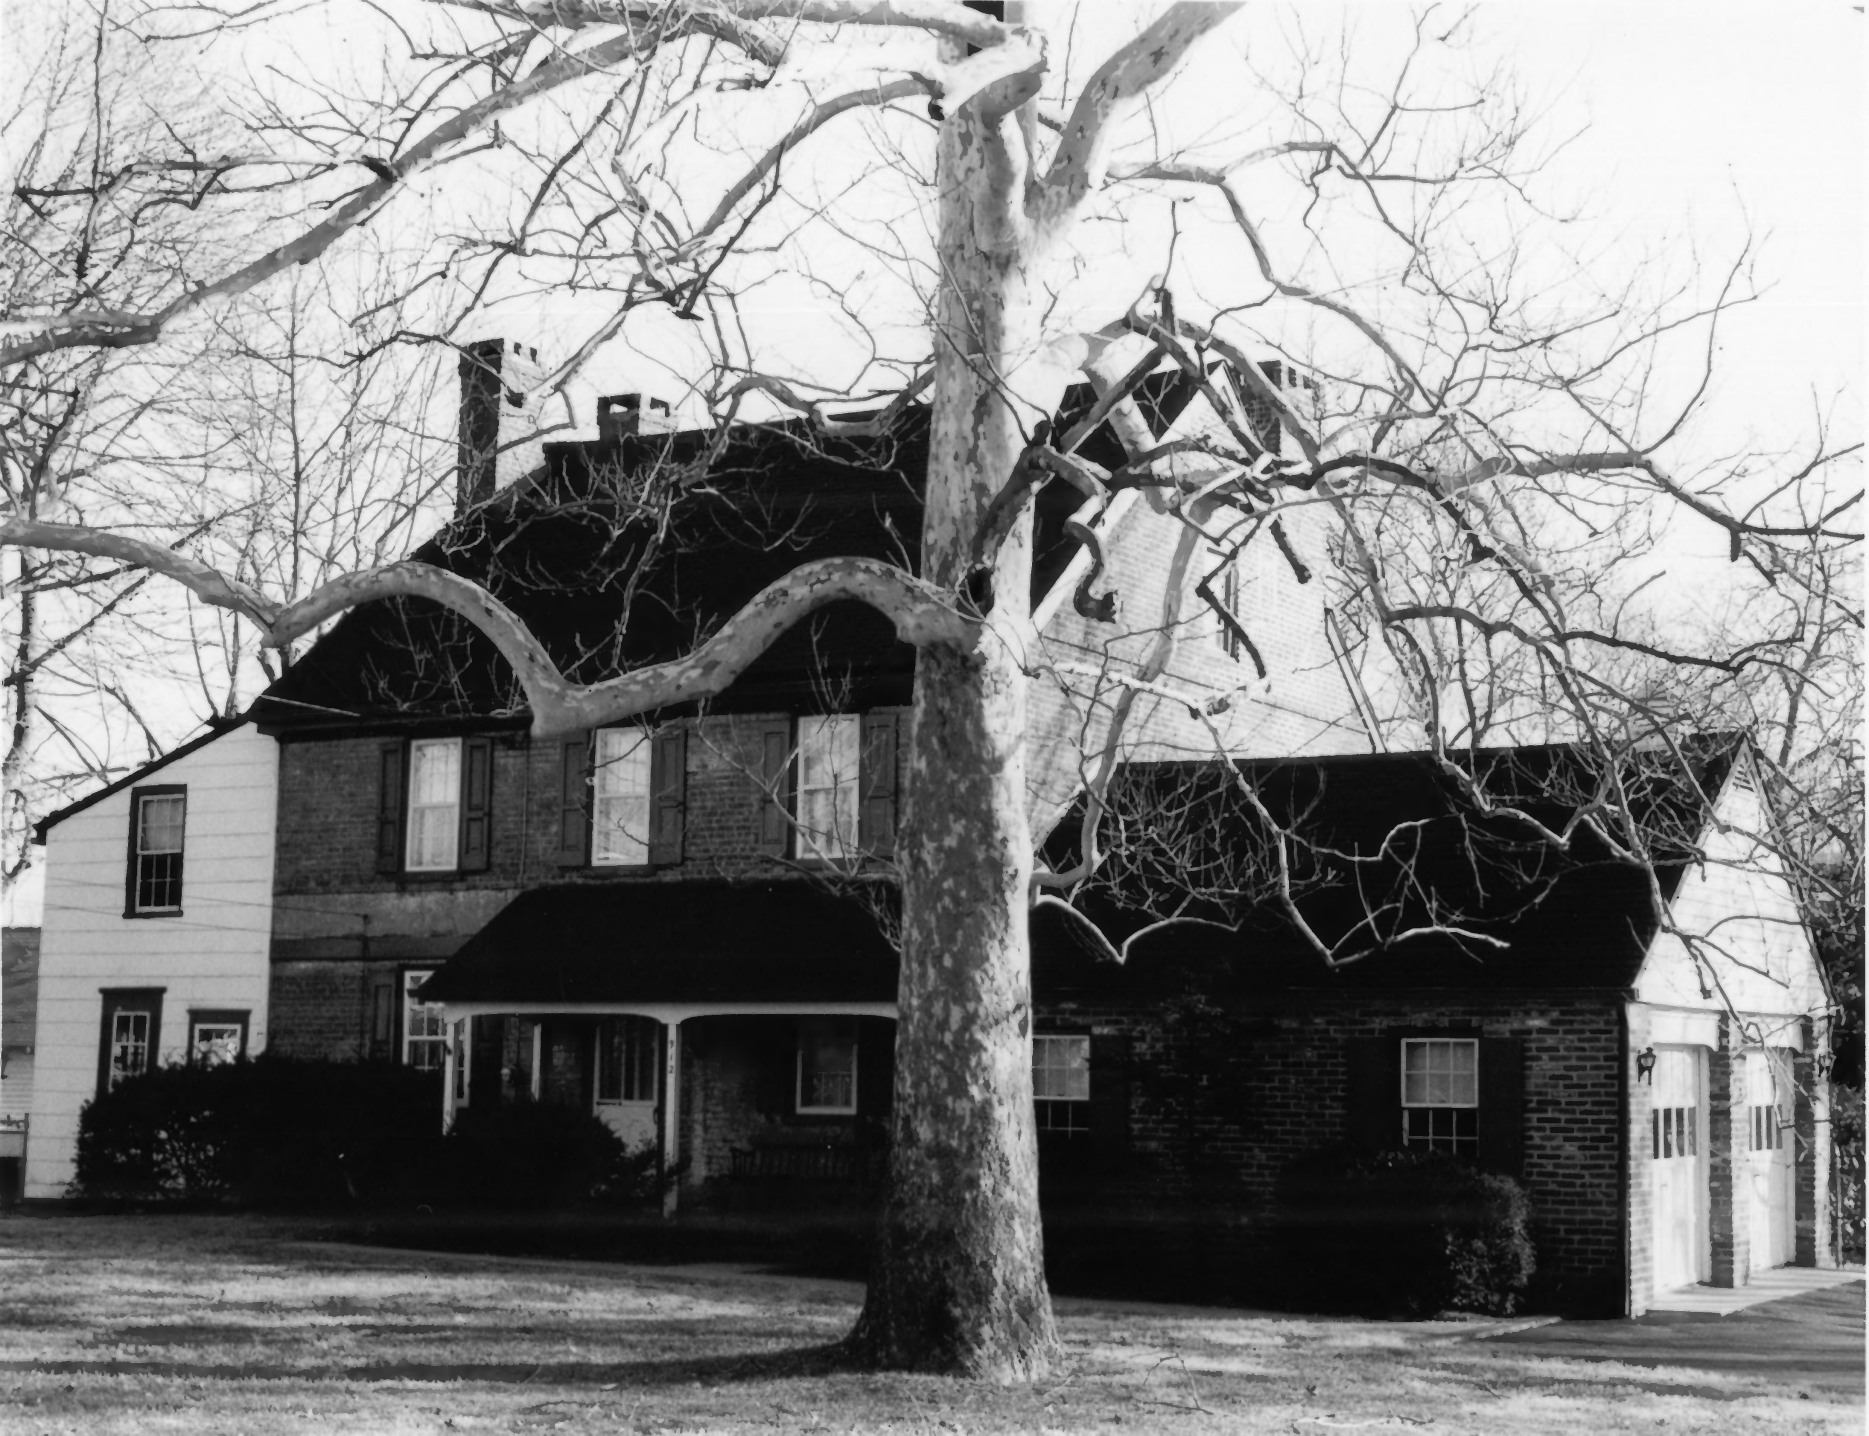
Photograph No. 2 of 13

View from Northwest showing present front of house (originally the rear).

Garage and meeting-house porch added by present owner in 1957. Camera facing southeast.

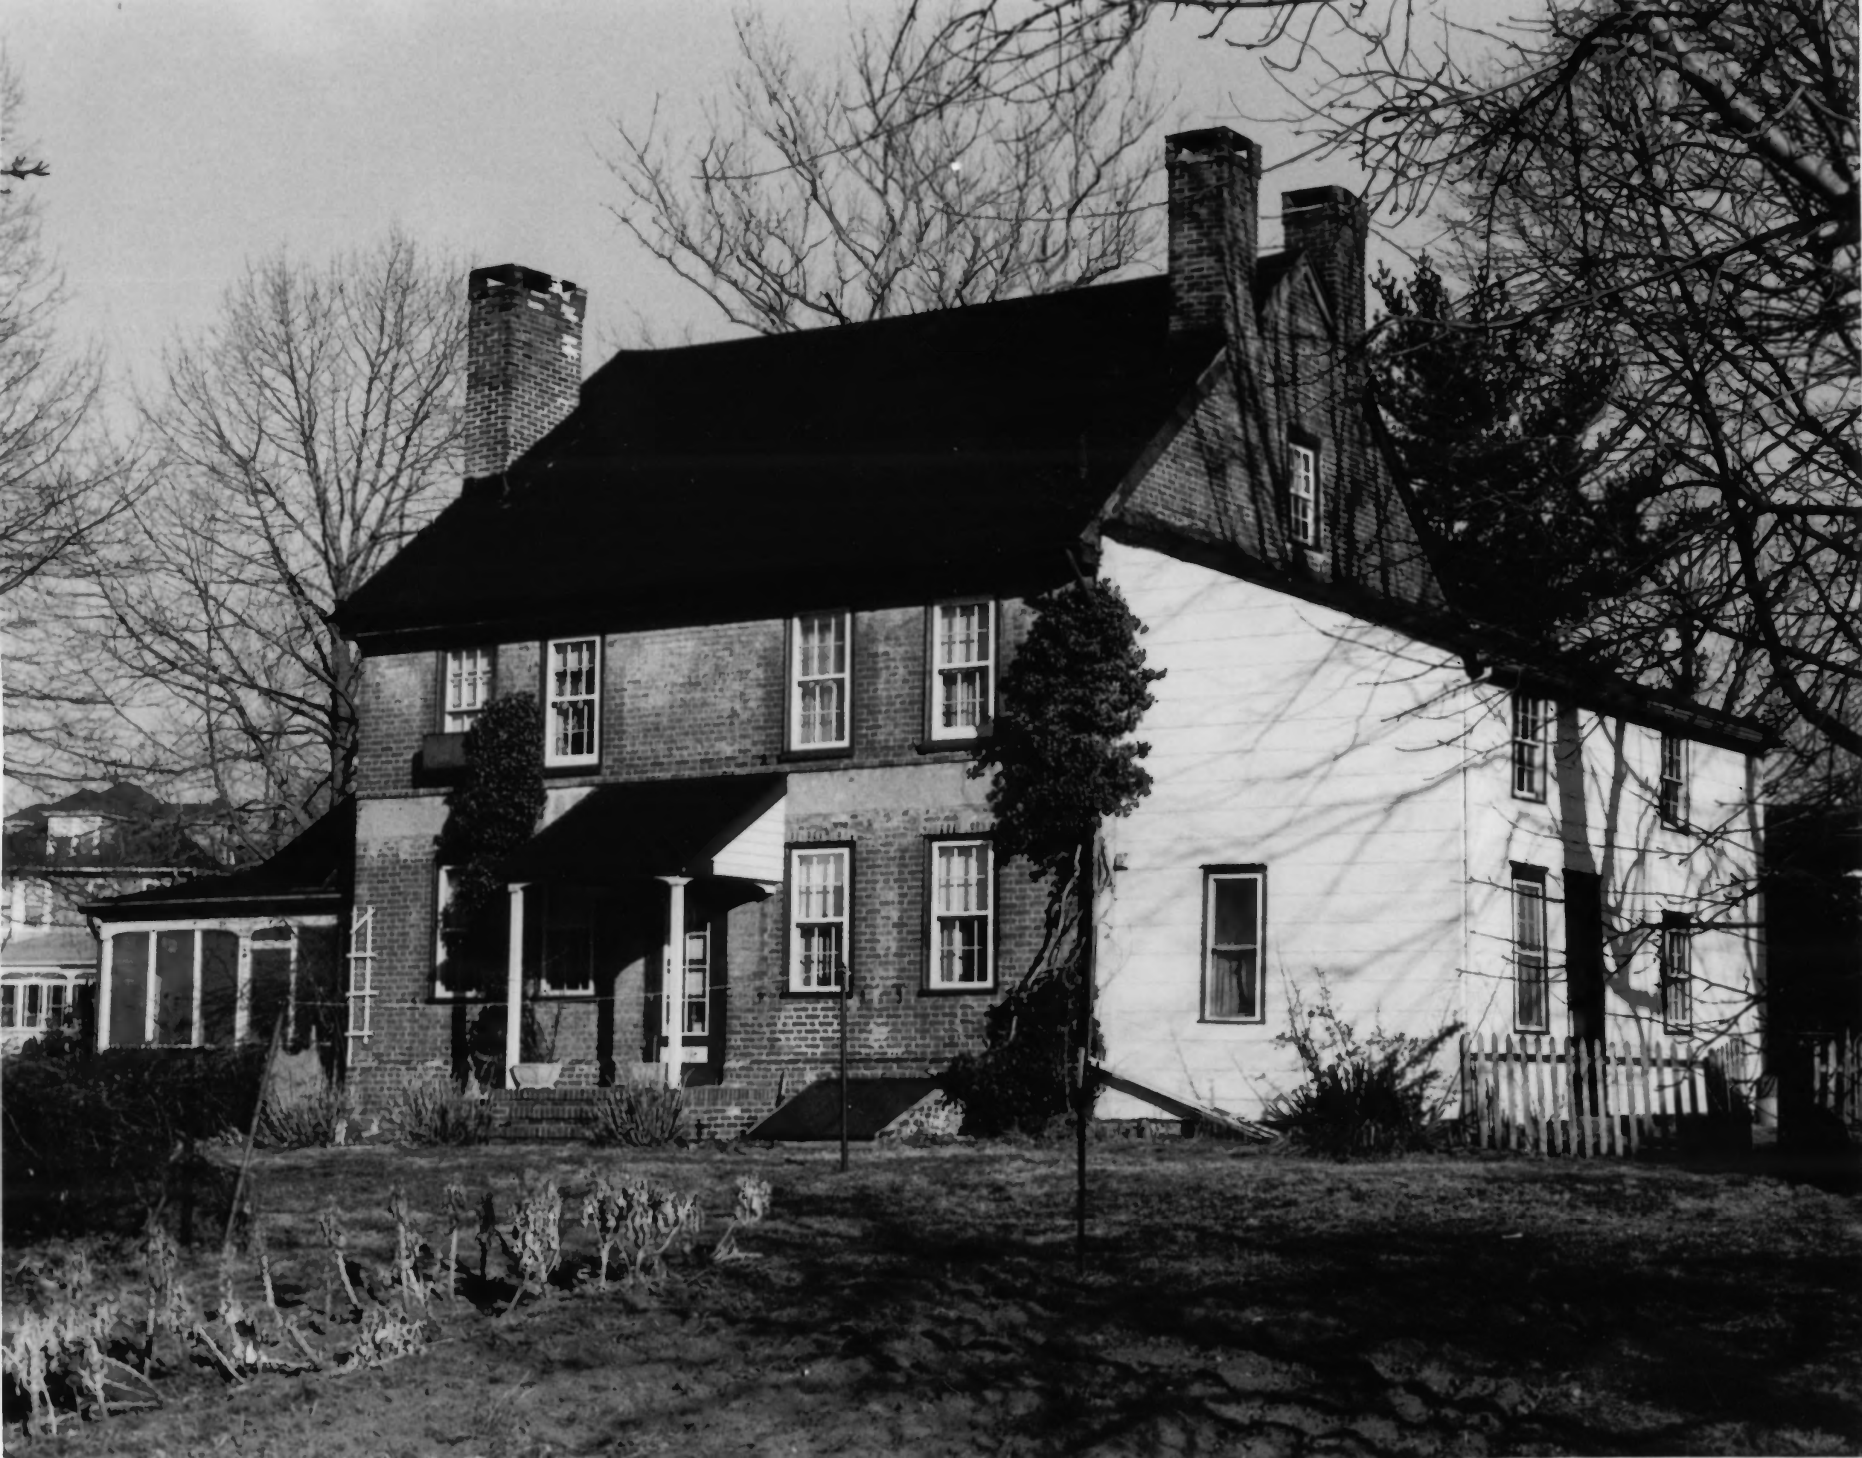
Photograph No. 3 of 13

View from southeast showing original front
of house. Camera facing northwest.

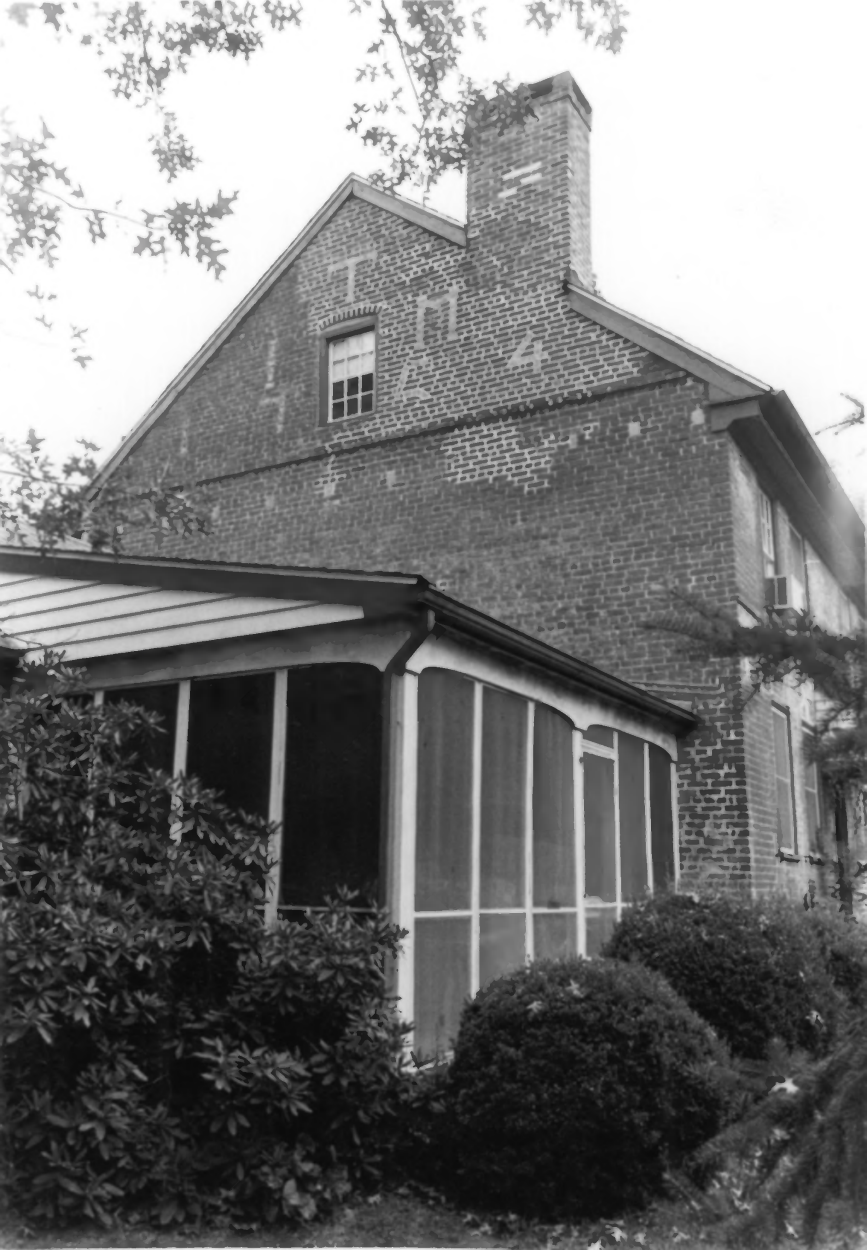
Photograph No. 4 of 13

View from south west showing
west gable end with initials and
date in glazed headers, and
evidence of original pent roof.

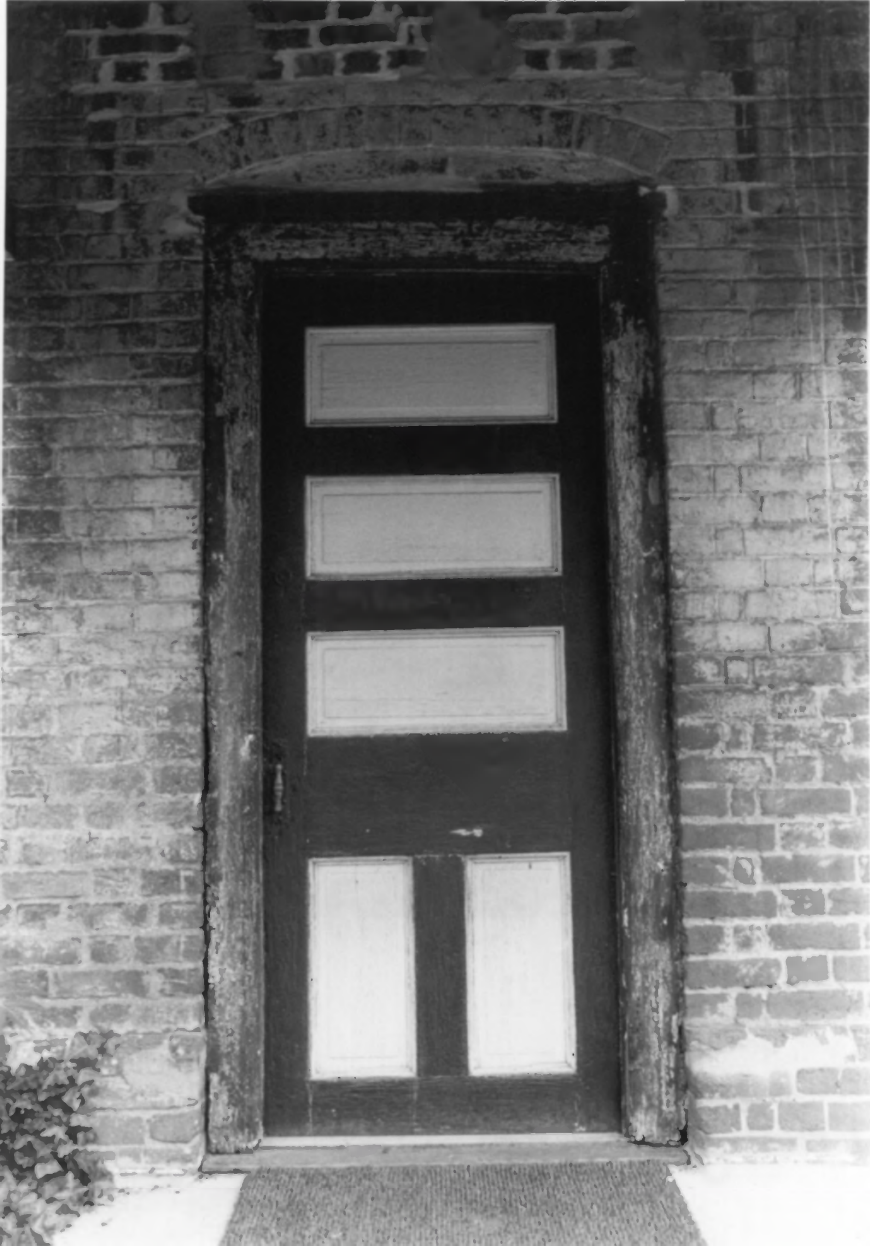
Photograph No. 5 of 13

Detail of original front doorway
opening on south elevation.

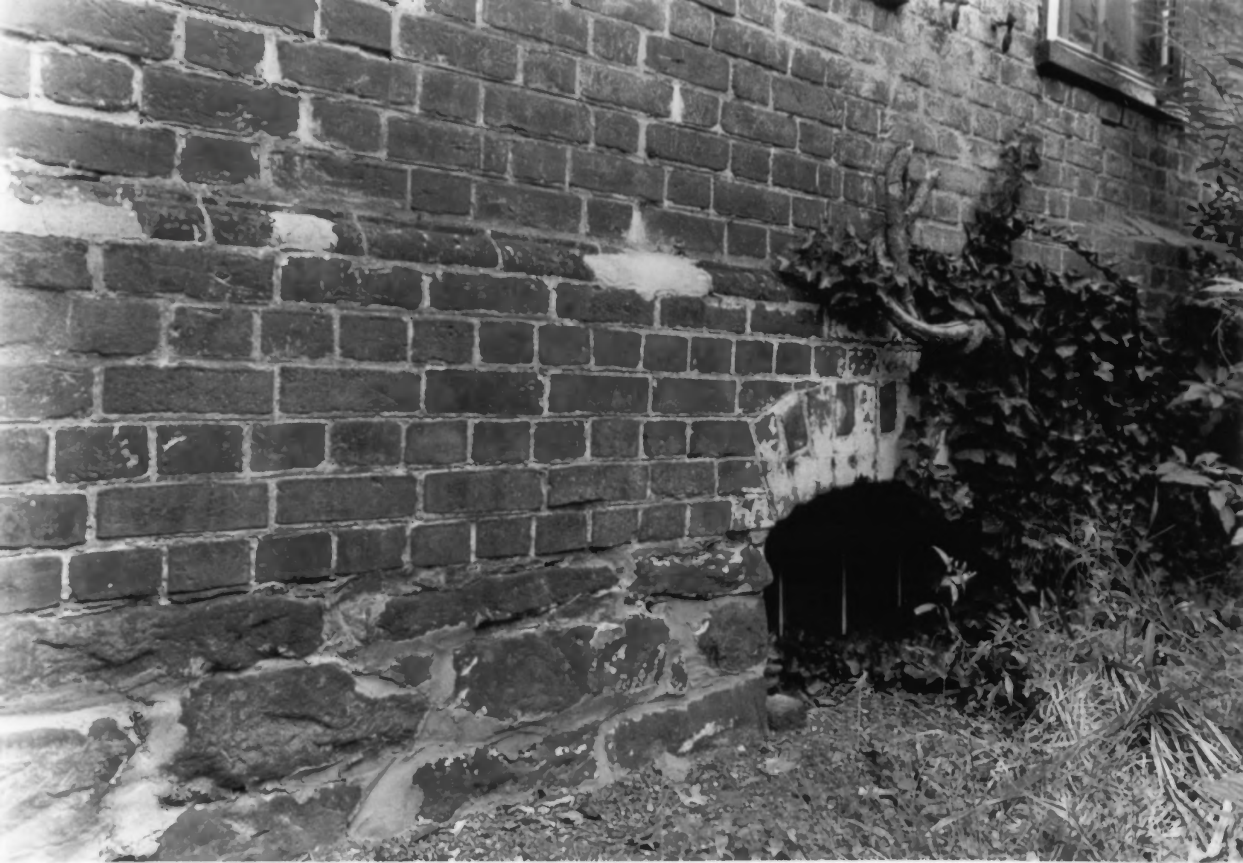
Photograph No. 6 of 13

Detail of original front facade showing coursed fieldstone foundation, molded brick water table, segmentally-arched head basement window opening, integral projecting wood sills of first floor windows, and cast iron shutter dogs.

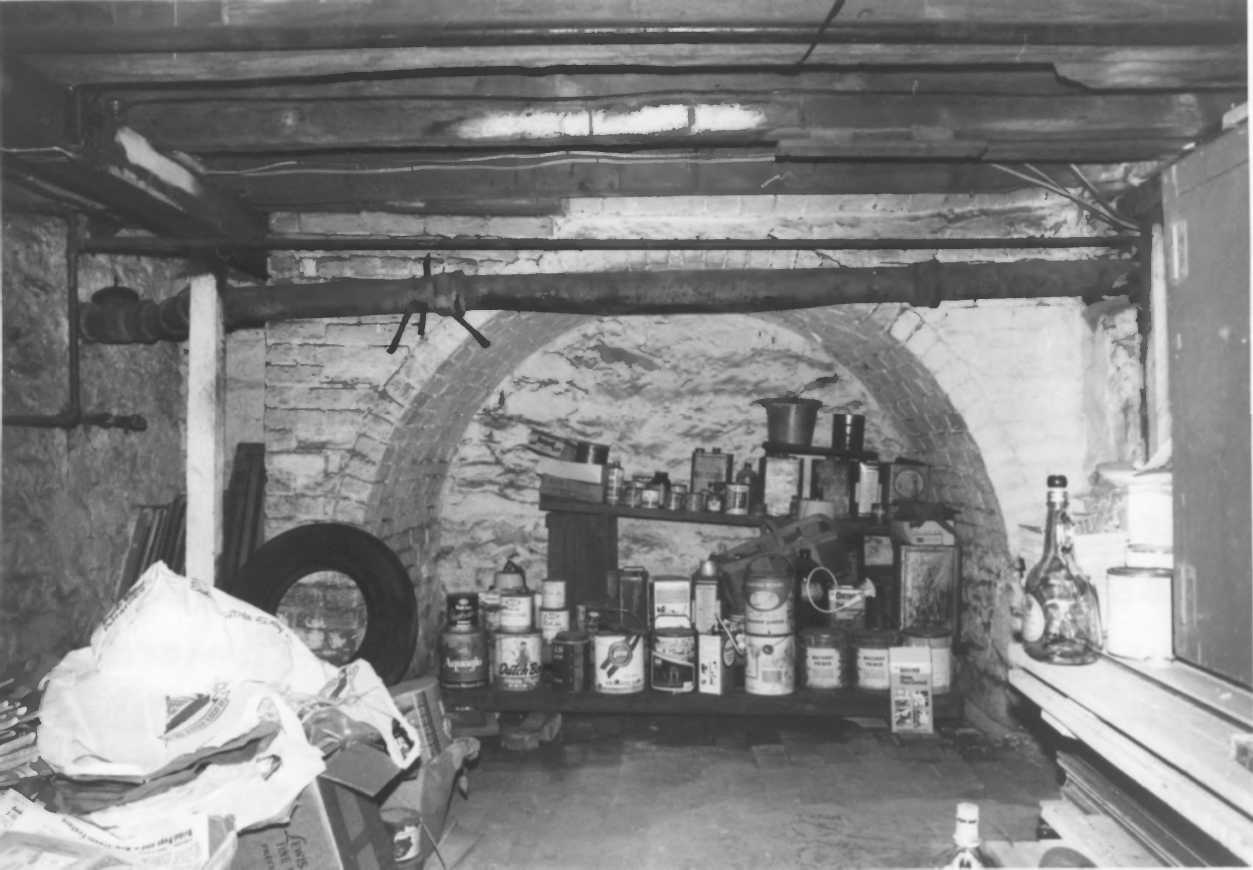
Photograph No. 7 of 13

View of basement showing brick vault under original kitchen fireplace, uncoursed fieldstone foundation walls, and adzed heavy timber joist construction. Camera facing east.

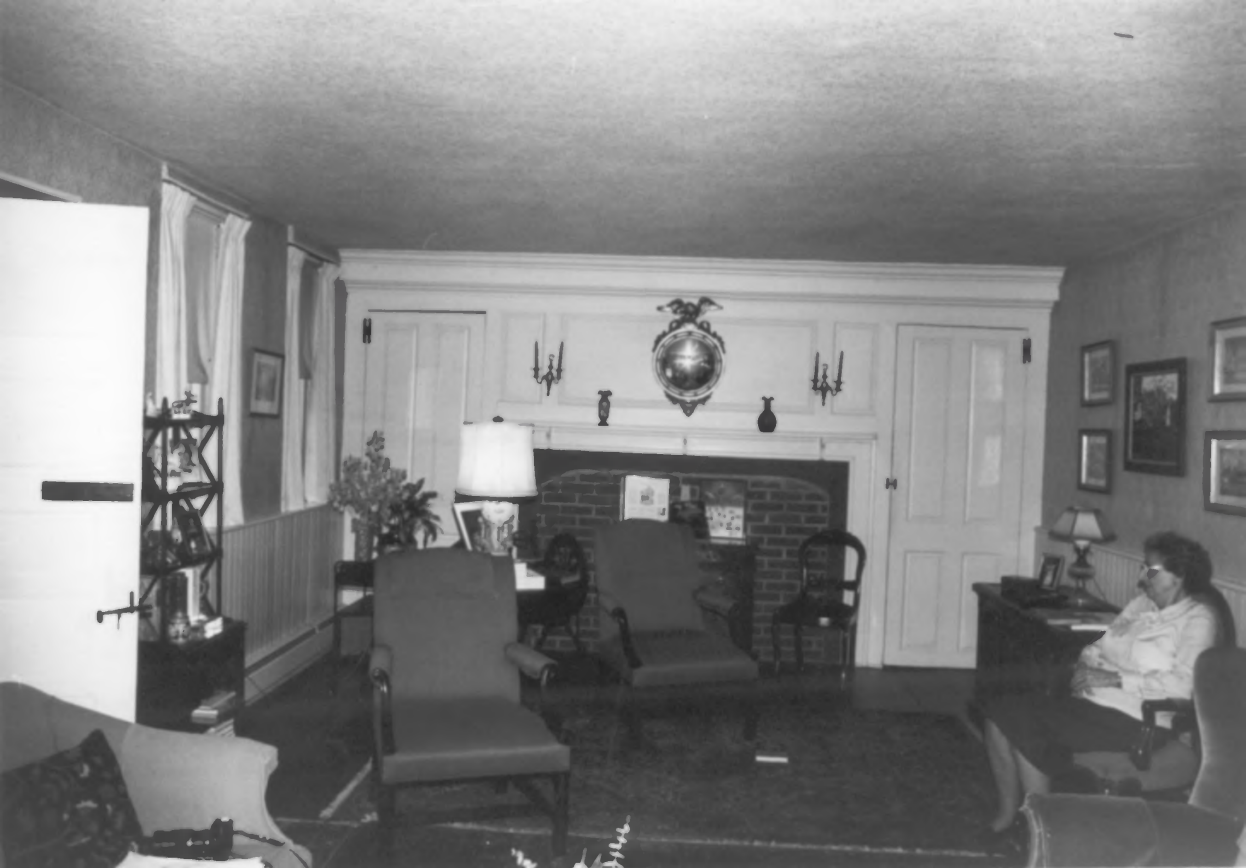
Photograph No. 8 of 13

View of first floor livingroom showing panelled fireplace wall with closets flanking original fireplace opening (infilled for chimney flue), random width wood floor boards, Victorian wainscotting, and back of entry door with original hardware. Camera facing west.

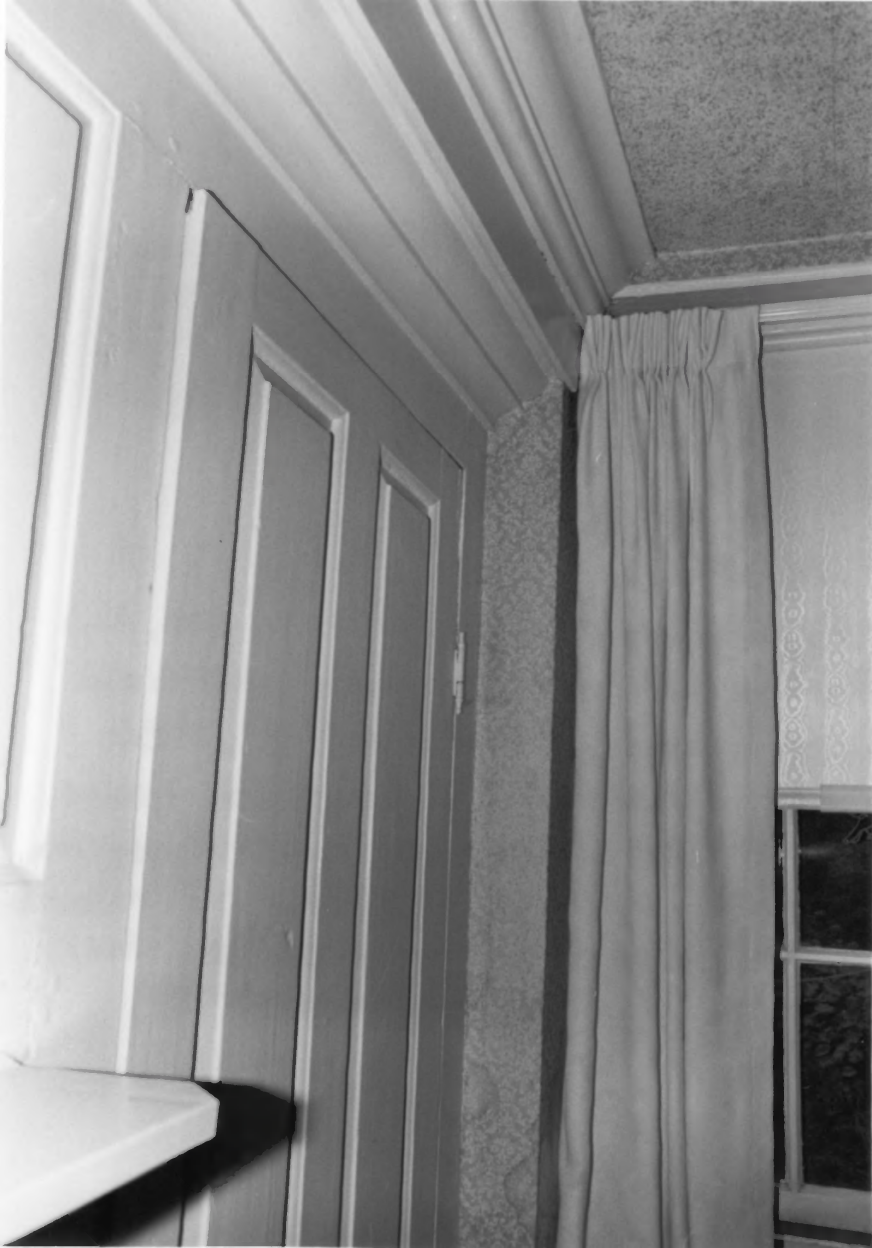
Photograph No. 9 of 13

Detail of fireplace wall showing
molded cornice, profile of raised
panels, and later mantle shelf.

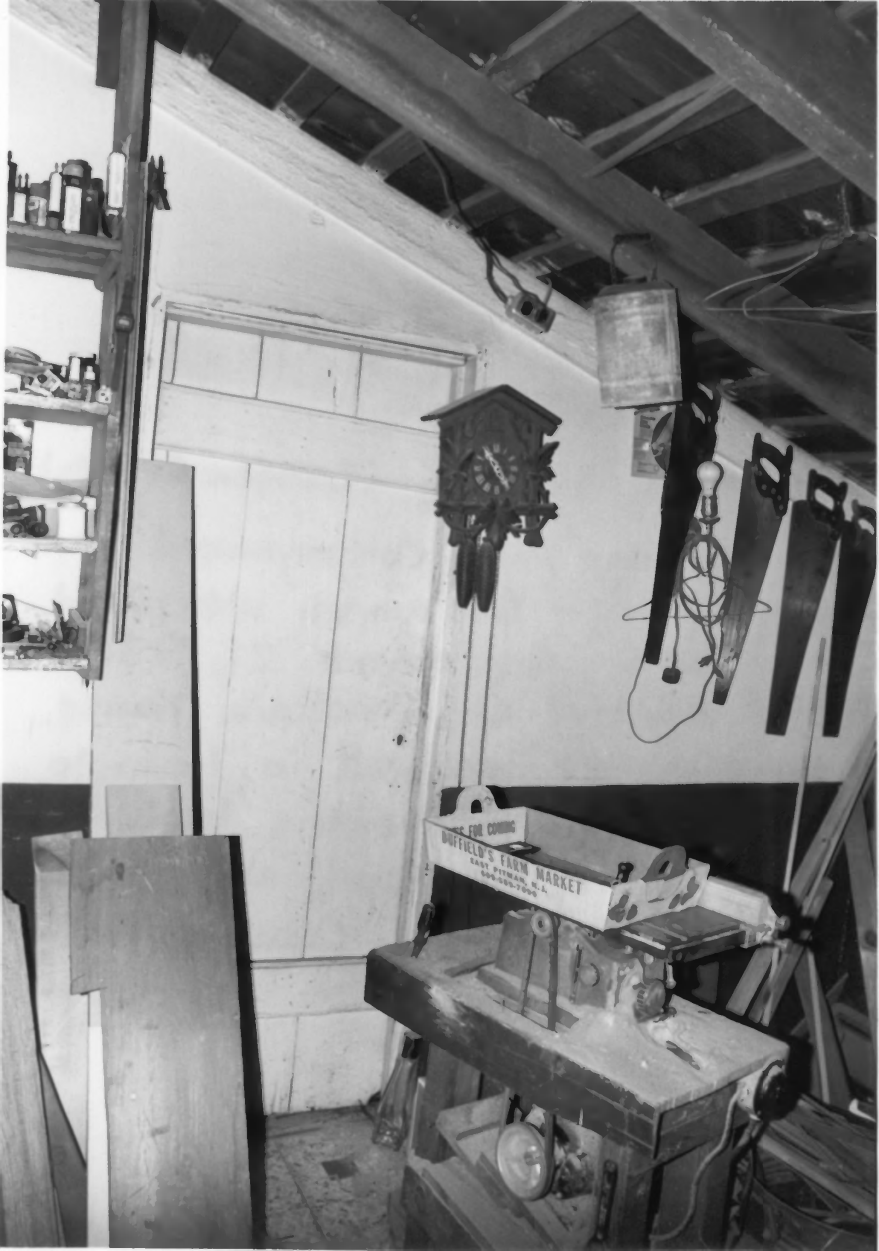
Photograph No. 10 of 13

View of partition wall in lean-to frame addition showing beaded board-and-batten door and vertically sawn roof rafters. Camera facing north, at second floor level.

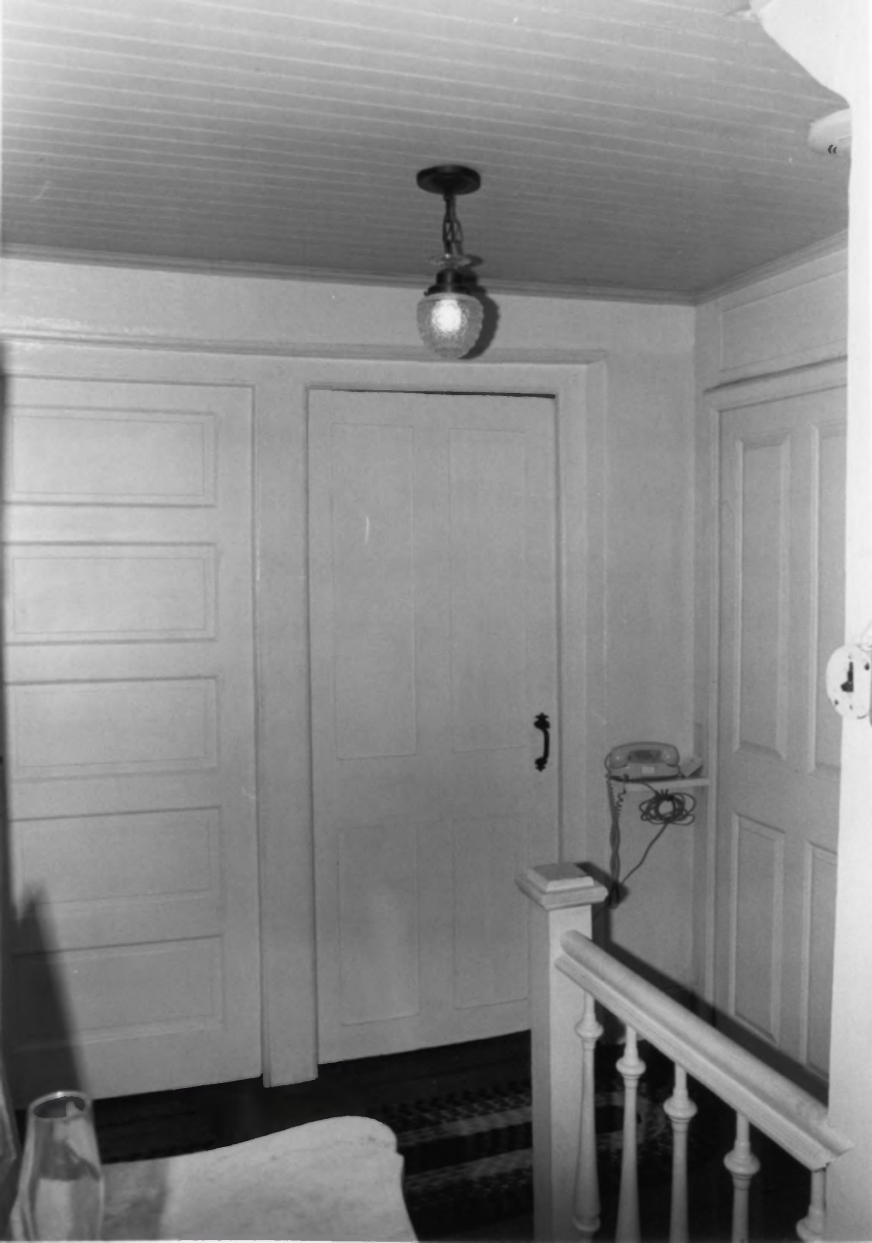
Photograph No. 11 of 13

THACKARA HOUSE (Camden County)
912 Eldridge Ave., Collingswood, NJ
Photographer- Margaret Westfield
Date taken - September 21, 1984
Photo negative at Thackara House.
View of second floor stairhall
showing over-door panel (raised
on room side), both sides of
original four-panel doors, Victorian
door in original door opening
(at left), and Victorian stair
railing. Camera facing south.

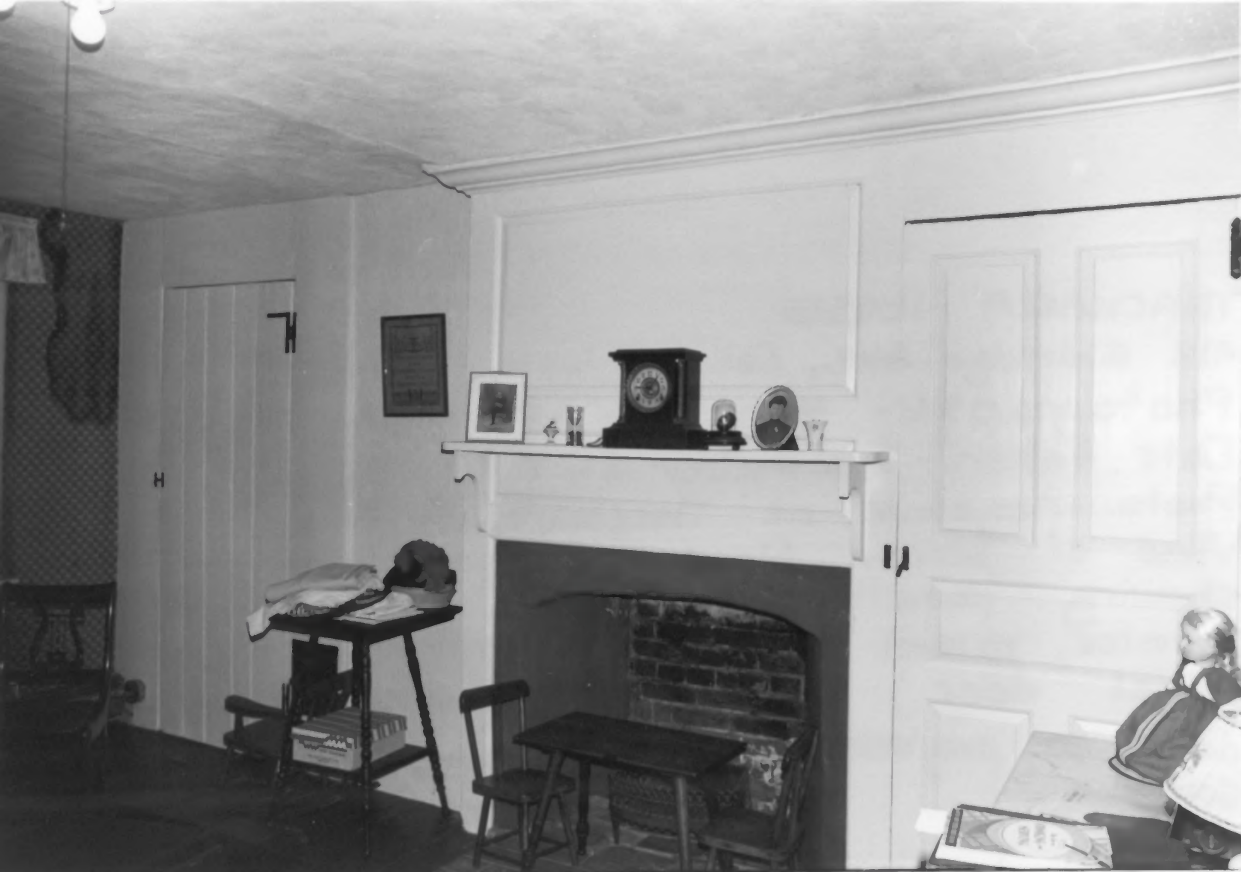
Photograph No. 12 of 13

View of second floor southwest chamber showing panelled fireplace wall with ogee/cove cornice, raised panels, integral closet (with 6 panel door) and early board-and-batten door to pegboard closet. Camera facing southwest.

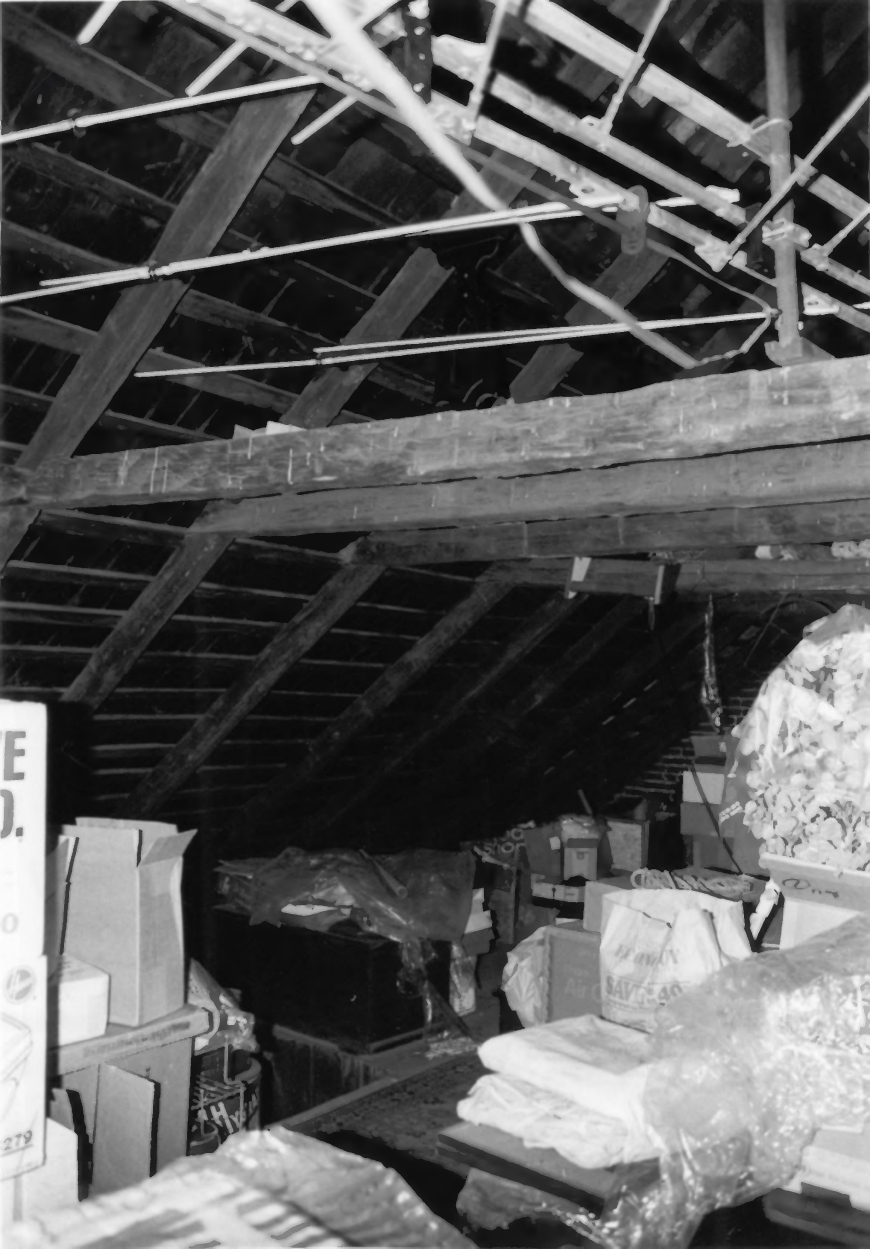
Photograph No. 13 of 13

View of garrett showing adzed heavy
timber tie beams dovetailed into
rafters, early wood shingles
(attached with cut nails), and board
partitions coming up on either side
of stairway opening. Camera facing
northeast.
