CLASSIFIED STRUCTURE FIELD INVENTORY REPORT
(Attach 4" x 5" Black and White Photograph)

STRUCTURE NAME ANTON SCHOENBERGER HOMESTEAD STRUCTURE NUMBER HS-1250

Historic Name: ANTON SCHOENBERGER HOMESTEAD
(SCOTTY BEATON PLACE)

Form Prepared by: Patricia L. Bick, Historian, October 1986.

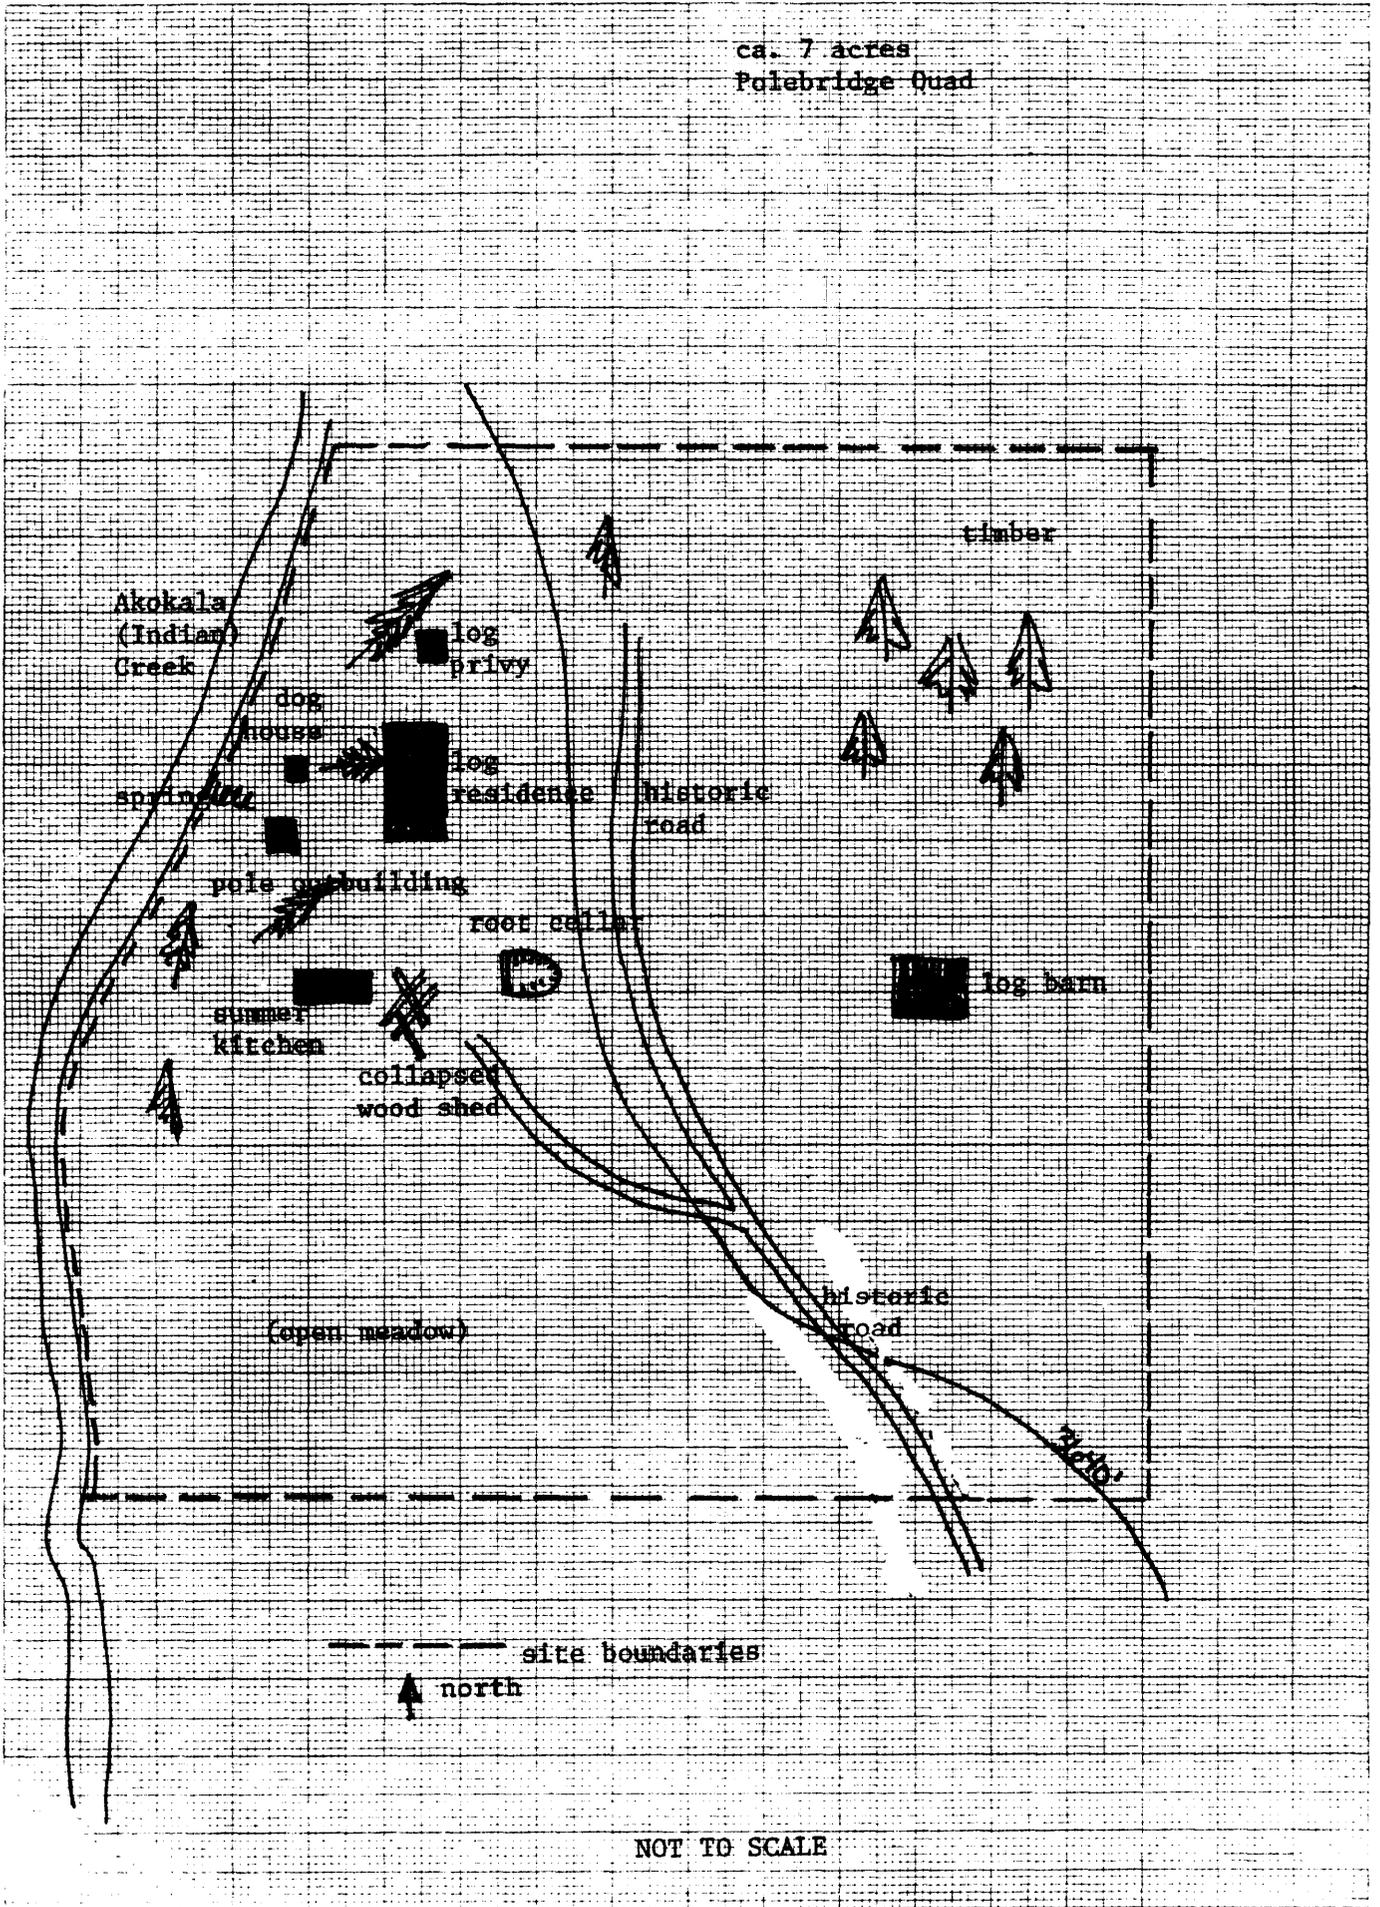
ANTON SCHOENBERGER HOMESTEAD
SCOTTY BEATON PLACE

The site consists of four standing structures, three collapsed buildings and a dog house. The boundaries are drawn to include the lower overgrown meadow where the house stands and a portion of the upper ridge where the small log barn is located. The grounds are overgrown with young trees, Sweet William survives in the meadow grasses, and hops climb on the privy.

Akokala Creek serves as the western boundary. From a point of beginning at the NW corner of the NE 1/4 NE 1/4 SW 1/4 of section 10; T35N;R21W, thence approximately 400 feet west-northwest, thence 400 feet east-northeast, thence 425 feet north-northeast, thence 250 feet east along the quarter section line, thence 550 feet south, thence 200 feet west-southwest, thence 200 feet south-southwest to the point of beginning.
