National Register of Historic Places Registration Form

historic name Robles Ranch House
other names/site number _____

street & number 16130 W. Ajo Highway
city or town Robles Junction
state Arizona code AZ county Pima code 019 zip code 85735

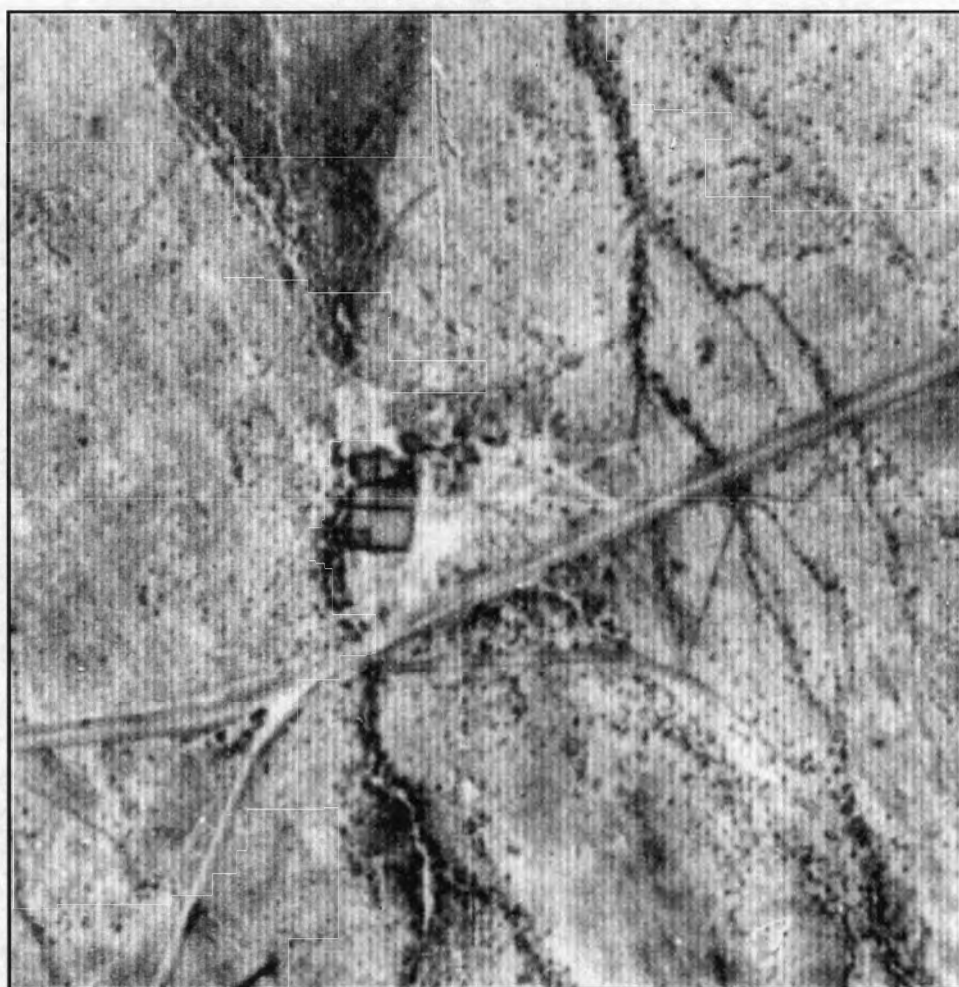
**Figure 4. Aerial photograph of Robles Ranch headquarters,
1936 (U.S. Department of Agriculture [USDA] 1936).**

An aerial photograph of the property, taken in 1936, shows a probable enlargement of the stacked-mesquite corrals since the Robles era (Figure 4). Other than the wash and the Ajo Highway, little else can be discerned in this difficult-to-interpret photograph. Marianna Locke Laird's 1942 site plan sketch depicts a circular driveway accessing the headquarters from Ajo Highway (Figure 5). She labeled what she called Brawley Wash to the west. Within the two zones were the separate residential buildings to the east and a barn on the northeastern edge of the corrals. By this time, the family residence was the east house, and the west house was used by employees. There were a windmill and well north of the dwellings (Doyle and Associates 1999:4). The 1953 aerial shows the rambling ranch house, now joined together; the probable older barn near the corrals; and a large garage building northwest of the house (Figure 6). There was also a walled or fenced back garden and residential landscaping. By 1967, an oval pool was visible in the garden north of the ranch house (Figure 7).

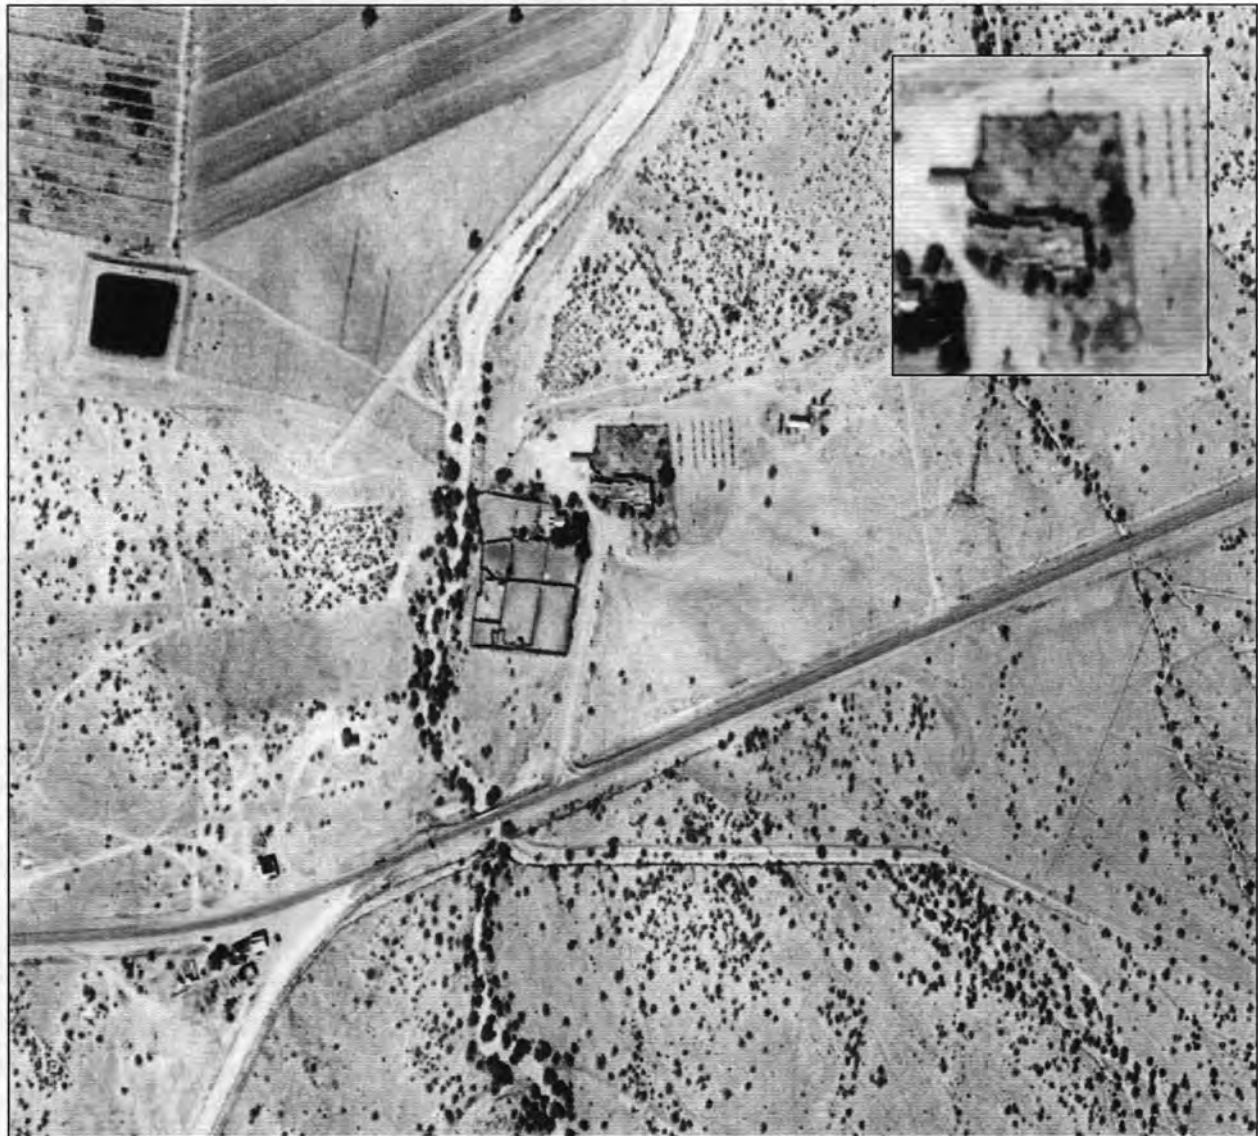
Figure 6. Aerial photograph of Robles Ranch headquarters with ranch house in inset, 1953 (USDA 1953).

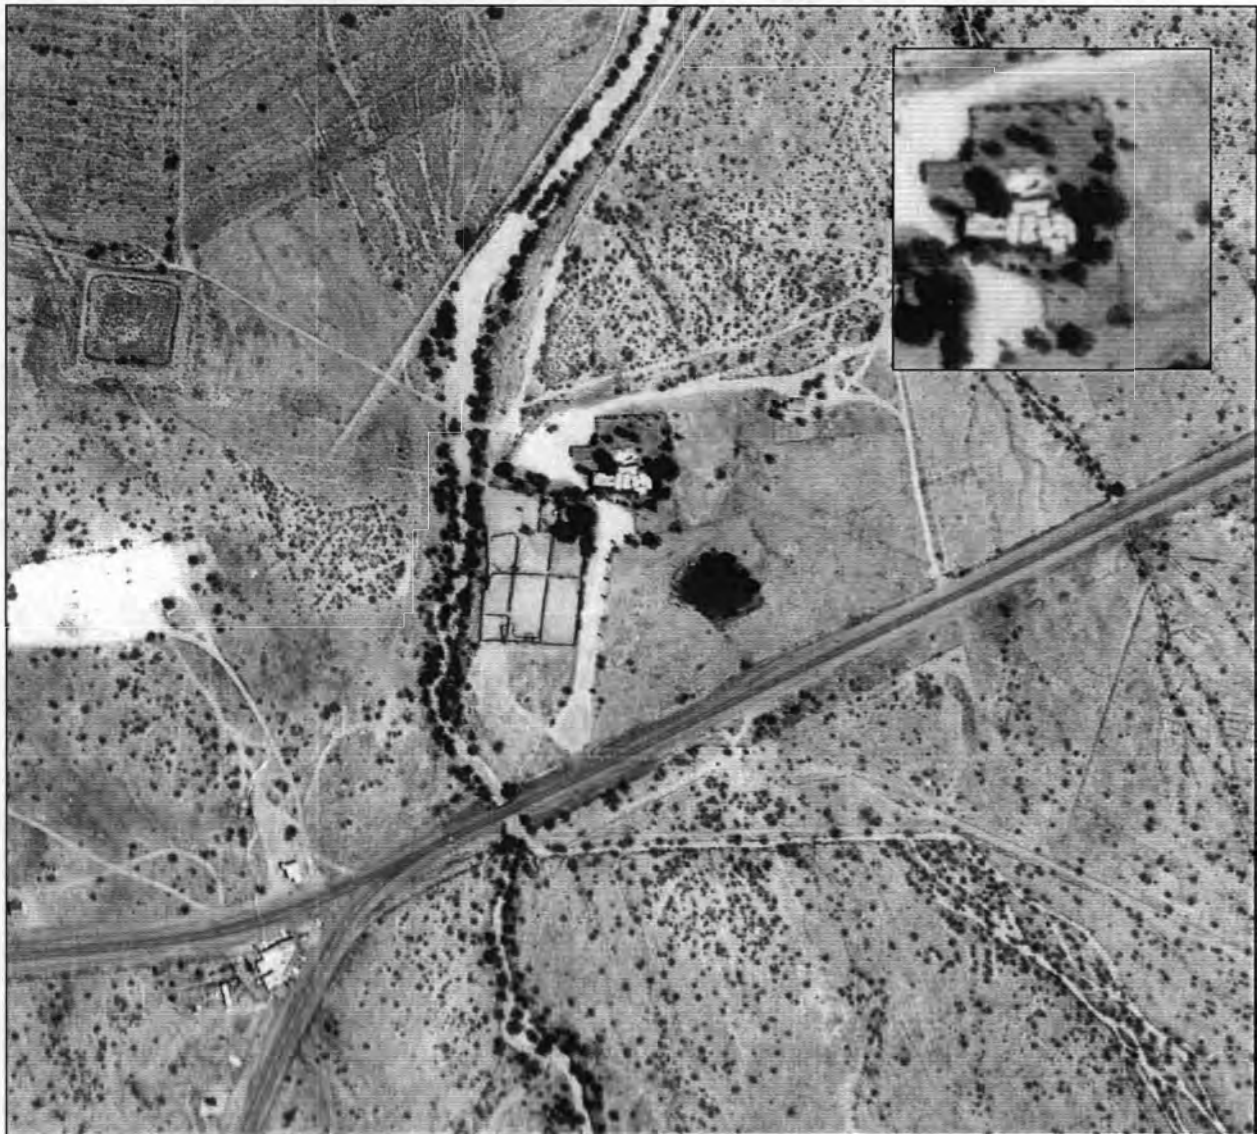
Figure 7. Aerial photograph of Robles Ranch headquarters with ranch house in inset, 1967 (USDA 1967).

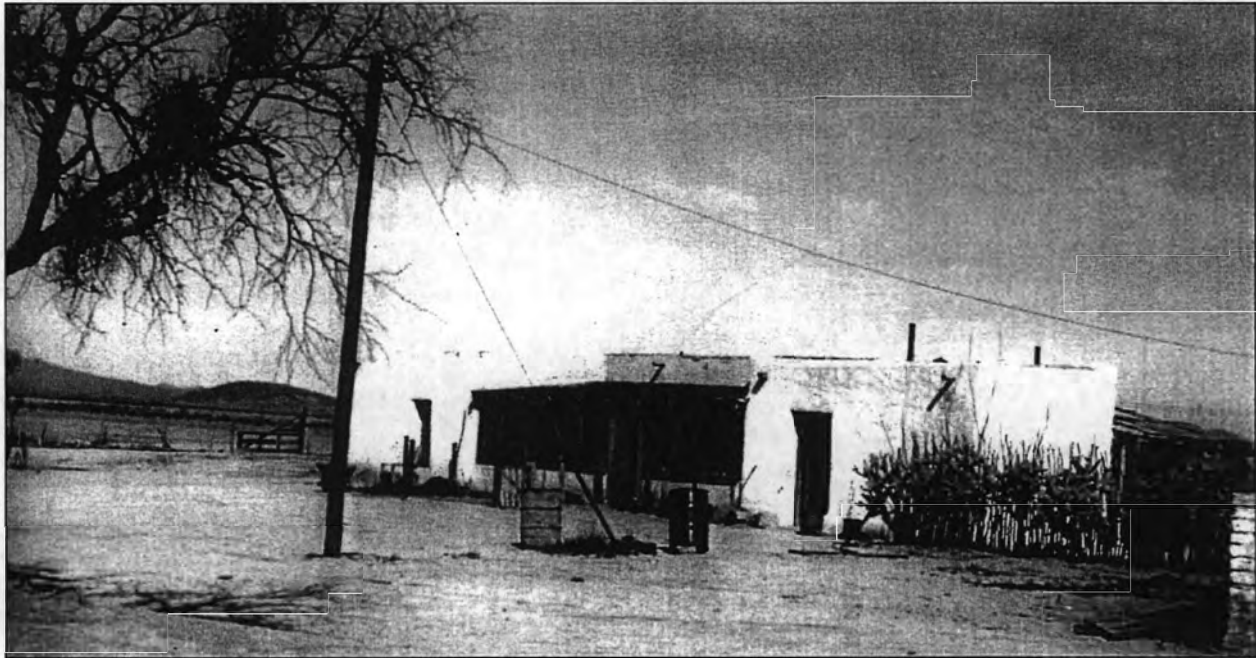
Figure 11. West house, view to northwest, ca. 1943 (Doyle and Associates 1999:Figure 3).

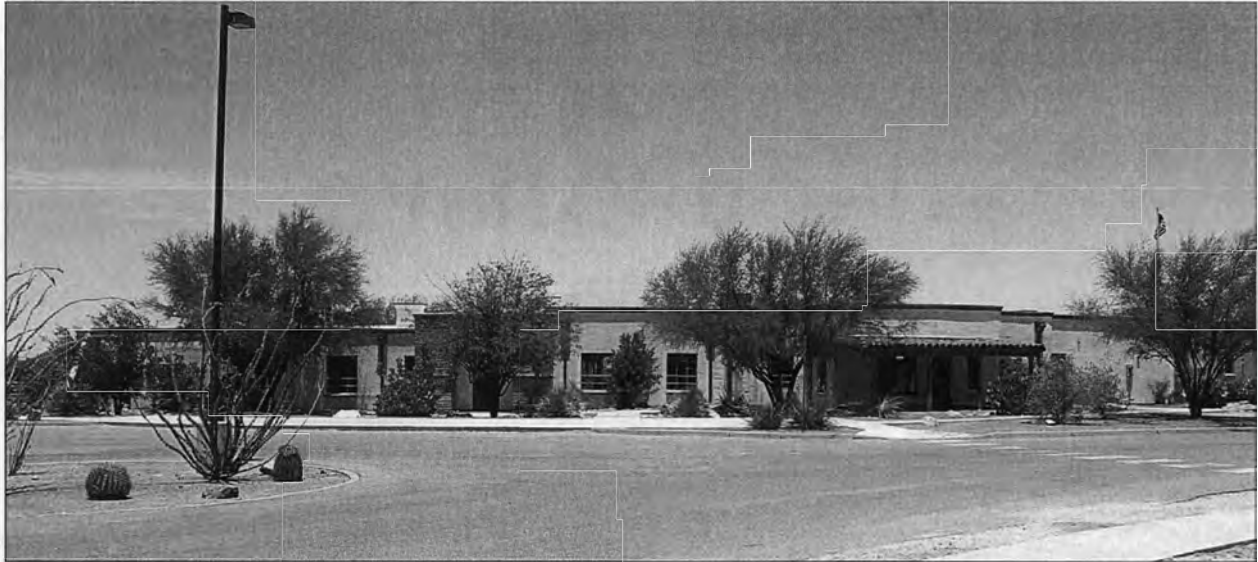
Figure 13. Robles Ranch House, south facade, view to north, June 9, 2010.

The Robles Ranch House is a one-story dwelling with Sonoran Revival variant, Spanish Colonial Revival–style features (Figure 13). The house is cubic in form, rather long and narrow, and measures approximately 160 by 35 feet, with a number of rectangular elements. A central entry joins two slightly angled wings that extend east and west. This arched entry is a Spanish Colonial Revival–style feature.

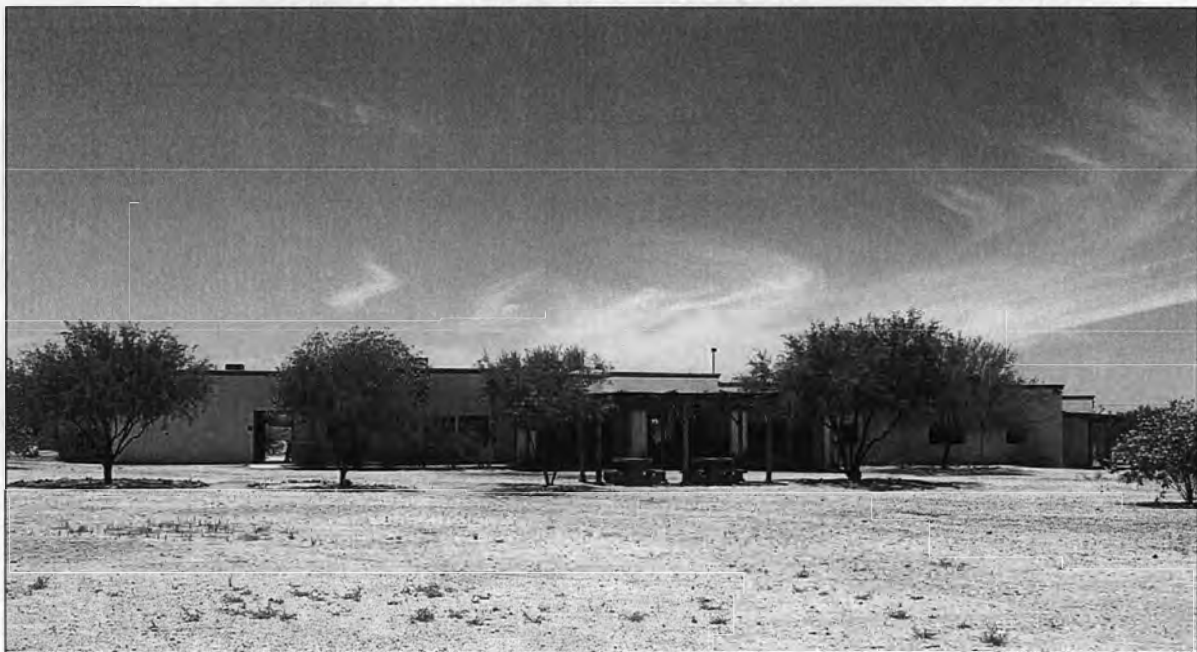
Figure 14. Robles Ranch House, north facade, view to south, June 9, 2010.

The facades are flat, stuccoed masonry and extend vertically to form parapets of varying heights (Figure 14). The parapets are topped by two projecting courses of concrete brick. Scuppers with metal conductor heads and downspouts drain the roofs and are located at intervals along the facades. There are irregularly spaced steel-casement windows painted a turquoise color. The facades are white with reddish brown or terra-cotta-colored parapet caps, conductor heads, and downspouts.

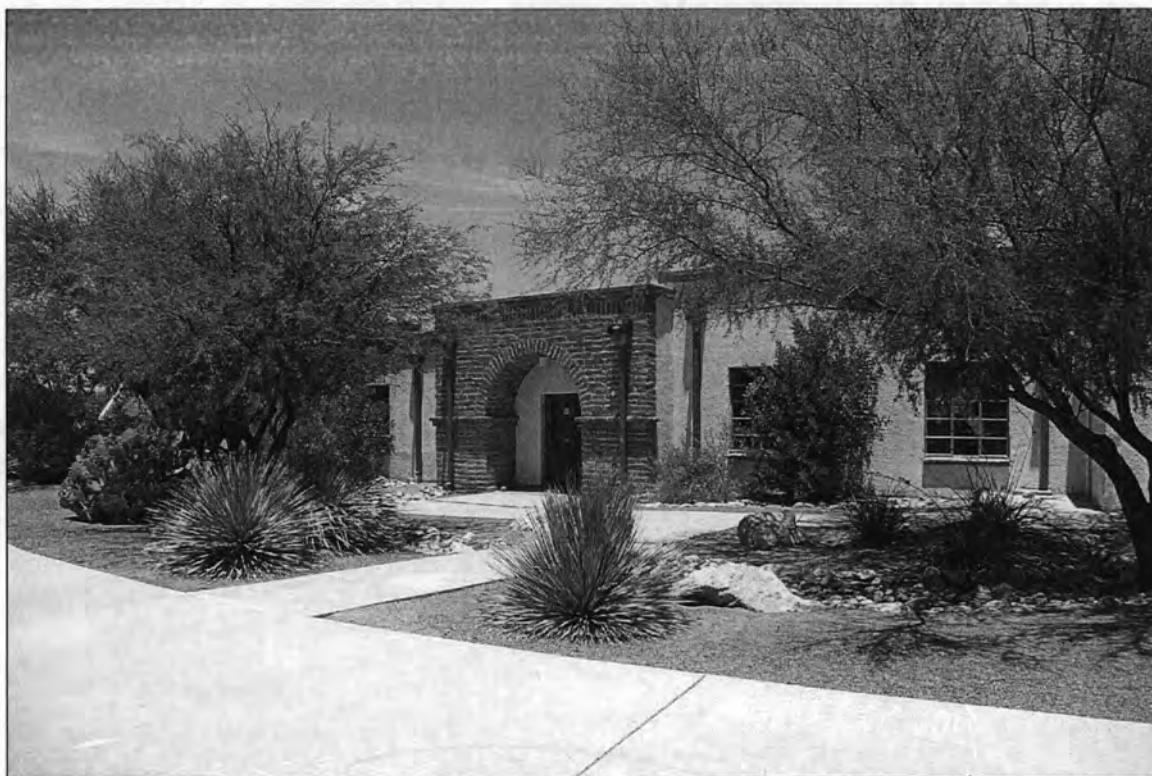
Figure 15. Detail of entry, south facade, view to north-northwest, June 9, 2010.

The projecting entry in the front facade is constructed of burnt-adobe brick with belt courses and an arched opening that frames a recessed, paneled-wood entrance door (Figure 15). The left, or west, corner of the front facade is supported by two angled masonry buttresses. Toward the east end is an open, framed porch with red-Mission-tile roofing. Six steel-casement windows on the south facade are original to the 1950 construction (Rooms 10, 13, and 20). The windows were repaired, reglazed, and repainted as part of the rehabilitation work.

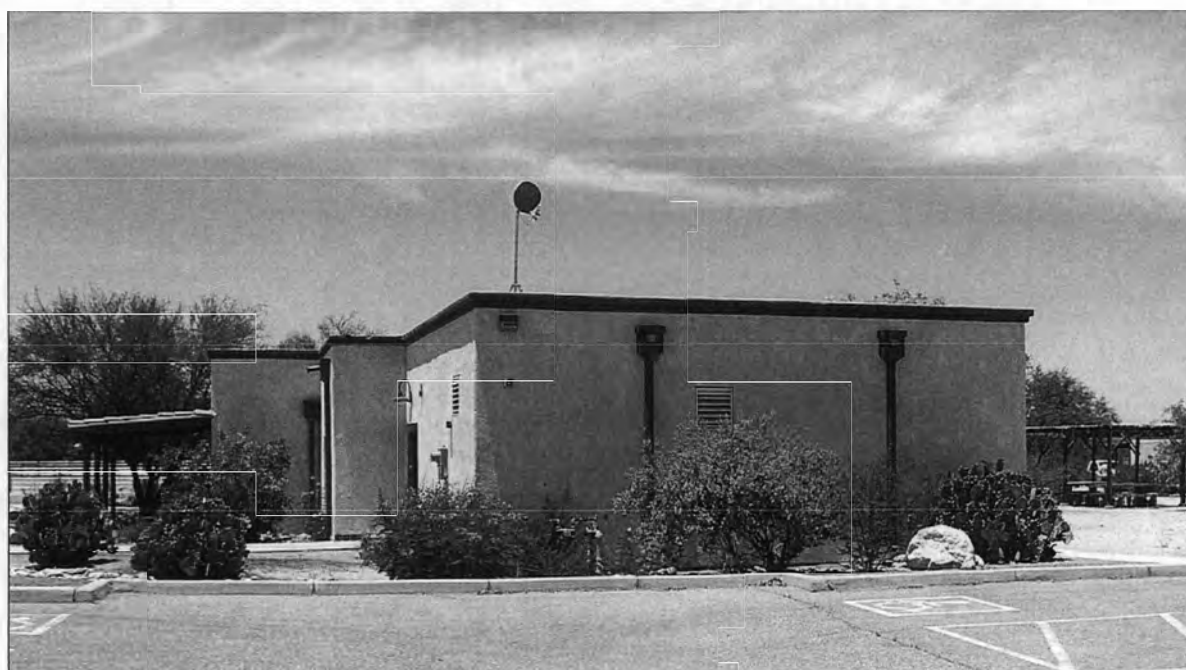
Figure 16. Robles Ranch House, east facade, view to west, June 9, 2010.

At the far east end, separated from the original house by a breezeway, is a recently constructed rectangular element containing public toilets. The east facade of this building is a blank wall with two conductor heads and downspouts (Figure 16).

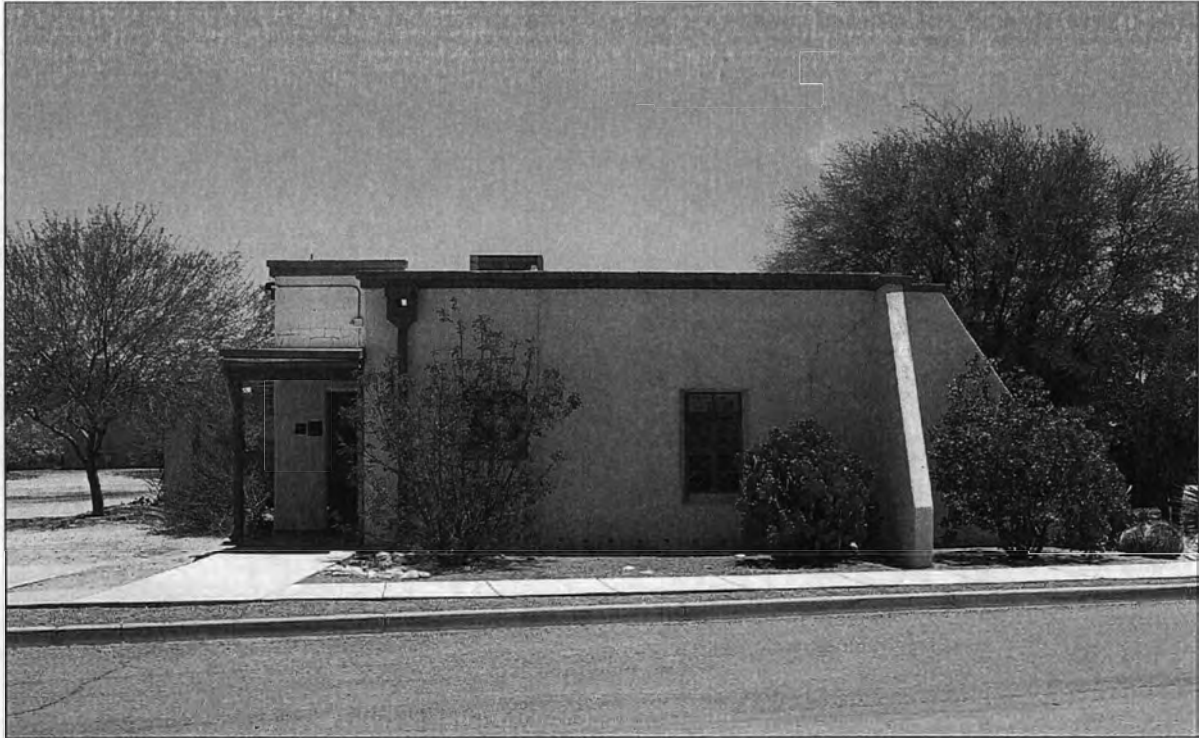
Figure 17. Robles Ranch House, west facade showing corner buttresses, view to east, June 9, 2010.

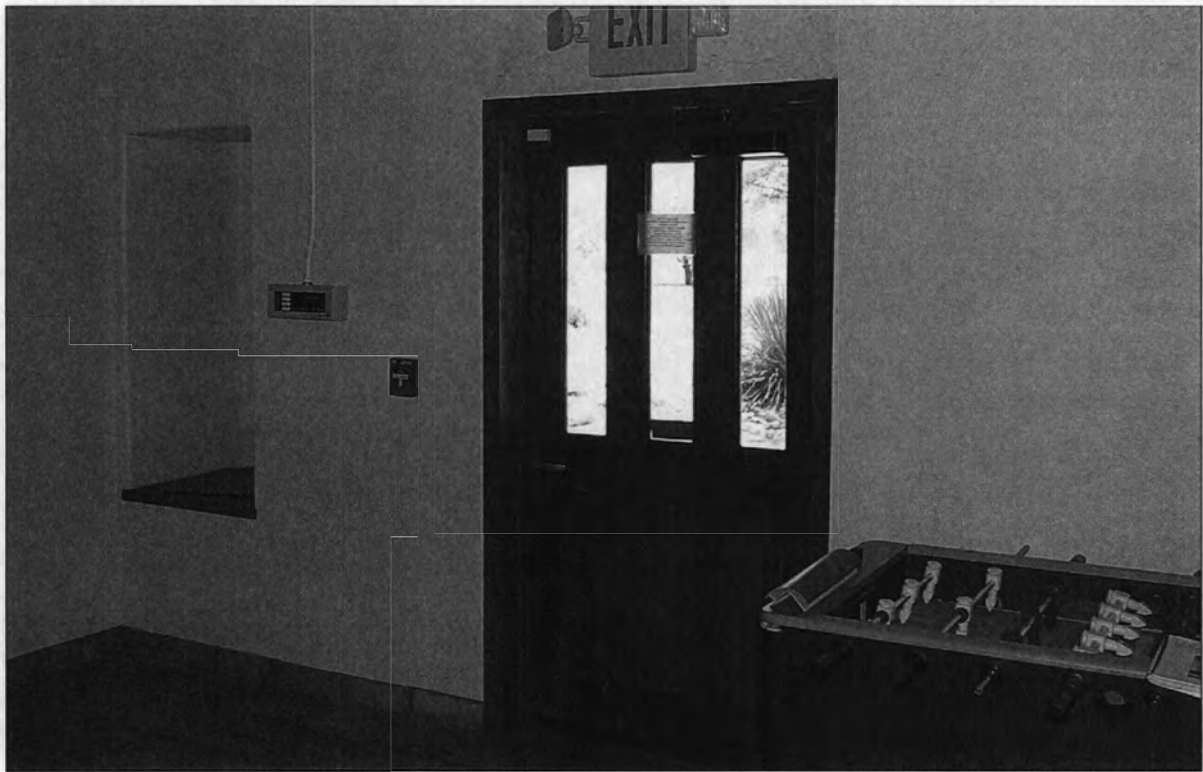
Figure 19. Detail, main building entrance, Coordinator's Room, June 9, 2010.

Doyle and Associates' Rehabilitation Floor Plan (Figure 18) illustrates the following text. Inside the main entrance is the 11-foot-6-inch-by-12-foot-6-inch Museum Coordinator's Office (Room 11) (Figure 19). The floor is covered with a tan-colored 12-inch-square Saltillo clay tile with a tile base. The walls are plastered with a sand-colored, rough-troweled, knock-down finish. There is a 9-foot-6-inch-high exposed plank-and-beam ceiling that is original to the 1950 construction. The 4-by-8-inch beams at 2 feet on center are painted a reddish brown, and the plank decking is painted a cream color. The four-panel wood doors and full-width frames are stained a rich brown color. These colors and materials and ceiling heights are repeated throughout the building. There are ceiling-mounted light fixtures in this and other areas with exposed ceilings.

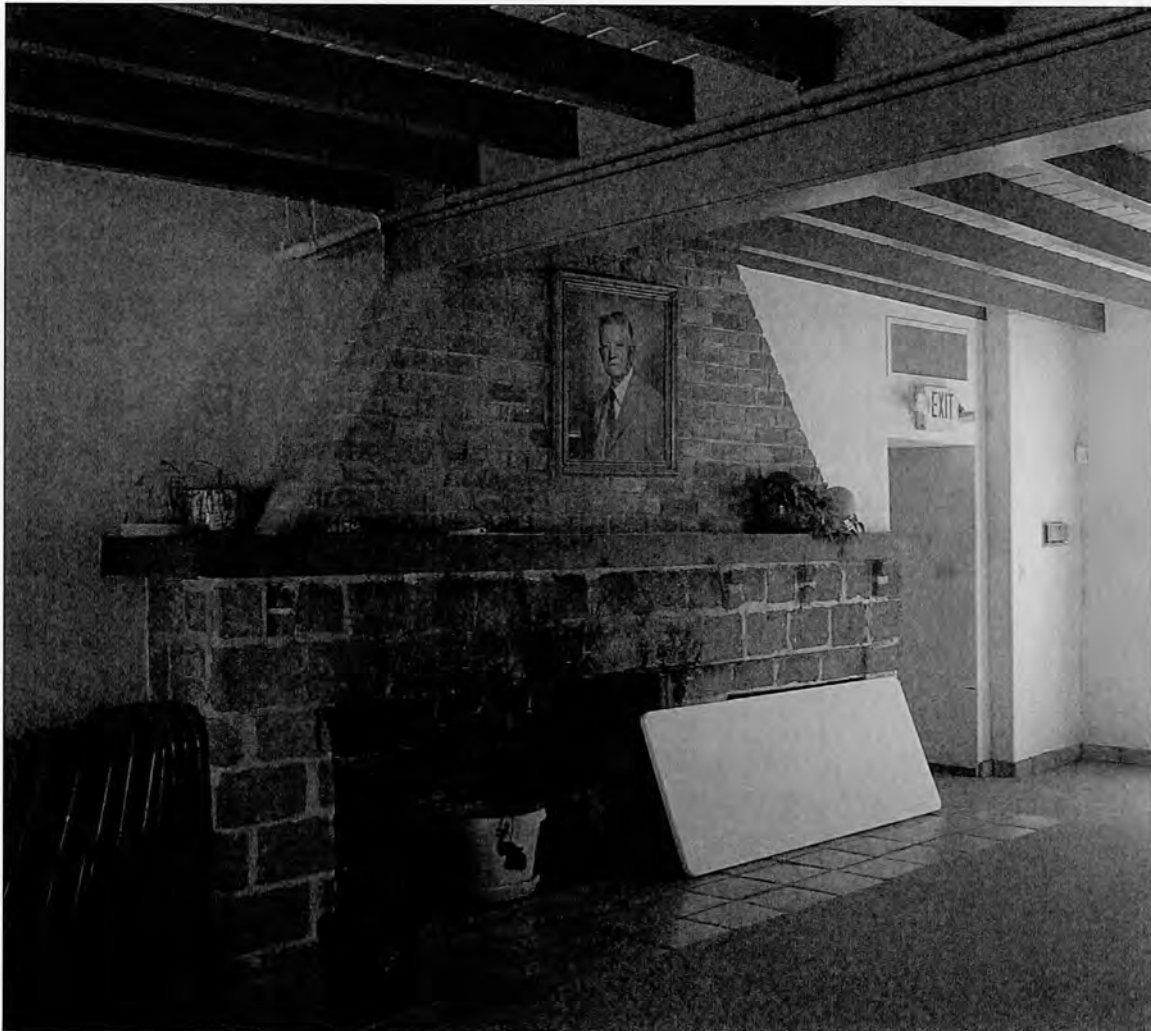
Figure 21. Detail, east wall, Meeting Room, showing fireplace, June 9, 2010.
