National Register of Historic Places Inventory—Nomination Form

- A. Property Name: Exchange Building
- B. Location and Verbal Boundary Description: The Exchange Building is located at 154/158 East Main Street. The property being nominated includes the building and parcel of land which fronts 70 feet on East Main Street with a depth of 91 feet on Choate Street (Property Tax Map, City of Newark, no. 20, lot no. 131.)
- C. Owner: Frank Cairo, 154/158 East Main Street, Newark, Delaware 19711

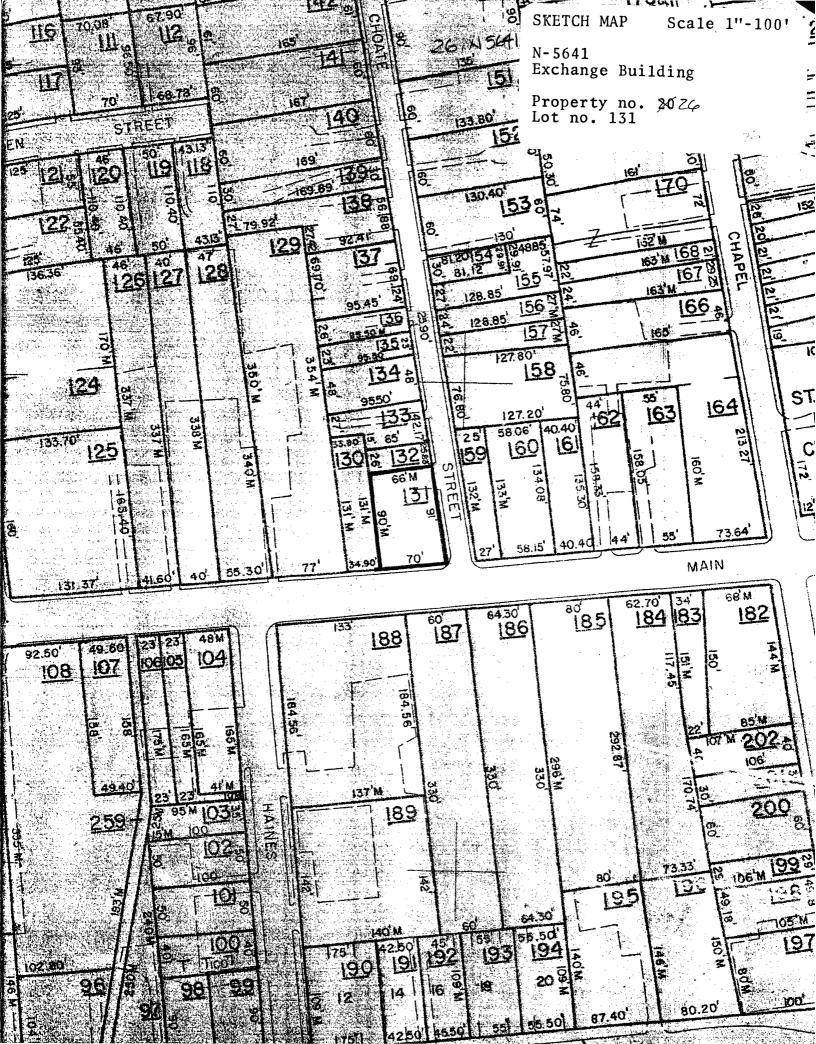
26.(N-5641):

This property is a three story rectangular building with a five bay facade and a deep mansard roof enclosing the third floor. The building is constructed of brick; exterior walls are finished with stucco and painted mustard yellow with gray trim. The windows have segmental arched openings (probably built of brick lintels with wooden sills) and are the two-over-two double hung sash type. Paneled shutters flank the first and second story windows at the south main facade. The third floor windows, projecting from the mansard roof, feature heavy pedimented cornices. Patterned slate covers the roof exterior and a molded wooden cornice with notched brackets outlines the perimeter of the building at the base of the roof. A narrow exterior chimney rises up the center of the building at the main facade. Three entrances are located on East Main Street including: a single door with a rectangular panel of glass; a set of double doors with raised panels and overhead stained glass transom; and modern plate glass doors. A handsome set of double doors, with raised panel woodwork probably original to the building, is located at the northeast corner of the rear facade.
