National Register of Historic Places Registration Form

Historic name: Mutual Savings and Loan Association Building

Street & number: 601-605 NW 23rd Street

City or town: Oklahoma City State: OK County: Oklahoma

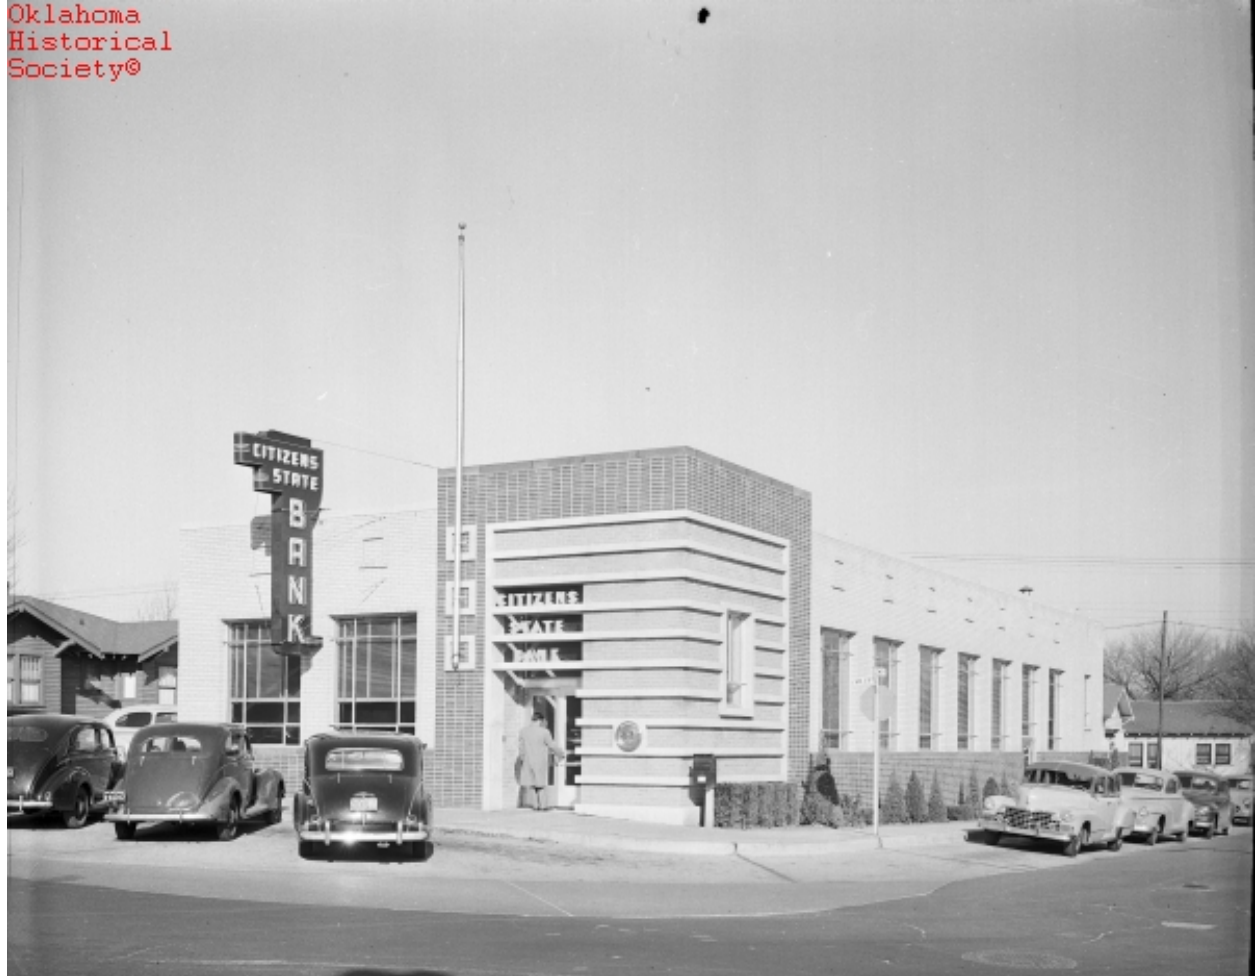
Figure 7: Historic photograph. 1948. Citizens State Bank 601-605 NW 23rd Street. Source: Vertical File: Ray Jacoby, box 3. Oklahoma History Center.

The original 1948 Citizen's State Bank building expressed a tentative step toward the Modern Movement, while the 1959 renovation fully embraced the aesthetic to create a bold local example. Following a common architectural trend of its time, the 1948 free-standing suburban commercial building was a departure from earlier bank buildings that were typically found in downtown business districts and featured traditional architectural designs.⁶ Rejecting the usual Classical Revival style of pre-Depression era bank buildings, Citizens State Bank's new building combined elements of Moderne architecture with classical symmetry to arrive at Streamlined Classicism.⁷ The building borrowed horizontal banding from the Moderne to accentuate a corner bay while maintaining symmetrical proportions and regular fenestration on the wings. The simplified ornamentation wrapping the corner element was a minimal adaptation of Moderne's curved forms (Figure 7).

The corner bay contained an entry on the north facade. The horizontal banding above the door created an architectural frame for a Citizen's State Bank sign. A centered window pierced the corner bay's east elevation. The accentuated corner joined the front and east elevations, which were both visible from NW 23rd Street. Regular, symmetrical fenestration with geometric brick patterns characterized the front and east side elevations.

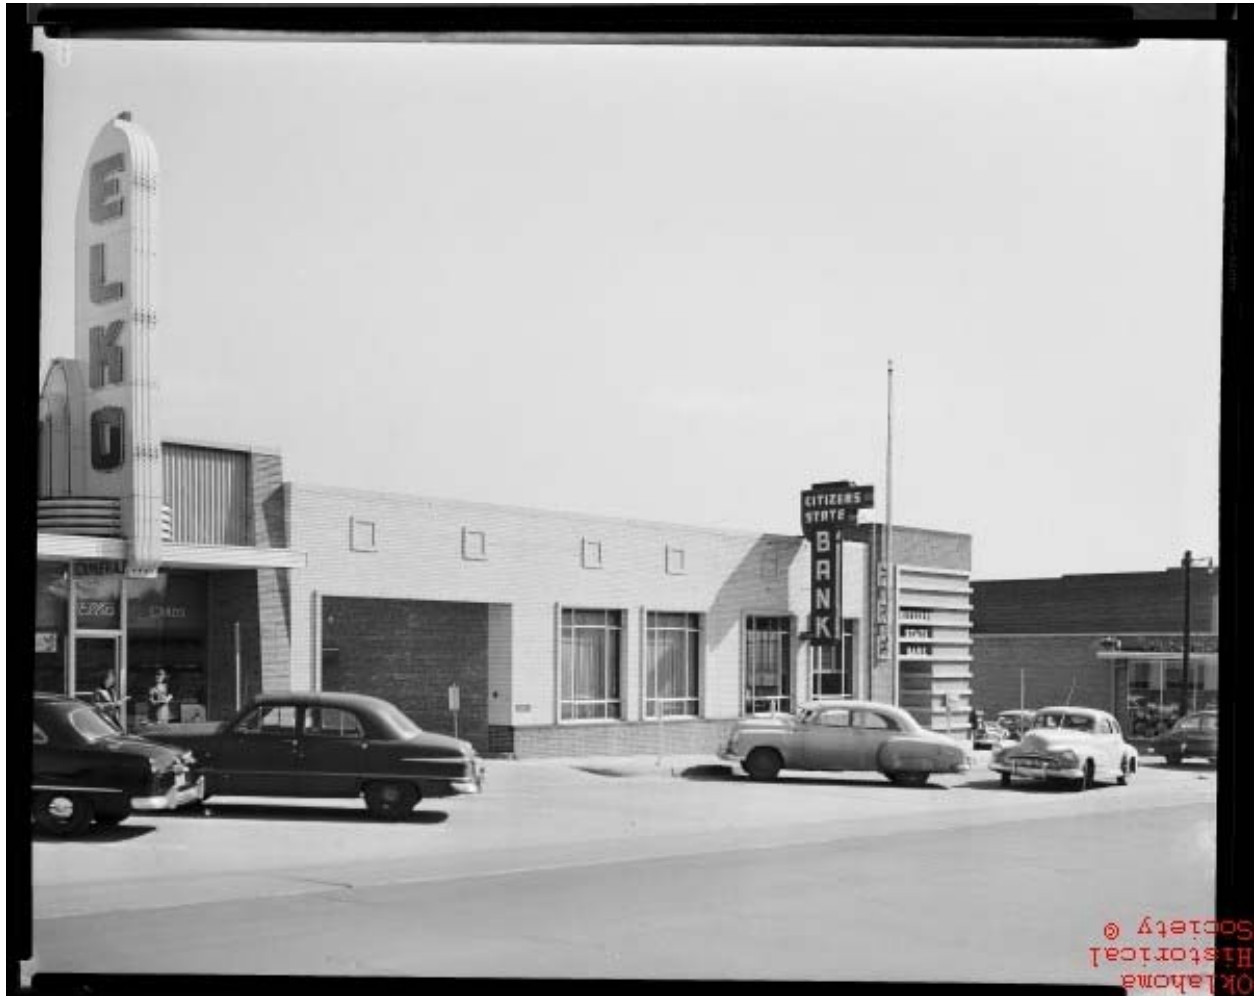
Figure 8: Historic photograph circa 1950. Source: Vertical File: Barney Hillerman, 13.13. Oklahoma History Center.

Citizen's State Bank enlarged its building to include drive-through service on the west side of the building circa 1950 (Figure 8). A one-story commercial building with multiple storefronts filled the rest of the block by 1955. In 1957, Citizen's State Bank began constructing a new building one-half mile to the west. The new Citizen's State Bank geodesic dome building was a dramatic statement of their modern expansion.¹⁰ Citizen's State Bank sold the 601-605 NW 23rd Street property to Mutual Savings and Loan Association in 1957.

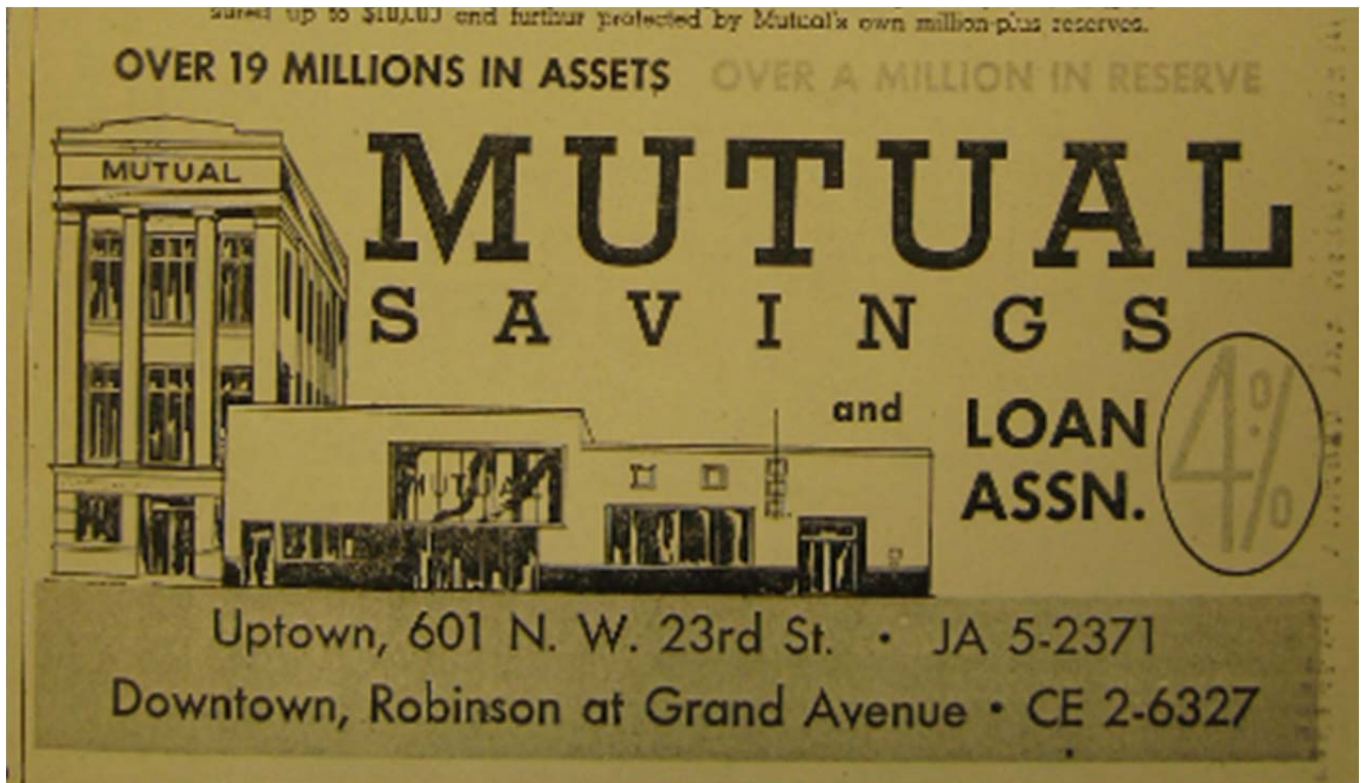
Figure 9: Rendering showing Mutual Savings and Loan Association buildings at 601-605 NW 23rd Street and downtown location 200 Grand Avenue, circa 1959. Source: Vertical File: Mutual Savings and Loan. Box 2 folder 6. Oklahoma History Center.

The new front façade's smooth surfaces and simplified shapes used the floating, mid-floor window to great advantage as an architectural canvas branding the building. Early renderings show "MUTUAL" painted on the front glazing¹¹ (Figure 9). The window also used horizontal mezzanine stairs to frame the vertical elevator shaft at the entry lobby. Visually, that ninety degree angle added a third dimension to the planar angles on the exterior façade. Functionally, the added central lobby aided circulation between expanded interior service areas.

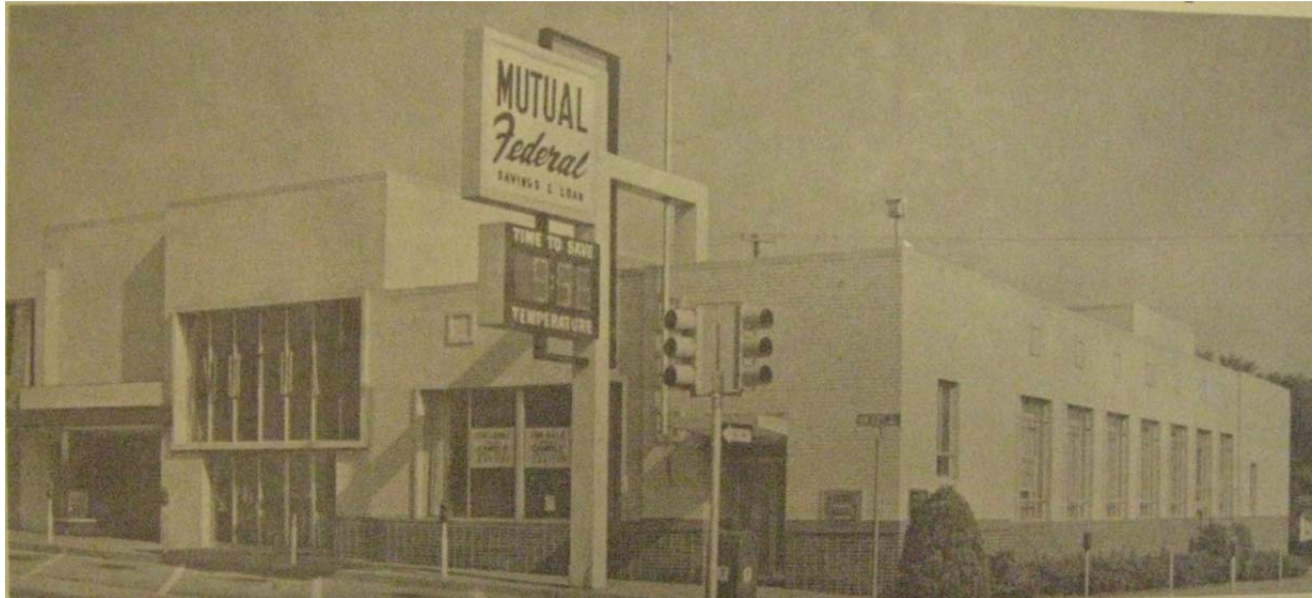
Figure 10: Historic photograph Mutual Savings and Loan at 601-605 NW 23rd Street. October 11, 1977.
Source: Vertical File Mutual Savings and Loan. Box 2 folder 6. Oklahoma History Center.
