National Register of Historic Places Registration Form

Historic name U.S. Inspection Station—Moors, New York
Other names/site number Moors Border Station; Moors Inspection Station

*U.S. Inspection Station—Mooers Clinton County,
New York*

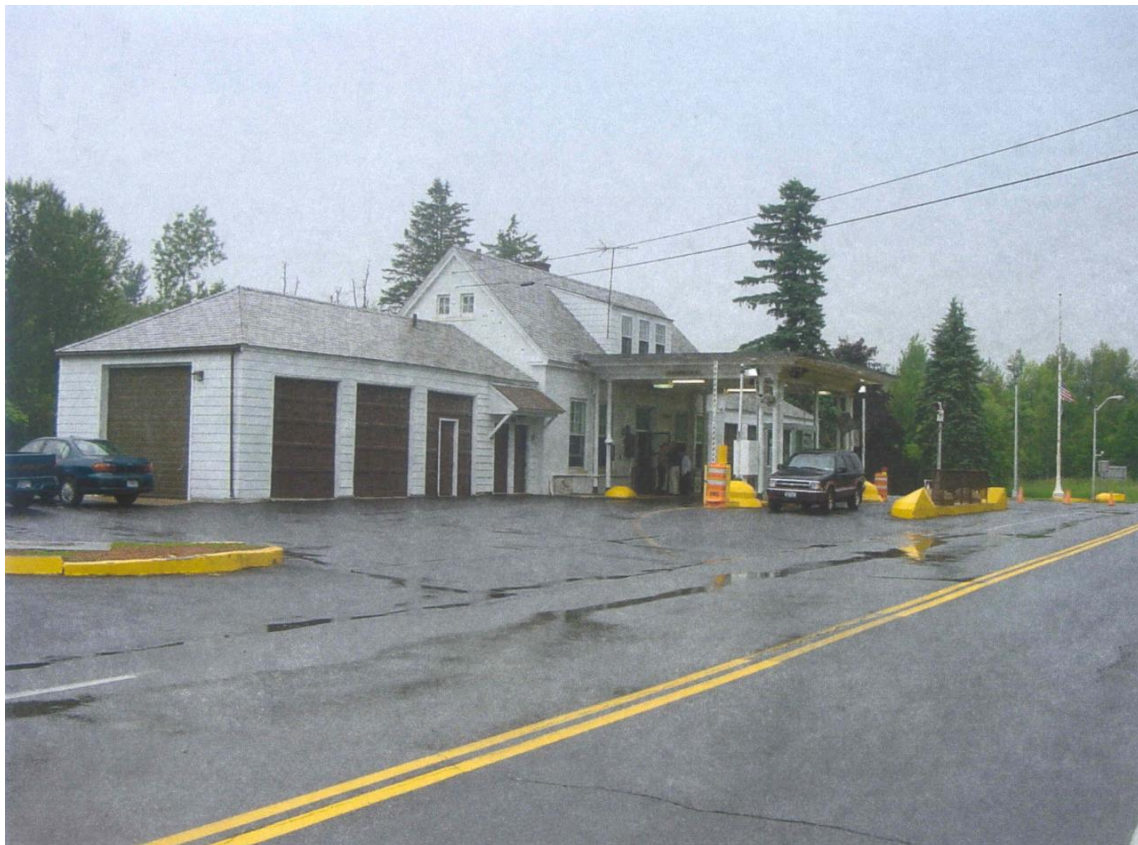
Photo number: NY_ClintonCounty_MooersBorderStation1.tiff

Description of view: front elevation and approach, view: northwest

The U.S. Inspection Station--Mooers is a rectangular plan, 1 ½ - story, side gabled inspection station designed in the Colonial Revival Style. The building has a concrete slab foundation and basement, and is wood frame construction clad in painted, flush-joint American bond brickwork. The roof is covered with asphalt shingle. The front elevation features two symmetrical end bays and one centrally located entry bay. Each end bay features a pair of 12/12 wood frame double hung windows each underscored, like the rest of the windows across the building, with concrete sills. All of the windows are topped by gauge brick jack arching and keystones. Above the centered entry is a transom window program. At each side elevation of the inspection station are gable ends with molded gable returns and a pair, at each end, of 4-pane fixed windows in a square arrangement. The rear of the Inspection station features two pairs of 9/9 wood frame double hung windows in a symmetrical composition. Within the roof are two, three-bay shed dormers placed to the front and rear of the ridgeline. Each of these dormers features three window bays with 8/8 woodframe double hung windows. Each dormer is clad in wood clapboard. A centered, brick chimney is also located on the roof behind the ridgeline.

Affixed to the front of the Inspection station is a flat roofed porte-cochere that covers one single lane and is supported by paired, thin metal columns with classical-inspired crowns. The porte cochere was expanded slightly in 1972. Symmetrically affixed to either end of the inspection station are two, four-bay garage wings. Each of the wings is of rectangular plan, is clad in wood clapboard and topped with eaveless, hipped roofs. The southern wing is an inspection wing. Within the southern wing, the bay closest to the inspection station has been converted into a pair of pedestrian entrances covered by a pent porch roof. The garage door in the bay next to this has also been fitted with a pedestrian access door. On the width end of the southern bay is another garage door. On the width end of the northern bay is a pair of 12/12 wood frame double hung windows. This wing was used to garage government vehicles. The base of the inspection station and its two garages is underscored by a concrete water table that is visible at its rear and a side elevation as the property descends in grade.

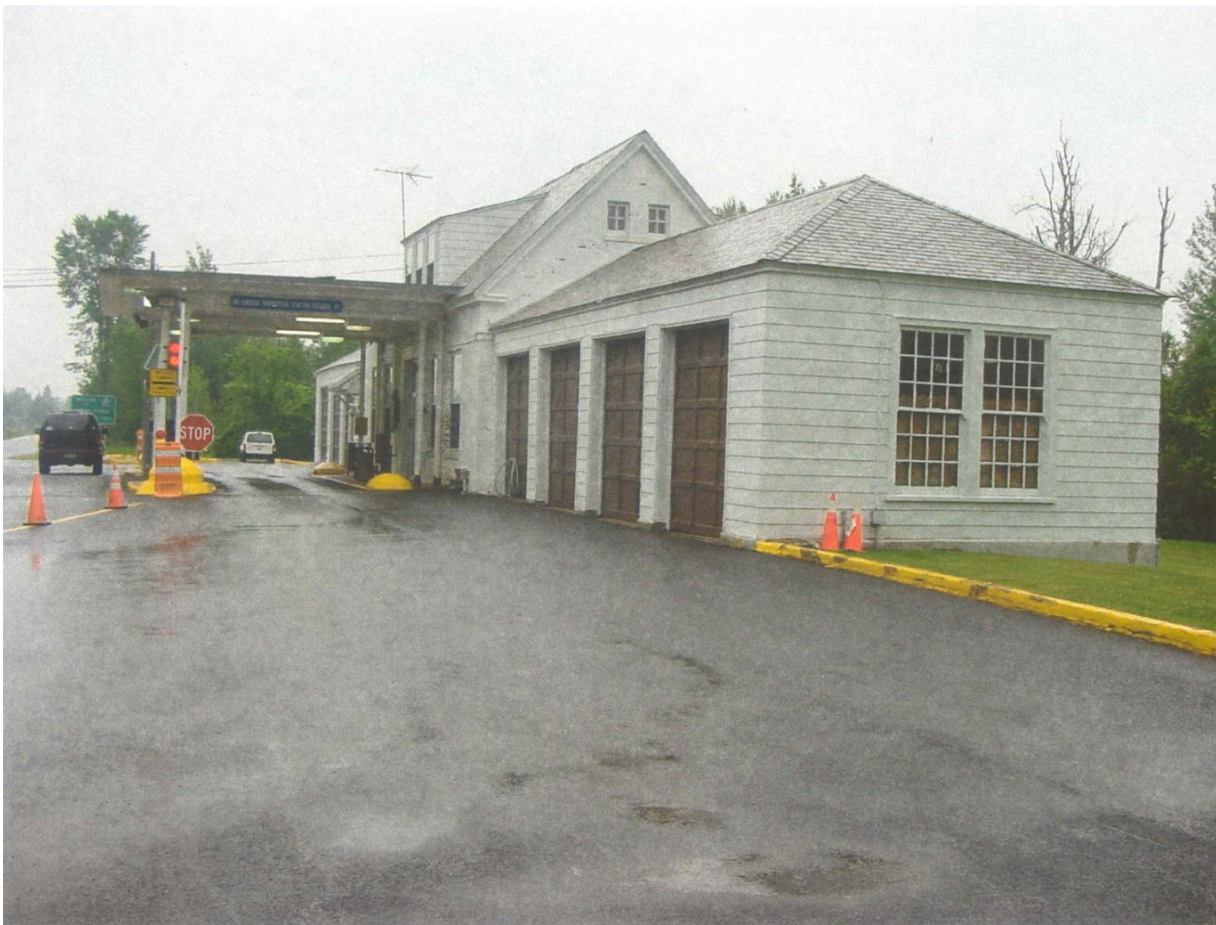
Photo number: NY_ClintonCounty_MooersBorderStation2.tiff

Description of view: front elevation and approach, view: southwest

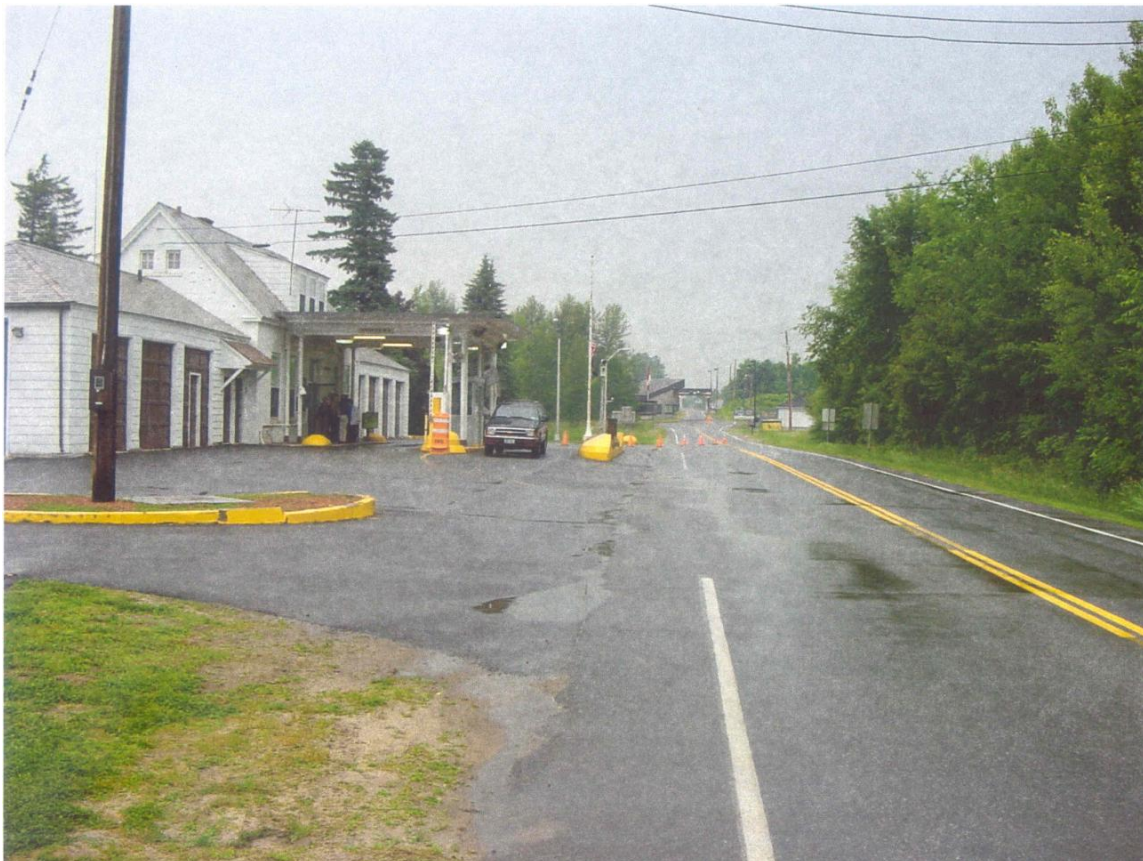
Photo number: NY_ClintonCounty_MooersBorderStation3.tiff

Description of view: State Highway 22 with Canadian station in distance, view: north/northwest

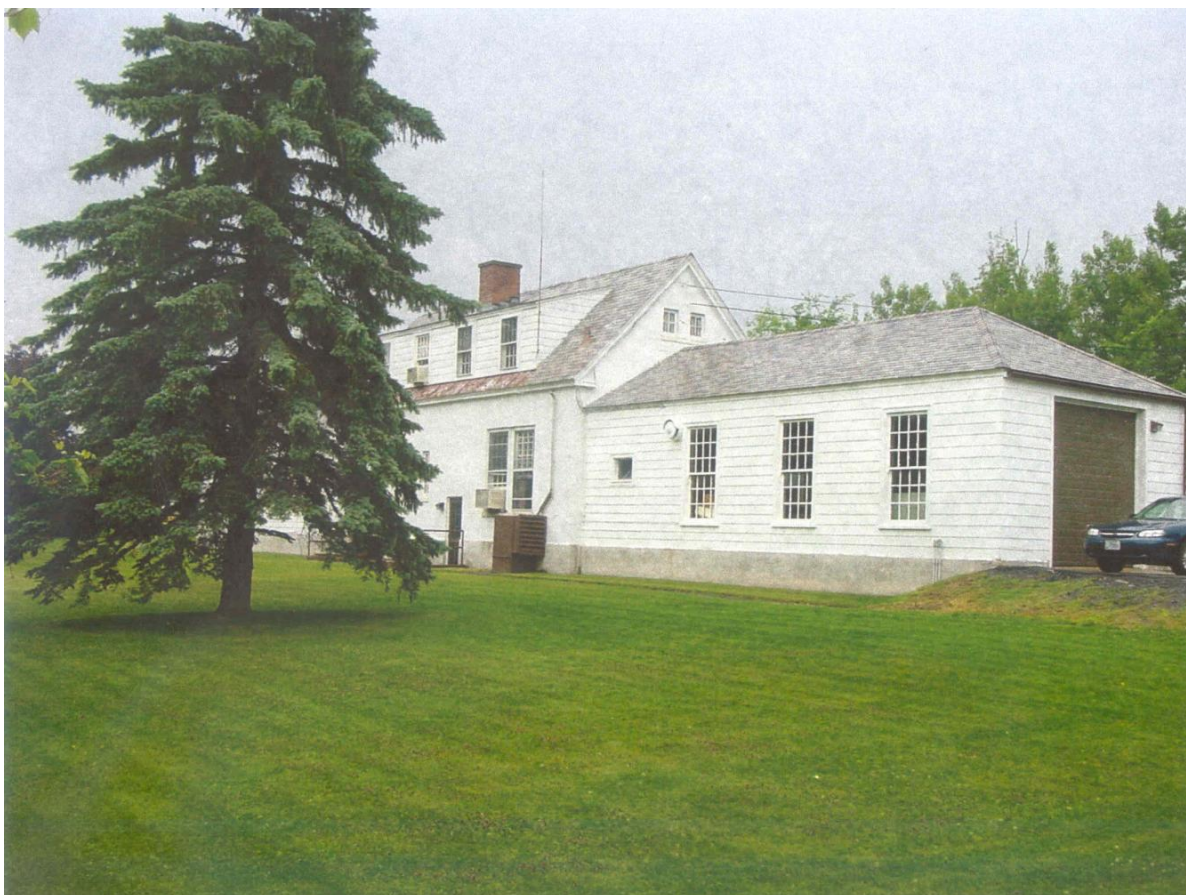
Photo number: NY_ClintonCounty_MooersBorderStation4.tiff

Description of view: rear elevation, view: northeast

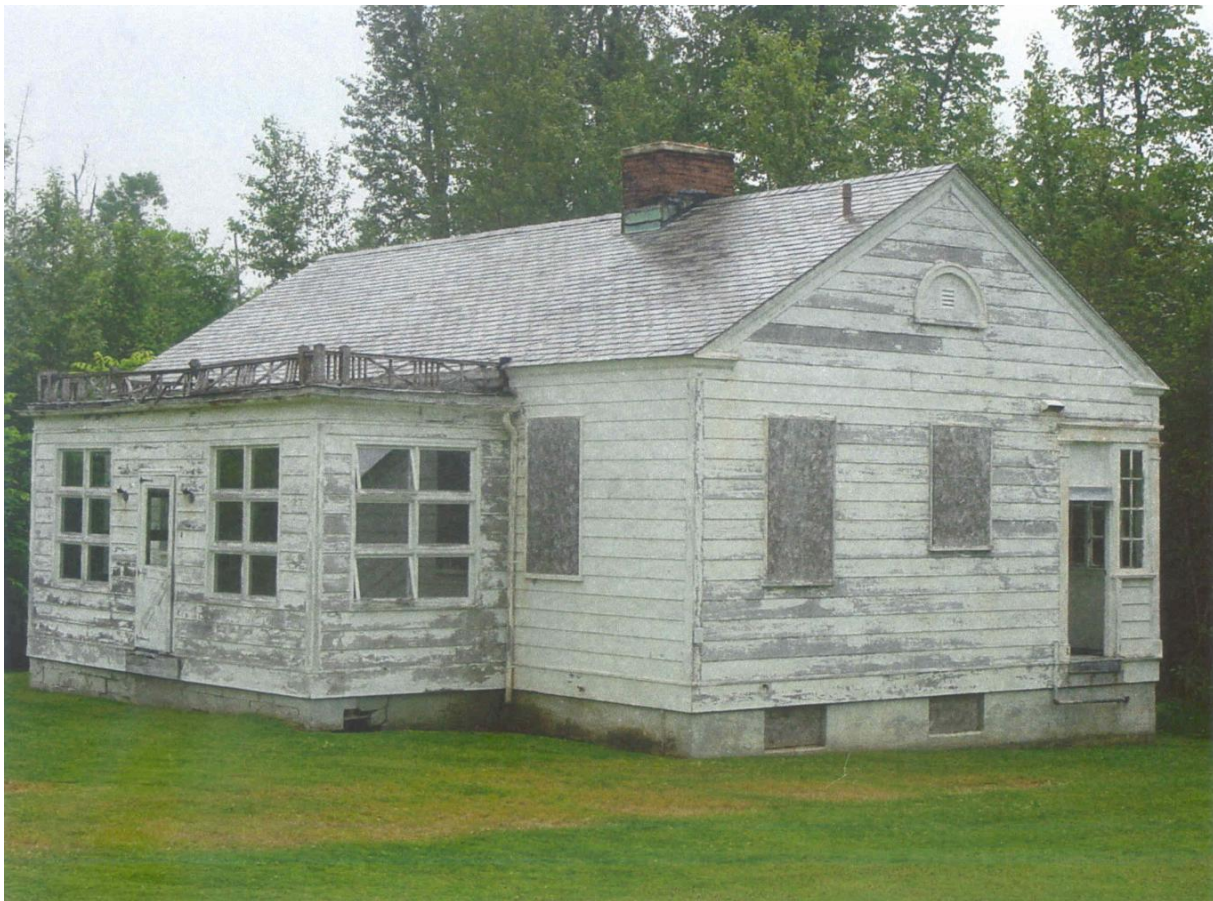
Photo number: NY_ClintonCounty_MooersBorderStation5.tiff

Description of view: Residence 1, view: south

Located to the north and south of, and directly behind this program, are two standalone residential buildings: one for a Customs Inspector (North) and one for an Immigration Inspector (South). Both are designed in a New England Cape Cod translation of the Colonial Revival. These structures are of a modified rectangular plan with concrete foundations and side gabled roofs clad in asphalt shingle. Placed off-center upon the roof ridgeline of each is a brick chimney.

The elevations of both residences are wood clapboard clad terminated with cornerboards. The gable ends of each residence feature molded gable returns, between which are molded, semi-circular lunette window wells containing attic vents. Many of the windows across the elevation of both residences are boarded up, as neither is currently occupied (as of 2006). Affixed behind each residence is a rectangular protruding unit. The rear units each feature a centered, rear entrance with a door of glass upper panel and x-batten lower panel. Six-pane woodframe projected windows are symmetrically placed at either side of these rear entrances and upon its side elevations. The protruding unit of each is topped by a patterned wood baluster. Located at the corner side of each residence is an off-center entry. Like the rear entry, the front elevation for each is elevated off the ground, above a running concrete basement that traverses all sides of the building. The entry is part of a composition that is paired with silled, 8-unit fixed vertical window surrounds. Above the main entry to each residence is a simple architrave molding which is topped by a plain transom panel. The entire entry program of each is topped by architrave molding and framed by two square shaped, engaged classically detailed columns.

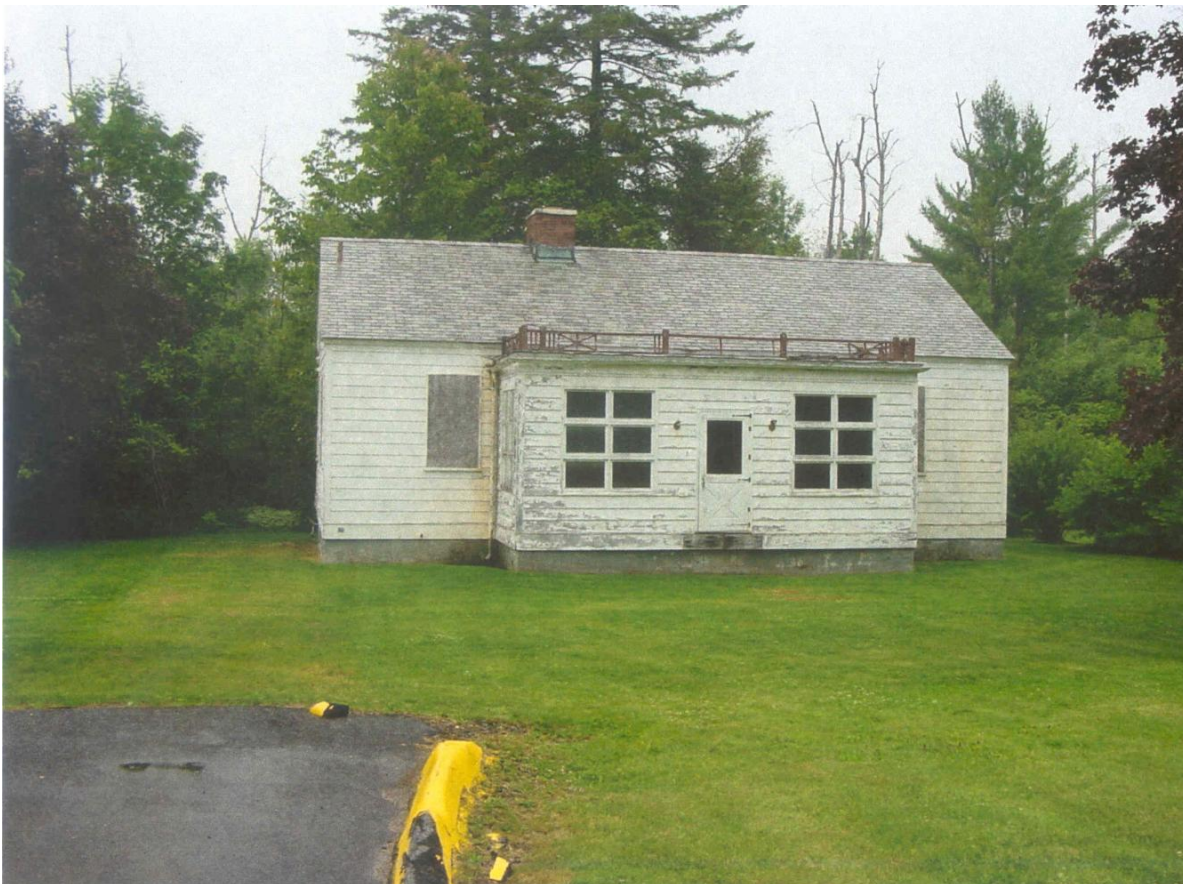
Photo number: NY_ClintonCounty_MooersBorderStation6.tiff

Description of view: residence, view: northeast

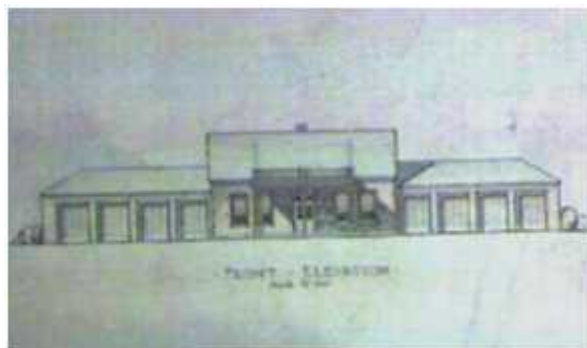
Description of view: front elevation

The renderings for the Mooers Inspection Station are found at the National Archives and Records Administration (NARA).¹ Based on a comparison with the original renderings, the Mooers Inspection station has undergone relatively few exterior alterations. The alterations present upon the inspection station include: two garage bays converted into doorways; a new use for the south garage wing; front entry replacement in 1953, recent garage doors, and an expansion of the porte-cochere roof in 1972.²

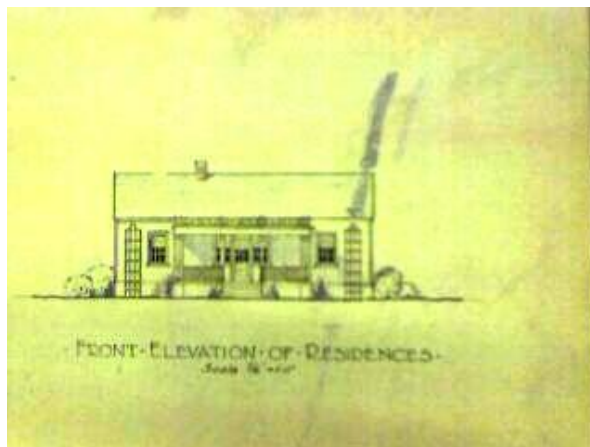
Description of view: standard residence, front elevation
