National Register of Historic Places
Registration Form

historic name Hampton
other names Hampton Mansion; Hampton Hall; Hampton National Historic Site (preferred name) (BA-103)

HAMPTON NATIONAL HISTORIC SITE NATIONAL REGISTER NOMINATION

Towson, Baltimore County, Maryland

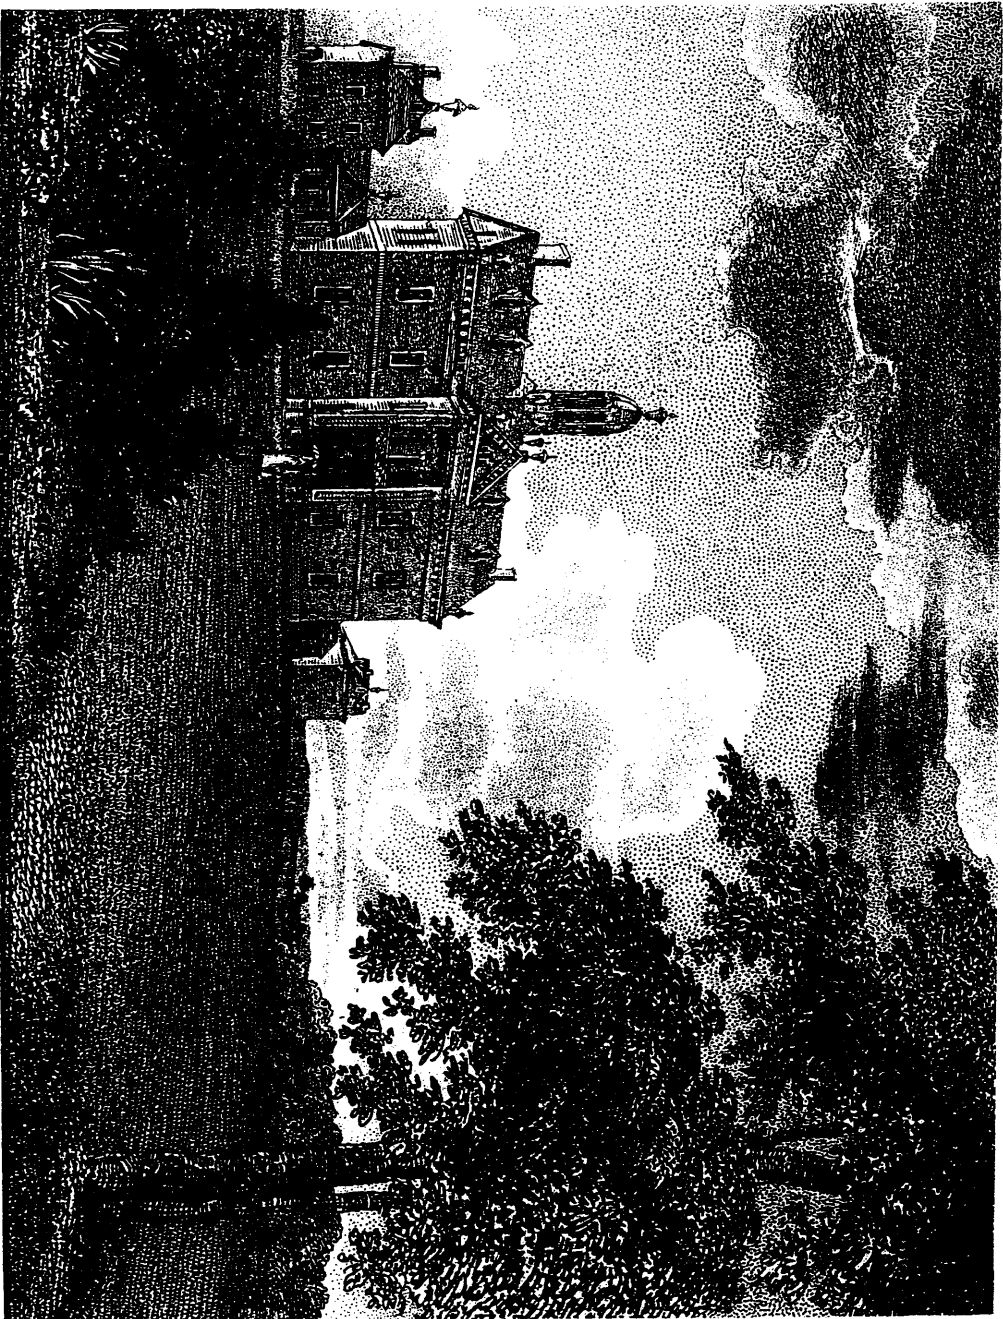
Fig. #4 Engraving of Hampton Mansion by William Russell Birch

Hampton the Seat of Genl Cha^s Ridgley, Maryland. —
