KENTUCKY HISTORIC RESOURCES
Individual Inventory Form

1. Name of Resource:
Tindall House

5. Location:
South side U.S. 60, Clay Village

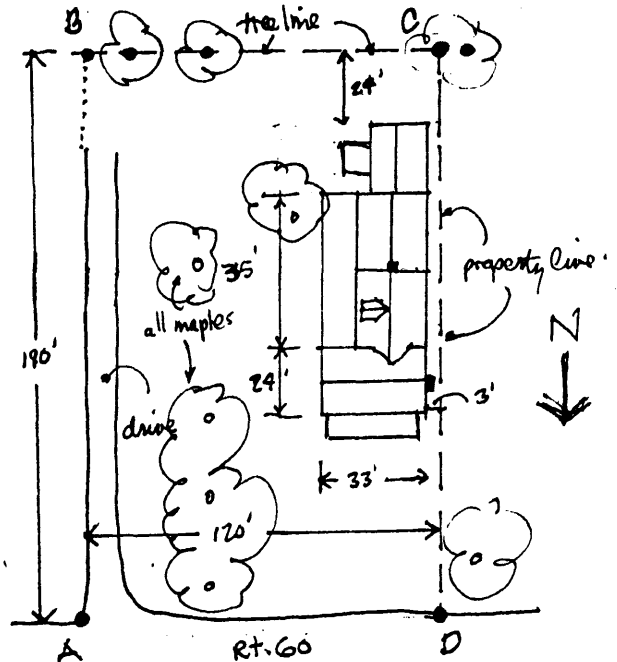
Site Plan (and boundary description and justification for N.R. sites):

Beginning at point A, south 190 feet along the east side of a drive and continuing south to point B, thence west 120 feet along a tree line to point C, thence north 190 feet along a property line to point D, thence east 120 feet east along the south side of U.S. 60 to the point of origin. The boundaries were chosen to encompass the house and its domestic-related space as defined by the highway, fences, tree lines, and drive which define the residential lot. There are no outbuildings.

Point A is located at the intersection of the eastern edge of the drive with the southern edge of U.S. 60 and is 104 feet northeast of the northeastern corner of the dwelling.

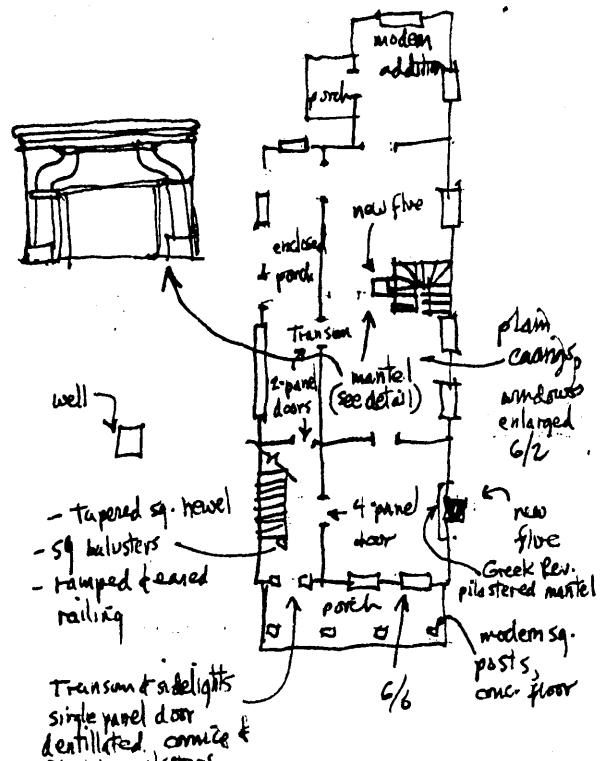
Description and House Plan:

The 1-story, 3-bay, frame side-passage plan dwelling has a two-room ell. The principal (north) front has exposed weatherboards, 6/6 sash, a door with sidelights, transom, and flanking pilasters. Side walls have bricktex applied over the weatherboards. A modern brick flue rises on the west end where original chimney was located, also between the ell rooms. Dormer lights first ell room. Original mantels in main room with pilasters, in first ell room with pilasters incorporating curving end blocks in frieze (see sketch to right). Orig. stairs climb to garret in entry passage, incorporating ramped and eased rail and square balusters and newel. 4-panel interior doors, two-panel doors onto enclosed porch along east side of ell, single-panel door (orig.) at main entry. Stair inserted between 1st and 2nd ell rooms. Porch on north front with modern square posts below earlier roof.

The boundaries enclose one contributing building.
