National Register of Historic Places Registration Form

historic name First Baptist Church of Ogdensburg Complex

street & number 617 State Street

city or town Ogdensburg

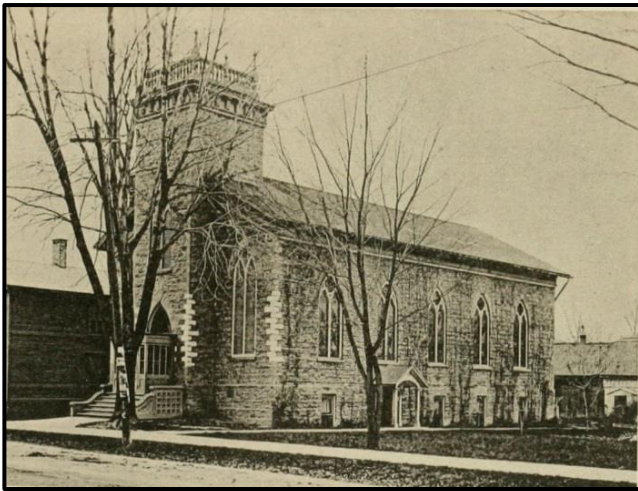
Figure 1. The First Baptist Church, 1895.

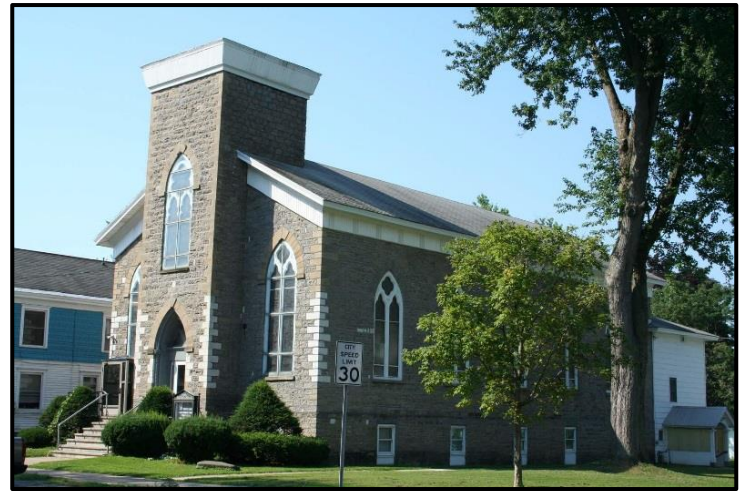
Figure 2. The First Baptist Church, 2017.

The side elevations of the church are nearly identical and simply composed. Each is five bays wide with a tall lancet window in each bay matching those on the primary elevation, though slightly smaller in size. The two rearmost windows have slightly different lintels, probably reflecting the extension of the church in 1855. Windows are decorated with grey voussoirs. There is no apparent seam in the stone walls marking the extension.¹ Although the fifth bay on the south elevation is obscured on the interior by the organ, a simple nineteenth-century stained-glass window is still in place and can be seen on the exterior.² Below a water table, each bay has a small rectangular window that was intended to light the basement. On the northern elevation, the basement windows are replacement vinyl, one-over-one sash, while on the southern elevation the window openings have been filled with concrete block.

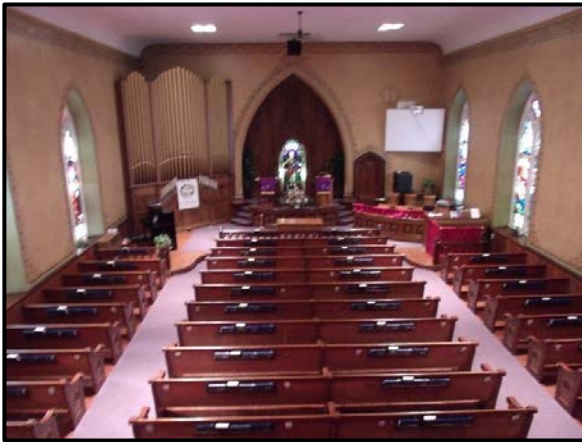
Figure 5. Interior, First Baptist Church, 2017.

The two-story, open volume of the church auditorium has plaster walls throughout, with wood wainscoting below and curved plaster coves at the ceiling. Above the chair rail, beneath the ceiling, and around each of the openings, the walls are stenciled with an intricate border of scrolled foliate elements. Throughout, the floors are hardwood. The ceiling is modern drywall and holds electric lights that are accessed from a hatch in the tower; these were added in 1947.⁴ In the center is a diamond-shaped panel, painted to match the borders and framed with simple plaster trim; it dates from before 1895, when it appears in an illustration in the *Souvenir of Ogdensburg*.⁵ (See Figure 6.)

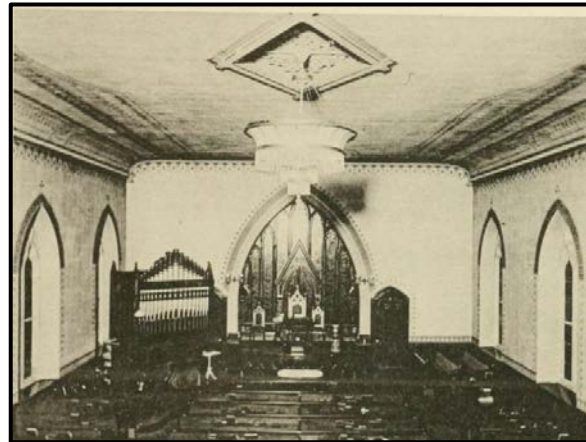
Figure 6. Interior, First Baptist Church, 1895, from the *Souvenir of Ogdensburg*.

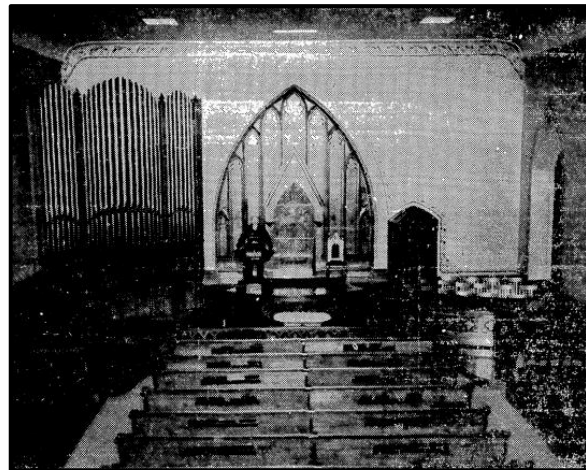
Figure 7: Interior, First Baptist Church, 1947. Note installation of the stained-glass window in apse.

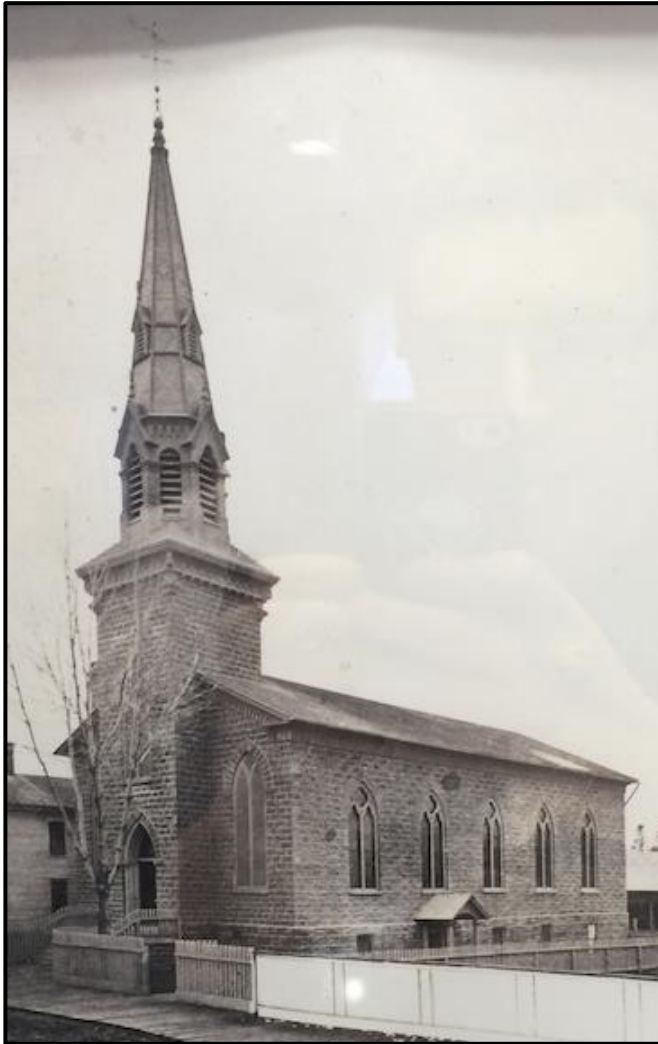
Figure 8. First Baptist Church of Ogdensburg after 1871 and prior to the fire that destroyed its spire. (Church Archives).

The exterior stonework was also reconstructed, apparently adding the wythe and decorative quoins to the building. (This visibly striking feature does not appear in Figure 8.) One element of the church that was not repaired was the spire. Afraid that lighting striking the steeple could cause another fire, a man living next to the church donated a sum of money for its repair on the condition that a new steeple not be erected. The congregation accepted his funds and the building has remained without a steeple since.

The original building, with its rectangular plan and engaged entrance tower, seems to have been an example of the Wren-Gibbs Protestant meetinghouse type common to the period. In 1855, the church was extended by twenty-four feet, and the pulpit reversed so that the congregation no longer faced east. The rearmost stone lintels on both the north and south sides of the church differ from the others but, interestingly, no clear line denotes the extension, indicating that the church was refaced at a later point. The church's current design appears to reflect one early detail described by historian Sally Svenson. She notes that Federal style churches in the Adirondack region of New York frequently possessed, "quoins set at an outer edge of the façade and tower."⁸² The First Baptist Church has quoins in contrasting colors that run the height of the primary façade, the central projecting tower, and the main entrance. However, contemporary photographs (Figures 8 and 9) show that this feature was added after 1881, an apparent anachronism. Another early feature – the projecting water table – appears to be original. Records indicate that a finished basement meeting room was being used before the building was finished, and the water table can be seen in the photograph (Figure 8) of the 1871 church.

indicates that the reconstruction was considered extensive: *First Baptist Church. Erected in 1831. Rebuilt in 1871.* This appears to be when the building became more definitively Gothic Revival in style. The national popularity of this style dates from 1840 to 1880.⁸³ Sally Svenson lists the following features in Gothic Revival churches in the Adirondacks: stone construction, lancet windows, arched doorways, and the placement of a church tower out in front of the main building.⁸⁴ While the 1830-1833 church had the basic form and engaged tower, Figure 8 shows a belfry and tall hexagonal steeple with patterned

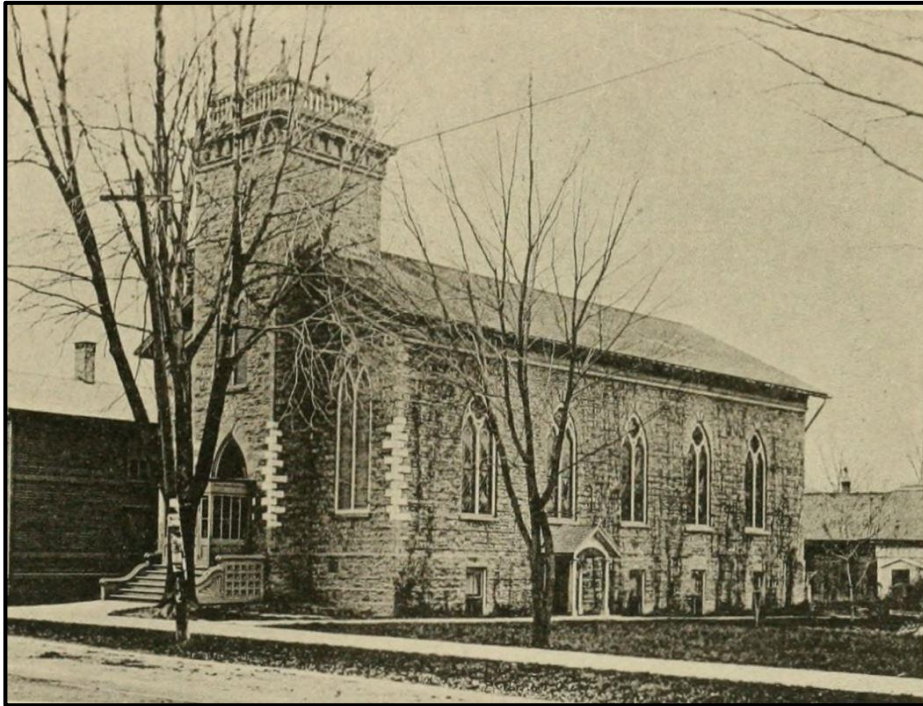
Figure 9. The 1895 *Souvenir of Ogdensburg* shows the First Baptist Church in its current form.

The last major change to the exterior was in 1881 and resulted from the fire that destroyed the roof and upper stages of the tower. A picture from that era shows the building with a shorter, square tower surmounted by a delicate wood balustrade. (This short tower may be closer in height of the tower on the 1830-1833 church.) Also new are the stone veneer and white decorative quoins, which are in startling contrast to the other elements of the trim. It is unclear whether the white quoins were a deliberate choice. A geological explanation for their appearance – which includes the apparently random placement of occasional white stones in the stone veneer – is also possible. Various inclusions, which weather to white, are found within the local grey limestones, and one hypothesis is that two types of stone were inadvertently mixed. However, the 1895 photograph (Figure 9) shows the white quoins after less than fifteen years of weathering which suggests that the effect was deliberate.

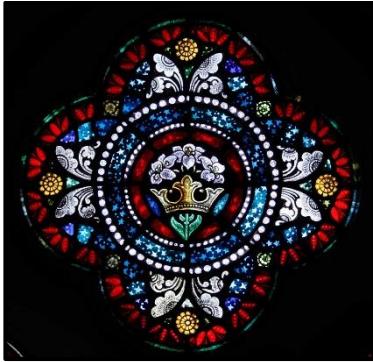
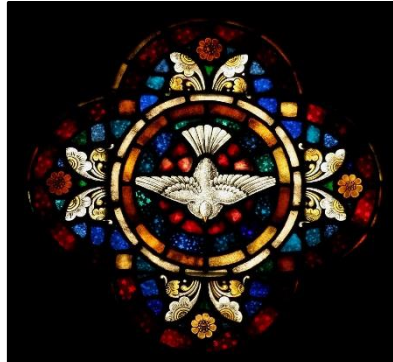
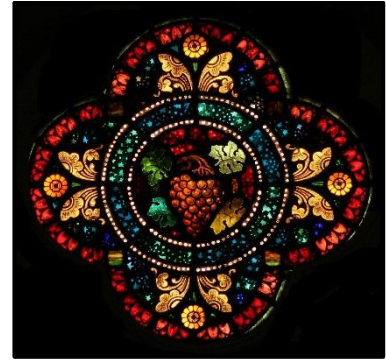
Figures 10-12. Quatrefoils.

quatrefoil is a small image of religious significance that compliments the main image below; these quatrefoil images include bibles, a dove, crown, bundles of wheat, sheep, flowers, and grapes. For example, the star in “The Wise Men Bring Jesus Gifts” signifies the Star of Bethlehem that guided the Wise Men to Jesus, while the grapes in “The Last Supper” signify wine and Jesus’s proclamation that wine was the blood of his new covenant. In “Jesus Blessing the Little Children,” the quatrefoil displays the Lamb of God, traditionally a symbol of innocence, while the lancets display Jesus blessing a group of infants and adolescents, another symbol of innocence.

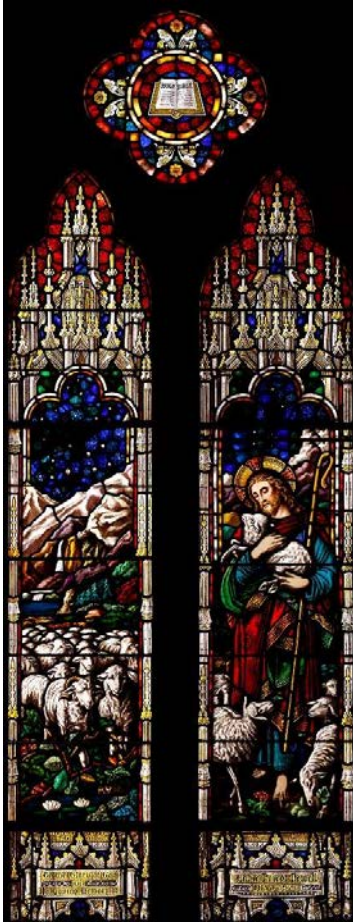
Figure 13: Jesus the Good Shepherd.

Jesus is the primary figure in each window, depicted during important moments in his life, such the Nativity, Last Supper, and Resurrection. The windows are extremely complex – some composed of more than 1,000 individual pieces of glass set individually into a frame and leaded together to create a harmonious image. In addition to their artistic qualities, all of the stained-glass windows in the First Baptist Church are operable to ventilate the church on hot summer days.

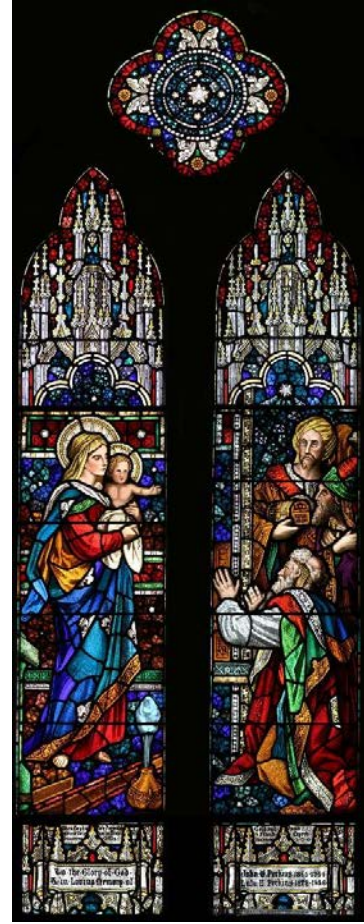
Figure 15: The Wise Men Bring Jesus Gifts.

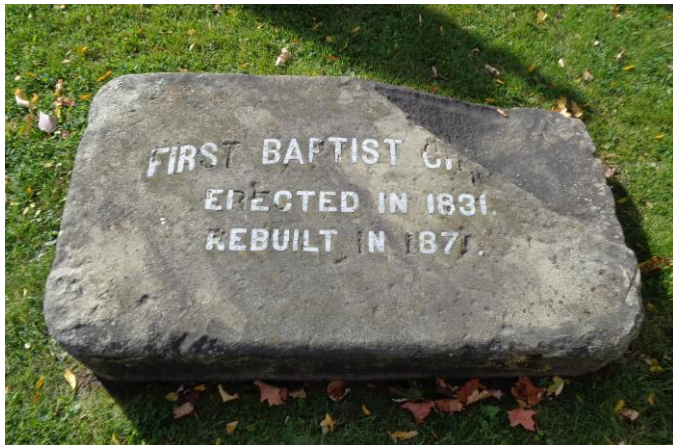
Figure 17. Dedication stone, 2017.

After the 1855 extension and interior rearrangement, the building was further refurbished in 1860-61, and another major alteration was carried out again in 1871. A dedication stone outside the entry steps of the church

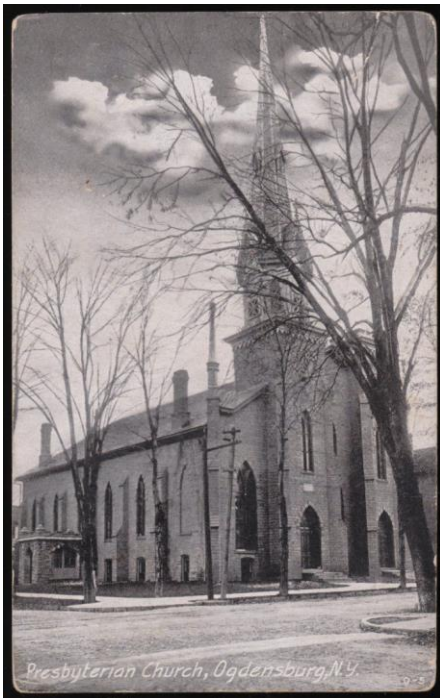
Figure 18. Presbyterian Church of Ogdensburg, (late nineteenth century).

The church's external appearance, reconstruction, and style are not uncommon for mid to late-nineteenth-century religious buildings in Ogdensburg. The stone Presbyterian Church was built in 1824-1825 and extensively rebuilt twice – once in 1848 with a replacement bell tower and again in 1866 in the Gothic Revival style. Only one wall of the original building survives, and it extends only half the height of lancet windows (apparently added later). Both the United Methodist Church (1850) and Notre Dame Catholic Church (1859) have large projecting center towers. The Methodist Church also uses decorative quoins in a contrasting color but, being earlier, has rectangular windows. Notre Dame Catholic Church has short lancet windows, but no quoins, and its tower was once one level taller. Both buildings are brick rather than stone.

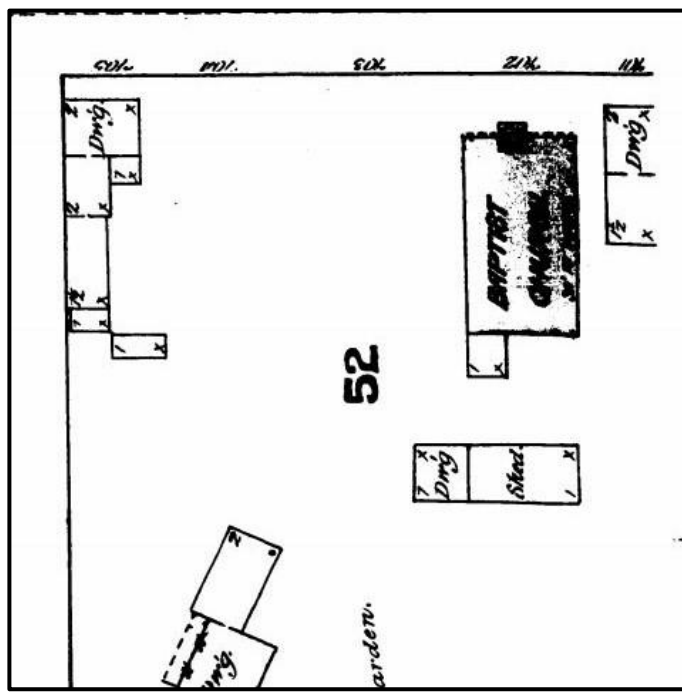
Figure 21. Sanborn Fire Insurance Map from 1884 depicting the First Baptist Church of Ogdensburg, Sexton's Dwelling, and Horse Shed. Note the Parsonage is still a private dwelling. (Sanborn Map Company, Ogdensburg, St. Lawrence County, New York, 1884, Sheet 2.)

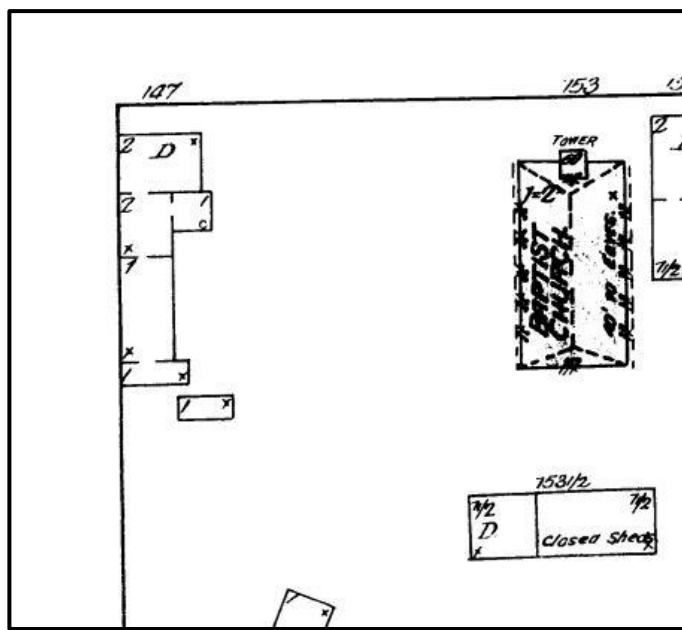
Figure 22. Sanborn Fire Insurance Map from 1892, showing the Parsonage as a private dwelling with a one-story addition where the tower was later built. (Sanborn Map Company, Ogdensburg, St. Lawrence County, New York, 1892, Sheet 9.)

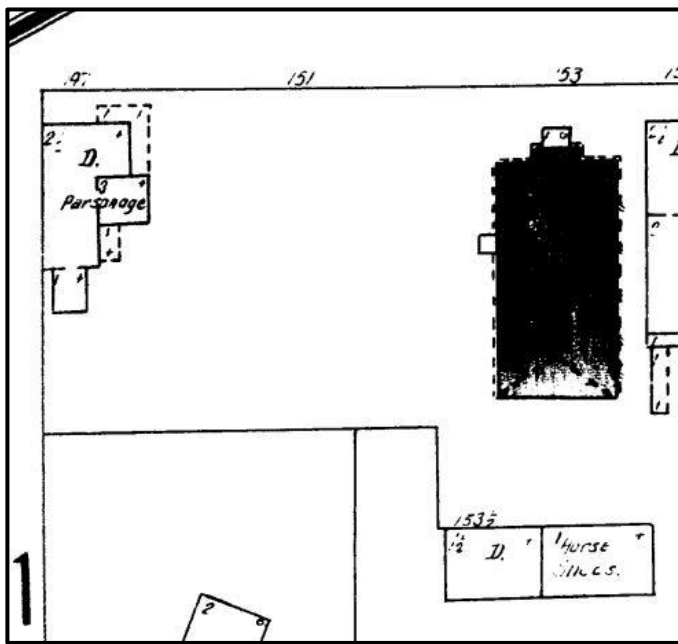
Figure 24. Sanborn Fire Insurance Map from 1904 labeling the parsonage and describing the tower as 3 stories high. It had probably not changed its configuration, only the criteria applied to it. (Sanborn Map Company, Ogdensburg, St. Lawrence County, New York, 1904, Sheet 11.)

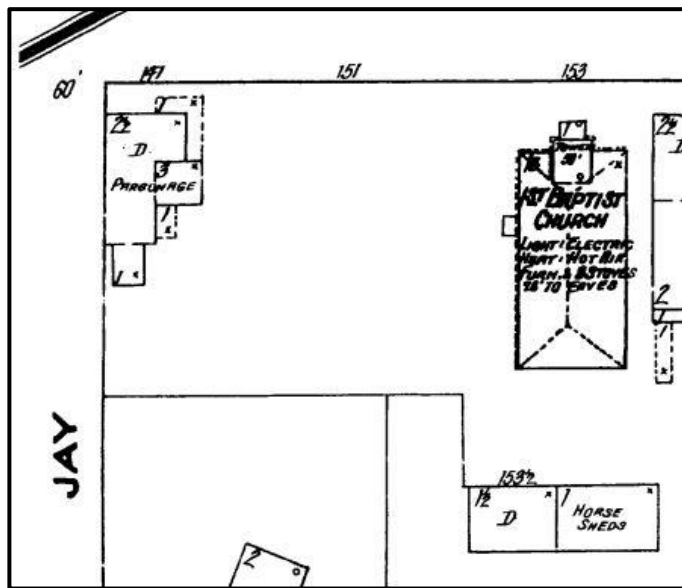
Figure 25. Sanborn Fire Insurance Map from 1909. No change. (Sanborn Map Company, Ogdensburg, St. Lawrence County, New York, 1909, Sheet 16.)

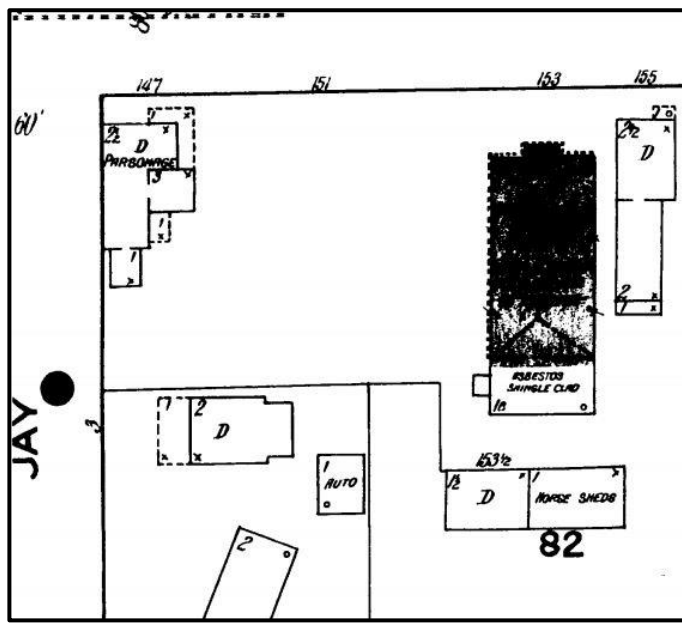
Figure 26. Sanborn Fire Insurance Map from 1918. The 1914 addition is visible at the rear of the church, along with the removal of the old entrance to the basement from the side elevation of the church. (Sanborn Map Company, Ogdensburg, St. Lawrence County, New York, 1918, Sheet 16.)
