1. Name of Property	
Historic name Balfour Dock Building	
Other names/site number Working Waterfront Museum	
2. Location	
street & number 705 Dock Street	not for publication
city or town - Tacoma	vicinity
	zip code98402

### **Narrative Physical Description**

Constructed in 1900 as part of a mile-long complex of wheat warehouses, the Balfour Dock Building is located along the waterfront in Tacoma, Washington. Set between the Northern Pacific's Half Moon Rail Yard to the west and the Thea Foss Waterway to the east, this broad, single-story, timber-frame building occupies a 143' x 300' footprint on a flat rectangular lot. The structure bears primarily on concrete footings, its foundation walls set on fill retained behind a rock sea wall. The eastern third of the building extends out over the Thea Foss Waterway on flat, heavy timber trusses and poured concrete beams. Composite timber and metal trusses provide the framing and structural divisions inside the building. Sidewall posts carry the trusses, and wood studs infill between the posts. A second set of inner posts, interconnected by north/south running beams, provides bridging for lateral rigidity between the trusses.

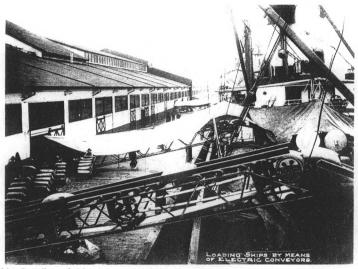
Ca. 1901. Loading of ships by means of electric conveyors. Source: Tacoma Public Library.

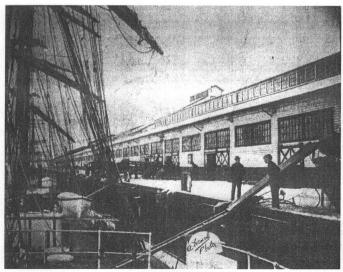
1902. Loading of wheat from the Balfour Dock onto the "Puritan." Source: Tacoma Daily
