NATIONAL REGISTER OF HISTORIC PLACES REGISTRATION FORM

1. Name of Property			
Historic Name: Slack-Comstock-Marshall Farm			
Other Name/Site Number: <u>CW 0186</u>			
2. Location			
Street & Number: N. of Arkansas Hwy 220 West			
	Not for Publication: N/A		
City/Town: <u>Uniontown</u>	Vicinity: N/A		
State: AR County: Crawford Code:	AR 033 Zip Code: 72955		
3. Classification			
Ownership of Property: Private			
Category of Property: <u>Building</u> Number of Resources within Property: Contributing Noncontributing			
Number of contributing resources previously lisk Register: $\underline{N/A}$	sted in the National		
Name of related multiple property listing: N/	'A

11. Form Prepared By				
Name/Title: Patrick Zollner, Architectural Historian				
Organization: Arkansas Historic Preservation Program Date: April 4, 1995				
Street & Number: 1500 Tower Bldg., 323 Center St. Telephone: (501) 324-9880				
City or Town: Little Rock State: AR ZIP: 72201

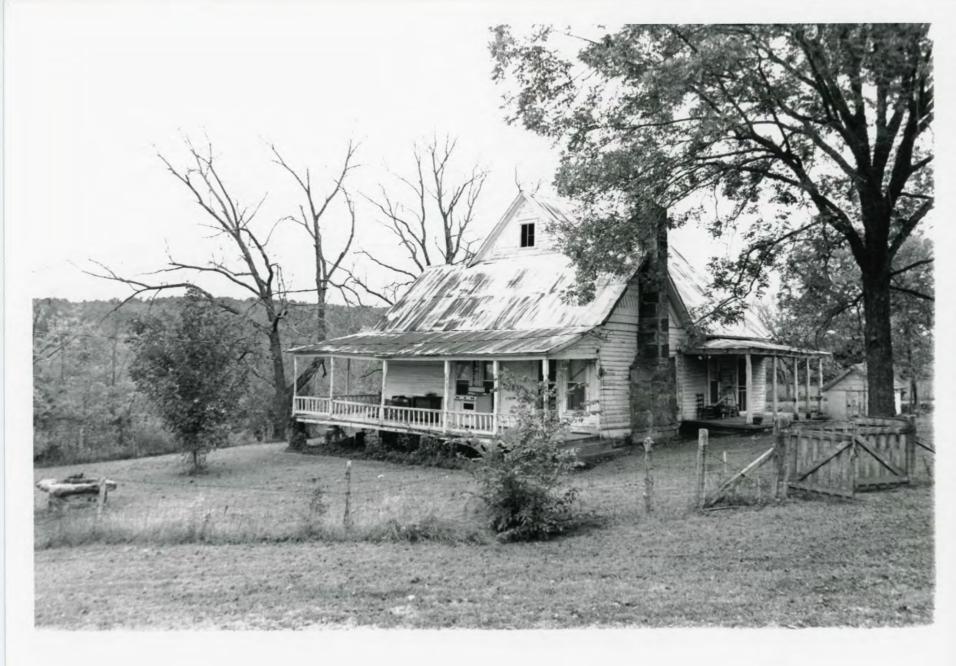
Slack-Comstock-Marshall Farm Uniontown, Crawford Co., Ark. Photo. by P. Zollner Oct. 1994 Neg. on file at AHPP View from the southeast

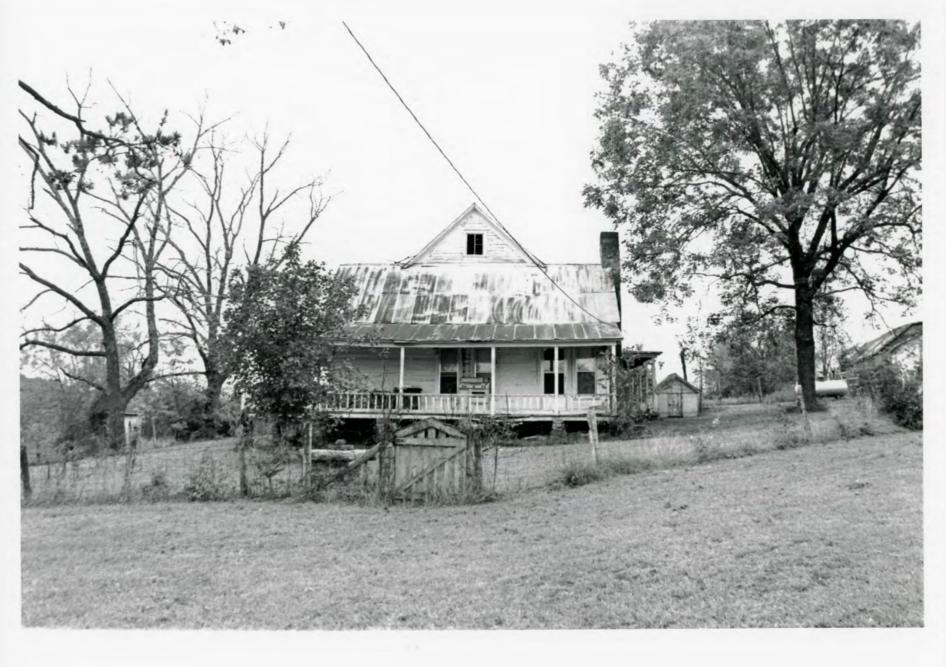
The front, or southern, elevation consists of the side-gabled double pen, the rear cross-gable end which extends above the side-gable roofline, and a shedroofed porch that wraps around to the western elevation. The entire wraparound porch is supported by eight turned-spindle and four chamfered posts with a stick balustrade. The chamfered posts, being the older design, are located on the front elevation. The front wall, which is entirely shielded by the porch roof, consists of double-beaded board that is documented in a historic photograph showing the Marshalls on the porch shortly after they acquired the property in 1918. Because the addition on the western elevation utilizes conventional weatherboard beneath the porch roof, it is probable that the beaded board is original to the double pen. The window/door arrangement was altered somewhat in the 1970's. Originally, this elevation contained a pair of one-over-one, double-hung windows in the center of the facade (one for each room) and a single-leaf door at the extreme eastern end The wood-panelled and half-glazed door was moved the of the elevation. distance of its width to the west and a one-over-one, double-hung window was added in the door's former location. Above the metal porch roof, the cross gable end is sheathed with conventional weatherboard, and the attic is lighted by a stationary four-pane window.

Slack-Comstock-Marshall Farm Uniontown, Crawford Co., Ark. Photo by P. Zollner Oct. 1994 Neg. on file at AHPP View from the south

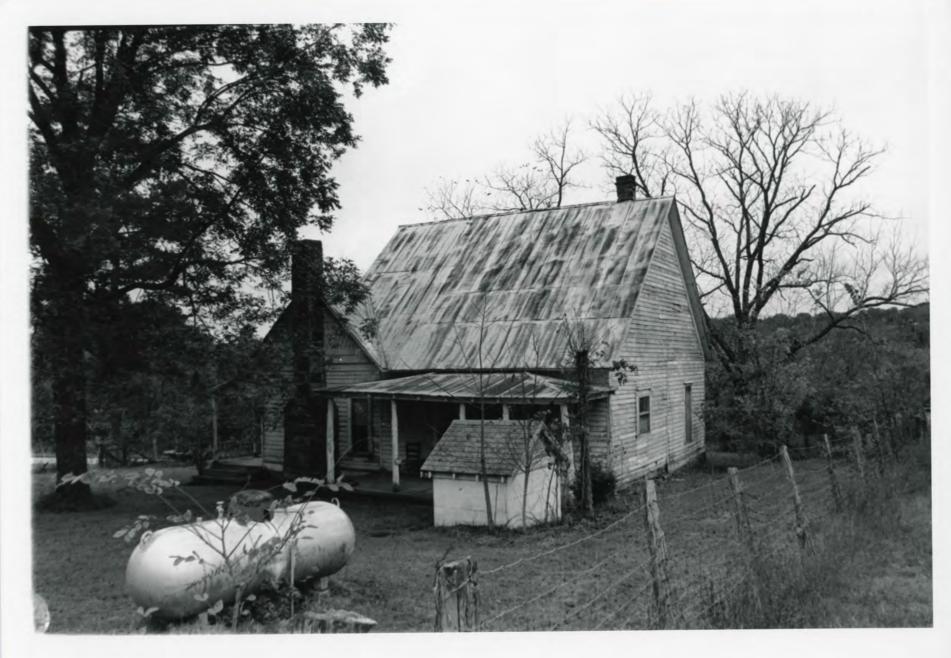
Slack-Comstock-Marshall Farm Uniontown, Crawford Co., Ark. Photo. by P. Zollner Oct. 1994 Neg. on file at AHPP View from the east / northeast

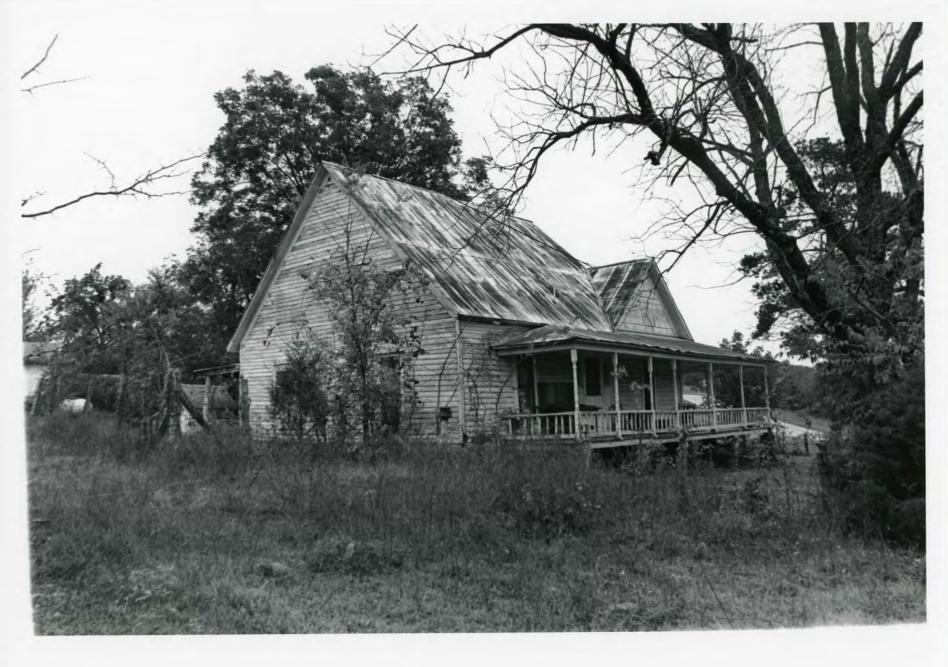
Slack-Comstock-Marshall House and Farm Uniontown, Crawford Co., Ark. Photo by P. Zolher Oct. 1994 Neg. on file at AHPP View from the northwest

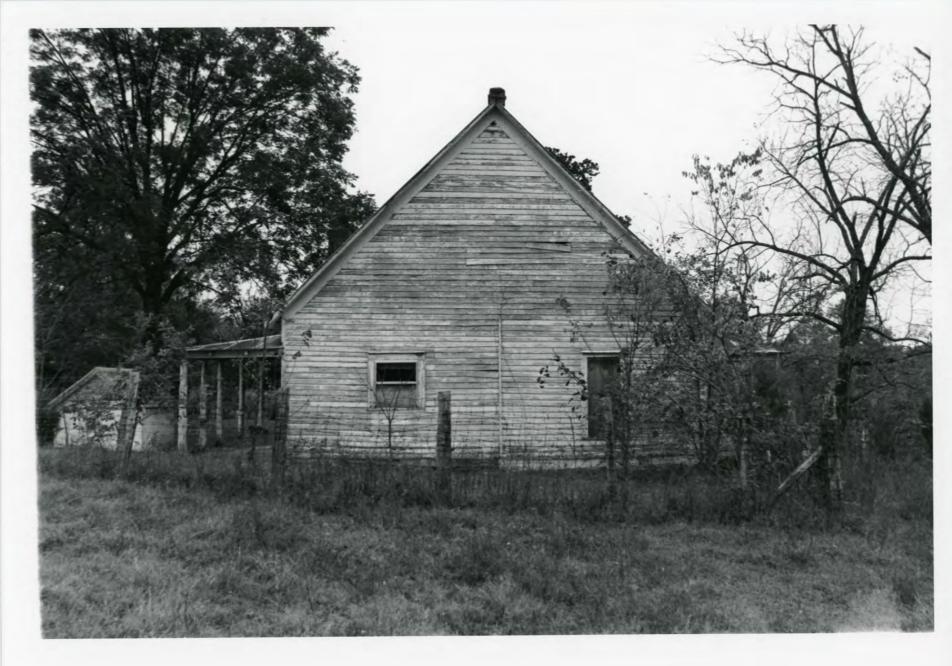
The rear, or northern, elevation is unadorned and contains only a regular one-over-one window to the west and a shorter one-over-one window to the east.

Slack-Comstock-Marshall Farm Uniontown, Crawford Co., Ark. Photo by P. Zollhor Oct. 1994 Neg. on file at AHPP View from the north

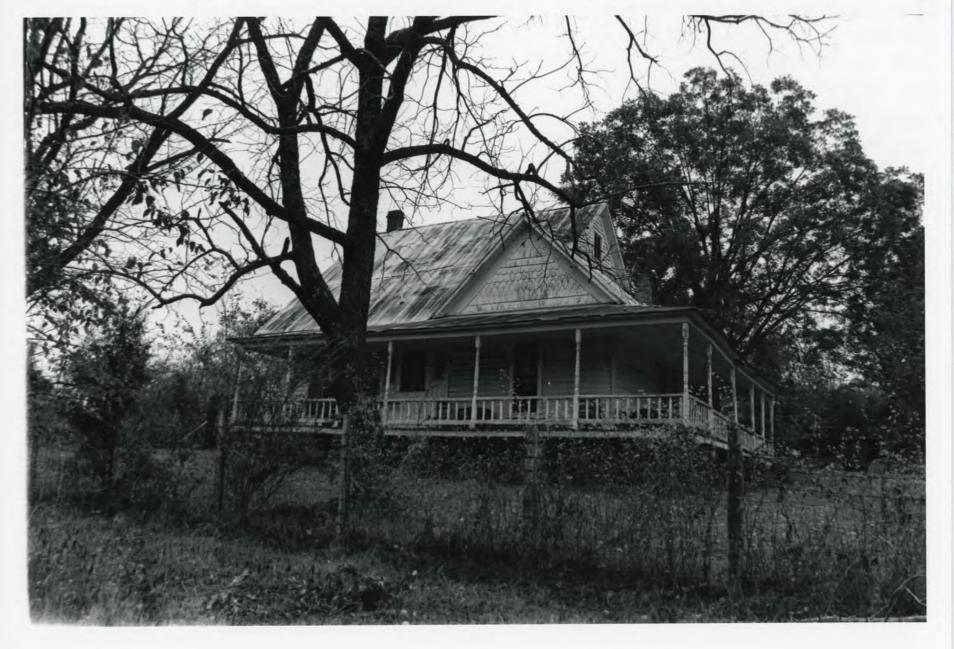
The western elevation of the double pen contains a single one-over-one window underneath the wrap-around porch and a gable end decorated with coursed, fishscale, and diamond-patterned wood shingles. To the north, on the addition, a single-leaf wood door and half sidelights were installed when the addition was constructed. Consequently, the front of the house was reoriented to the west. The door was removed and a small window added in 1948 when the house was modernized and a bathroom created out of the hall. A one-over-one window is placed to the north of this former entry and is just underneath the hipped ridge of the wrap-around porch, which extends almost the entire length of this elevation.

Slack-Comstock-Marshall Farm Union town, Crawford Co., Ark. Photo by P. Zollner Oct. 1994 Neg. on file at AHPP View from the west

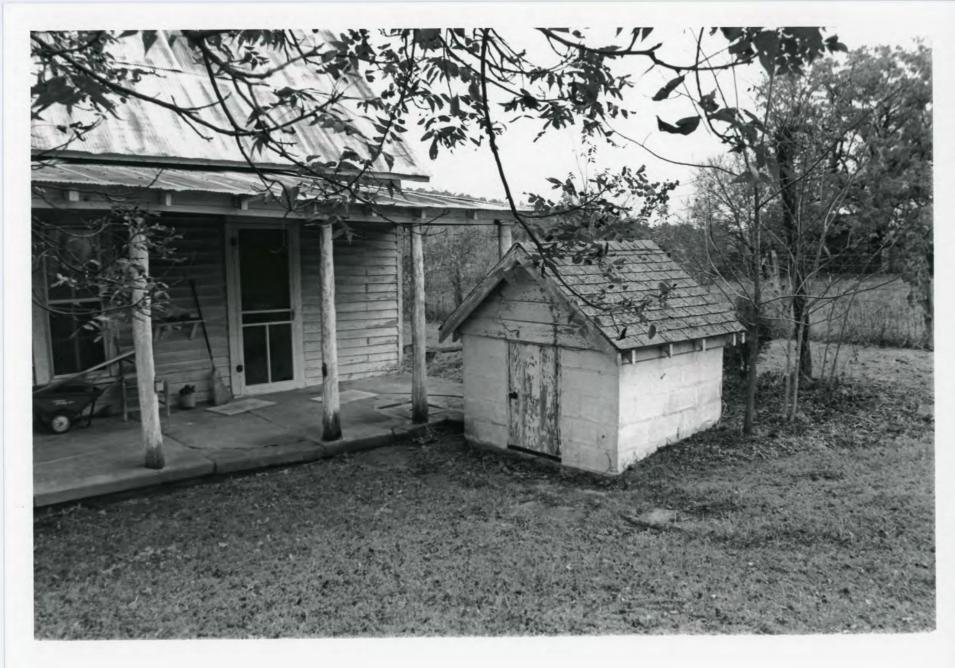
A hipped-roof porch supported by five peeled cedar posts on a concrete floor comprises the majority of the eastern elevation. This porch, added by the Marshalls to the north of the elevation during the historic period, protects a single-leaf door to the north and a four-over-four, double-hung window to the south. The gable end of the double pen features the aforementioned cutstone chimney, a four-over-four window to the north of the chimney, and shingle treatment similar to its western counterpart.

Slack-Comstock-Marshall Farm Uniontown, Crawford Co., Ark. Photo by P. Zollher Oct. 1994 Neg. on file at AHPP View of rear porch and pumphouse From the southeast

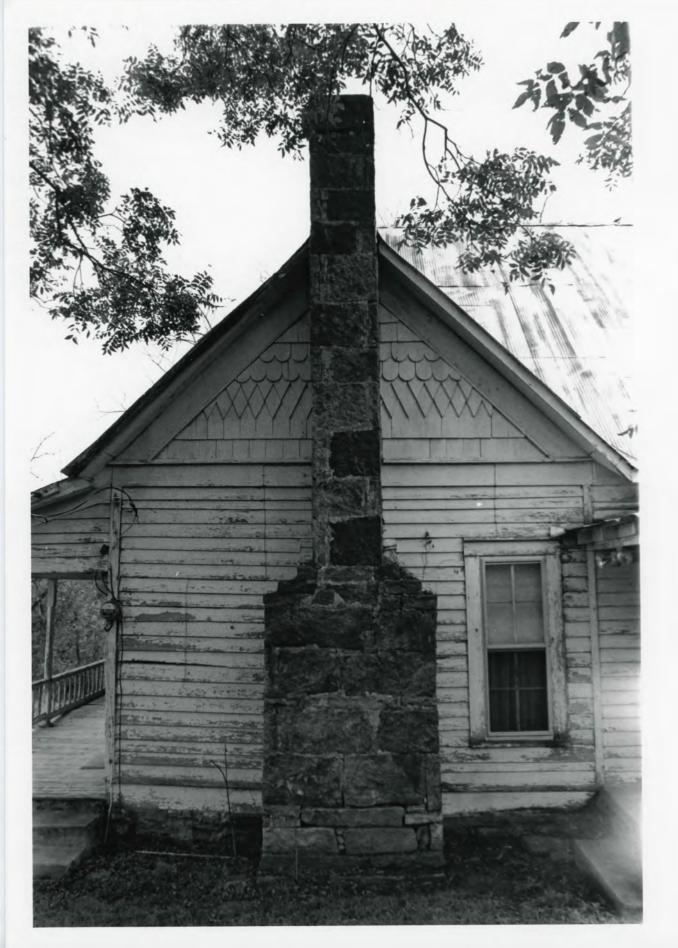
Slack-Comstock-Marshall Farm Uniontown, Crawford Go., Ark Photo by P. Zollner Oct. 1994 Neg. on file at AHPP View from the east

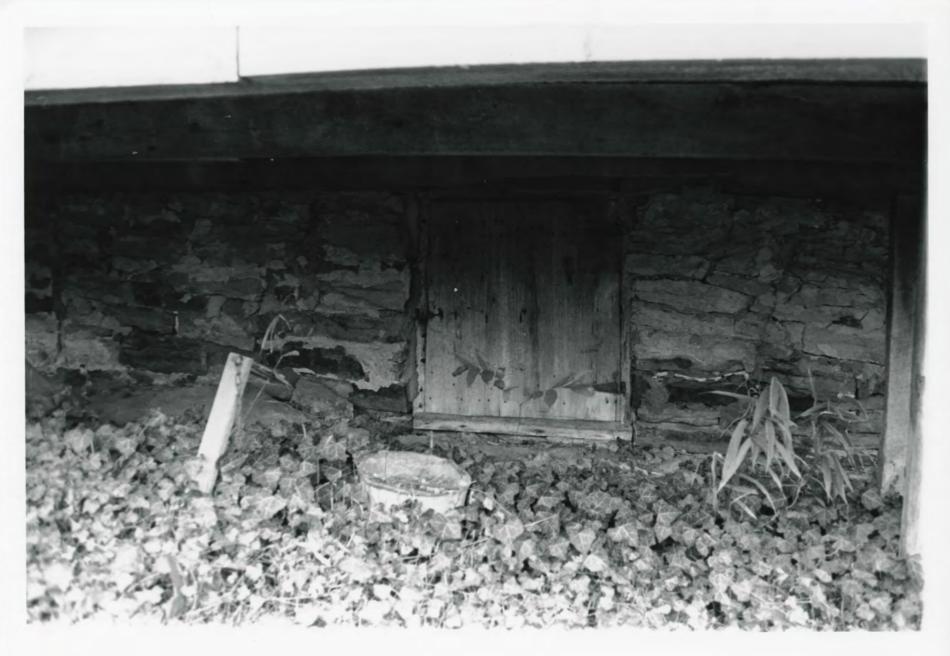
A continuous stone foundation with an incorporated post oak pier supports the structure, while the wrap-around porch rests upon stone piers. The cross-gable roof is covered with corrugated metal that was added over the original wood shingles in 1935. In addition to the exterior stone chimney, there is one interior brick chimney at the rear of the house.

Slack-Comstock-Marshall House and Farm Uniontown, Crawford Co., Ark, Photo by P. Zollher Oct. 1994 Neg. on file at AHPP New of stone foundation View of stone foundation underreath porch froor

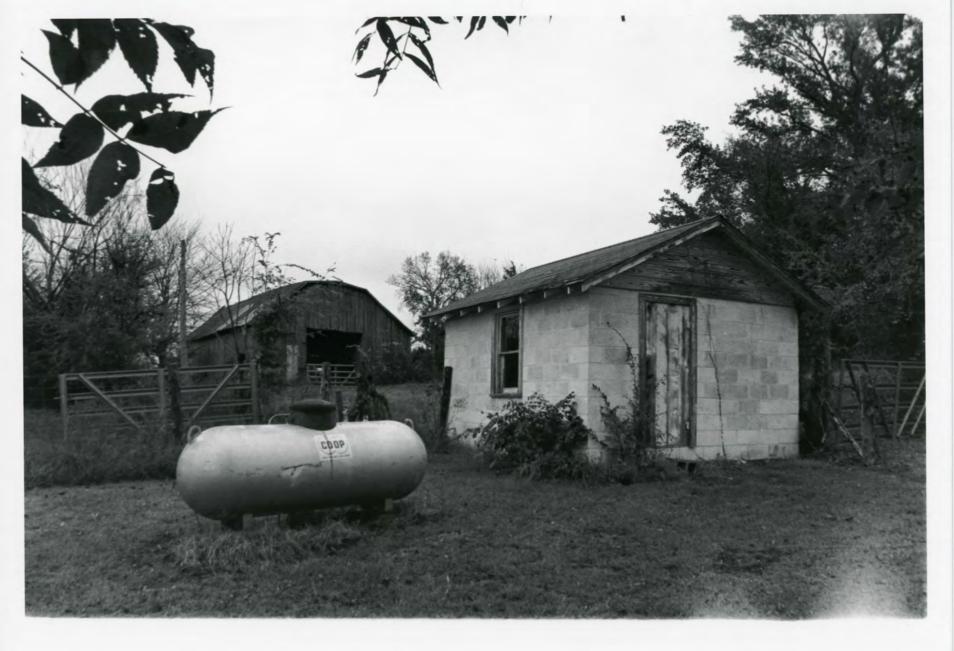
Slack-Comstock-Marshall Farm Uniontown, Crawford Co., Ark. Photo by P. Zollher Dct. 1994 Neg. on file at AHPP View of pumphouse and barm from the south west

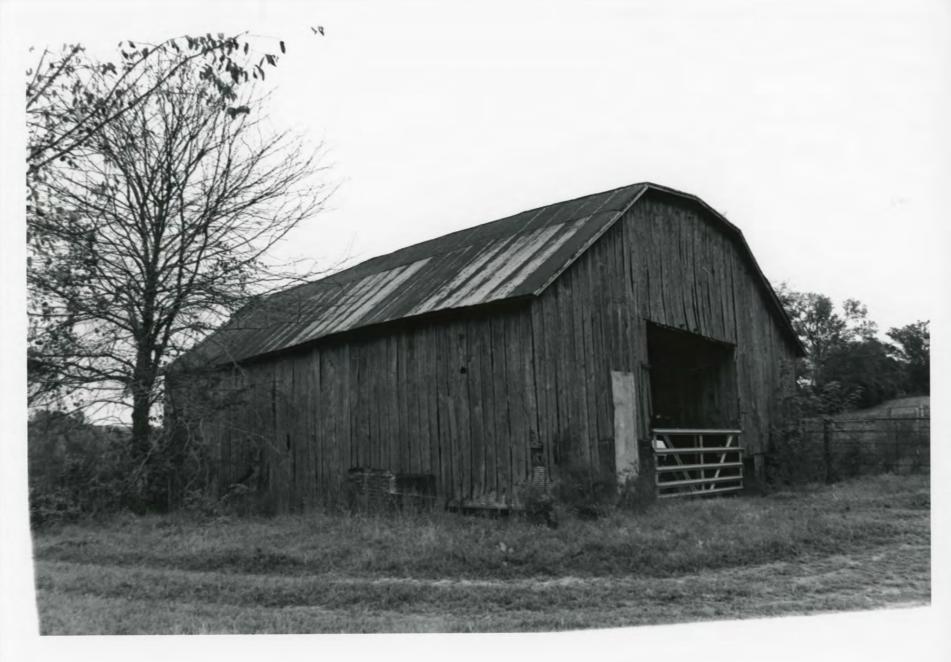
the house is a livestock barn built in 1922 after the earlier barn burned. Erected at a cost of \$500, the barn was constructed of vertical rough-sawn oak lumber and covered by a metal-covered gable roof with a dual pitch that is nearly flat at the top. A historic dug well with a stone well head is located in the front of the house. There are two noncontributing pumphouses constructed in the late 1940's northeast of the house and between it and the barn. Both are constructed of modern-type formed concrete blocks. The smaller pumphouse nearest the house was erected over an existing well; however, this source was soon exhausted, and a new well was dug several feet to the northeast and a larger pumphouse constructed.

Slack-Comstock-Marshall Farm Uniontown, Crawford Co., Ark. Photo by P. Zollher Oct. 1994 Neg. on file at AHAP View of barm from the southwest

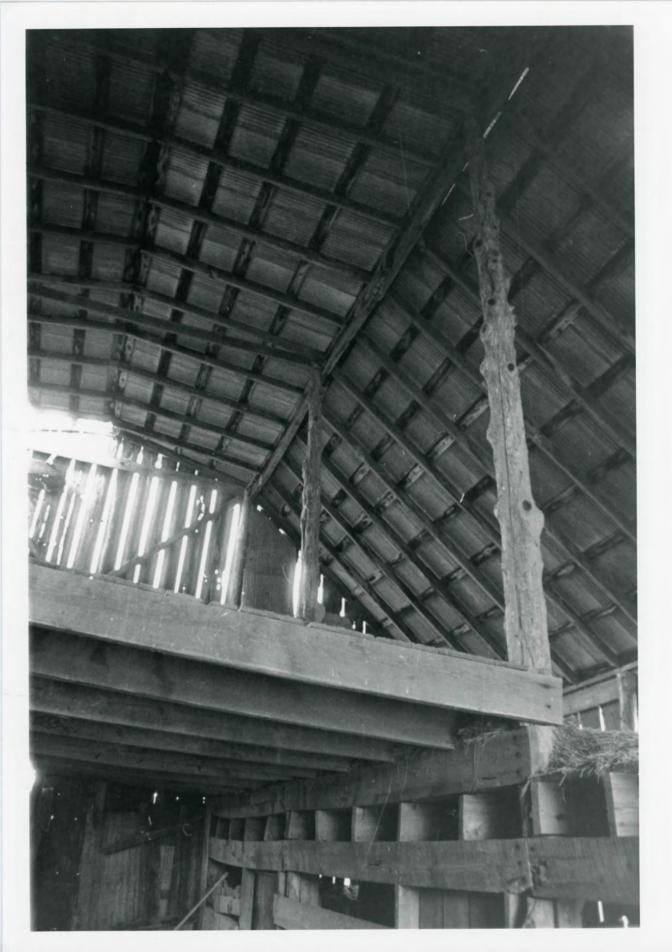
Slack-Comstock-Marshall Farm Uniontown, Crawford Go., Ark. Photo by P. Zollner Oct. 1994 Neg. on file at AHPP View of Burn interior From the southwest

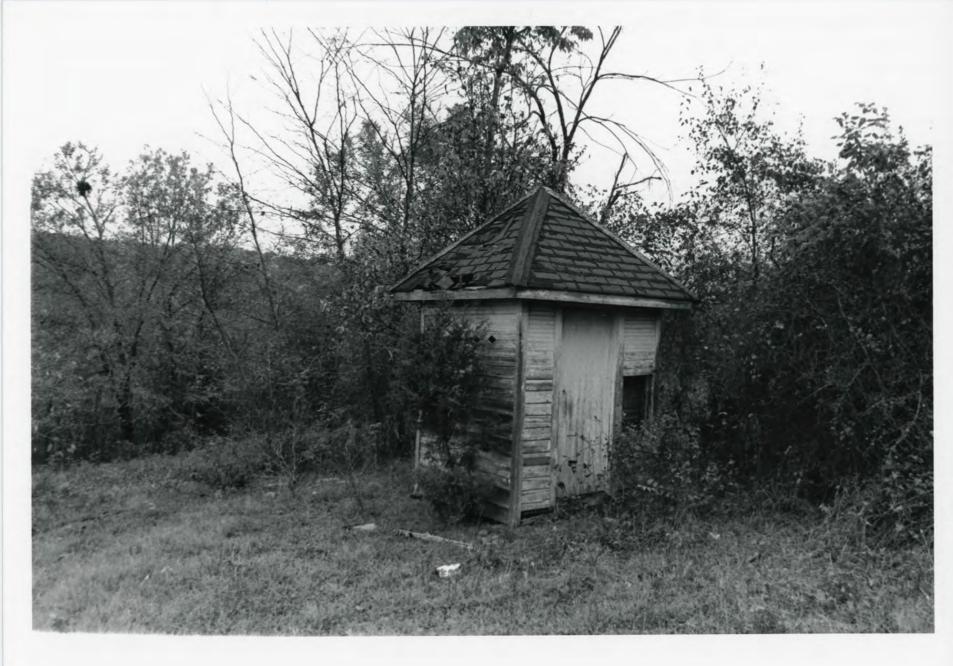
The Slack-Comstock-Marshall Farm contains several outbuildings and extensive fencing of indeterminate age. To the northwest of the house stands a frame privy with a hipped roof that dates to 1886. A gift from Ruth's father, the structure was moved to the Marshall property c. 1935. To the northeast of

Slack-Constock-Marshall Farm Uniontown, Crawford Co., Ark. Photo by P. Zollner October 1994 Neg. on file at AHPP View of privy from the Southeast

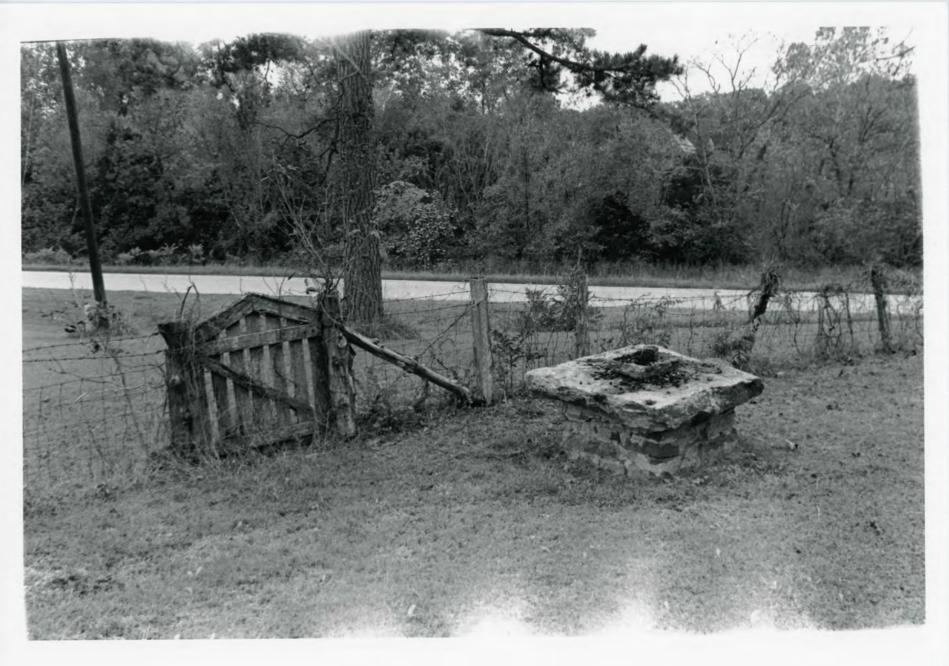
Slack-Comstock-Marshall Farm Uniontown, Crawford Co., Ark. Photo by P. Zollner Oct. 1994 Neg. on file at AHPP View of otenewell from the northeast

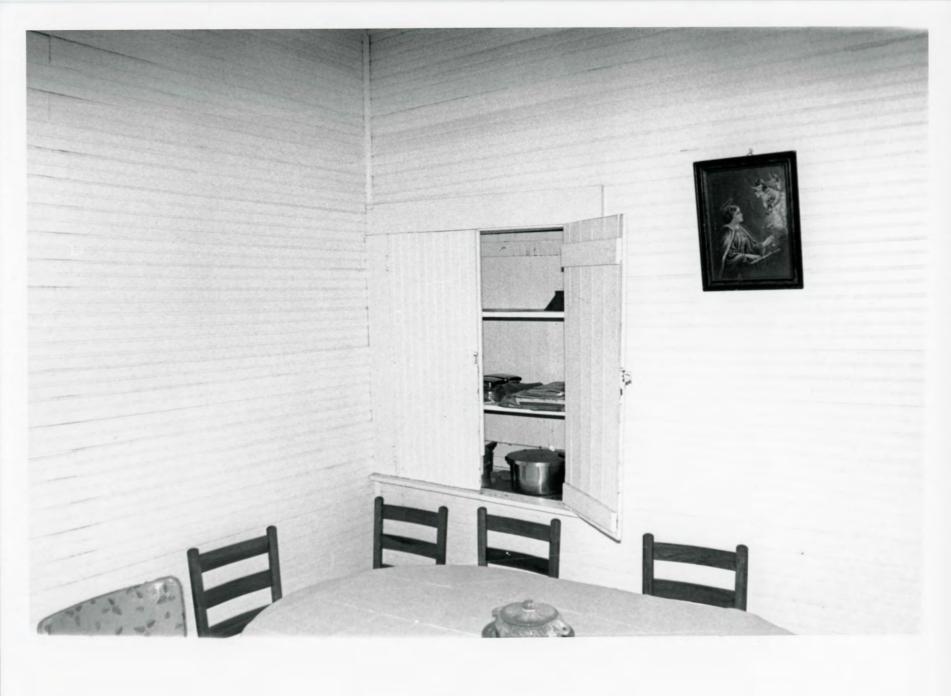
Slack-Comstock-Marshall Farm Unionteum, Crawford Co., Ark. Photo. by P. Zollner Oct. 1994 Neg. on file at AHPP View of dining soom

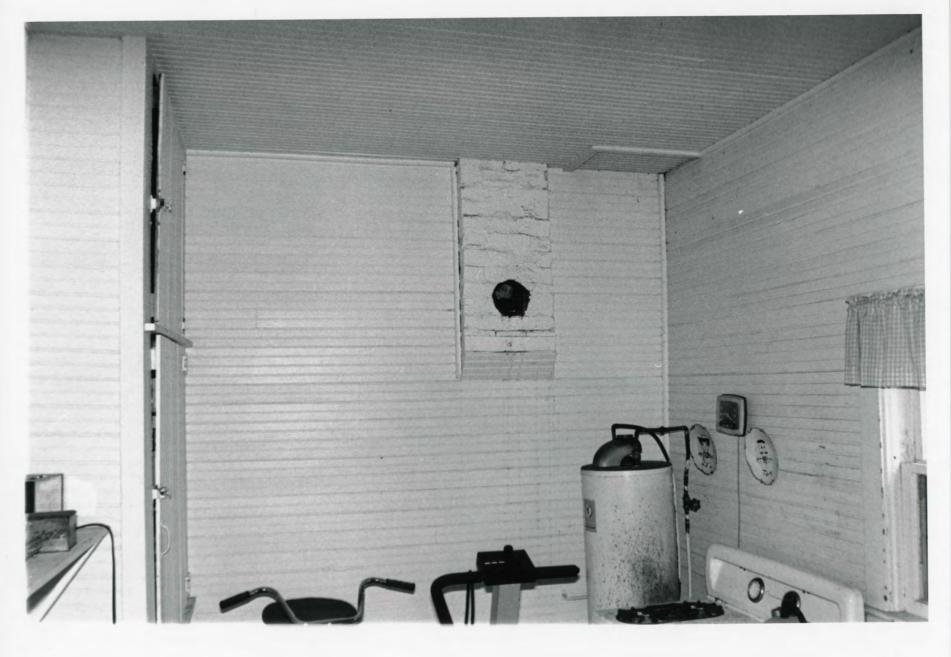
As alluded to in the exterior description, the interior has been changed somewhat since 1918. The first major change occurred in 1948 when the house was wired for electricity and the kitchen cabinets and bathroom were added. In the 1970's after the death of Tom Marshall, simulated wood panelling was applied to the living room (and over the fireplace) and one bedroom, and carpet was laid in the kitchen, dining room, living room, and one of the bedrooms. Still, most of these changes are reversible and much of the original simple trim moldings and beaded-board walls remain visible.

Slack-Comstock-Marshall Farm Uniontown, Crawford Go., Ark. Photo. by P. Zollher October 1994 Neg. on file at AHPP View of Kitchen
