HISTORIC RESOURCES INVENTORY
BUILDING AND STRUCTURES

| IDENTIFICATION | 1. BUILDING NAME (Common) (Historic) | | Norton House | | |
| | 200 Pine Orchard Road | | | | |

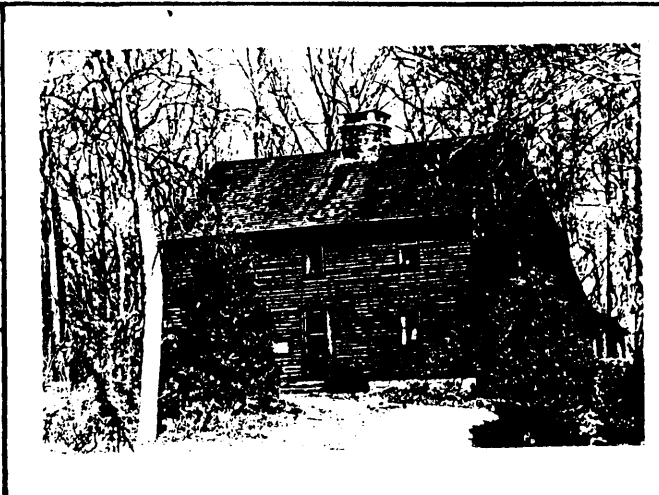
| West & South Elevations | | CHC-File 45 Neg 8 |

| | <p>Constructed on a rectangular plan with its ridge parallel to the street, this structure has a steeply pitched roof with a minimal overhang at the cornice. Its stone center chimney straddles the ridge. It has a five-window facade and a three-window gable exclusive of the lean-to at the rear of the house. Windows have eight-over-twelve sash. Its entry has wide jambs and flared head trim. A one-story addition is located at the rear of the house.</p> | |
