KENTUCKY HISTORIC RESOURCES
Individual Inventory Form

1. Name of Resource:
J. B. Allen House

5. Location: West side of KY 53, 1/2 mile
north of Chestnut Grove

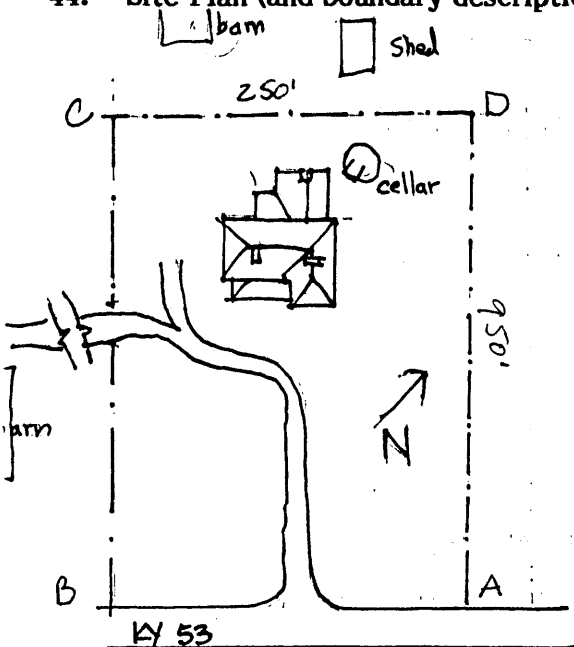
44. Site Plan (and boundary description and justification for N.R. sites):

Beginning at A, southwest 250' along the west side of KY 53 to B, thence 950' northwest along a fence to C, thence 250' northeast along a fence to D, thence 950' southeast along a fence to the point of origin. The boundaries were chosen to encompass the house and its domestic-related space as defined by fences and the road as separate from the surrounding fields. A tree-lined drive leads up to the house from KY 53 and adds an important visual quality to the site. Included is an underground cellar.

Point A is at the intersection of the northeastern yard fence with the northwestern edge of KY 53 and is 100 feet northeast of the northeast edge of the drive at KY 53.

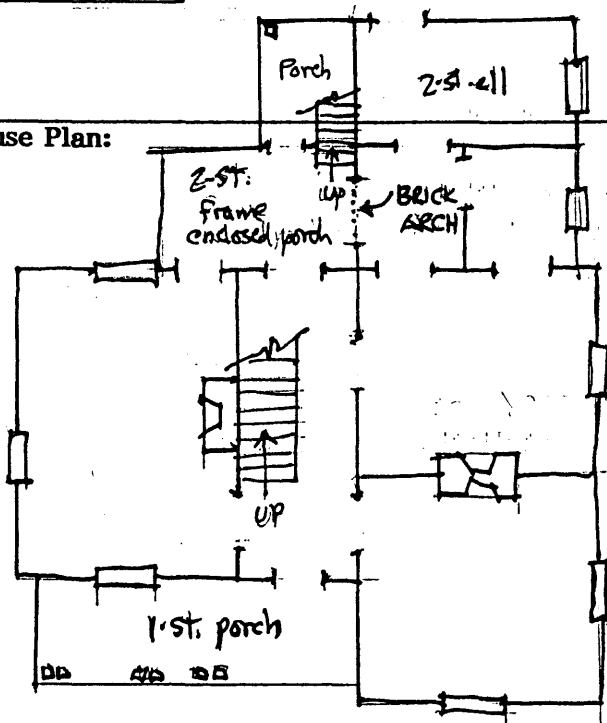
45. Description and House Plan:

2-story, brick T-plan with passage, asphalt shingle, hipped roof, running bond on principal (southeast) facade, segmental arched brick hood molds over 2/2 sash windows, cornice removed, handsome 1-story wood porch on new concrete foundation with paired columns, brackets, and jig-sawn trim, coursed stone foundation, 1 1/2-story ell, enclosed shed-roofed porches in angle of ell, open space on first floor along south-

west side of ell with enclosed stairs, brick arch (see plan) appears original and space to north of arch gives access to pantry (?) and kitchen.

Eared door and window surrounds, 4-panel doors, original woodwork throughout, mantels original.
