# National Register of Historic Places Registration Form

Historic name: Harmony Mennonite Meetinghouse and Cemetery

Street & number: 114 Wise Road

City or town: Jackson Township State: PA County: Butler

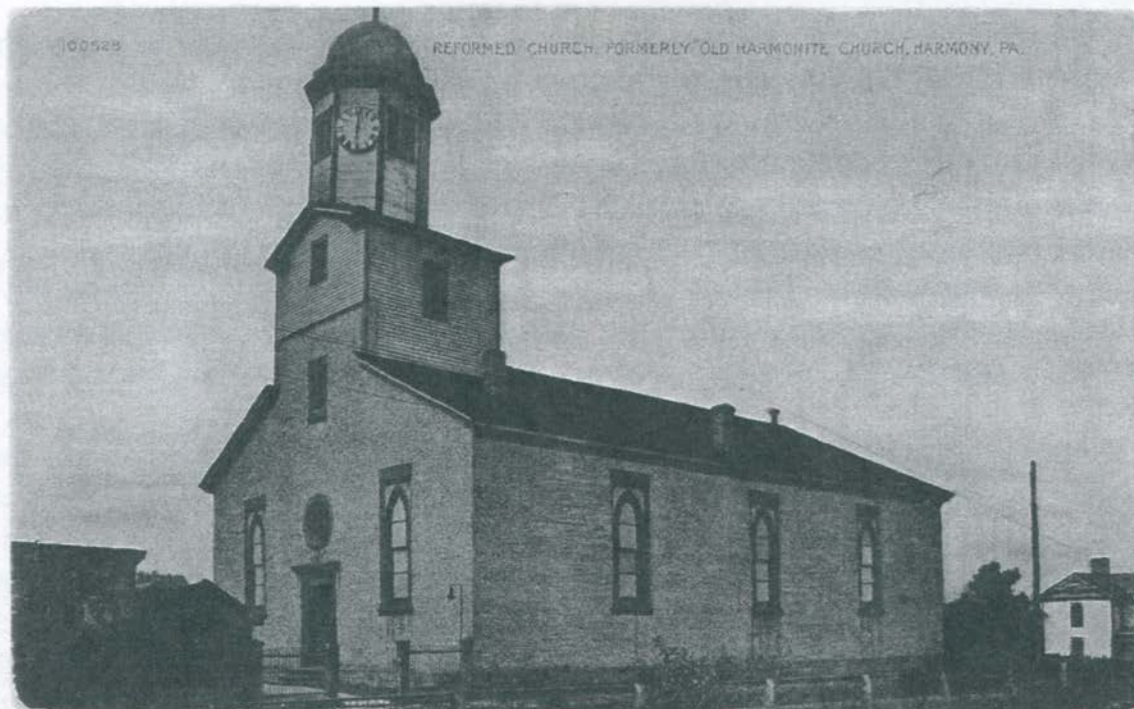
Figure 3: Harmonist Church, sometimes referred to as Rappite Church, built in 1808 at 538 Main Street, Harmony, Butler County, Pennsylvania. When the Harmonists left for Indiana a German Evangelical and Reformed congregation shared this church with the Mennonites before they built the meetinghouse south of Harmony village. Now owned by Grace Church of Harmony and greatly altered.

Founded in 1816, Harmony's Mennonite congregation originally shared space with a German Evangelical and Reformed congregation at the Harmony village church building built in 1808 for the Harmonist sect at 538 Main Street.<sup>5</sup> Early images of that church show a high steeple/clock tower and pointed arch windows, neither of which was repeated on the Mennonite meetinghouse of 1825 (Figure 3). Sharing worship space was a common practice in early Germanic denominations: "the building was utilitarian, not a sacred symbol or monument."<sup>6</sup> Besides worship space, congregations would also often share meetinghouses and cemetery grounds specifying that "people of all faiths might use their building for funerals, and also that they might bury their dead in the meetinghouse ground."<sup>7</sup> While Mennonites were generally pacifists, they were also tolerant and accepting of other's beliefs, which explains the presence of many military veterans' burials in the adjacent cemetery.

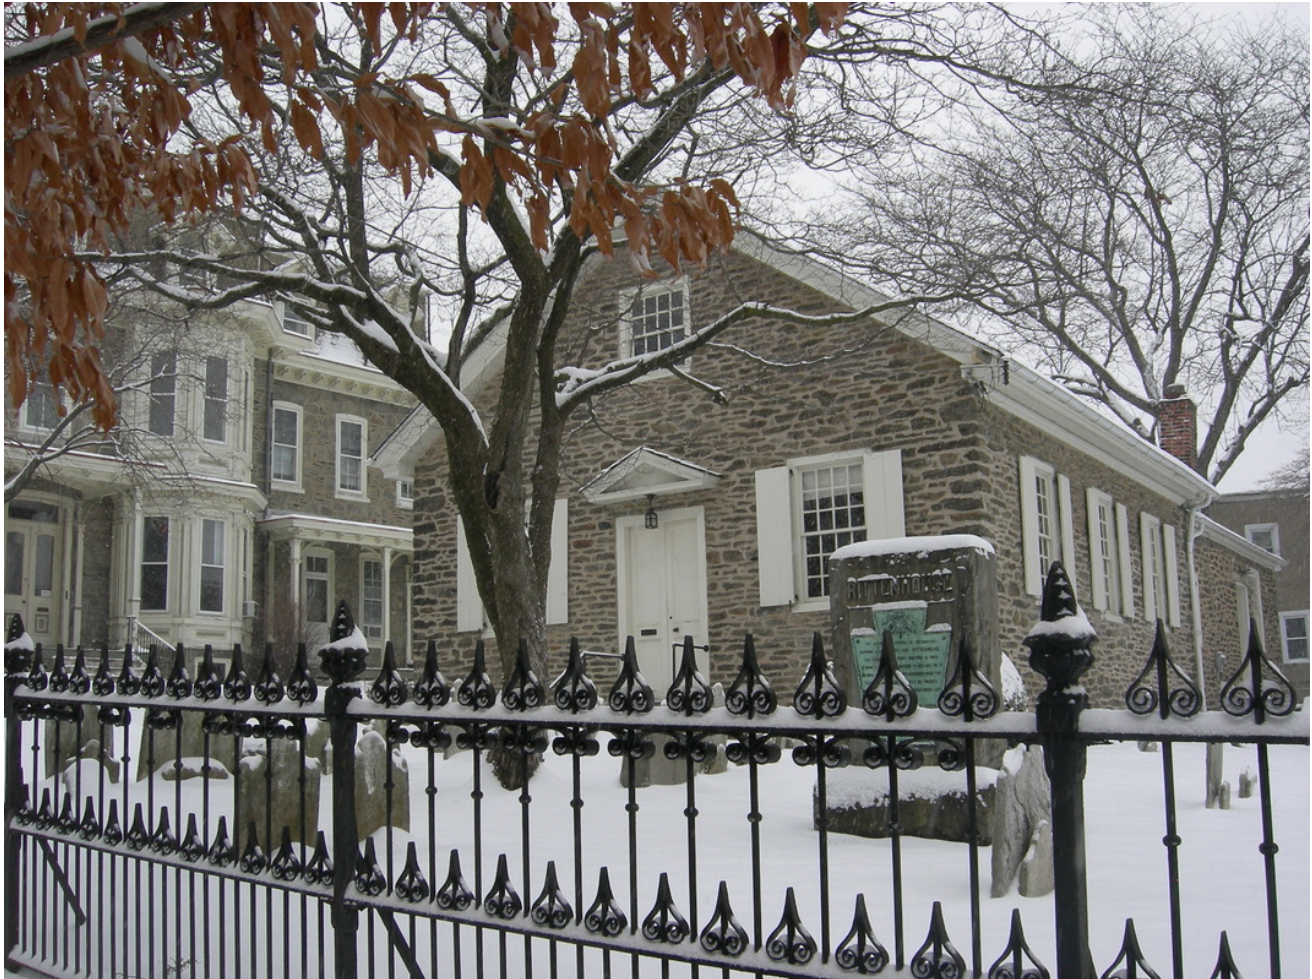
Figure 5: 1770 Germantown Mennonite Meetinghouse, Germantown, Philadelphia  
(<http://www.meetinghouse.info/photo-gallery.html>, accessed August 8, 2016).

The earliest stone Mennonite meetinghouse in continuous use, the Germantown Mennonite Meetinghouse at 6119 Germantown Avenue in Germantown, Philadelphia (Figure 5), dates from 1770.<sup>17</sup> Like the Harmony Mennonite Meetinghouse it is a one-and-a-half story masonry building; however, unlike the Harmony Mennonite Meetinghouse, it is front-gabled. Later Mennonite meetinghouses featured more standardized architecture, as noted by architectural historian Jerry Clouse:

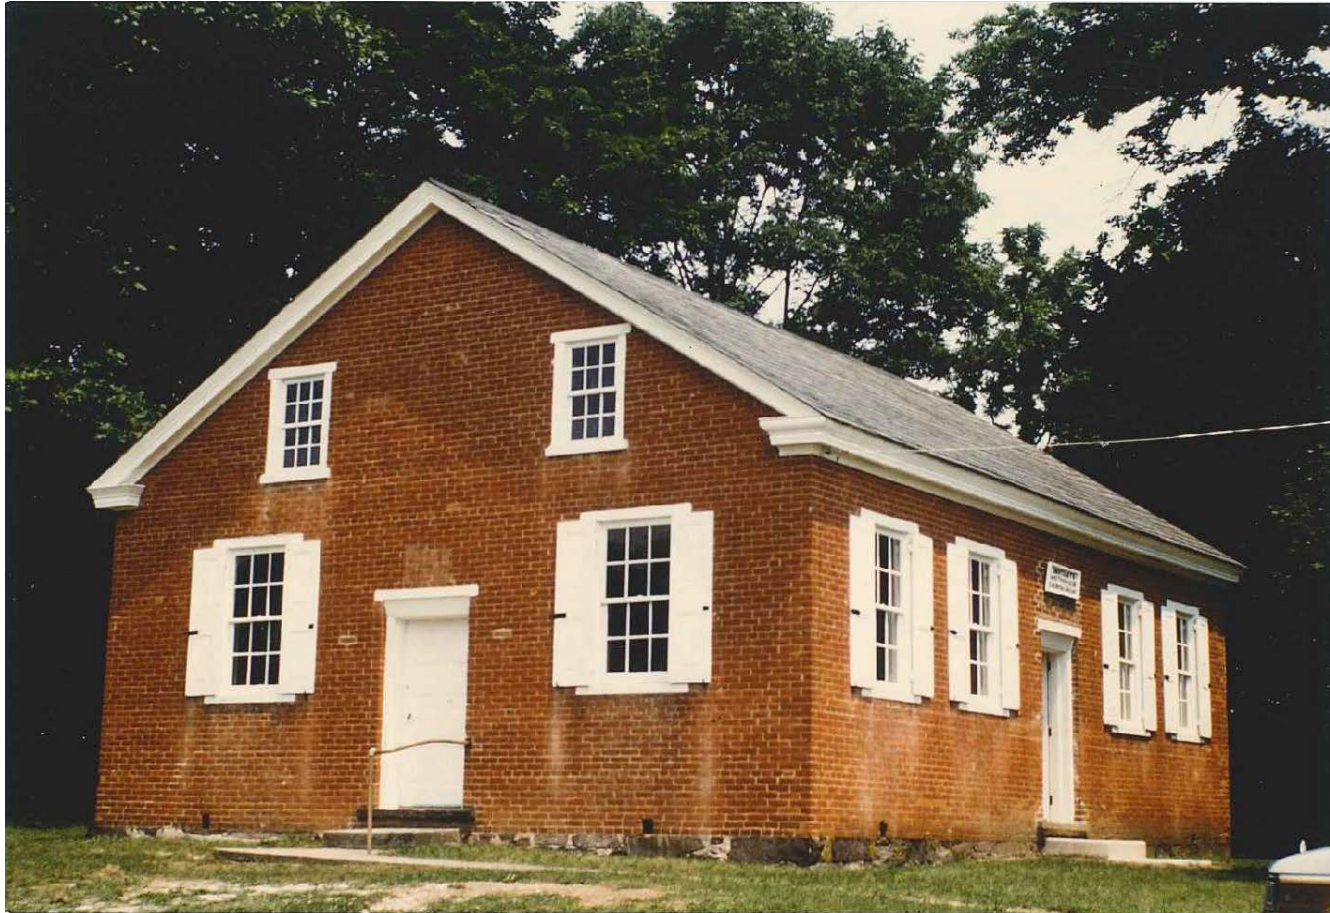
Figure 6: 1847 Bertolet's Mennonite Meetinghouse, Colonial Road, Upper Frederick Township, Montgomery (from PA SHPO Files).

The Harmony Mennonite Meetinghouse generally follows this pattern but is smaller (with a four-bay façade) and, while it features two entrances on its facade, its original section had only one entrance in the façade, with one in the side elevation. The 1847 Bertolet’s Mennonite Meetinghouse (Figure 6) on Colonial Road in Upper Frederick Township, Montgomery County, also generally follows the pattern, but lacks the two entrances in the facade. Like the Harmony Mennonite Meetinghouse, it is a side-gable, one-and-a-half story building that features an entrance on its façade and a three bay (including a second entrance) side elevation. Unlike the Harmony Mennonite Meetinghouse, however, Bertolet’s Meetinghouse was never added on to and is entirely made of brick. In addition, it features a symmetrical five-bay façade and lacks the more elaborate lintels and sills seen on the Harmony Mennonite Meetinghouse. The later, 1855, Alleghany Mennonite Meetinghouse (Figure 7) at 39 Horning Road in Brecknock Township, Berks County, like the Harmony Mennonite Meetinghouse, generally follows the pattern but is smaller with a four bay façade. Like the Harmony Mennonite Meetinghouse, it is a side-gabled stone building with a four bay façade featuring two entrances; however, unlike the Harmony Mennonite Meetinghouse, it was never added on to, does not feature a side entrance, and lacks the more elaborate lintels and sills seen at the Harmony Mennonite Meetinghouse.

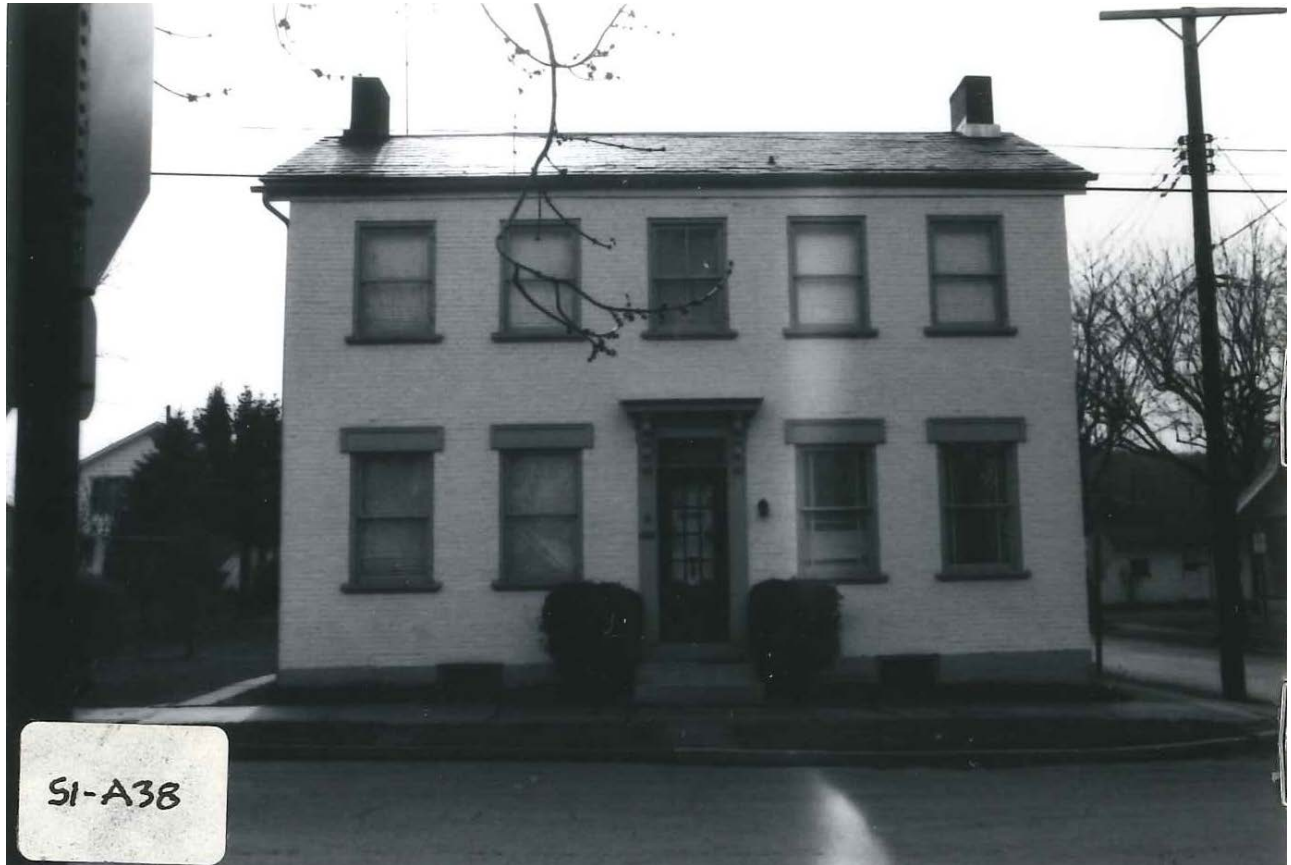
Figure 8: Mennonite-built house at 510 Main Street in Harmony (from PA SHPO Files).

Some Mennonites, however, chose to settle in Harmony, building symmetrical three to five bay, predominantly brick buildings with slate gable roofs such as those at 510 Main Street (Figure 8) and at 636 Wood Street (Figure 9). These featured some ornament, including stone lintels and sills and somewhat elaborate entryways. The Mennonites also built frame three to five bay buildings with slate gable roofs and symmetrical facades, such as that at Liberty Street (Figure 10), and that at 309 Monroe Street (Figure 11).

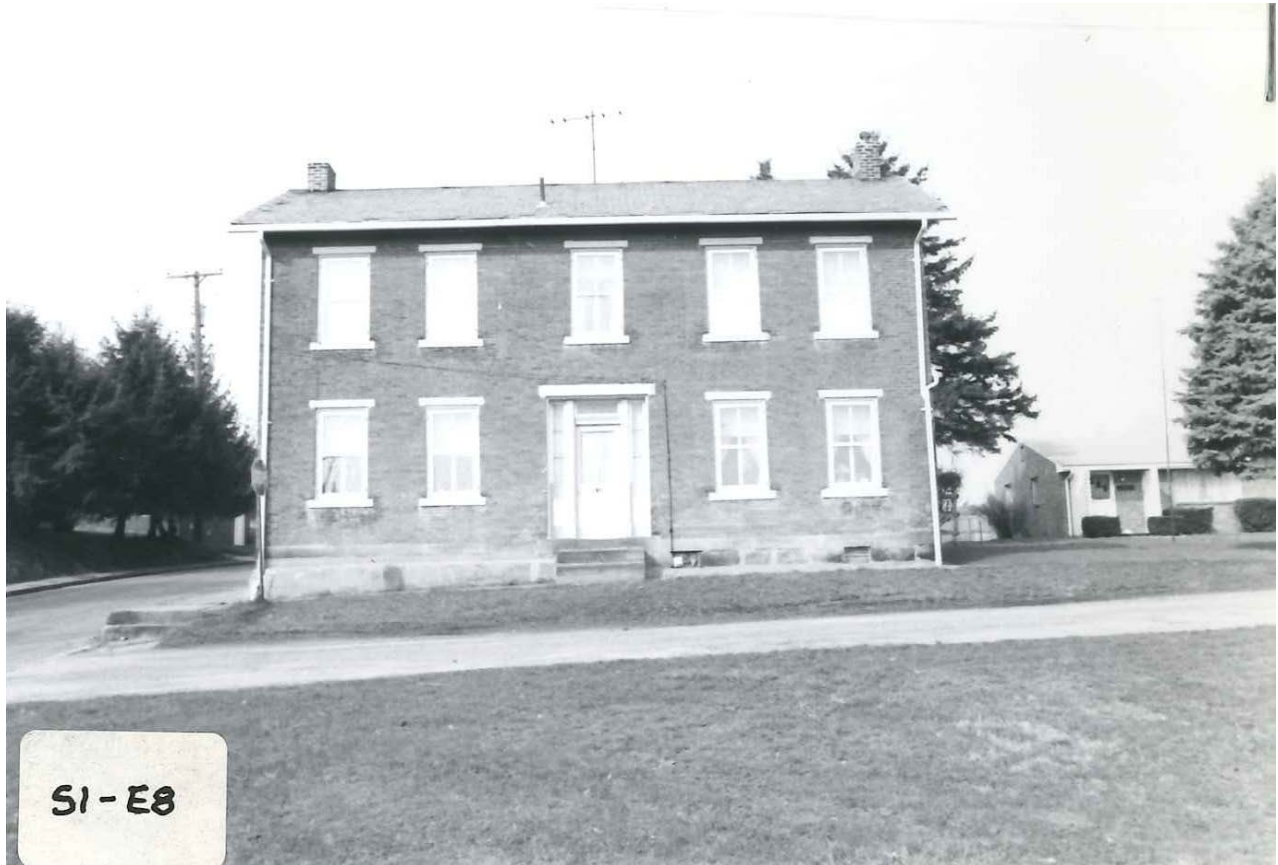
Figure 9: Mennonite-built house at 636 Wood Street in Harmony (from PA SHPO Files).

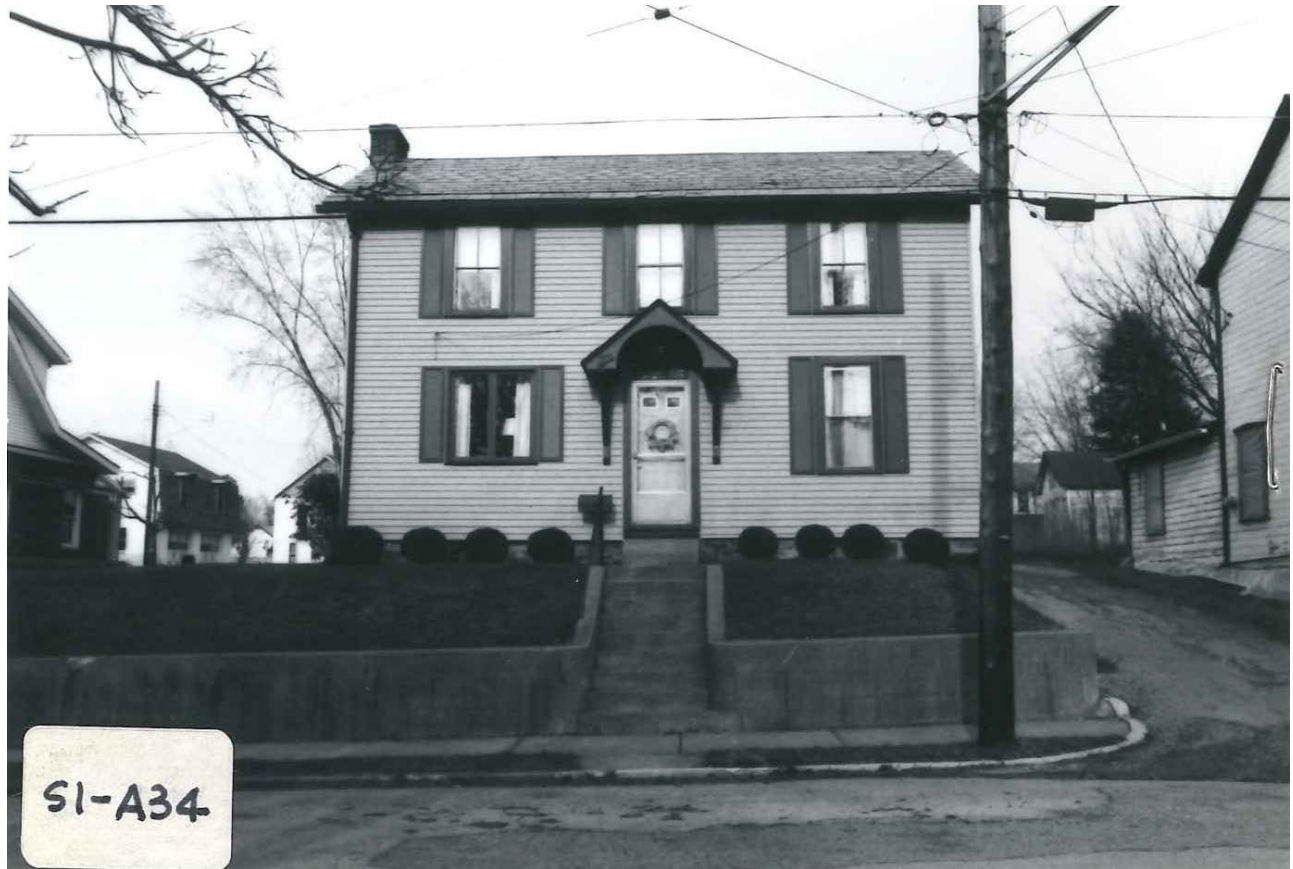
Figure 10: Mennonite-built house on Liberty Street in Harmony (from PA SHPO Files).

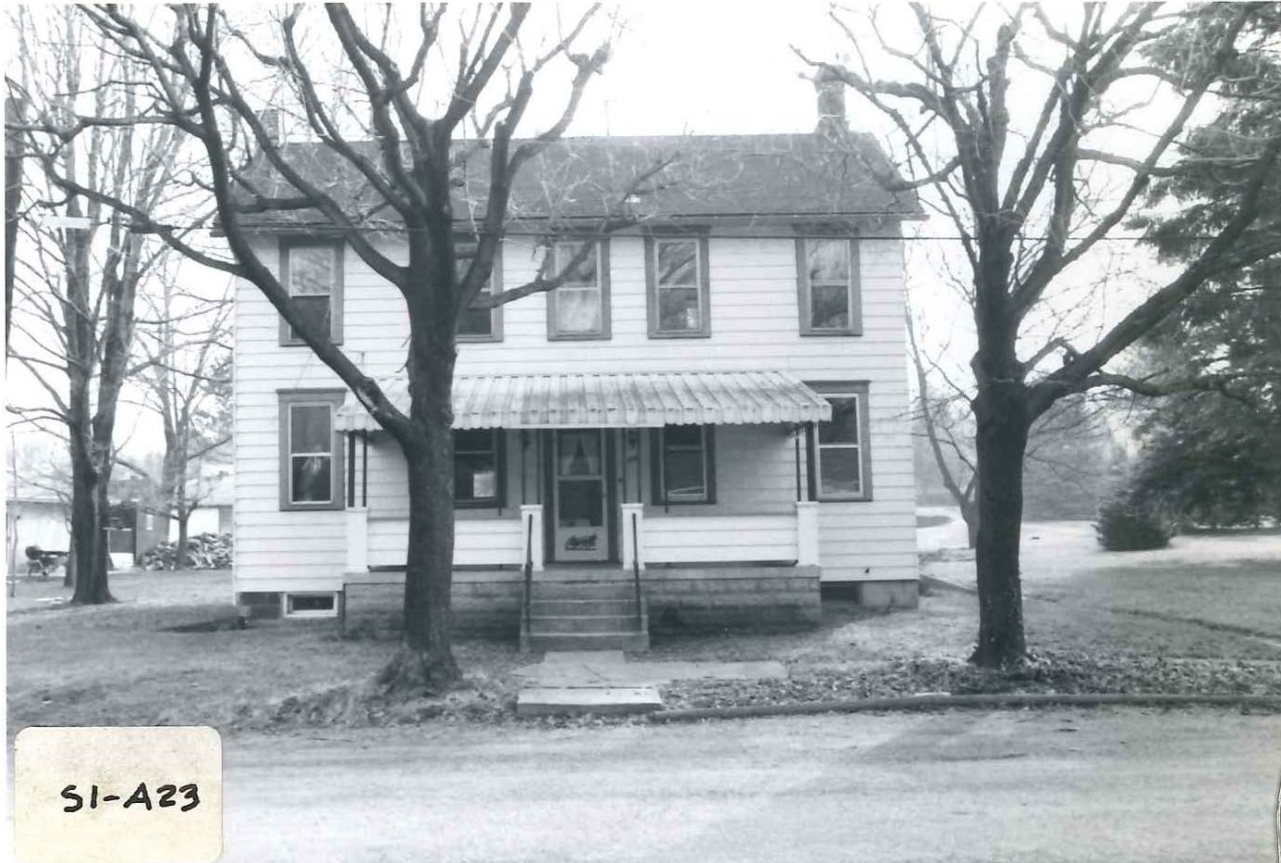
Figure 11: Mennonite-built house at 309 Monroe Street in Harmony (from PA SHPO Files).

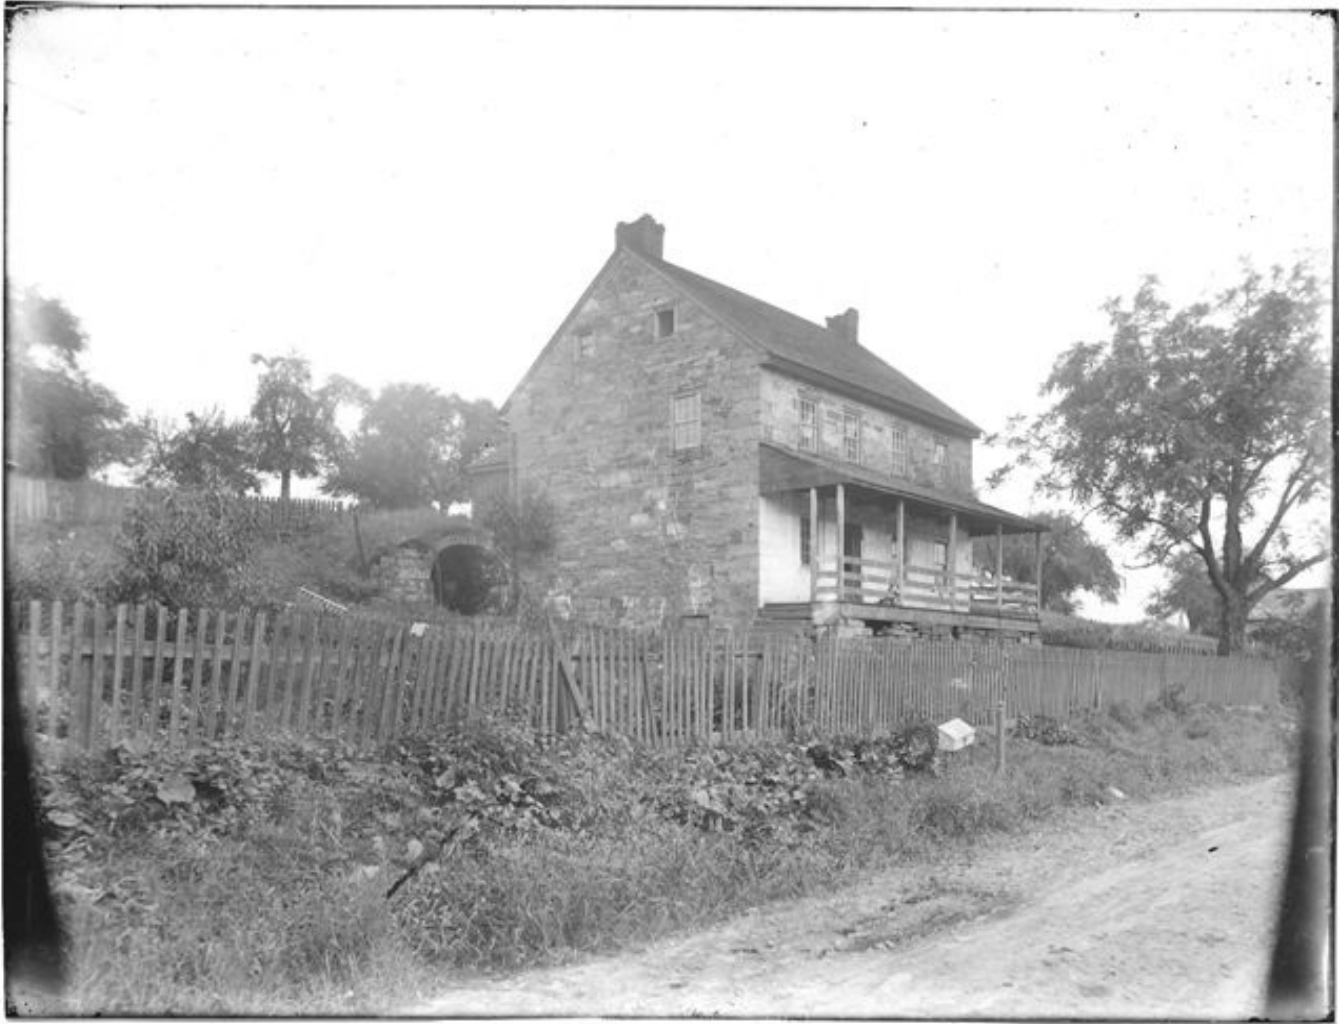
Figure 13: The first Mennonite Bishop of Harmony, John Boyer (1762-1828) commissioned this house in 1816. The house is located at 295 Perry Highway and is privately owned but under an easement held by Pittsburgh History and Landmarks Foundation to preserve it.

Because there are no other Mennonite meetinghouses of the same time period in the area, comparisons to nearby Mennonite-built stone farmhouses best illustrate local building techniques. The first predates the meetinghouse by nine years. Its owner, John Boyer (c. 1762-1828), was among the first Mennonites to join Abraham Ziegler in Harmony and he acted as the first Mennonite Bishop for the congregation (Figure 13). He was the first Mennonite bishop to the Harmony congregation and his descendants remain in the area. He was given ten shares of capital stock in the Harmony Farm Company and conveyed 1,080 acres in an 1818 deed.<sup>20</sup> In 1816 he commissioned a two-story, gable roofed, sandstone house just over half a mile northeast of the future meetinghouse site.<sup>21</sup>

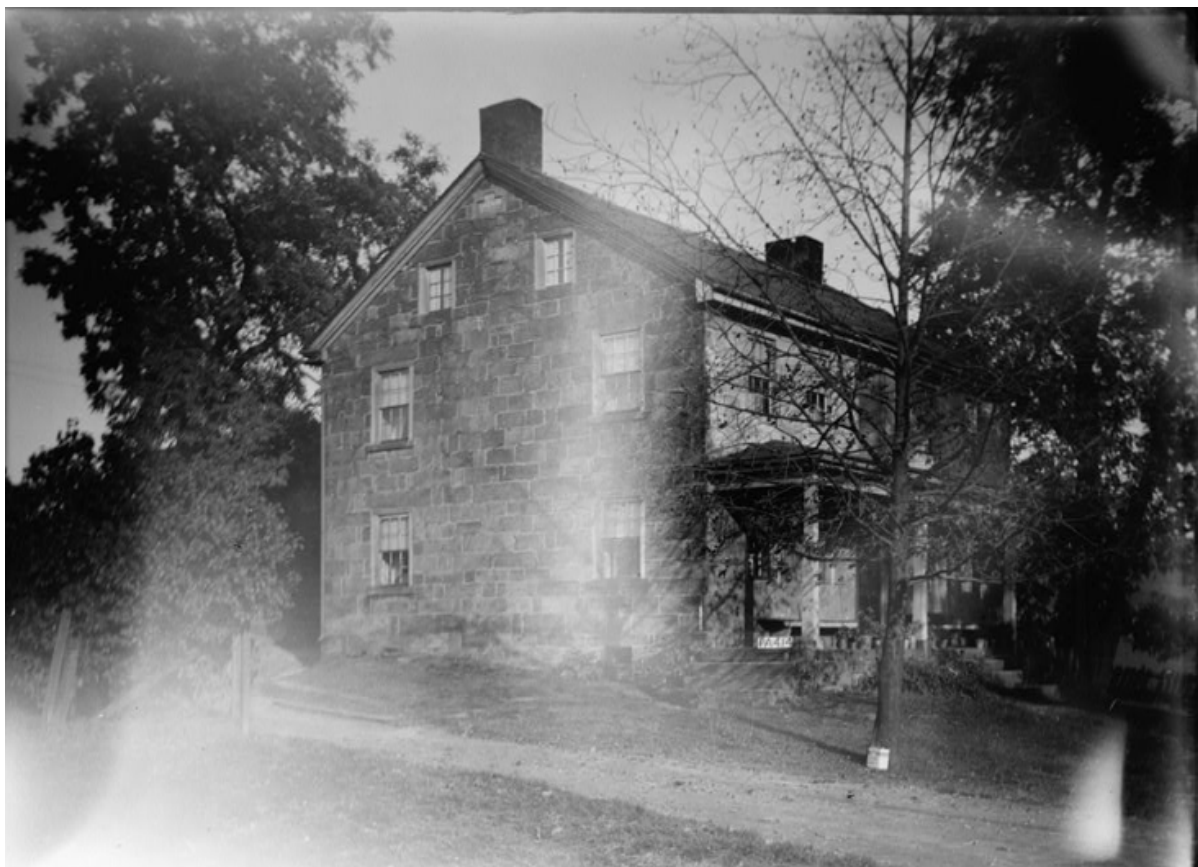
Figure 14: Stone vernacular house built for David Stauffer (c. 1794-1856) in 1839. He raised sheep for Abraham Ziegler who then sold the wool to the Harmonists in Indiana. In return for his shepherding Stauffer received the land surrounding his farmhouse, which is located approximately four miles north of Zelienople west of Route 19 (HABS PA-414, <http://lcweb2.loc.gov/service/pnp/habshaer/pa/pa0200/pa0221/photos/131444pv.jpg>, accessed April 29, 2016 .

A second Mennonite-built house of the same time period in the area is the David Stauffer house of 1839 (Figures 14 and 15). This property was built by another of Abraham Ziegler's early Mennonite colleagues who agreed to raise sheep and be paid for his wool by being given more land for farming. Ziegler was having trouble paying off the debt to the Harmonists for the Butler County land and so he worked out the deal with several early settlers that if they allowed him to sell their wool at a profit to the Harmonists in Indiana, he would pay them in land.<sup>22</sup>
