**HISTORIC RESOURCES INVENTORY
BUILDING AND STRUCTURES**

1. BUILDING NAME (Common)		(Historic)	
Lewis Woodruff House		Jotham Woodruff House	
2. TOWN/CITY	VILLAGE	COUNTY	
Southington	Southington, CT 06489	Hartford	
3. STREET AND NUMBER (and/or location)			
137-139 Woodruff St. (map 109, parcel 84) 3 acres			
4. OWNER(S)			
Florian, Don Alan et al (vol.285,p.216) <input type="checkbox"/> Public <input checked="" type="checkbox"/> Private			
5. USE (Present)		(Historic)	
Residential		Residential	
6. ACCESSIBILITY TO PUBLIC:	EXTERIOR VISIBLE FROM PUBLIC ROAD	INTERIOR ACCESSIBLE	IF YES, EXPLAIN
<input checked="" type="checkbox"/> Yes <input type="checkbox"/> No	<input type="checkbox"/> Yes <input checked="" type="checkbox"/> No	<input type="checkbox"/> Yes <input checked="" type="checkbox"/> No	N.A.

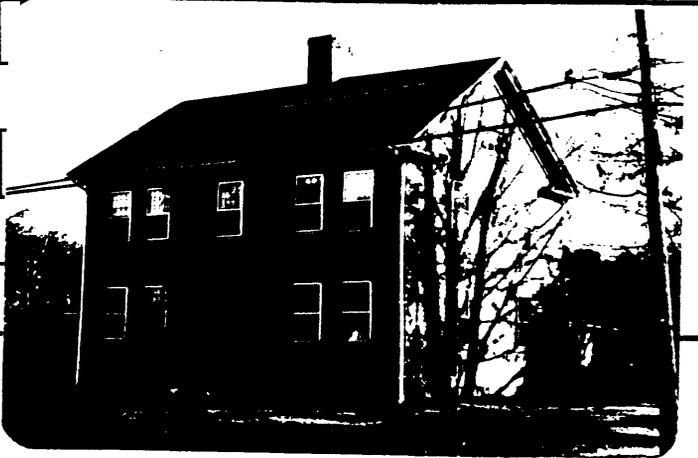
PHOTO

In the front 5-bay elevation the central doorway has side lights and plain pilasters that support a plain architrave and frieze and molded flat cornice. Windows are 12/12 with plain caps and slightly projecting sills. There is a shed-roofed rectangular 1-story bay at the left. On the end elevations there is a broad fascia under the sloping roof edges, and the eaves return. The central brick chimney is somewhat smaller than often found in mid-18th-century houses.

VIEW
 South
