# M.E. HELME HOUSE FURNISHING CO.

HELME-WORTHY RESIDENCE AND STORE

513-519 Walnut Street and 128 Sixth Street  
Huntington Beach, Ca 92648

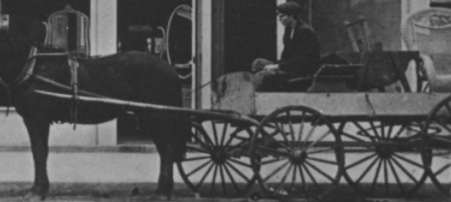
Front facade of store taken in 1907. The only changes from this photo are the sign across the top of the cornice and the plain doors in the center which replace the original.

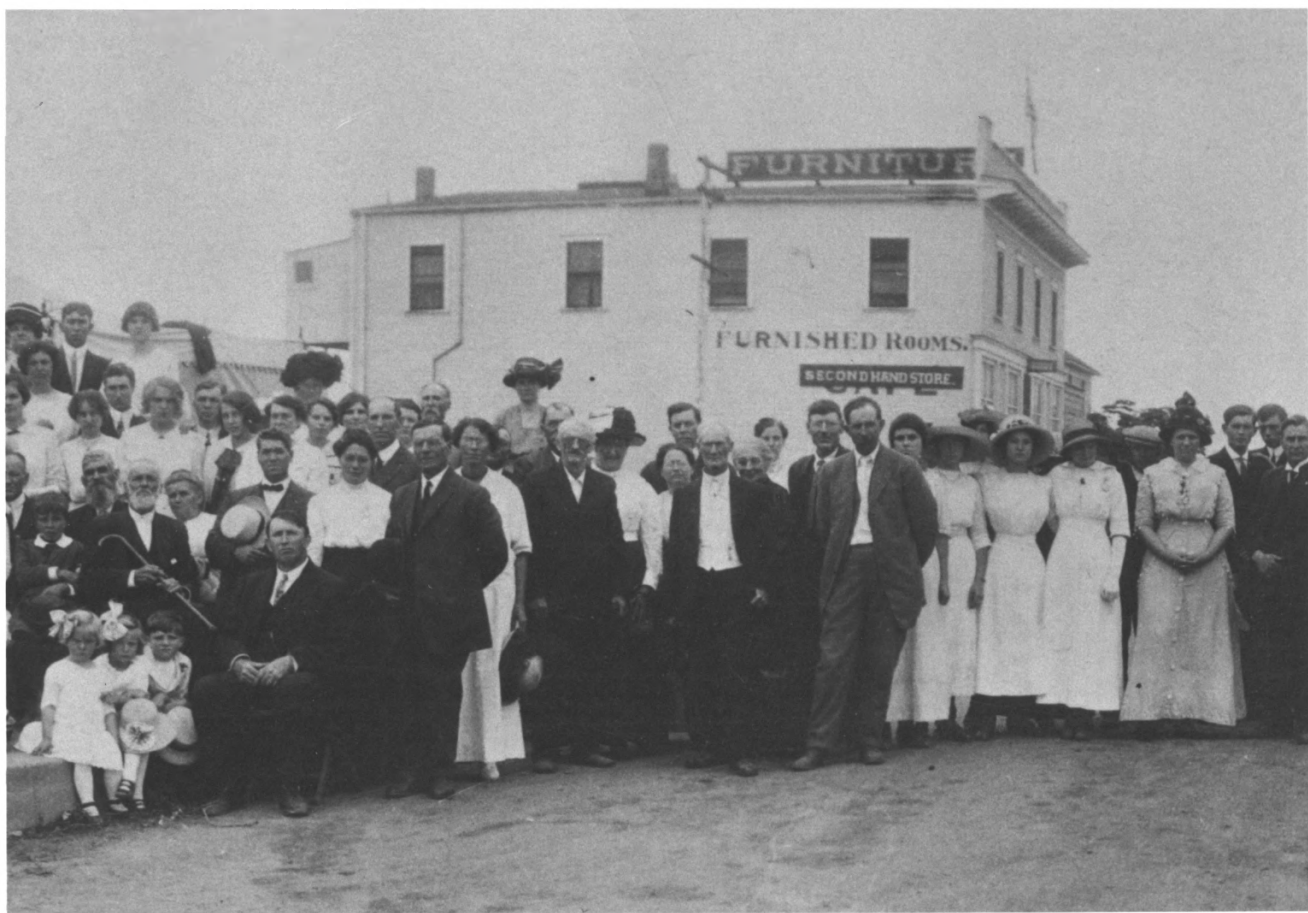
1912 photograph of the Helme House Furnish-  
ing Company taken in 1912. Event and per-  
sons in picture unidentified. Note back of  
store with second floor porch. The sign  
"furnished rooms" refers to the second floor  
of the store building

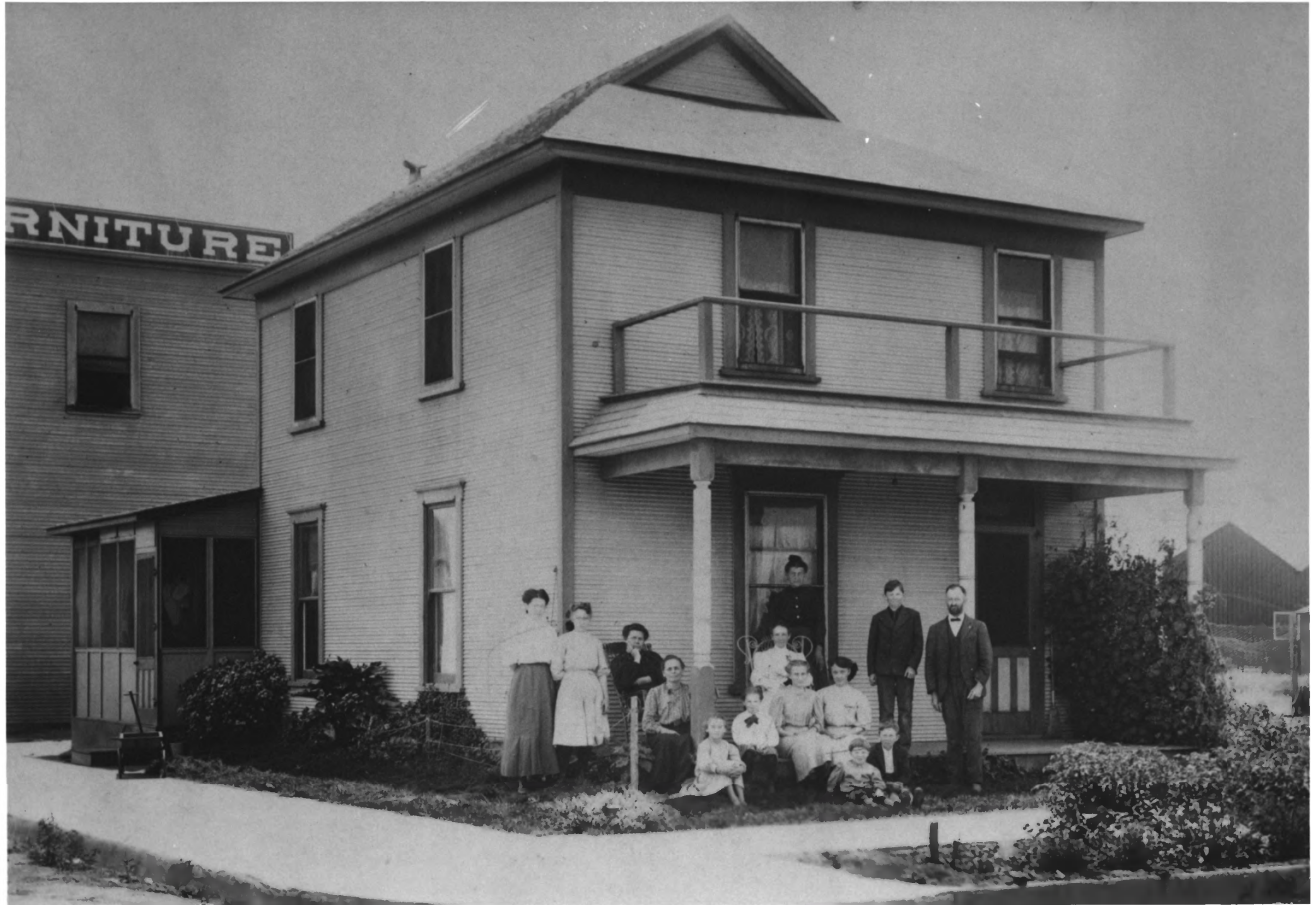
Front (Sixth St.) facade on right with Walnut facade on left. Store at rear faces Walnut. At this point, the front porch of the house had not been enclosed and the bay window built on the Walnut side. Porch at rear had not been enclosed yet and manufactured-stone-fronted addition to store had not been built yet.

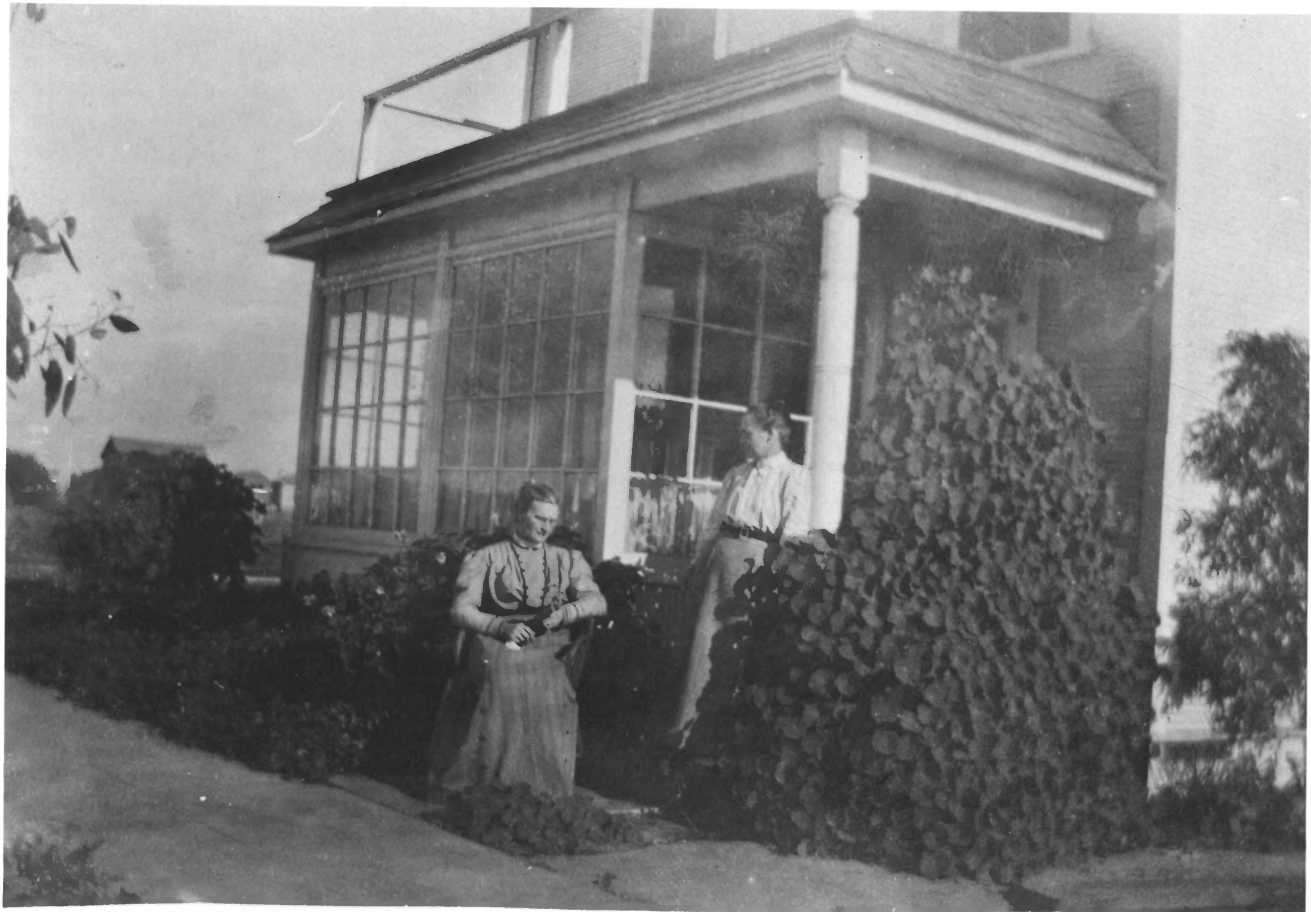
View of front porch from northwest. Front facade with porch enclosed. Mollie Helme (seated). Side of porch nearest west side (right side) has been enclosed with louvers which will soon be removed. A fence has been added to the right (west) side yard.

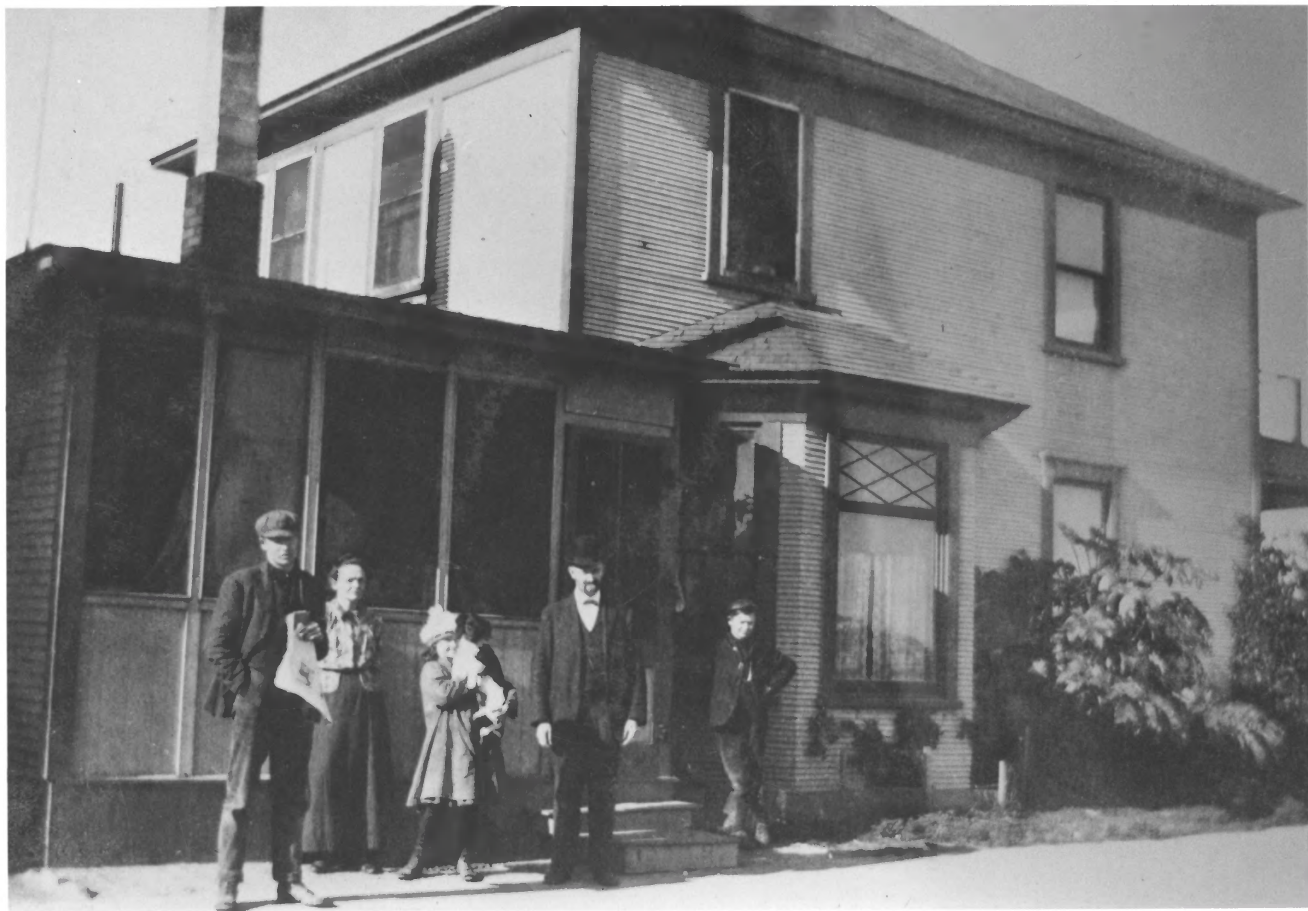
Walnut Street side of house approximately  
1907. Bay window was a then-recent addi-  
tion to existing house. Back porch had not  
been enclosed at this time. Yard and set-  
ting were about the same as they are at  
present.

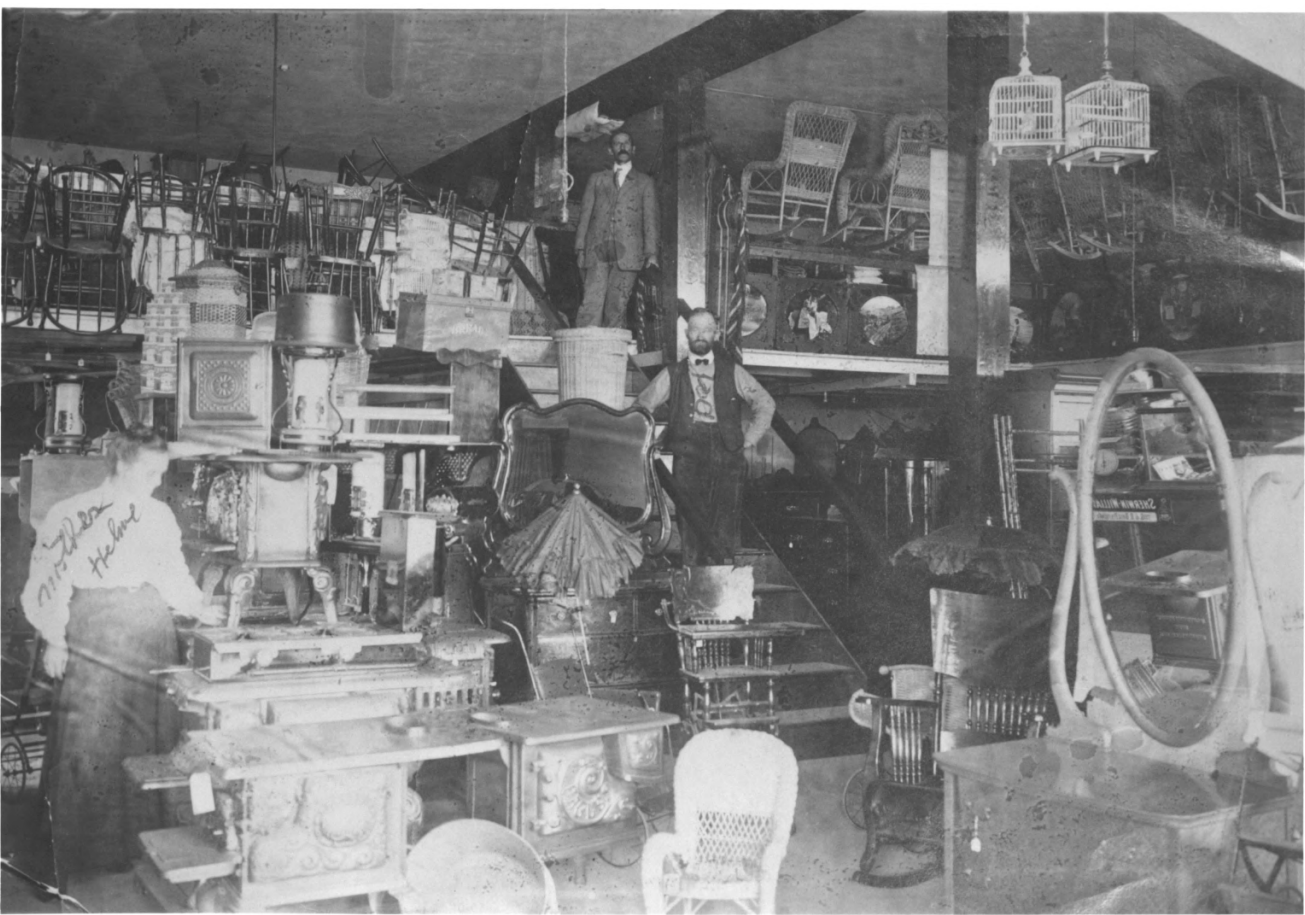
Interior of store ca. 1906-08. Mollie Helme  
on left and Matthew Helme on stairs in center.  
Walls have been built where the structural  
supports are visible on the right, and in  
front of the balcony.

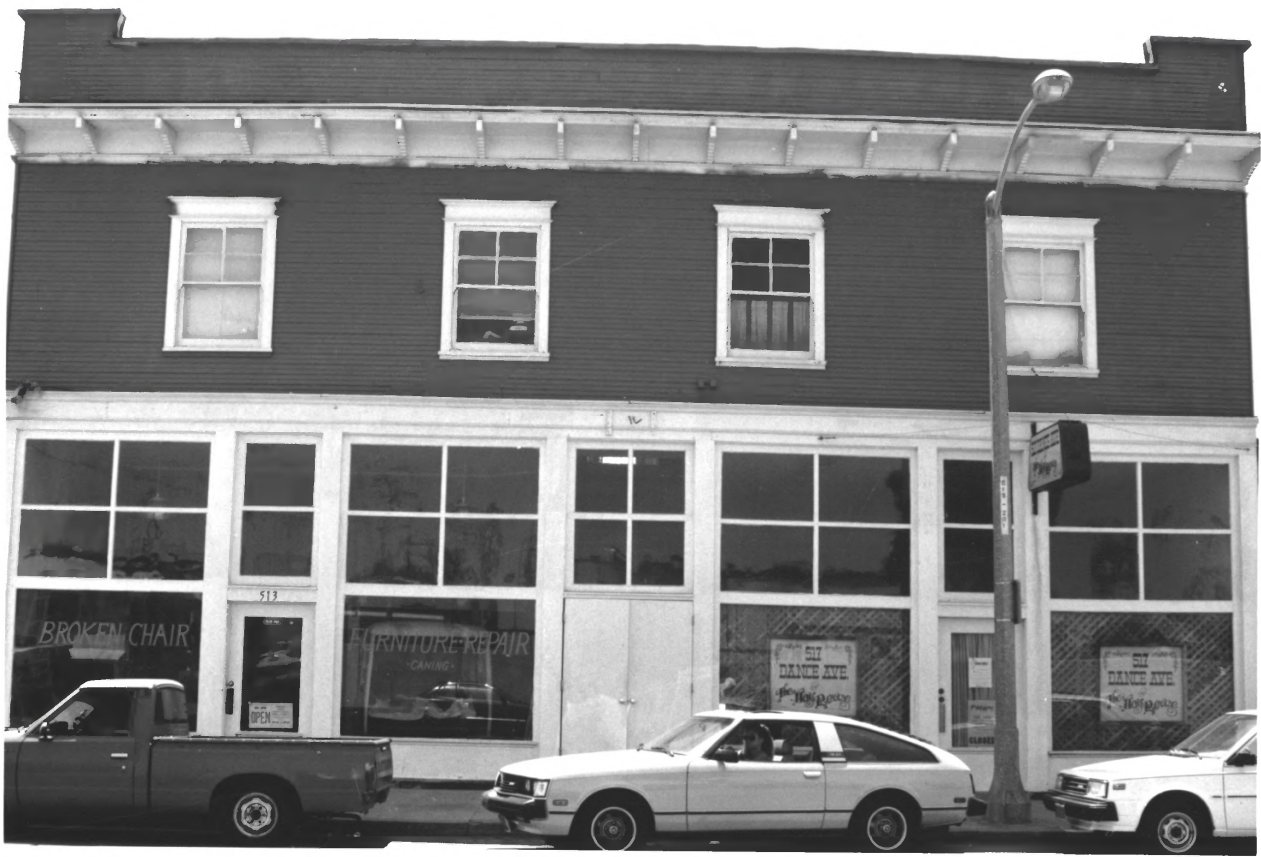
Front facade of store building, from east.

All architectural elements are original except center front doors.

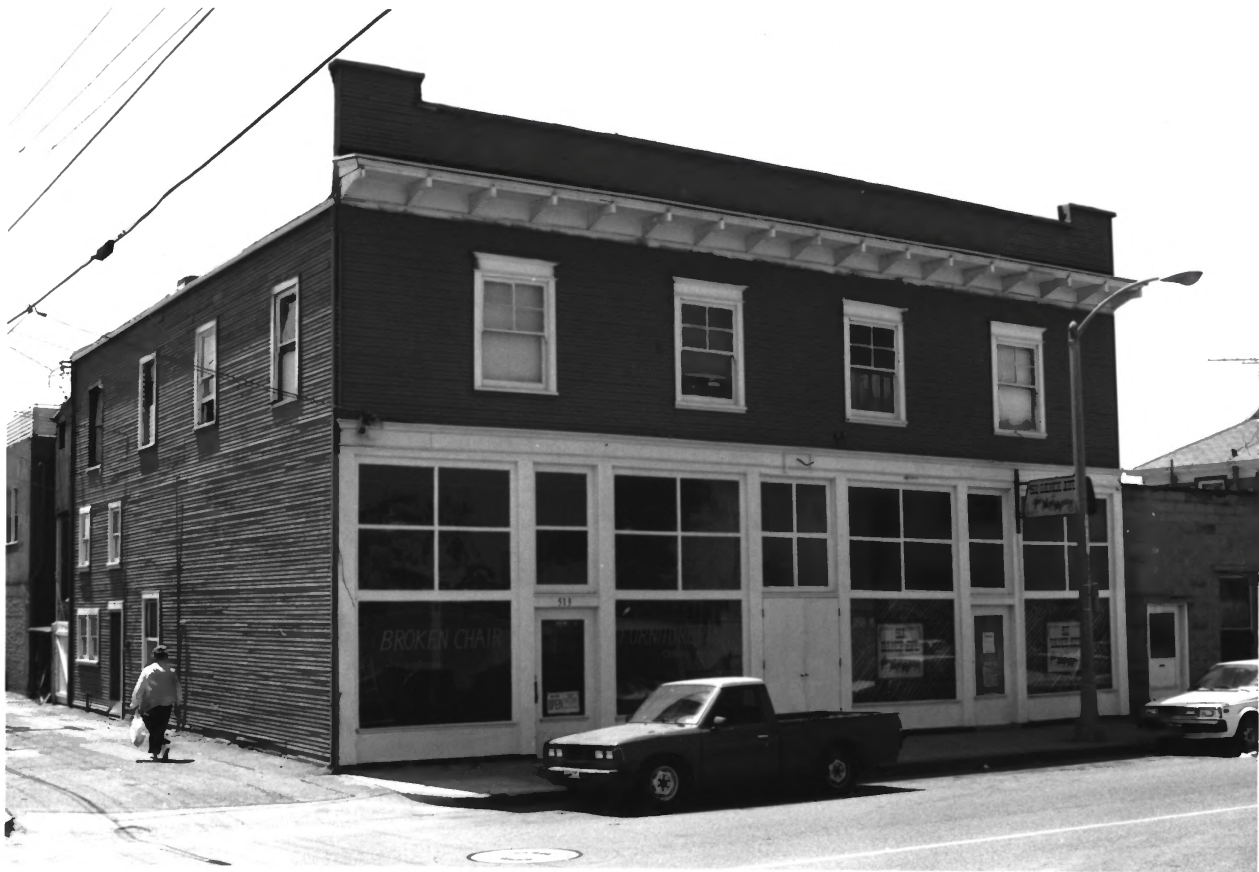
Front facade of store (on right) faces east.  
side facade (on left) faces south, on the  
alley

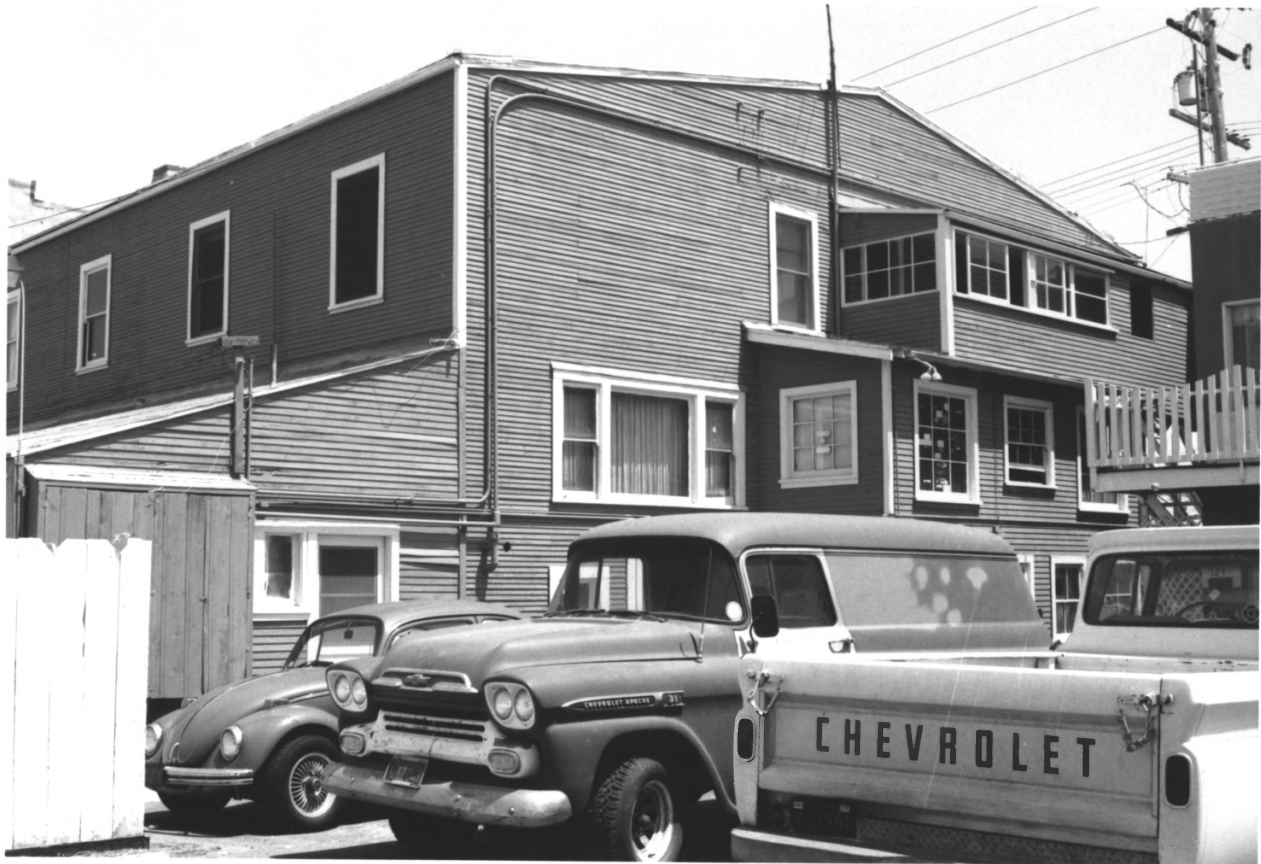
Rear facade of store taken from northwest.  
Single-story shed-style addition on right  
is back end of manufactured-stone-fronted  
addition. Porch at top level is original  
with two additional enclosed porches on the  
first and second levels added at a later  
time. Edge of 1949 garage/apartment seen  
on right.

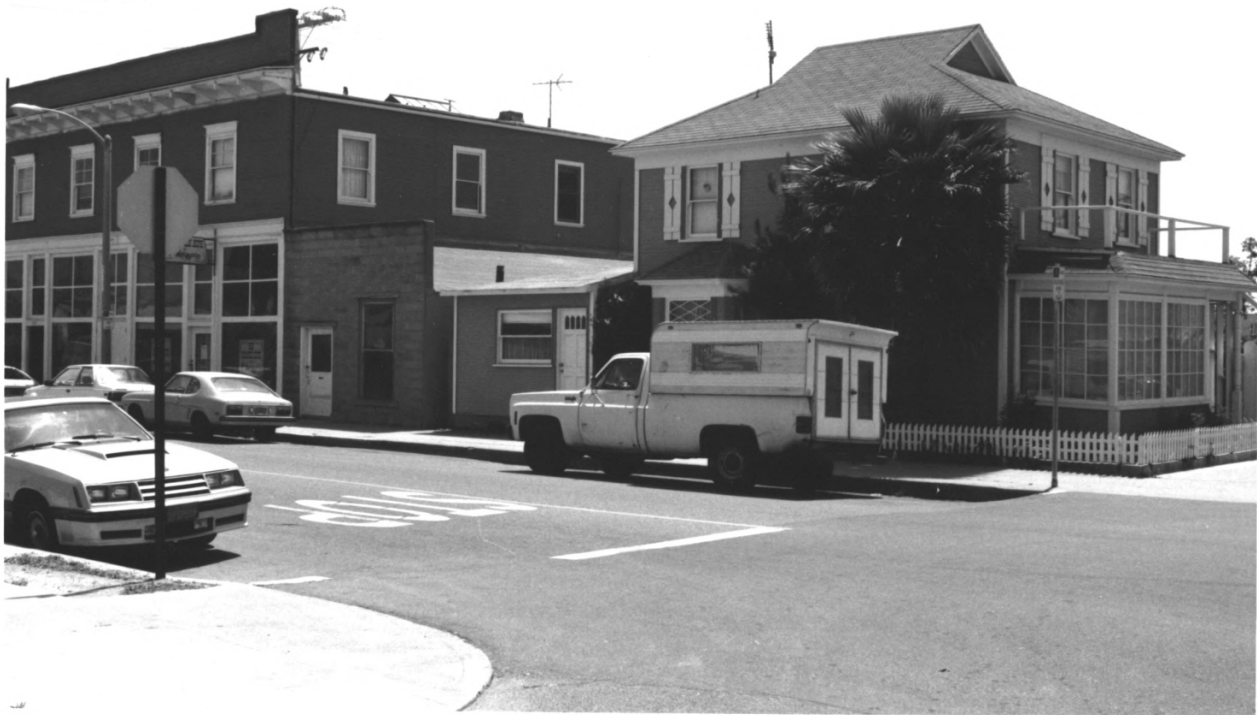
View from corner of Walnut and sixth, looking southwest. Front and north side of store and front and east side of house, with the manufactured stone front between,

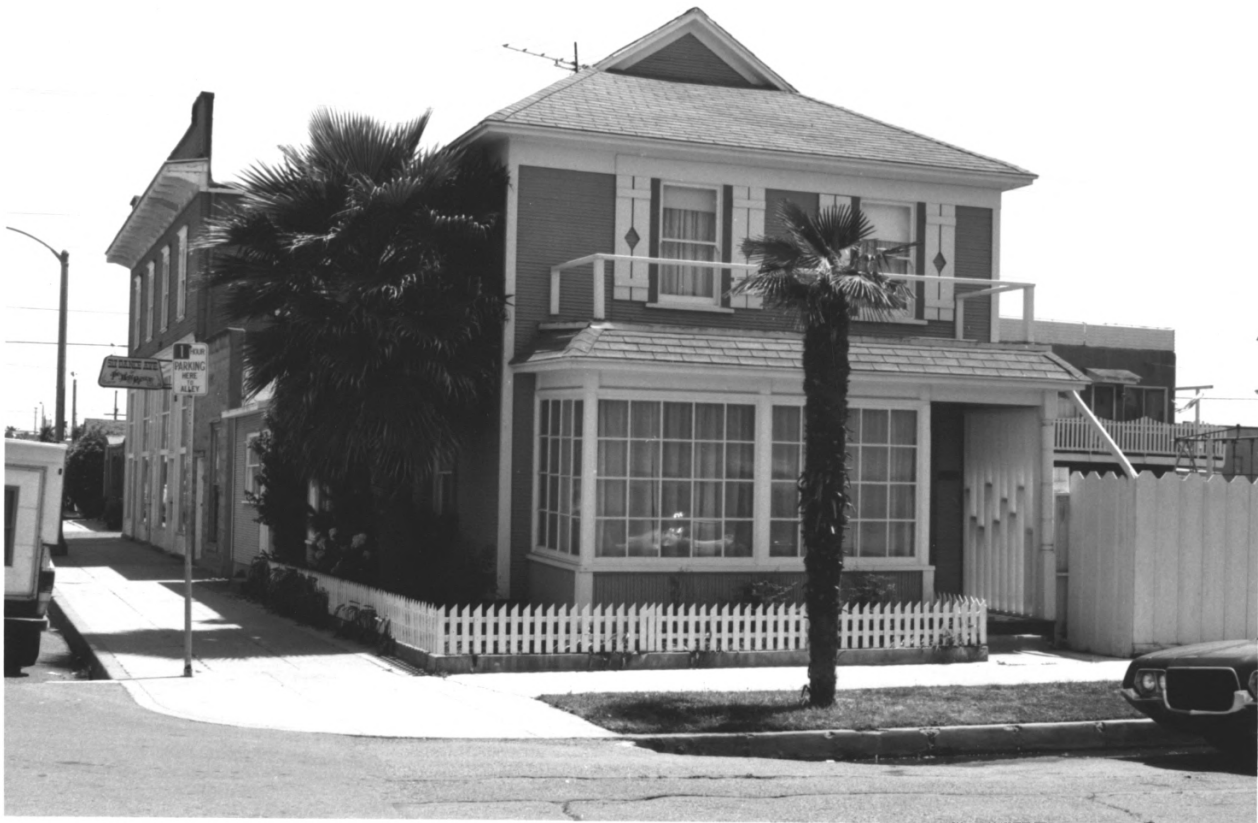
Corner of Sixth and Walnut (along left side)

Porch glassed in before 1917. Shutters and

louvers on side of porch will be removed soon

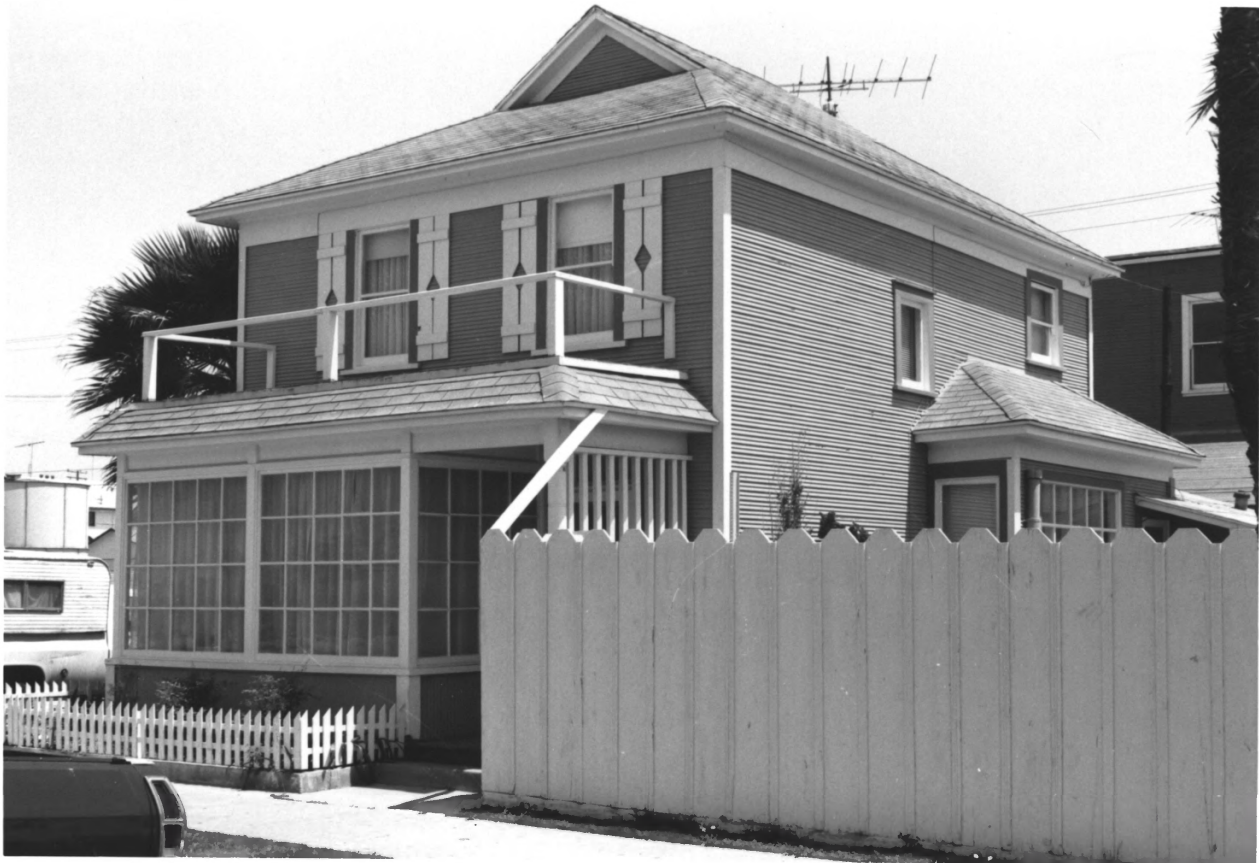
Front and west (right) side of house, looking southeast from Sixth Street. Side of store can be seen in background. Glassed in porch on house was done before 1917. Shutters and louvered wood on side of porch will be removed in the near future. "Back" yard is on west side of house.

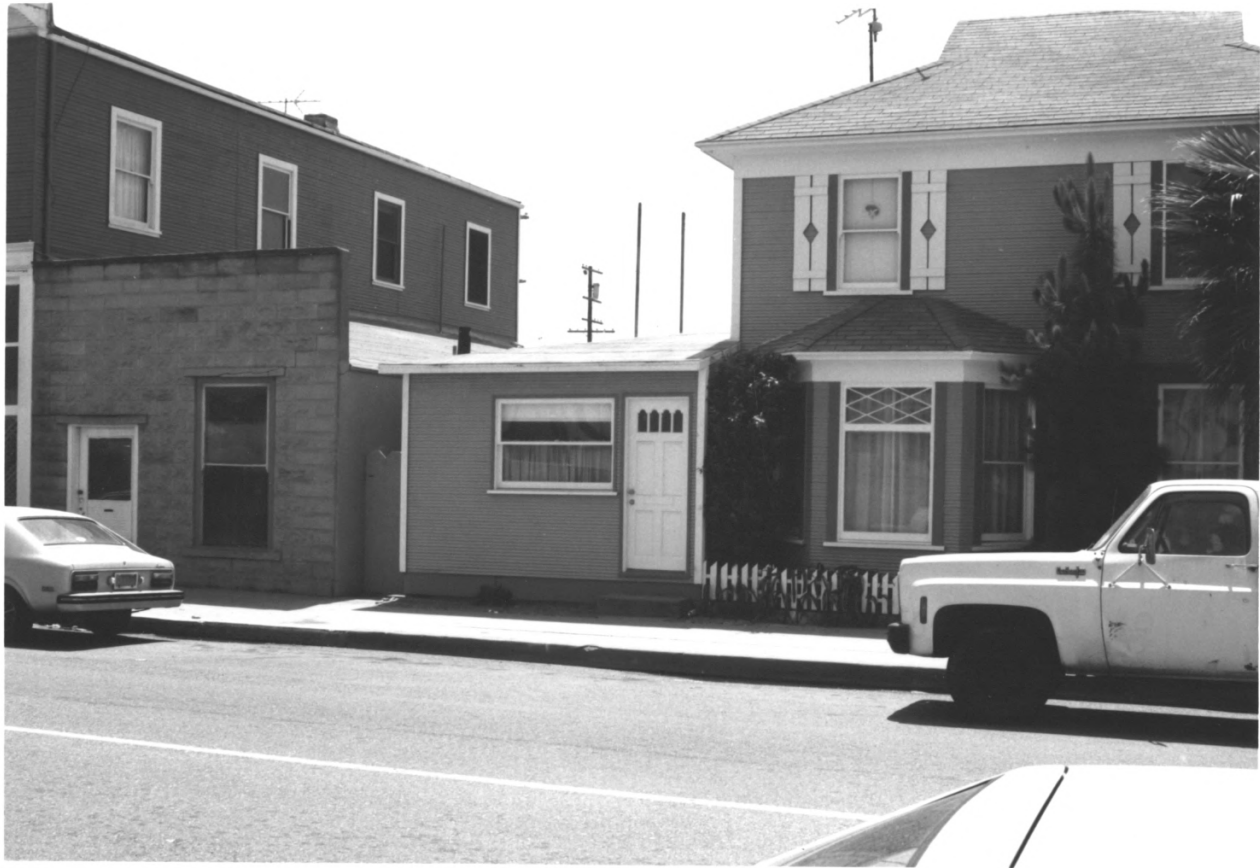
North side of store from Walnut Street, looking southwest. This is the east or Walnut side of the house. The manufactured stone addition in the center is attached to the north side of the store and has a shed-style roof.

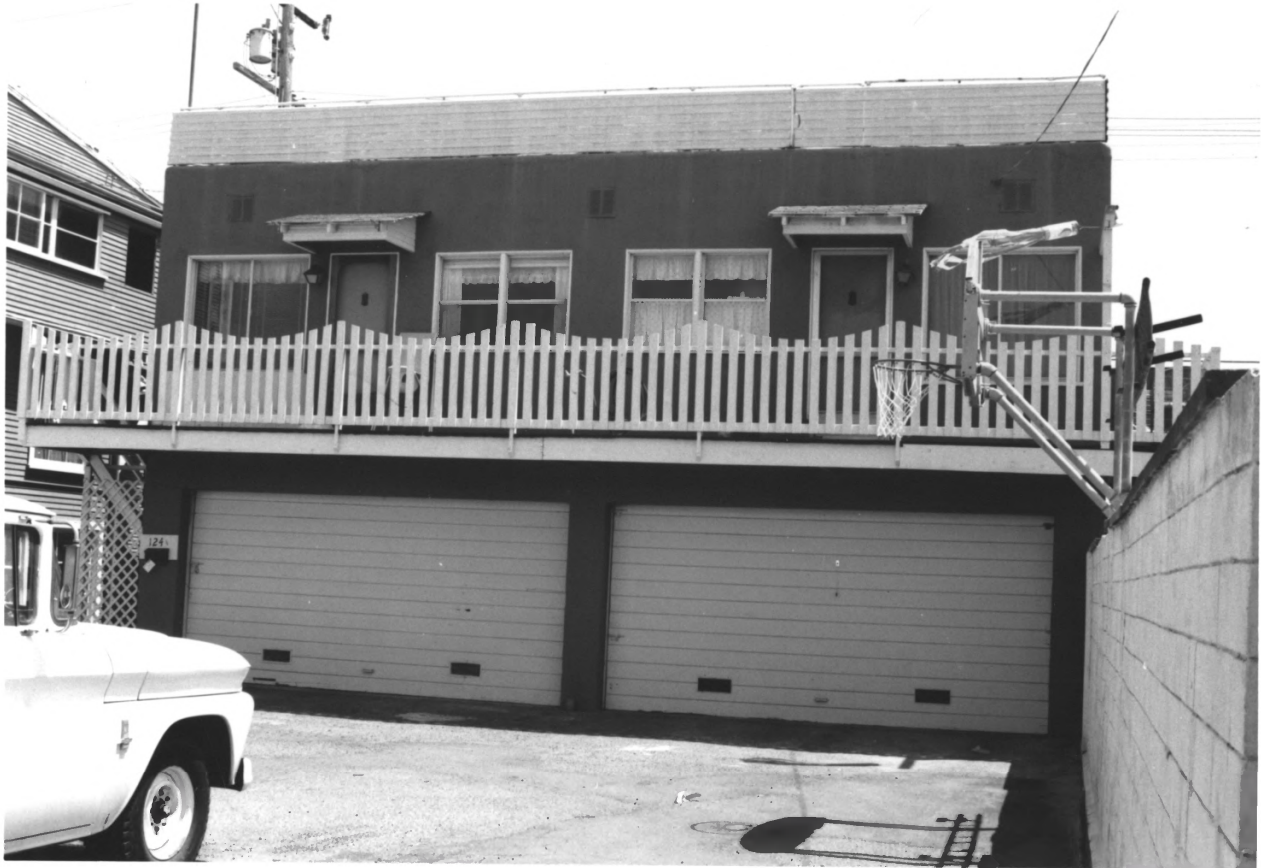
Garage/Apartment at rear of property is not visible from front (Walnut Street) and mostly hidden by the wooden side-yard fence to the west of the house on the Sixth Street side.

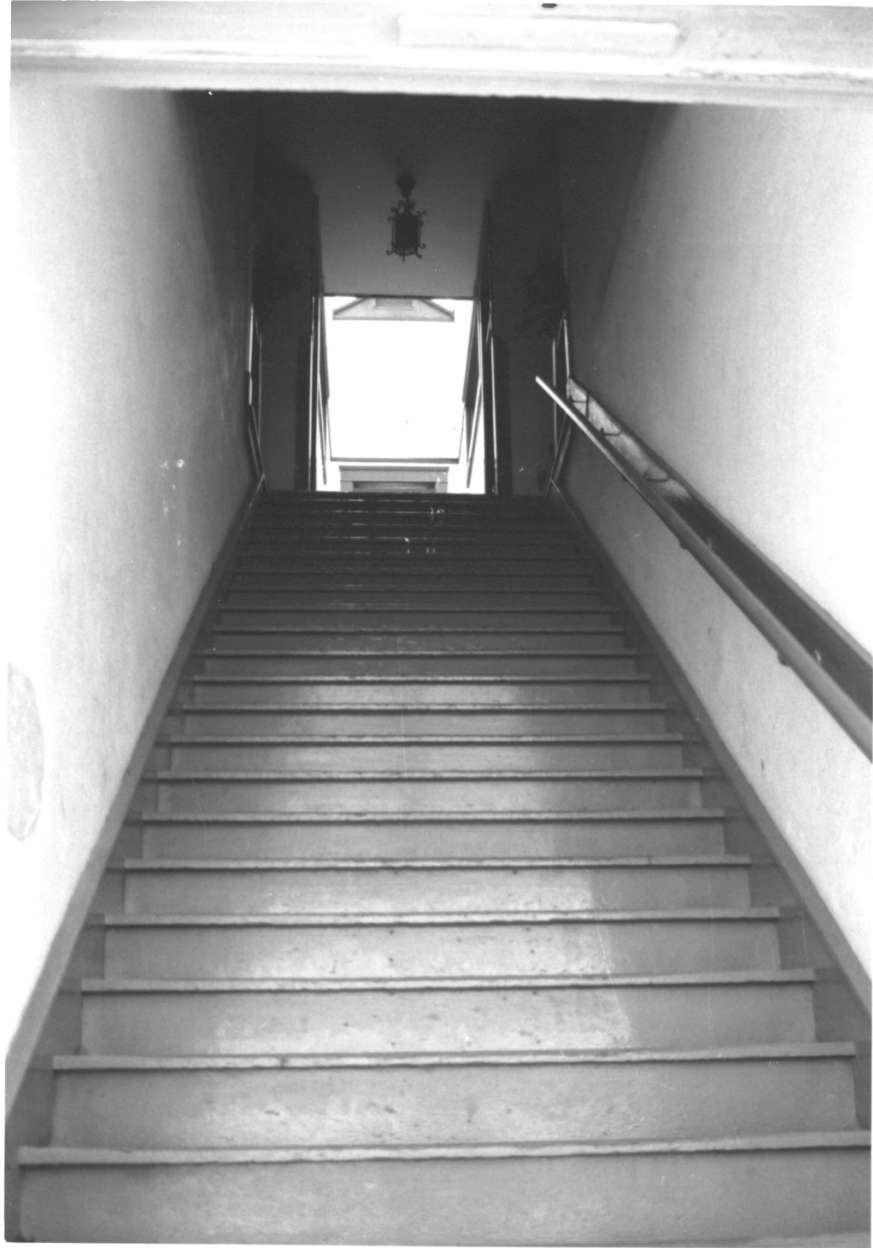
Stairway in store building, looking west  
from bottom. Stair is in center of build-  
ing and runs front to back

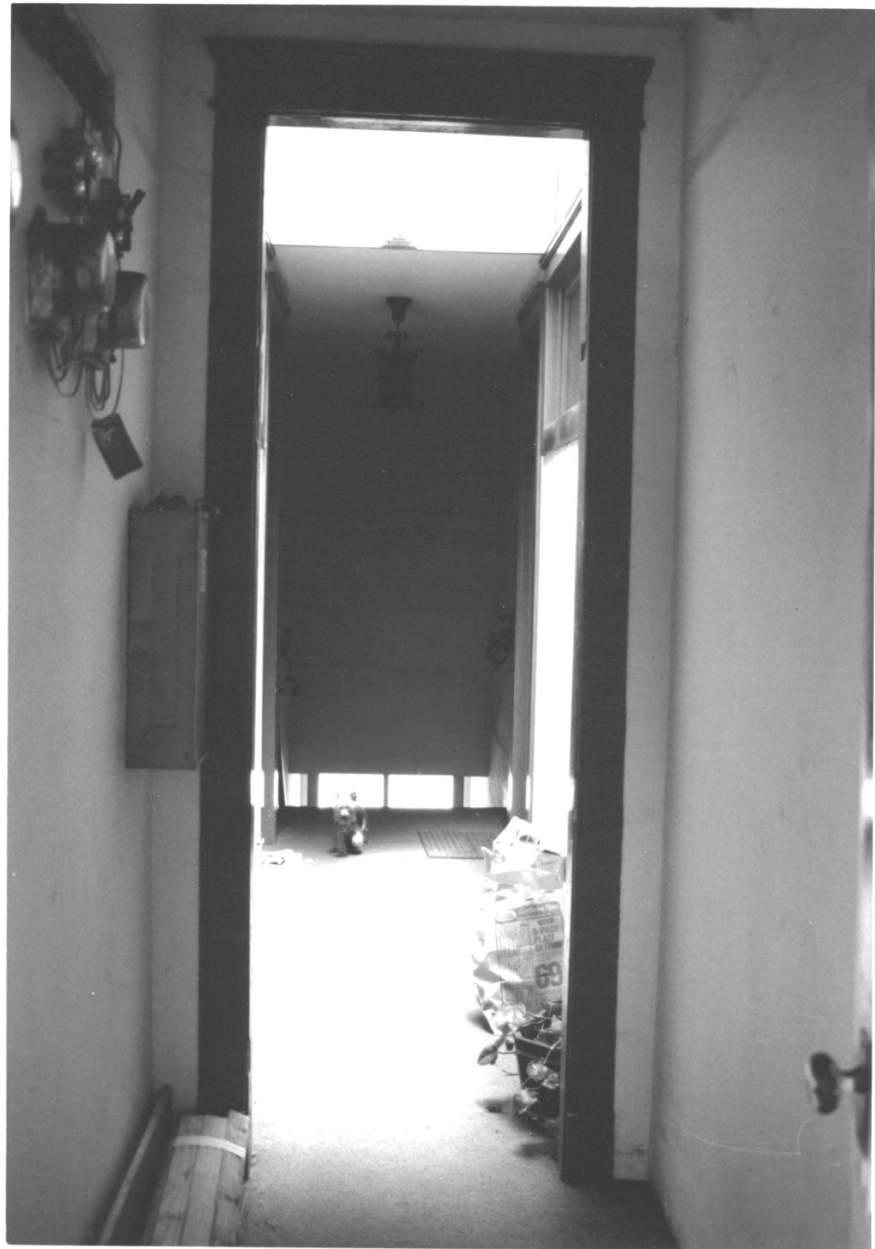
Second floor hallway, looking to the rear,  
with porch at rear and skylight above, center  
(Looking west)

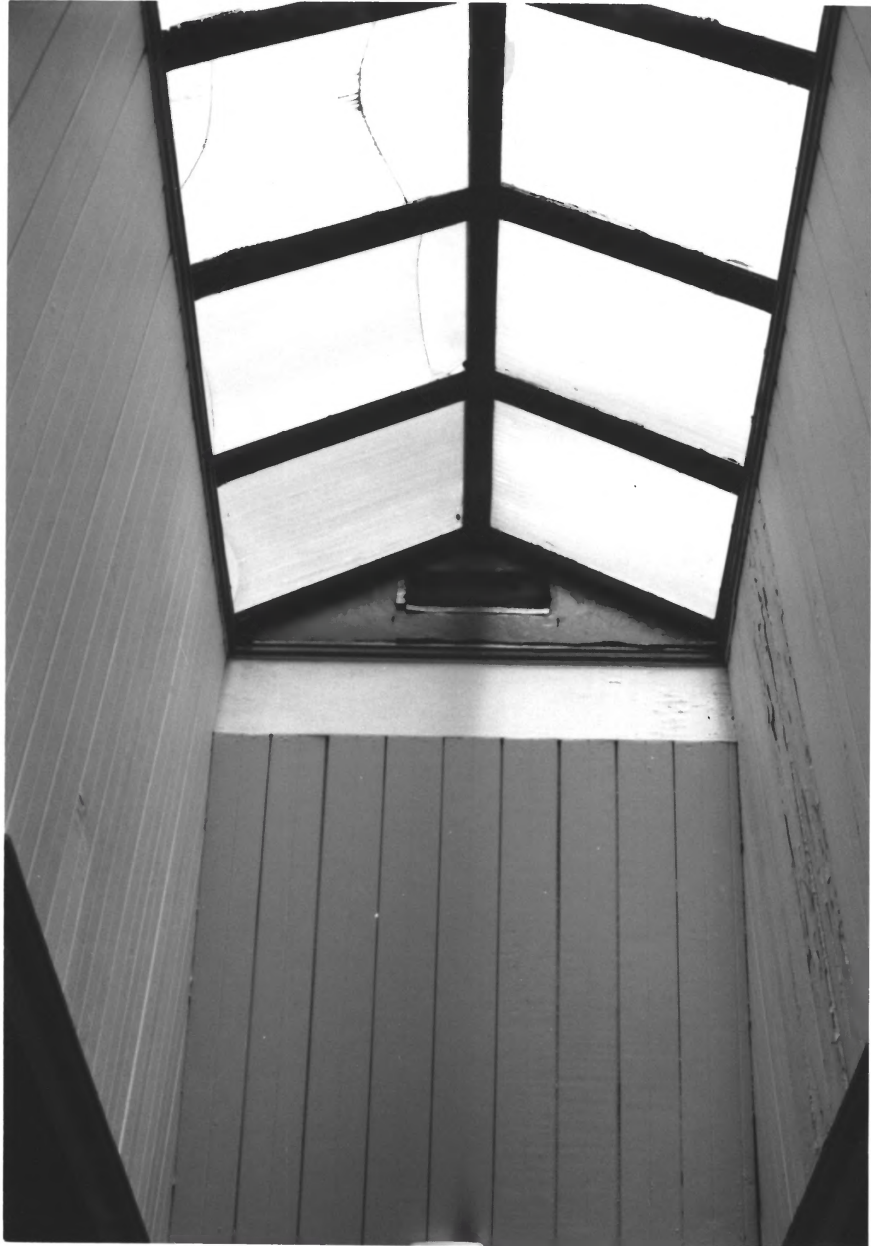
Skylight in center of second floor of store  
building is original, and made of wire glass  
in metal frames. Looking west

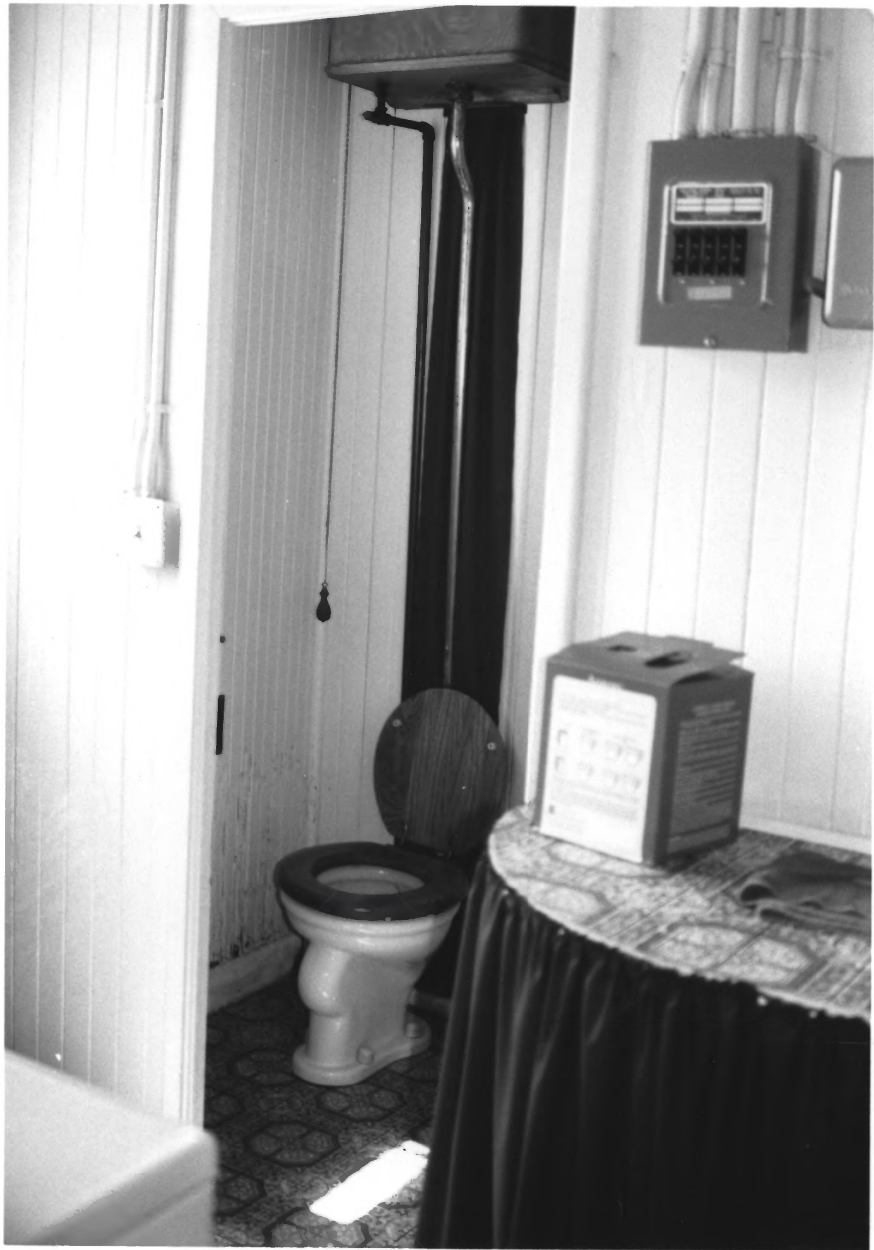
In store building, original bathroom, looking northwest, in rear corner of building.
