United States Department of the Interior National Park Service	л Л	KEGELVI
National Register of Historic Plac	es Registration For	JUN - 9 2017
1. Name of Property		Natl, Reg. of Historic Bl
Historic Name: Garland Downtown Historic D Other name/site number: NA Name of related multiple property listing: NA	istrict (Boundary Increase	for Alston House)

2. Location		
Street & number: 212 N. 7 <sup>th</sup> Street City or town: Garland State: To Not for publication: D Vicinity: D	exas County: Dail	las
3. State/Federal Agency Certification		
<ul> <li>☑ nomination □ request for determination of eligibility Register of Historic Places and meets the procedural ar property ☑ meets □ does not meet the National Regis</li> <li>I recommend that this property be considered significan</li> <li>□ national □ statewide ☑ local</li> <li>Applicable National Register Criteria: ☑ A □ B</li> </ul>	nd professional requirements set ster criteria. nt at the following levels of signifi	t forth in 36 CFR Part 60. In my opinion
Signature of certifying official / Title Texas Historical Commission State or Federal agency / bureau or Tribal Governm	State Historic Preservation Office	Date
In my opinion, the propert

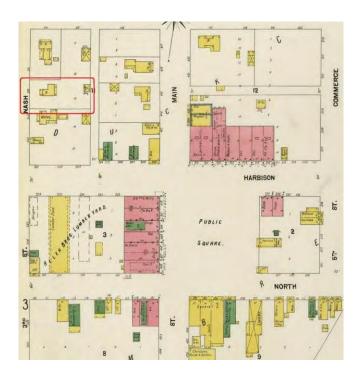
**Map 4:** 1901 Sanborn Map shows the property now listed as 212 N. 7<sup>th</sup> Street in red. Note the 'L' shaped structure on an 'L' shaped parcel.

A comparison of the Sanborn maps for the blocks near 212 N. 7<sup>th</sup> Street between the years 1901 and 1928 show the evolution of the area (See Maps 1-4). As noted in the Garland Downtown Historic District, residential neighborhoods developed along the edges of the commercial center. These maps depict the loss of grand houses and the division of land for new construction. Between 1915 and 1919, the adjacent residence to the north sold the back portion of their property and the current buildings were constructed.

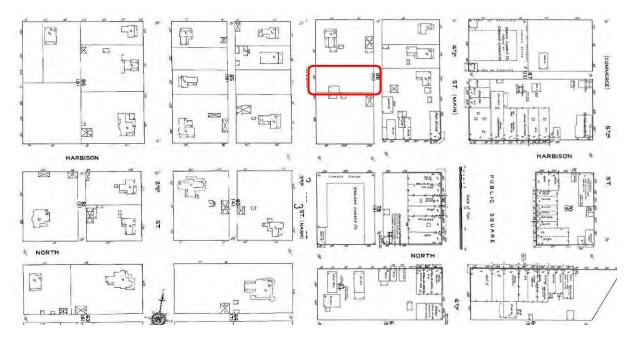
**Map 5:** 1915 Sanborn Map shows change in parcel shape and loss of the previous dwelling.

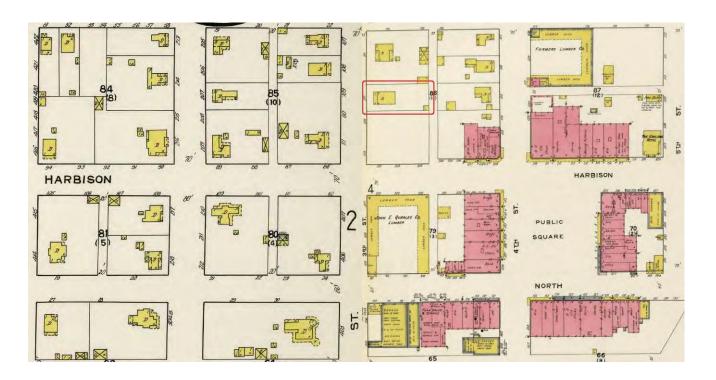
**Map 6:** 1919 Sanborn Map shows the current house at 212 N. 7<sup>th</sup> Street and the current parcel shape.

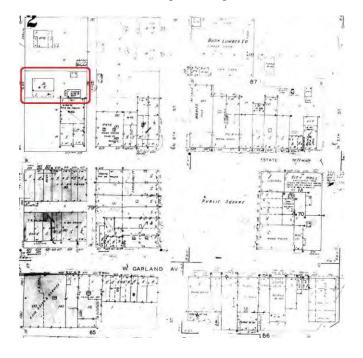
**Map 7:** 1958 Sanborn Map shows the porch enclosed, the south shed, and two outbuildings constructed.

In addition, the property was also modified by the inclusion of north and south elevation sheds, and two outbuildings. The attached south elevation shed was constructed first, sometime in the mid to late 1950s, to replace an earlier canvas awning used for the family's furniture business. It appears in the 1958 Sanborn Maps and in an aerial photo from the same year. The attached north elevation shed was constructed in 1962 and can be verified by the date inscribed in a concrete footing of one of the posts. The attached sheds have a similar appearance, are constructed with a post and beam wood frame and extend the length of the north and south elevations. The roof is supported by posts located along the exterior edge and roof framing secured through the cornice trim of the house. The roof material for both sheds consists of corrugated tin spanning wood rafters. The grade around the house was raised at some point to within a few inches of the porch floor elevation.

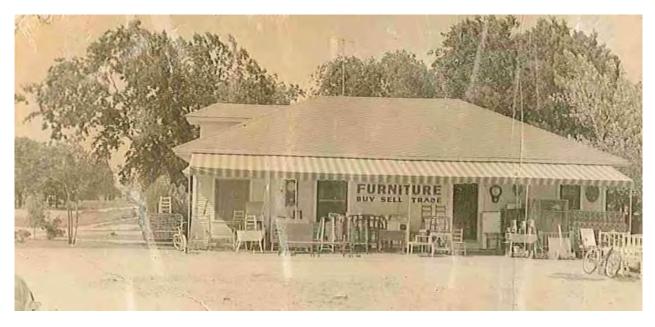
Figure 1: View of south elevation, looking north. Note canvas awning and furniture sign, c 1953. Courtesy of the Alston family.

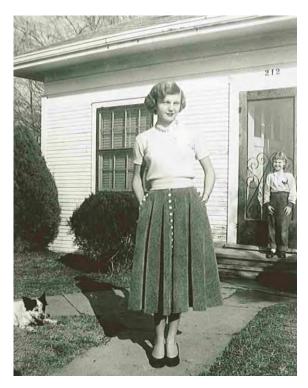
**Figure 2:** View of front elevation, note 6-over-6 window on enclosed porch, c 1953. Courtesy of the Alston family.

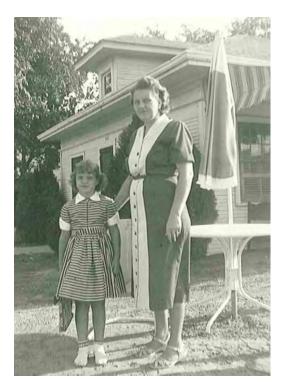
**Figure 3:** View of southeast corner, note canvas awing, c. 1953. Courtesy of the Alston family.

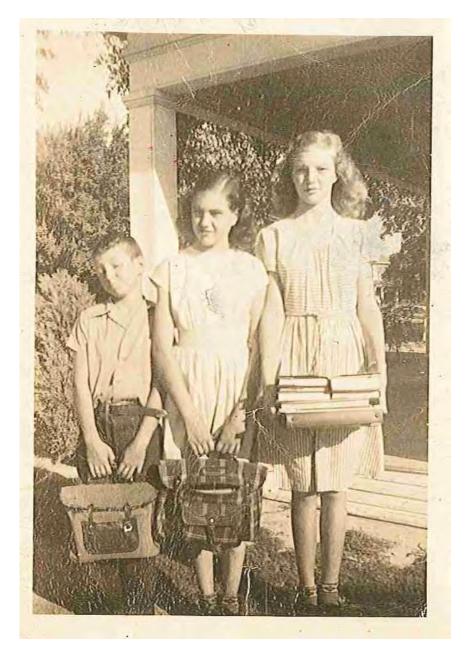
**Figure 4:** This photograph might show the front porch before it was enclosed but could not be verified because of a lack of context. In the photograph are three of the Alston children. The family had lived in Garland for several years by the time this photograph was taken for possibly the first day of school. Similar shrubs can be found in these locations in later photographs of the enclosed porch. The photograph might be of the southwest corner of the porch looking northwest. Courtesy of the Alston family.

**Photo 13:** Note the trim in the cornice is similar to trim in Figure - 4. This is one of the few clues that Figure - 4 might be the original porch. Camera facing east.

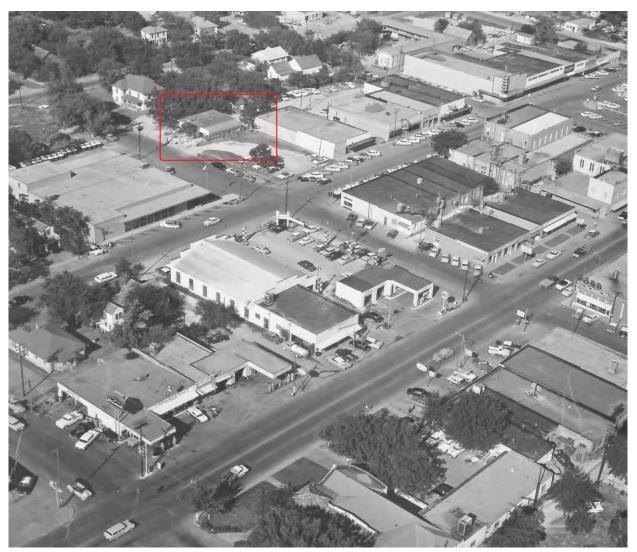
**Figure 7:** View looking northeast toward 212 N. 7<sup>th</sup> Street, marked in red. Note the shed constructed the length of the south elevation and merchandise in the front yard, c 1958. Courtesy of the Garland Landmark Society.

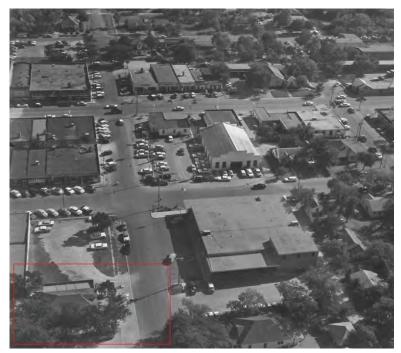
**Figure 8:** View looking southwest toward 212 N. 7<sup>th</sup> Street, marked in red. Note the shed constructed the length of the south elevation, c 1958. Courtesy of the Garland Landmark Society.

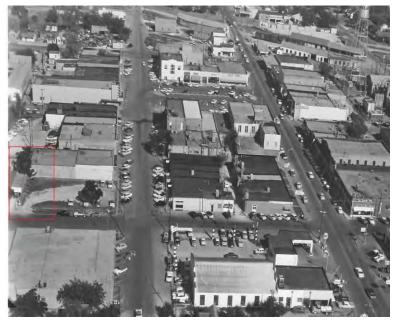
**Figure 9:** View looking east toward downtown, 212 N. 7<sup>th</sup> Street marked in red at the edge of photograph. Note the shed constructed on the south elevation, c 1958. Courtesy of the Garland Landmark Society.

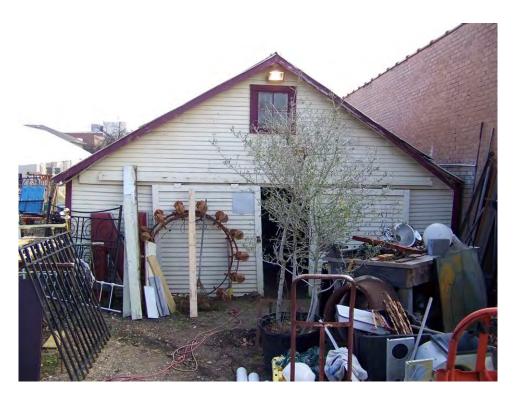
Photo 5: View east from backyard of west elevation of garage. Camera facing east.

Two contributing outbuildings exist on the property, both constructed in the 1950s. The larger of the two was originally used as a garage/workshop by the family. The rectangular building has wood stud framing, clad with a variety of siding including wood on the primary facade, and corrugated and V crimped tin panels on the other facades. The west elevation is the primary façade with a central opening for two large "sliding barn doors." A moderate pitch gable roof extends the full length of the building and the roofing material is V crimped tin panels. The building has a four-light window in the west gable.

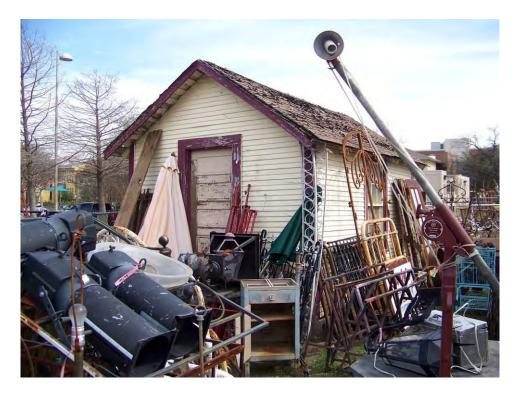
Photo 7: View east of bedroom structure. Camera facing northeast.

The smaller of the two outbuildings was used at one time by the family as a spare bedroom for one of the teenage boys. The rectangular building has wood stud framing and is sheathed in wood rounded drop siding that matches the house and board and batten siding. The primary (west) elevation also has a central door. A moderate pitch gable shingle roof extends the full length of the building. It features a six-over-six divided light sash window on the south façade.

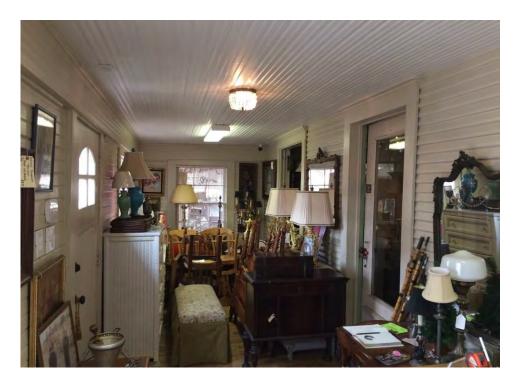
**Photo 9:** Interior view of enclosed front porch. Note the wood siding, front door and window trim of the original front elevation on the right side of photograph. Camera facing north.

The house was altered within the period of significance. The porch was enclosed by the Alston family in the early 1950s as shown on Sanborn Maps and family photographs from that period. The original front façade and porch ceiling remain intact within the 1950's porch enclosure. Original design features include the window and door trim, window openings, wood rounded drop siding and the front door. The porch columns and any possible balustrades were lost during the renovation. It is possible the small inset back porch was enclosed at the same time.

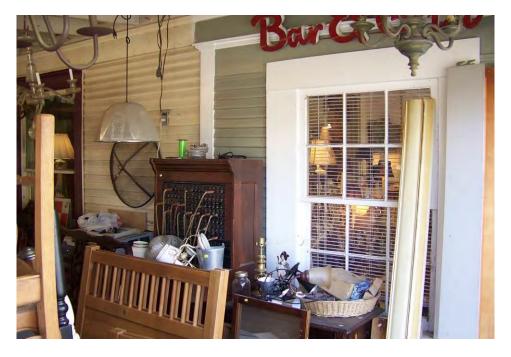
**Photo 10:** View of north porch enclosure wall painted green paint. The original window installed at this location at time of enclosure was used to replace deteriorated front window. This window is from a salvage yard and selected because it matched original. Camera facing southeast.

Recent repairs to the house include the replacement of deteriorated wood siding and windows, and the addition of shutters to the front façade. On the 1950s porch enclosure the wood rounded drop siding was replaced in kind from grade to the base of windows. The two deteriorated front 6/6 double hung windows were replaced with existing matching windows from the north and south walls of the porch enclosure. The windows openings in the north and

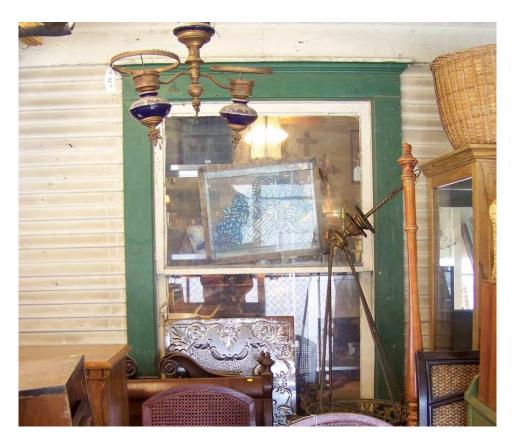
Photo 11: View of original window, trim and wood siding under the south shed. Camera facing north.

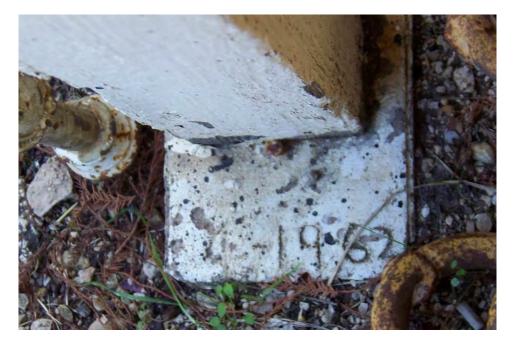
Photo 12: View inscribed concrete footing at the northeast column of shed.

In 1962 the north shed was constructed to accommodate further business expansion. The northeast column of the shed is inscribed with the construction date. In 1966, Mr. Alston diversified his commercial interests as indicated by a State of Texas Business Permit for "The Fruit Basket." This venture did not appear in Garland phone books until 1968. From 1968 to 1974 Alston's Furniture and Appliance and Alston Fruit Stand were listed at this address. By 1975, the Garland phonebook lists Alston's Fruit Stand, and not the furniture business. In 1976, Mr. Alston is listed at the 212 N. 7<sup>th</sup> address and retired. There was a period of vacancy after the death of Mr. Alston beginning in 1988 until Alston's Antiques opened in 1995.
