**HISTORIC RESOURCES INVENTORY
BUILDING AND STRUCTURES**

1. BUILDING NAME (Common)		(Historic)	
2. TOWN/CITY	VILLAGE	COUNTY	
Southington	Southington, CT 06489	Hartford	
3. STREET AND NUMBER (and/or location)			
1010 Shuttle Meadow Rd. (map 211, parcel 2) 1.92 acres

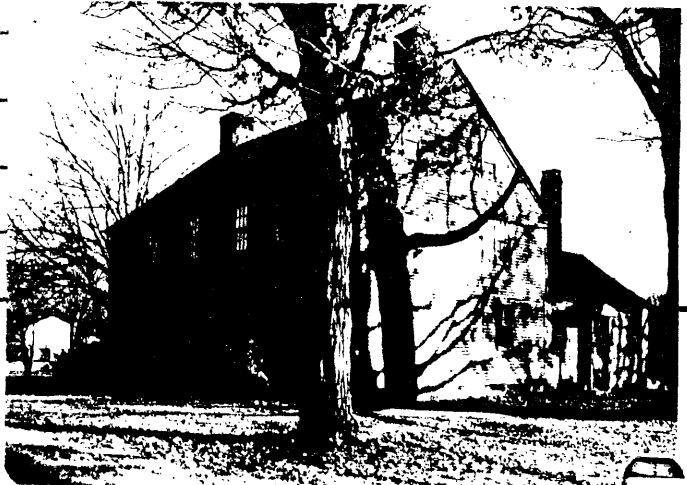
Southeast

11. NUMBER OF STORIES	APPROXIMATE DIMENSIONS		
2	36 x 28'		
12. CONDITION (Structural)		(Exterior)	
<input type="checkbox"/> Excellent <input checked="" type="checkbox"/> Good <input type="checkbox"/> Fair <input type="checkbox"/> Deteriorated	<input type="checkbox"/> Excellent <input checked="" type="checkbox"/> Good <input type="checkbox"/> Fair <input type="checkbox"/> Deteriorated

In the 5-bay front elevation the central doorway is flanked by fluted pilasters that support a narrow entablature and molded cornice. Flanking the pilasters are small 4/4 windows. Other windows are 6/6 in plain frames. The twin brick chimneys are located 2-3 feet in from the ends of the ridge line. There is a rear, shed-roofed, 1-story extension that appears to be old.
