Collings-Knight House

500 Collings Avenue

Collingswood, NJ 08108 (Camden County)

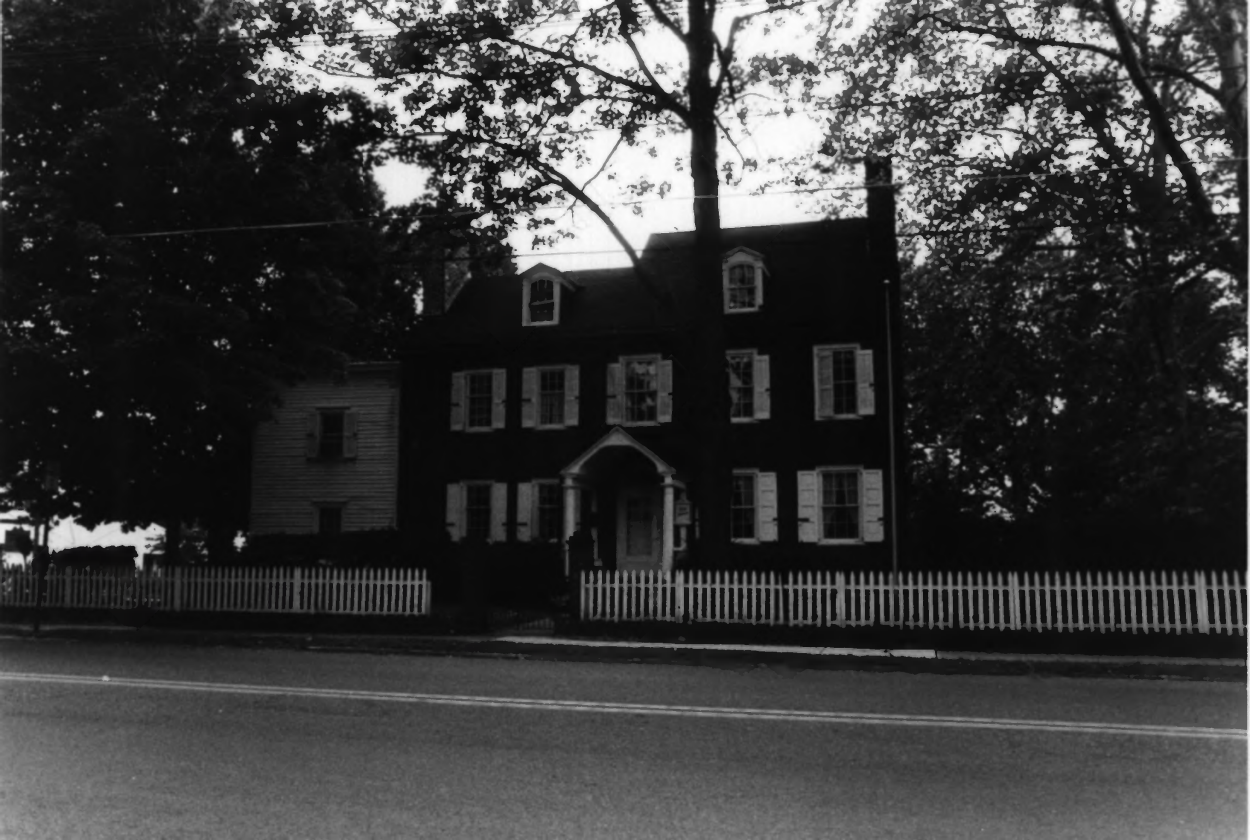
Photograph No. 1 of 16.

View of front facade. (Camera facing south.)

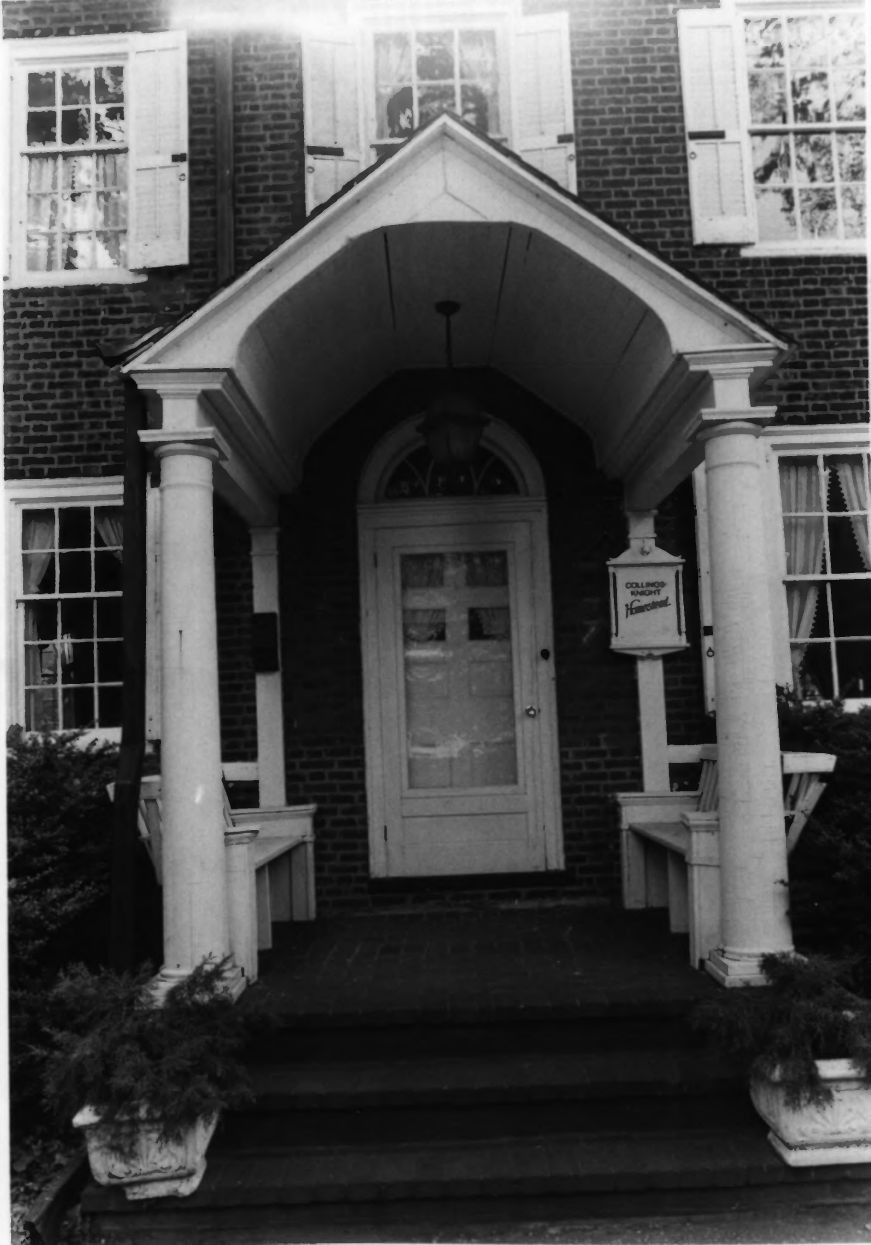
Photograph #2 of 16.

View of entrance portico, front facade. Note 6/9 windows at left; 6/6 windows at right.

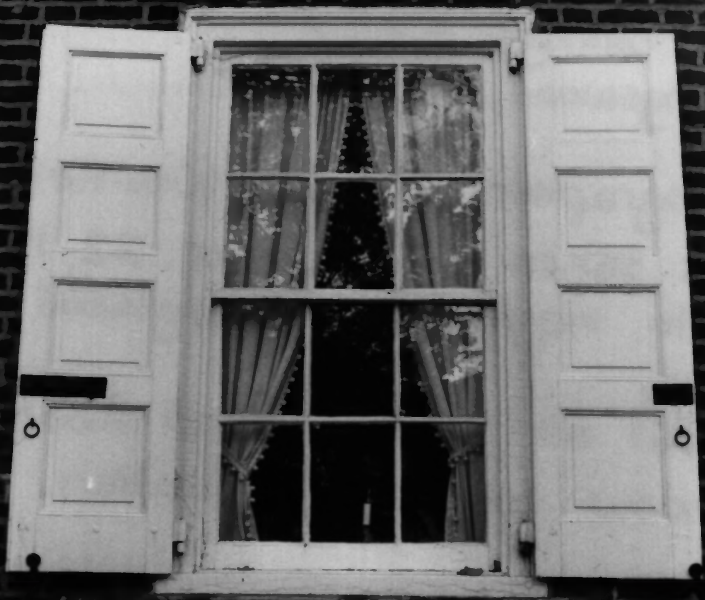
Photograph # 3 of 16.

Detail of western first floor
window on front elevation.

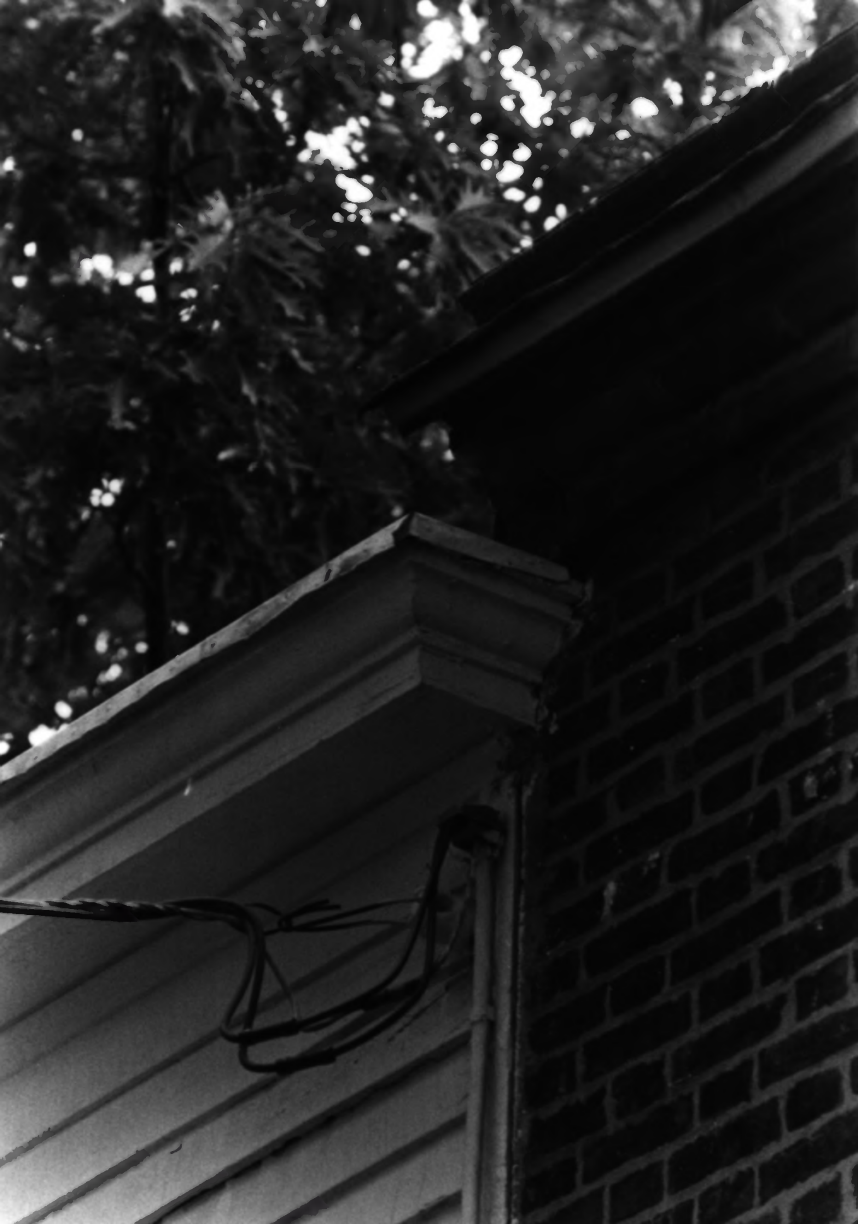
Photograph # 4 of 16.

Detail of cornices, front facade,
showing molded brick cornice
meeting box cornice of addition.

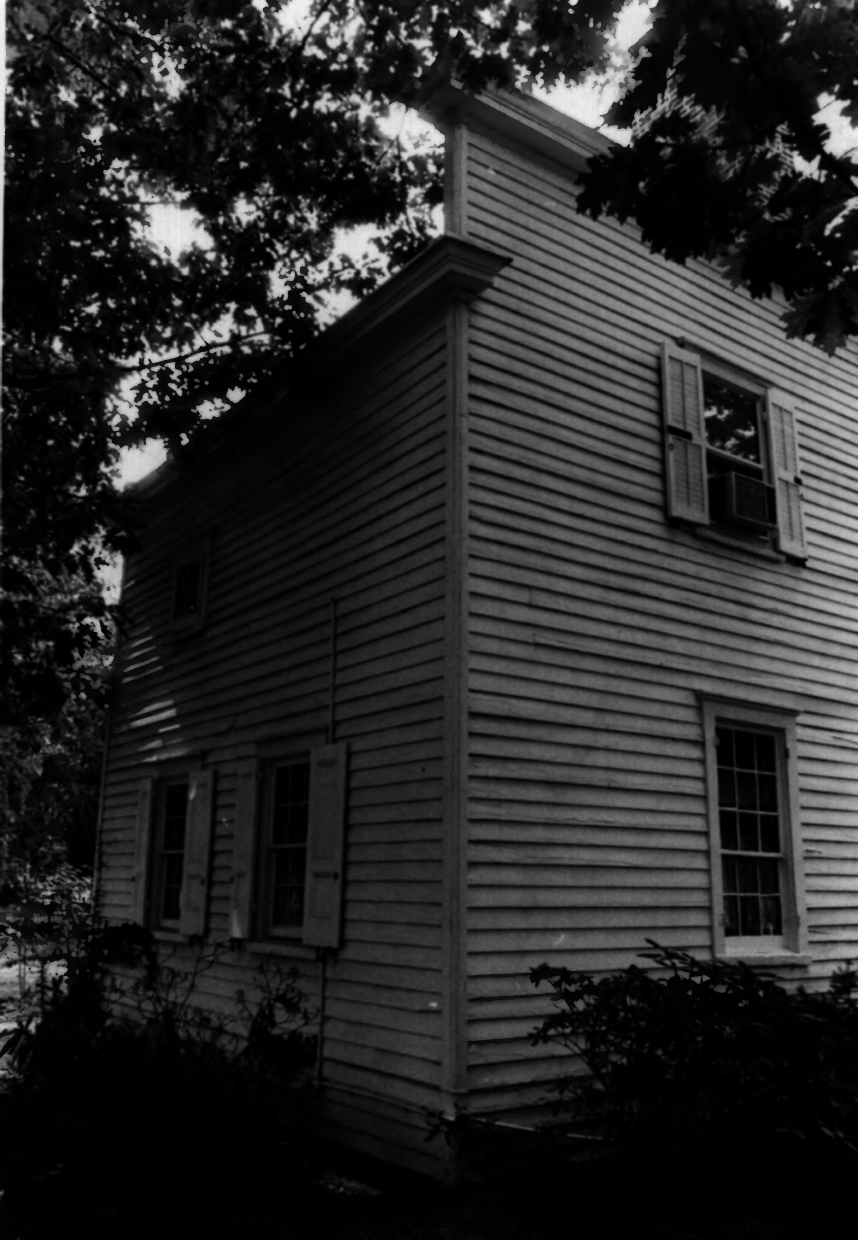
Photograph No. 5 of 16.

View from the northeast showing front and side elevations of early lean-to frame addition. Note false front parapet.

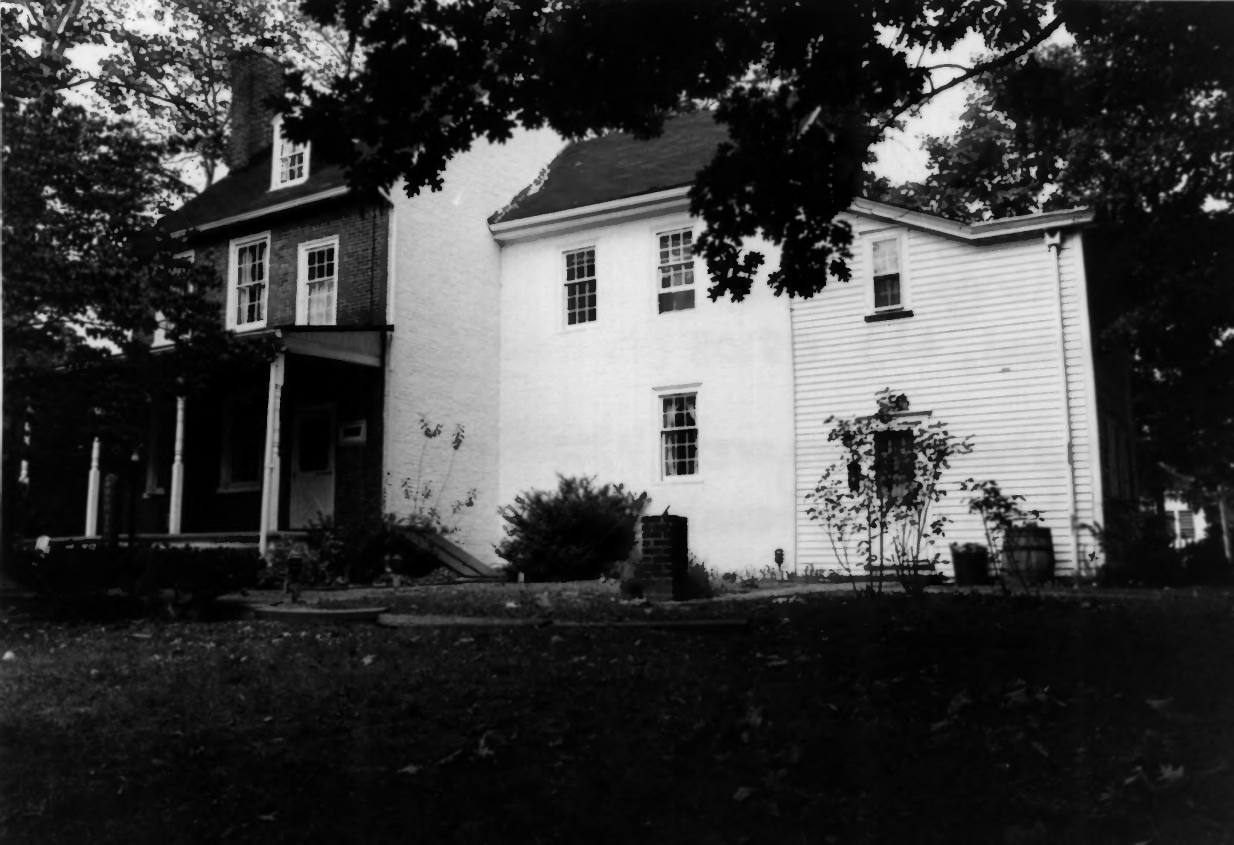
Photograph No. 6 of 16.

View from Southeast showing rear elevation.

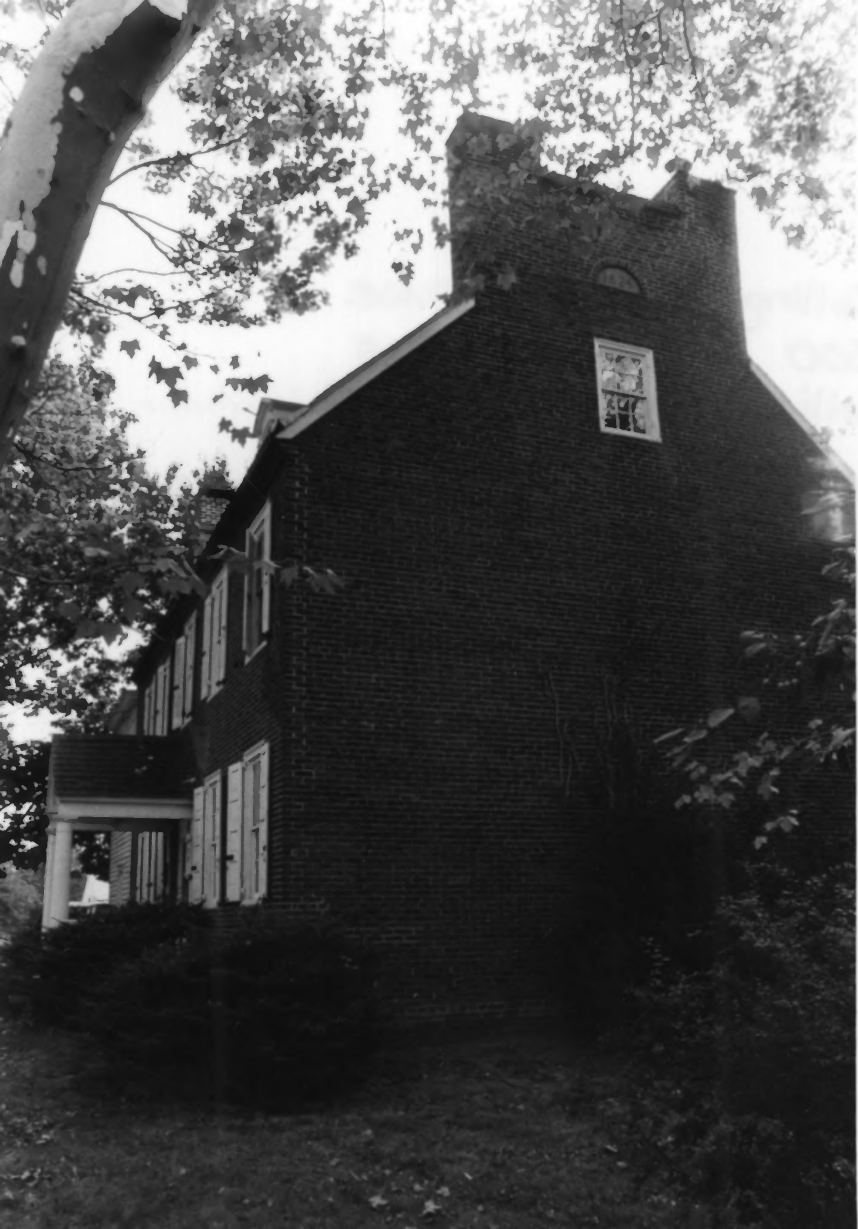
Photograph No. 7 of 16

View of west gable end. (Camera
facing southeast.) Note "1824"
date stone above third floor window.

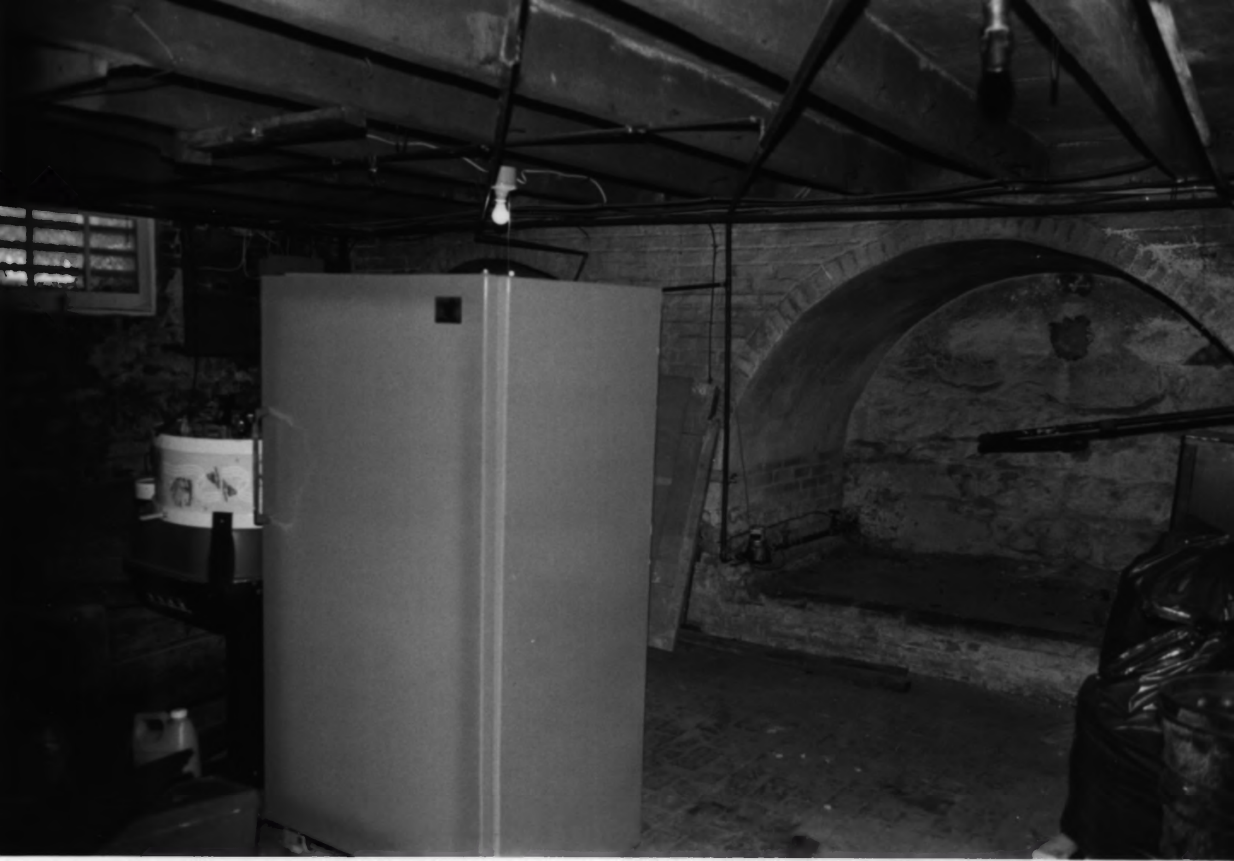
Photograph No. 8 of 16

View of basement showing brick vaults
under kitchen fireplace wall. Camera
facing northeast.

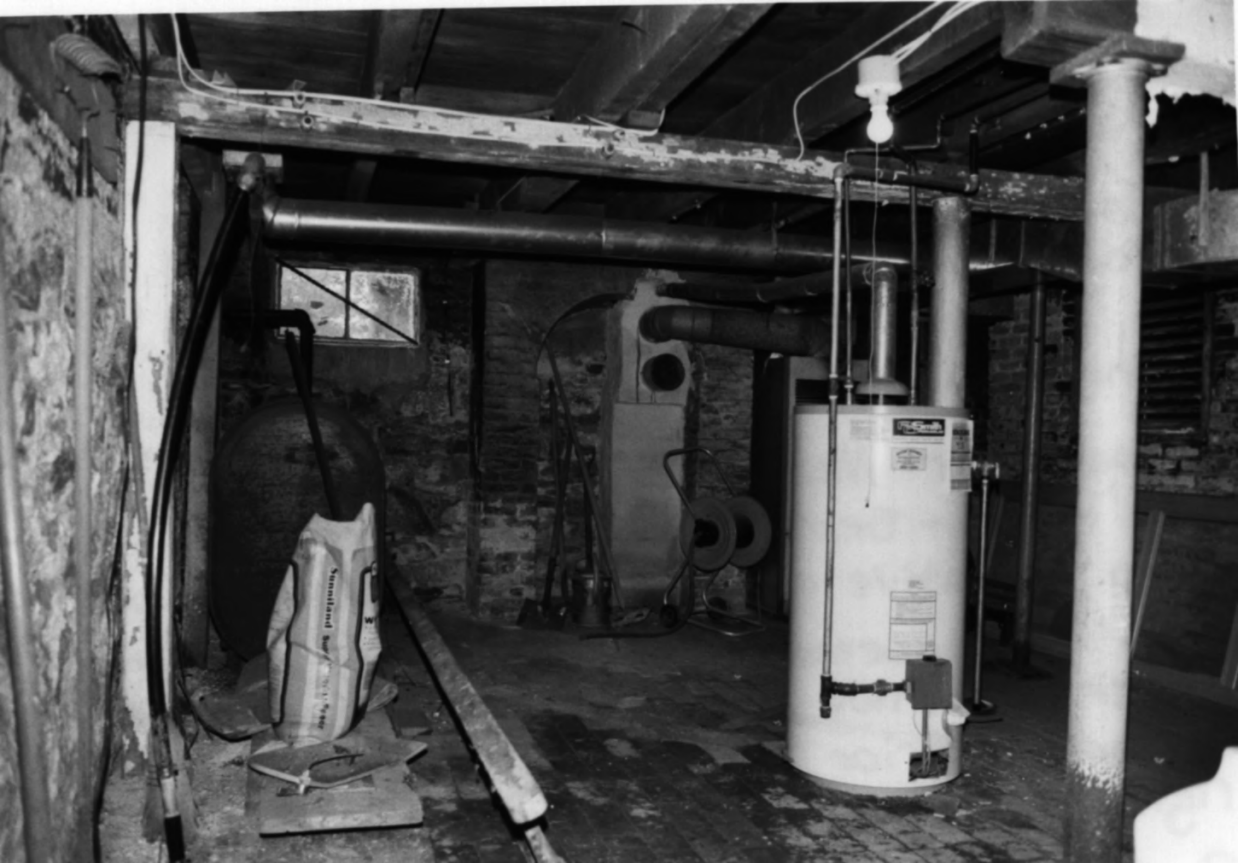
Photograph No. 9 of 16.

View of basement showing brick vault
under southwest parlor fireplace and
barred interior window for ventilation at
right. Camera facing west.

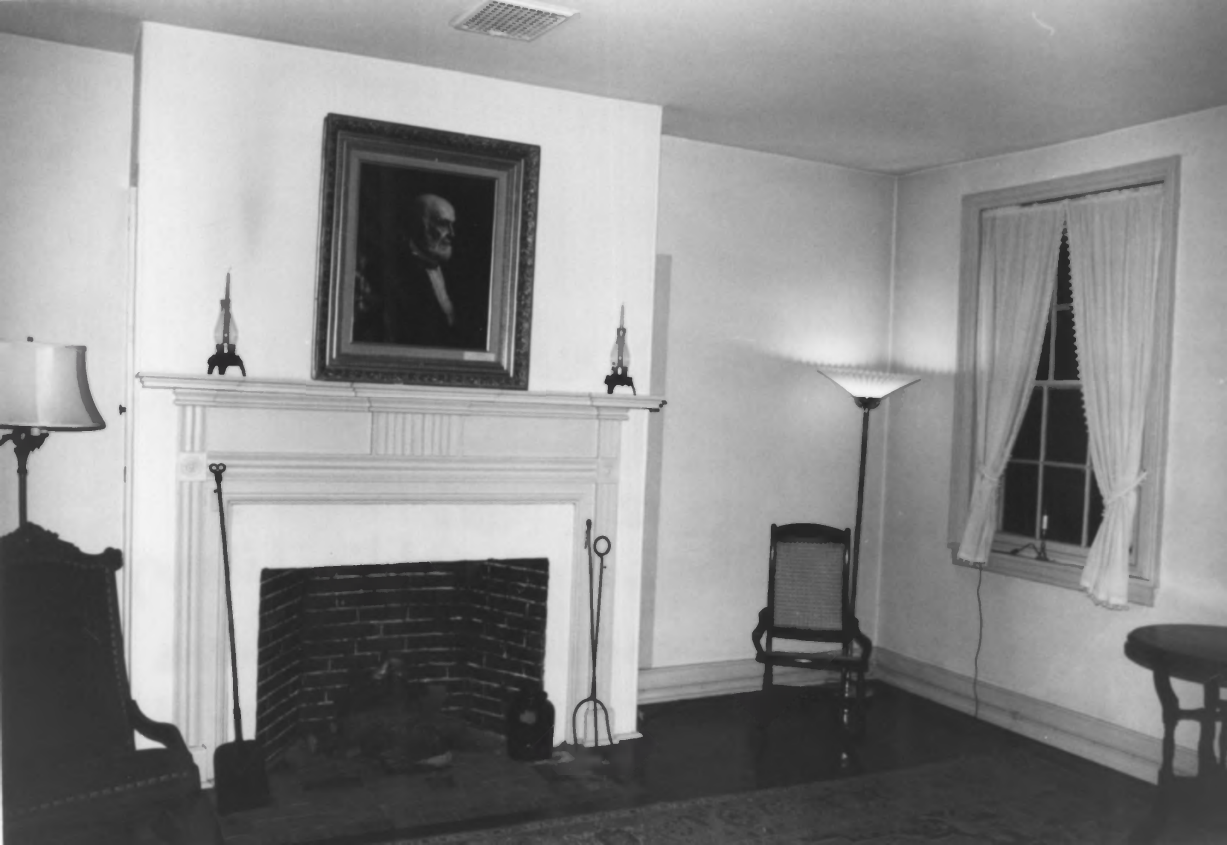
Photograph No. 11 of 16.

View of northwest parlor showing fine
Federal mantle & edge of fireplace closet door
at right. Camera facing northwest, first floor.

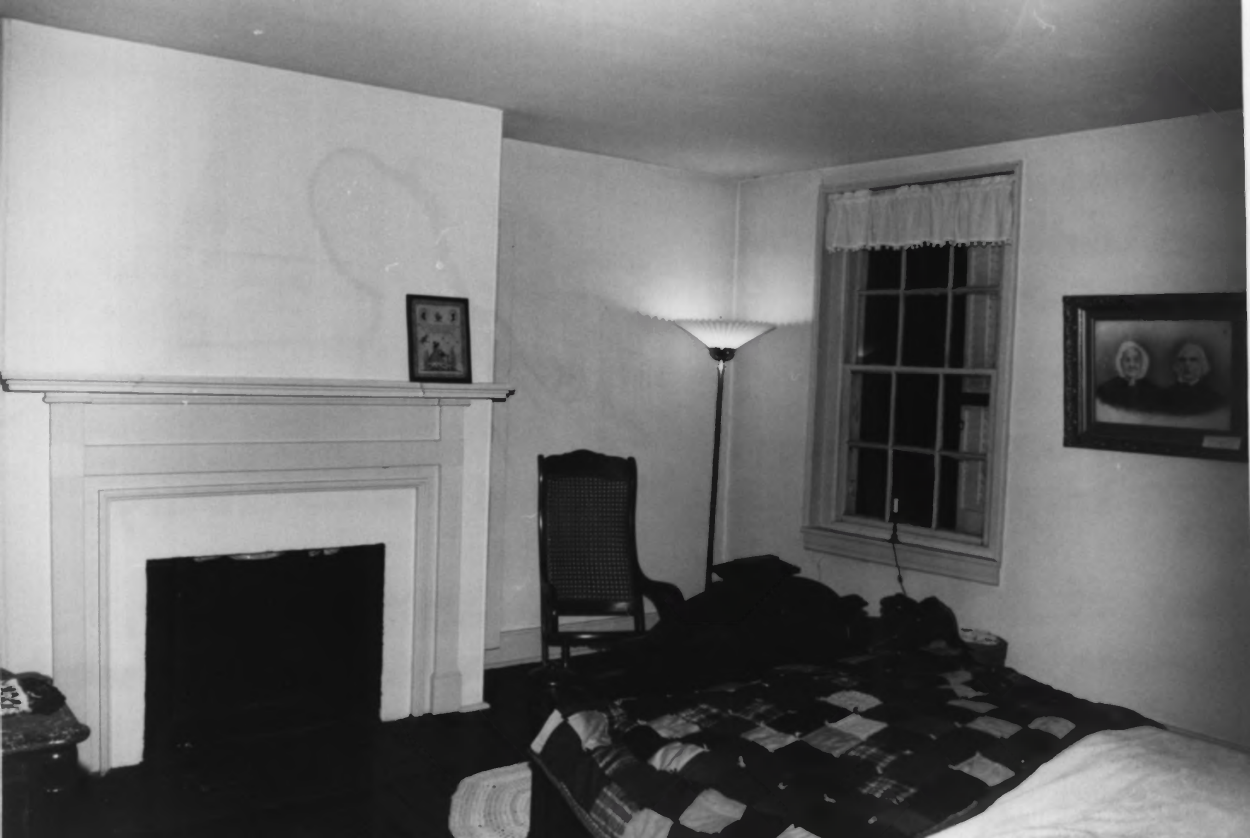
Photograph No. 12 of 16.

View of second floor northwest chamber,
showing reeded mantle. Camera facing northwest.

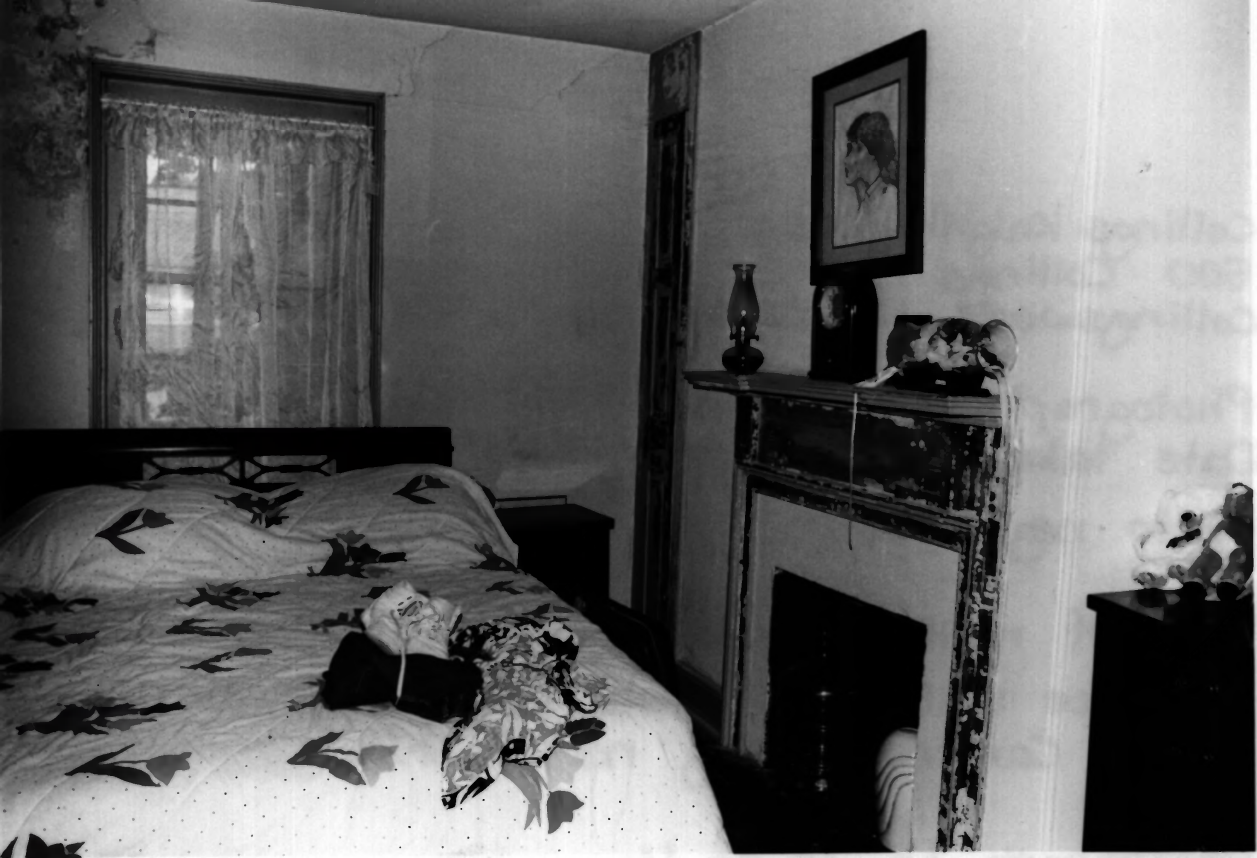
Photograph No. 13 of 16

View of northeast second floor chamber showing
fireplace wall with raised panel door to integral
closet. Camera facing northeast.

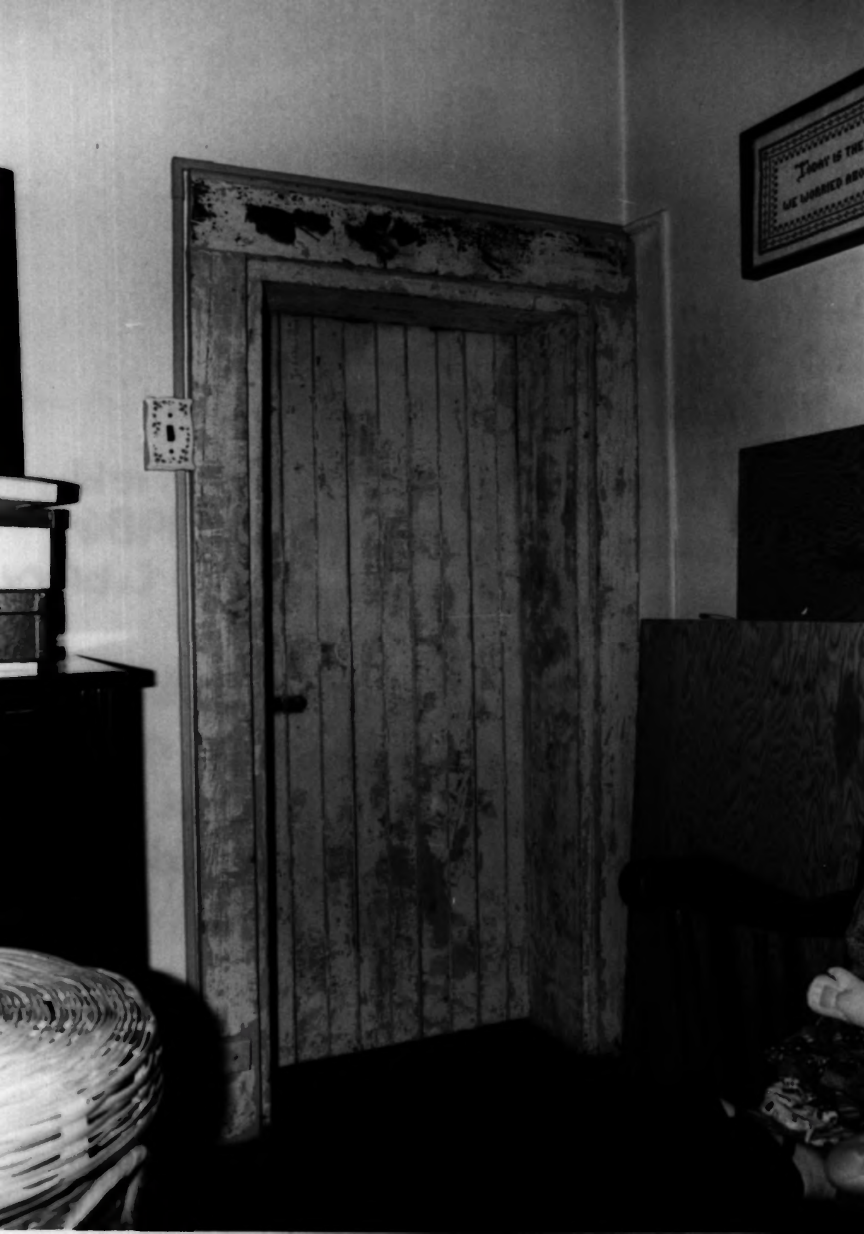
Photograph No. 14 of 16

Detail of early board-and-batten
door in doorway between northeast
bedroom chamber and second floor
room of frame lean-to addition.
Camera facing southeast.

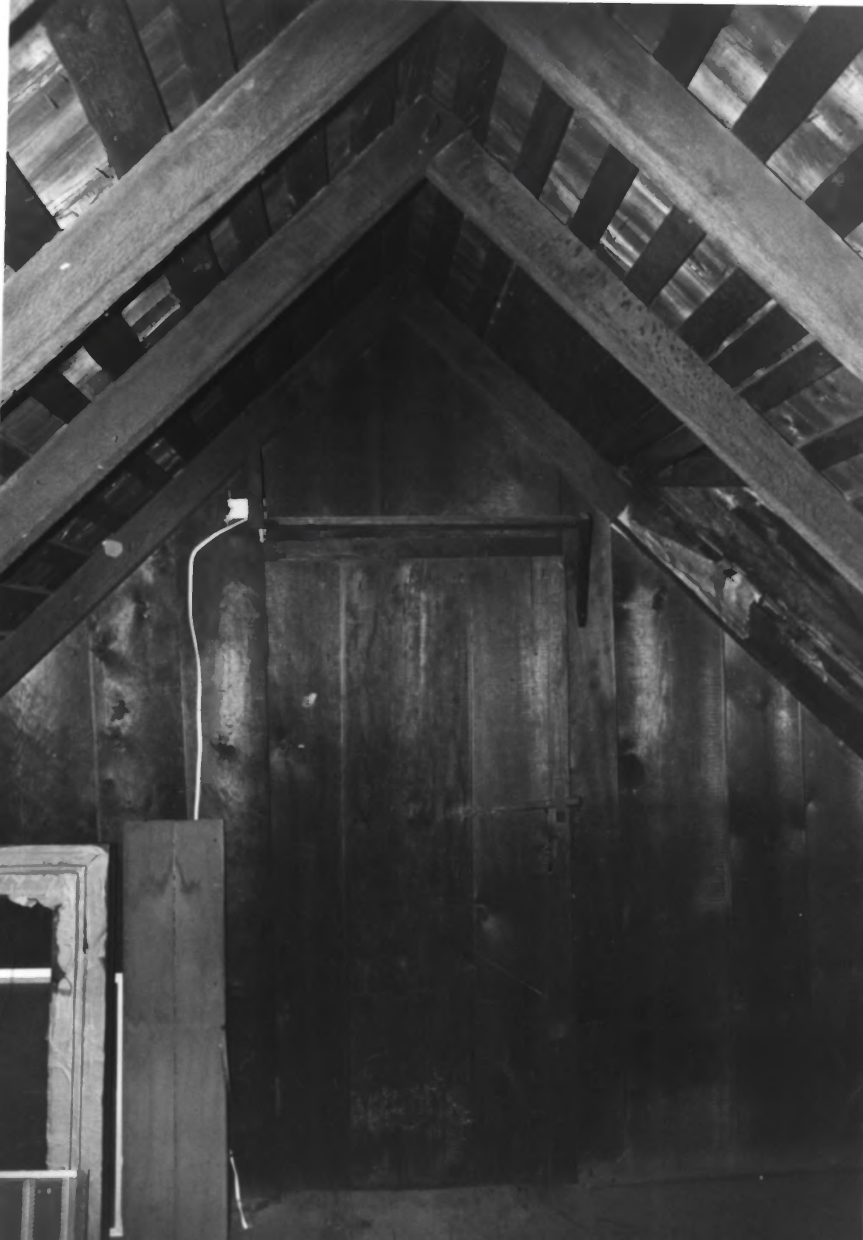
Photograph No. 16 of 16.

View of eastern third floor garret room showing random width vertical beaded board partition with board-and-batten door with early hardware, and pegged end-lapped rafter construction.
