# NEW JERSEY TRANSIT RAILROAD STATION SURVEY

- A. Name: Common  Mountain Station Line: Hoboken Division -  
Historic  Morrystown (DL&W)
- B. Address or location:  
  - 449 Vose Avenue  County: Essex
  - So. Orange, N.J. 07079  Municipality: South Orange Village
  - Block & lot: \_\_\_\_\_
- C. Owner's name: NJ Transit  
Address: Newark, N.J.
- D. Location of legal description: Recorder of Deeds, Essex County Court-  
house, Raymond Boulevard, Newark, N.J.
- E. Representation in existing surveys: (give number, category, etc.,  
as appropriate)

FACILITY NAME: Mountain

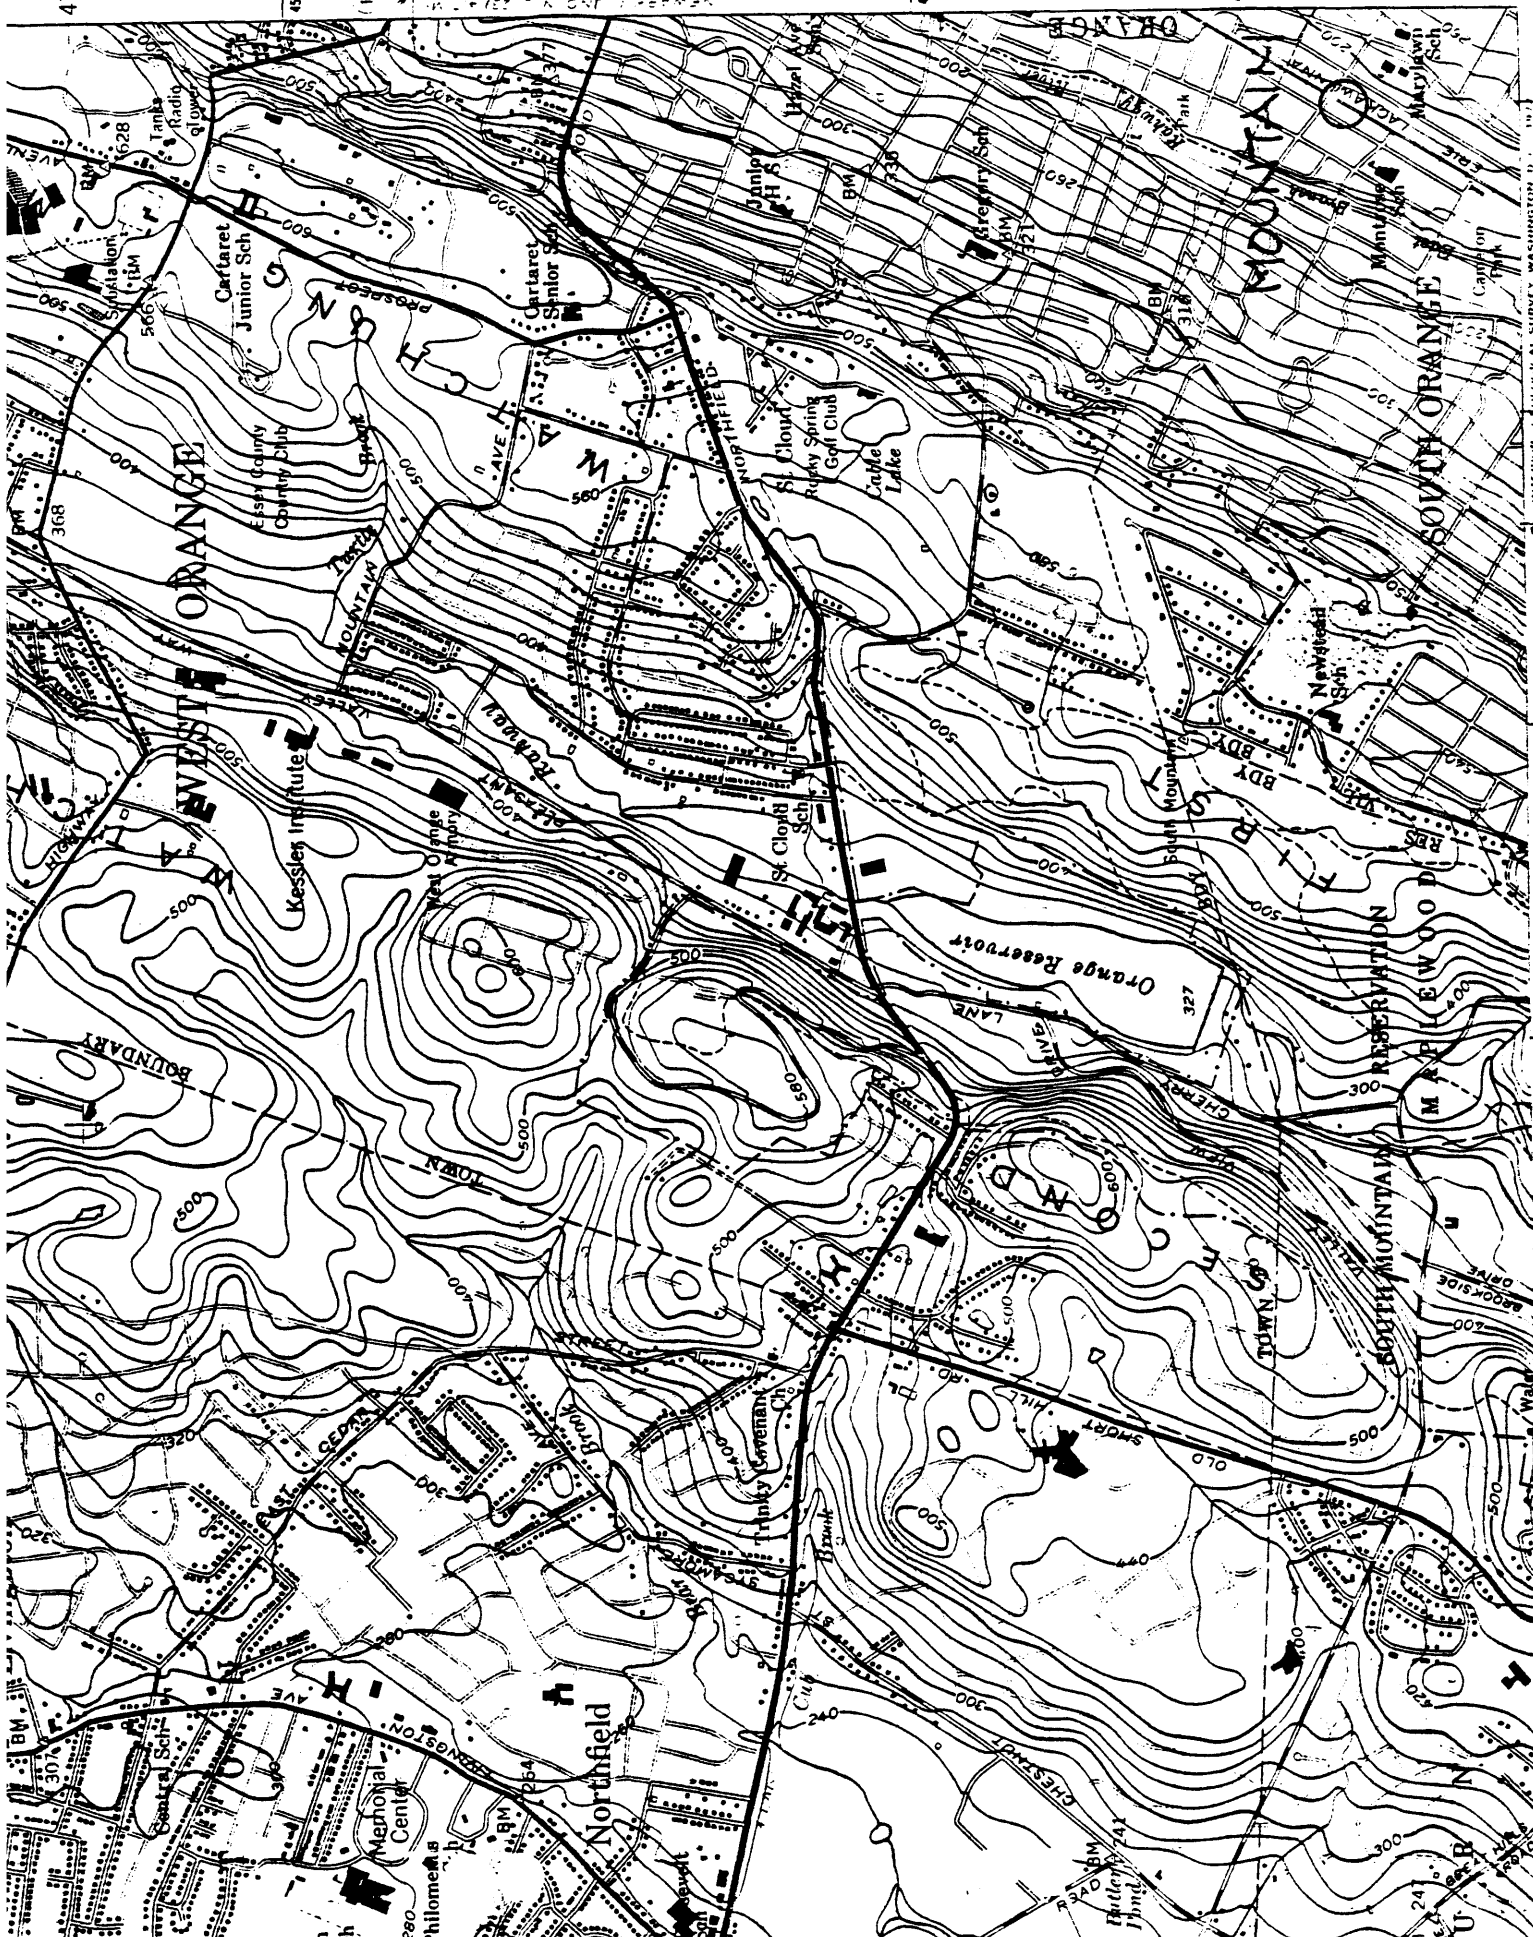
86 2-9 Mountain Railroad Station (Taber, 20th, p. 86)

Mountain Station, situated at Montrose Avenue, received a third track probably in 1901 as part of adding the section of third track to the Morristown line. The 1901 annual report mentions construction of a third track South Orange to Maplewood, but makes no mention in any report of the track addition to Mountain Station picture looks west in September 1913. The small station is the same one shown in photographs taken back in the 1

Mountain Station in South Orange was somewhat unique between Maplewood and Harrison. It was the only loc where the track elevation was not changed. In 1914 and 1915 Montrose Avenue was elevated over the tracks and new brick station constructed. At the same time the tracks were elevated at South Orange station.
