NEW JERSEY TRANSIT RAILROAD STATION SURVEY

FACILITY NAME: Park Ridge

PARK RIDGE
PASCACK VALLEY LINE

Park Ridge RR Station, Park Ridge
Boro, Bergen County

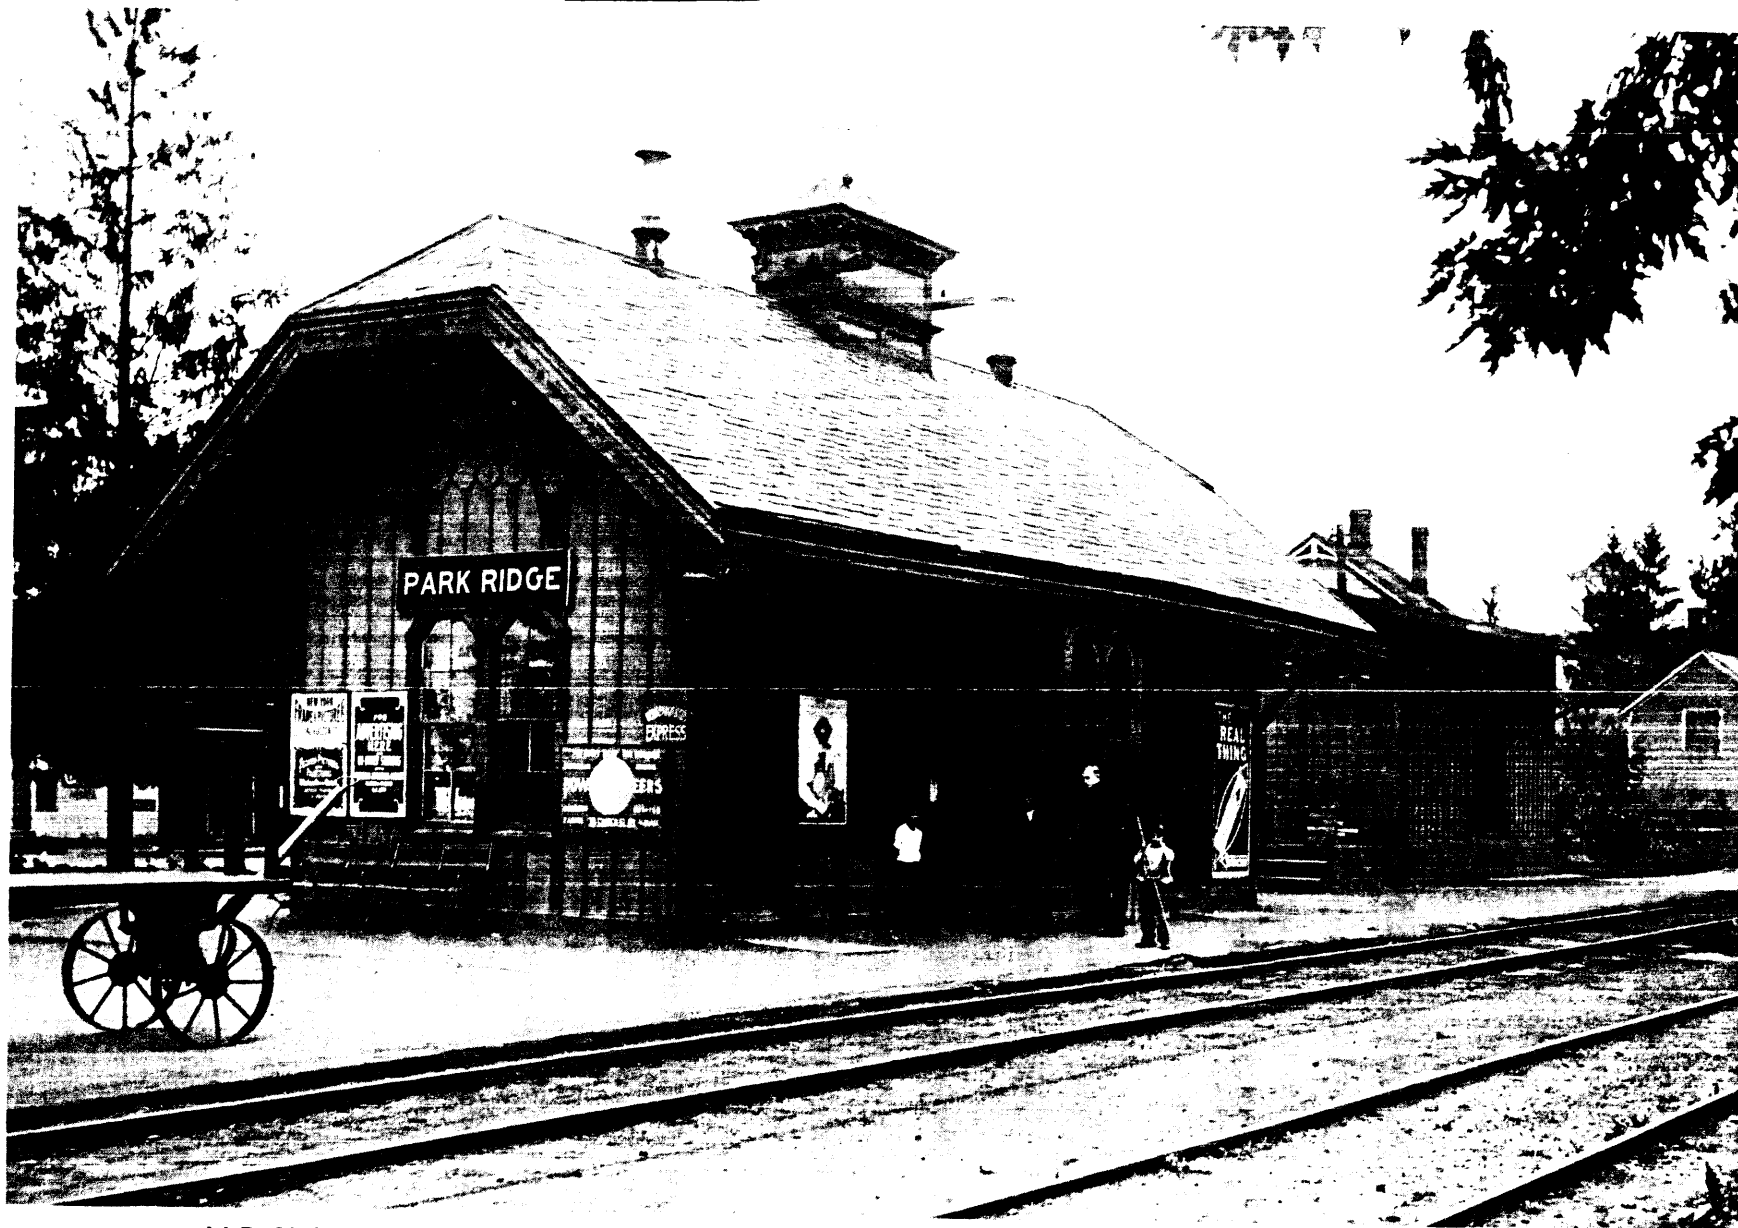
M.P.-23.7

The station at PARK RIDGE was built by the townspeople with the provision that all trains stop there. Total receipts on opening day, November 1, 1872, were \$3.50.
