# National Register of Historic Places Registration Form

historic name Fannin-Cooper Farm  
other names/site number Twin Creek Farm

street & number 620 and 511 Smith Road  not for publication  
city or town Hiram  vicinity  
state Georgia code GA county Paulding code 223 zip code 30141

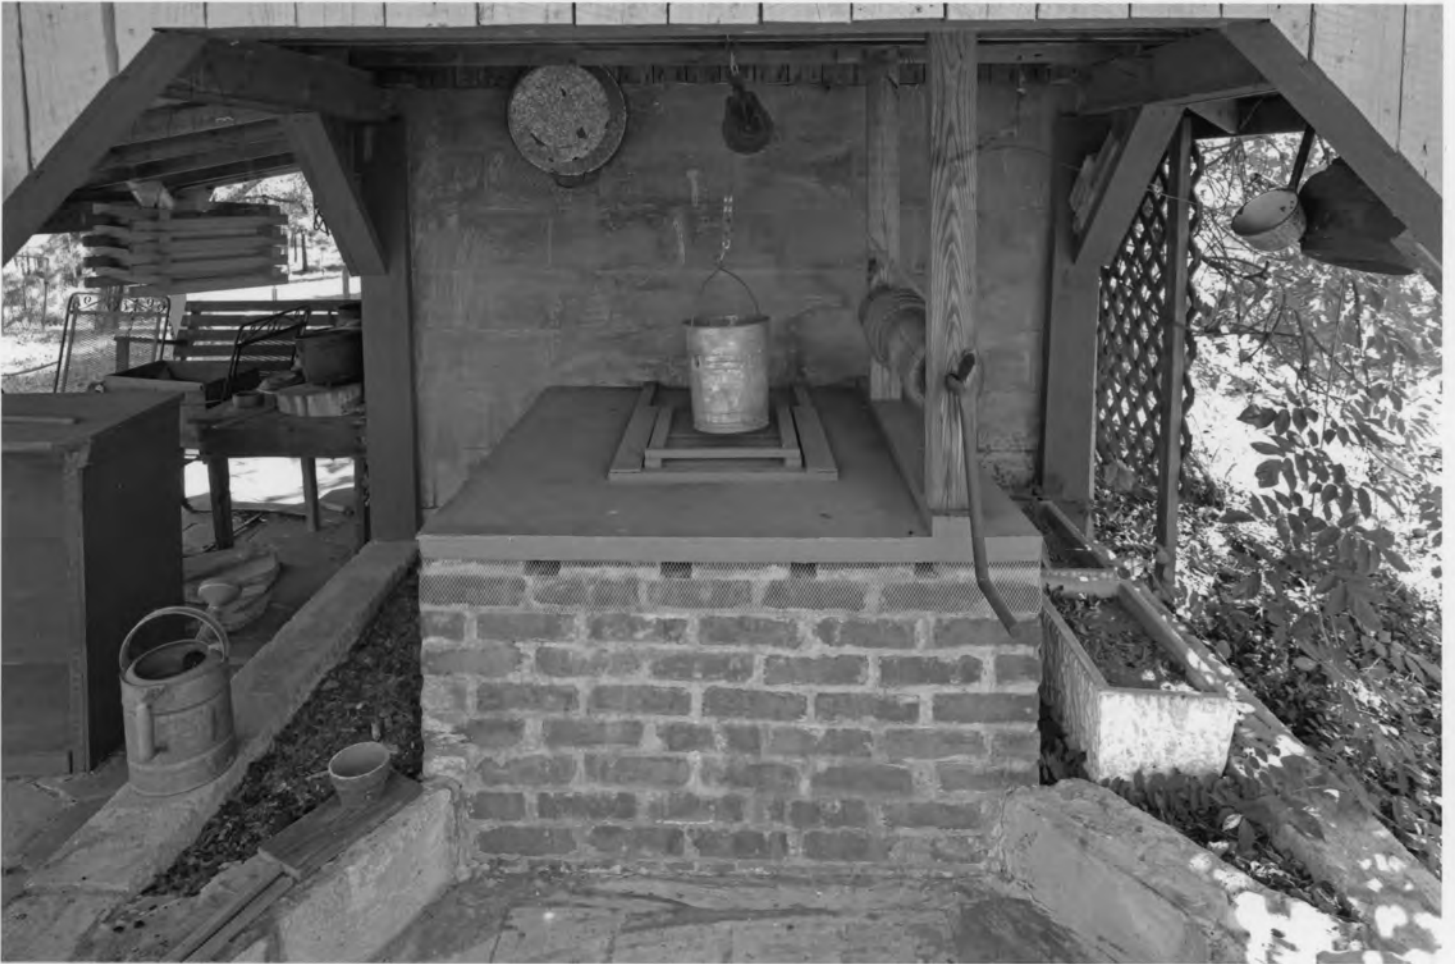
Fannin-Cooper Farm  
Paulding County, Georgia  
Photograph 4 of 27

A 50-foot deep, hand-dug well is located on the south side of the house. The well, a contributing structure, was dug sometime before 1962 with steps cut into the inner dirt walls for access. The well surround is made of brick. The cover is wood with a sliding door opening. There is a hand windlass system with wood winding drum, rope, pulley, and bucket. The well house has been expanded with a rear storage room and open, side porch, all contained under a metal roof (photograph 4).

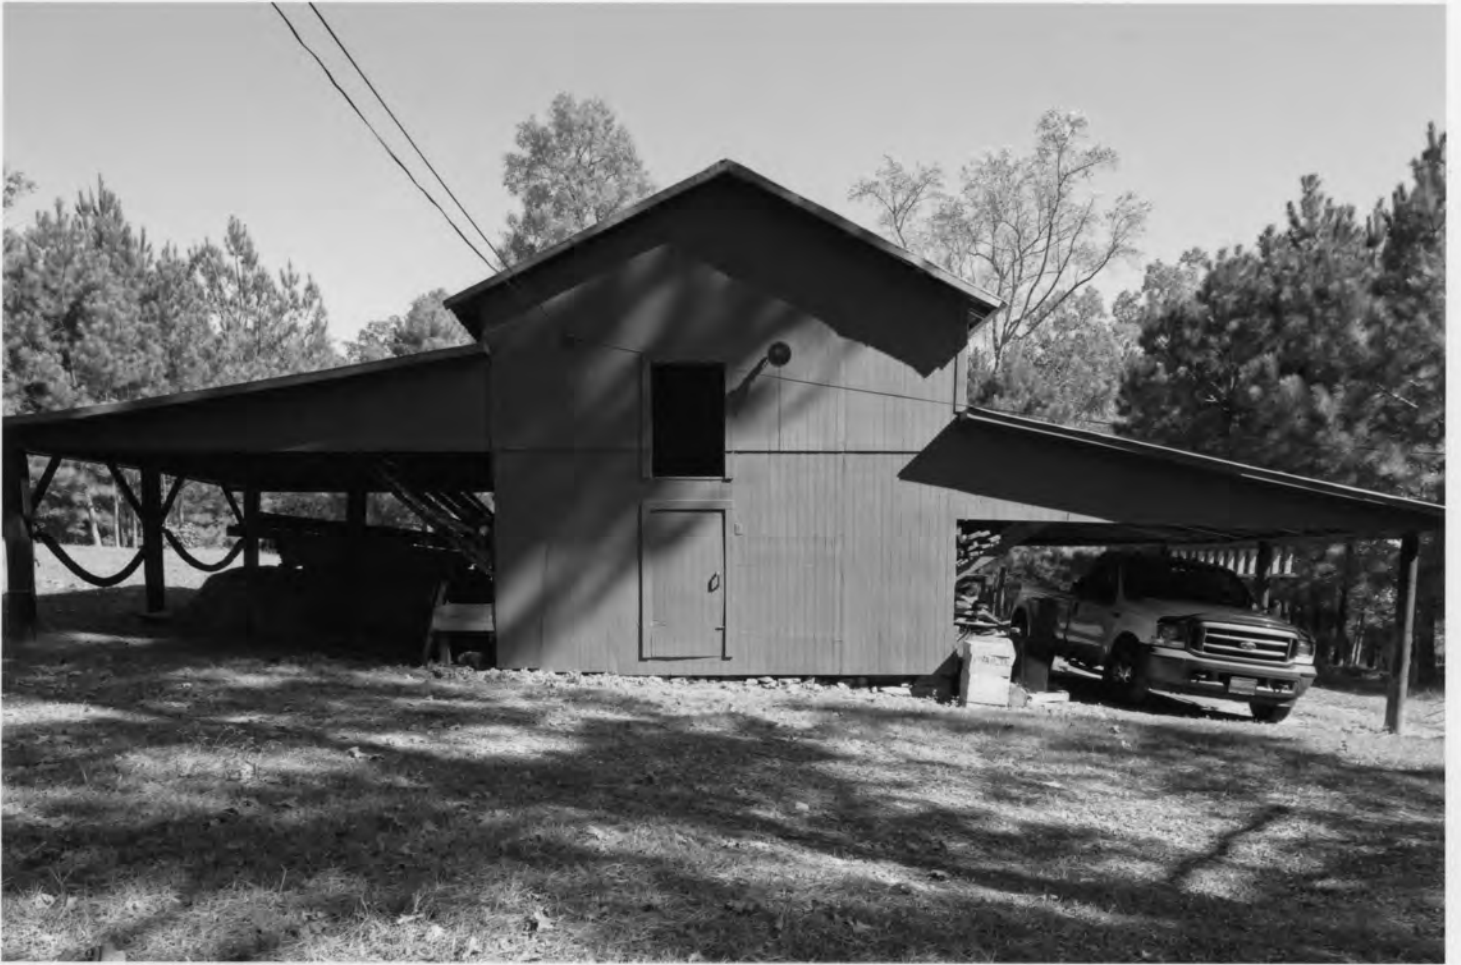
**Fannin-Cooper Farm**  
**Paulding County, Georgia**  
**Photograph 7 of 27**

The 1882 barn is located across Smith Road from the double-pen tenant house. The barn has an open shed on each side and entrances on the east and west elevations. The foundation is stone. The original pine boards are covered with plywood. The roof is metal. The barn contains one and a half stories and is approximately 900 square feet in size. There are two stalls and a ladder up to the loft. The stalls contain slots above each stall so that feed can be dropped into the feed troughs on the main level. The open side sheds are for feeding and storage (photograph 7).

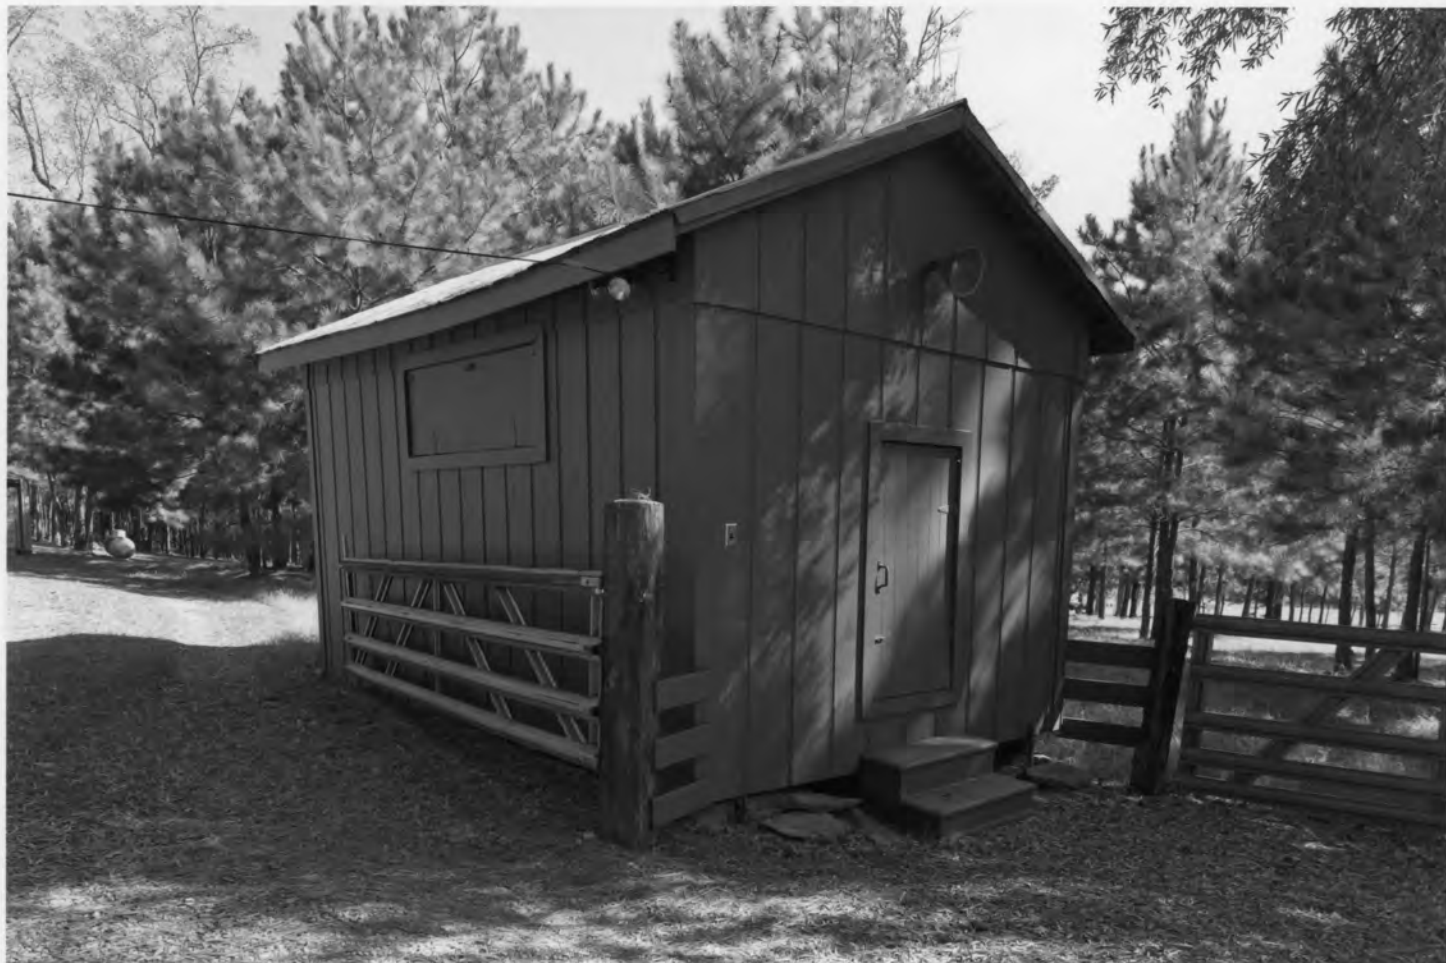
**Fannin-Cooper Farm  
Paulding County, Georgia  
Photograph 8 of 27**

The corncrib, a contributing structure, was built in 1882 (photograph 8). It is a one-story rectangular structure with a stone foundation and a corrugated metal roof. There is a small, horizontal, hinged-opening located on the upper part of the north elevation. This opening was used for filling the crib from a wagon. The entry doors are located on the east and west ends of the corncrib. The original exterior pine board has been covered with plywood or with vertical metal siding, as on the south elevation. The building is currently used for storage.

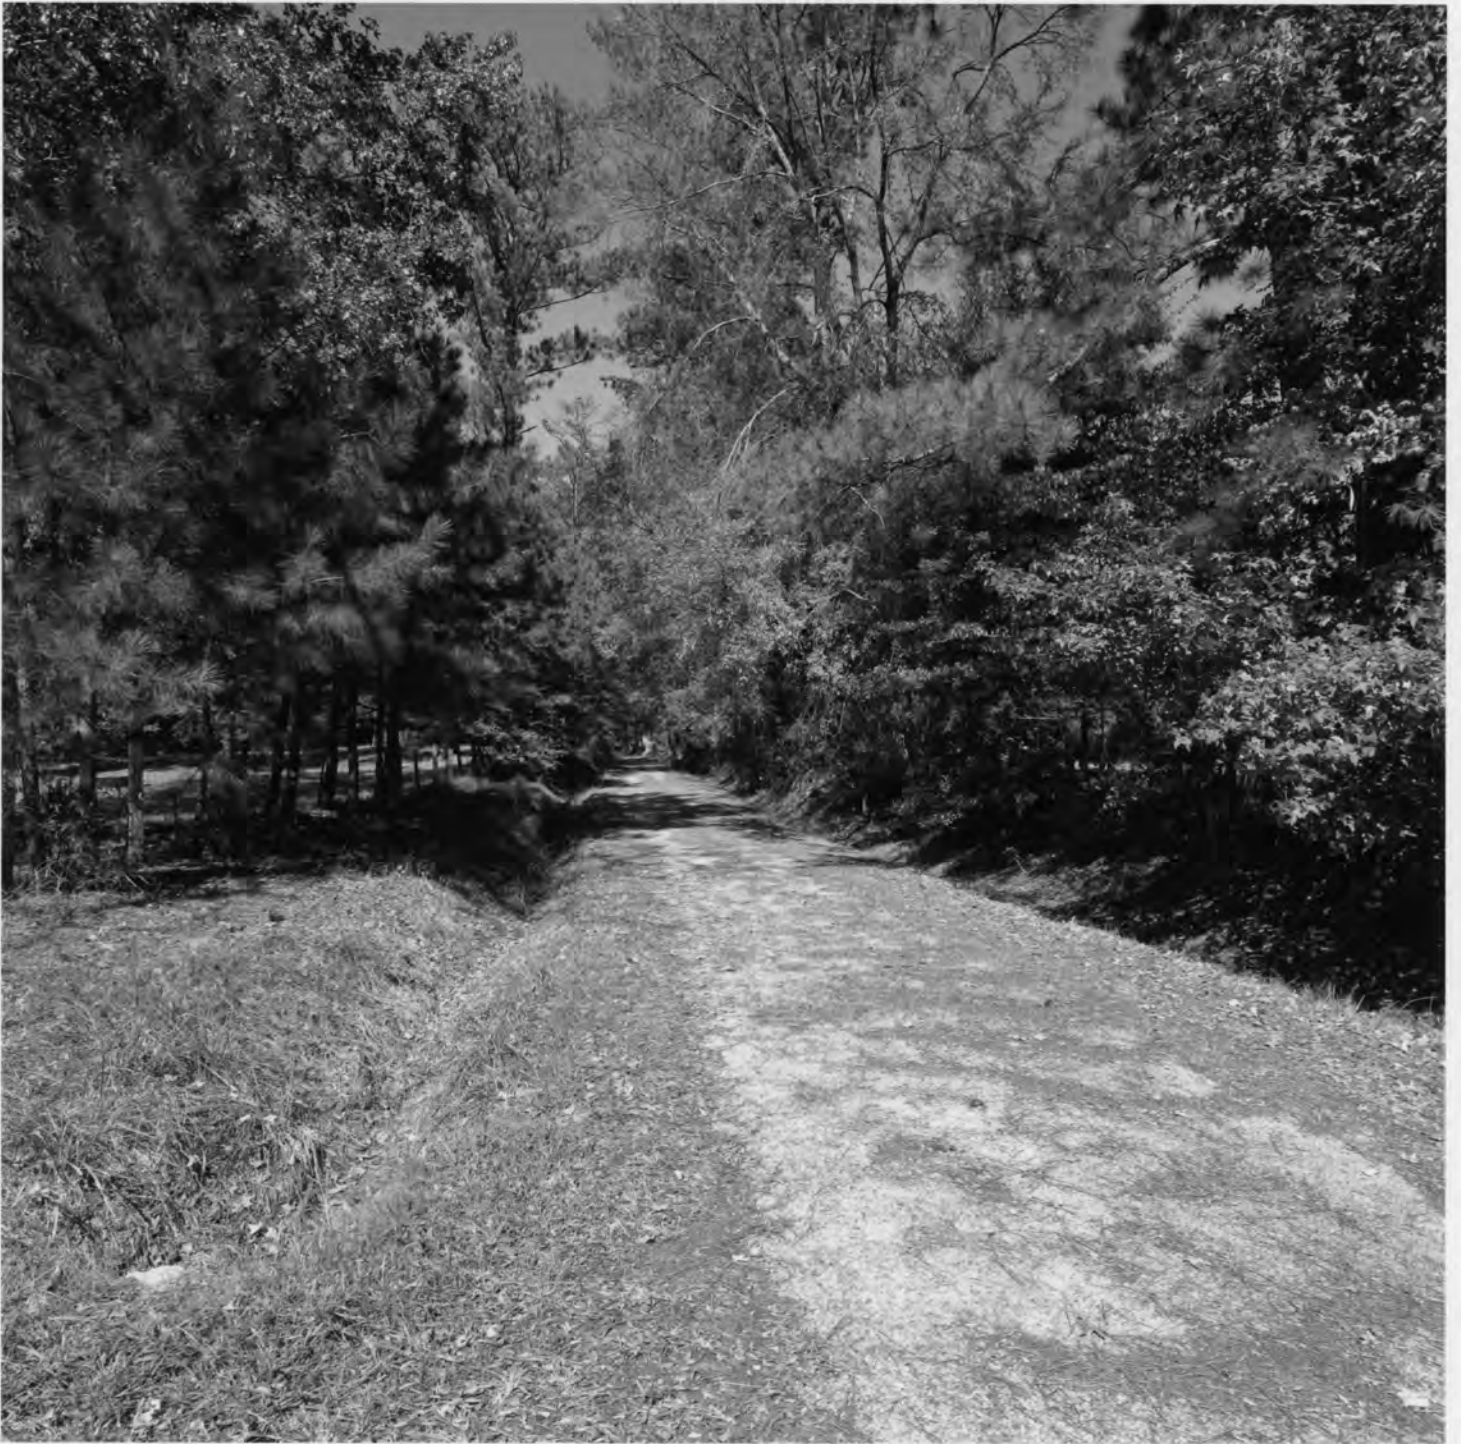
**Fannin-Cooper Farm  
Paulding County, Georgia  
Photograph 9 of 27**

property (photograph 11). Ditches installed for drainage in 1962 along either side of Smith Road remain intact (photograph 9). During the winter, the Atlanta skyline is visible from atop the two hills that exist on the farm.

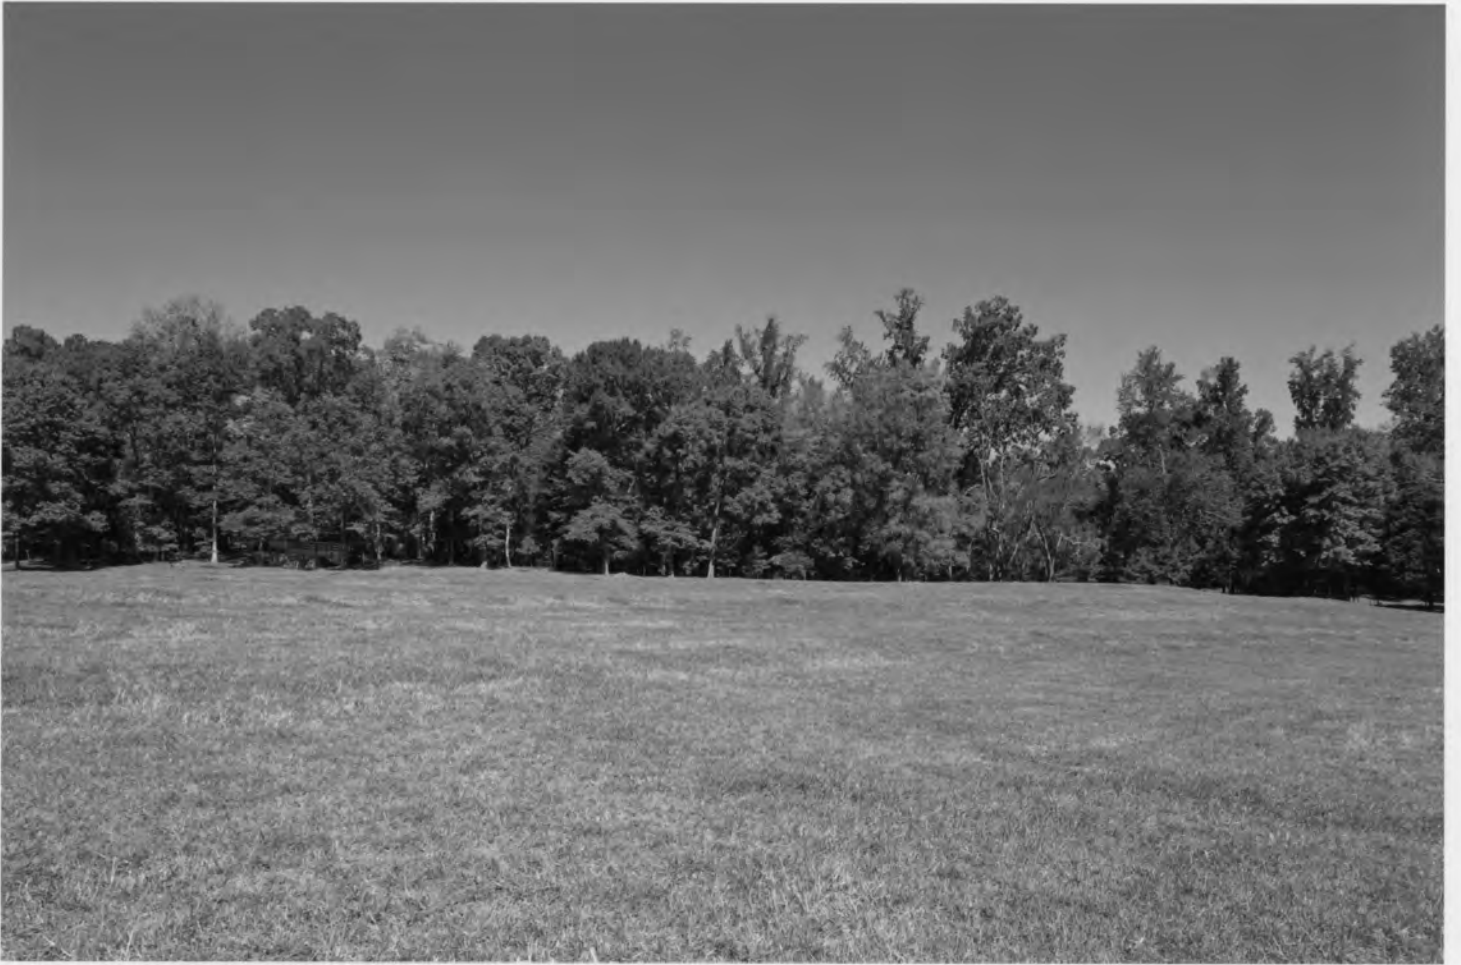
**Fannin-Cooper Farm**  
**Paulding County, Georgia**  
**Photograph 11 of 27**

The property contains two trout streams (photograph 14), bottomland (photograph 13), and terraced upland pasture for cattle grazing (photographs 11 and 12). The landscape is counted as a single contributing site. Approximately half of the land is forest and all of the property is fenced for cattle operation. Evidence of historic terraces are visible throughout the

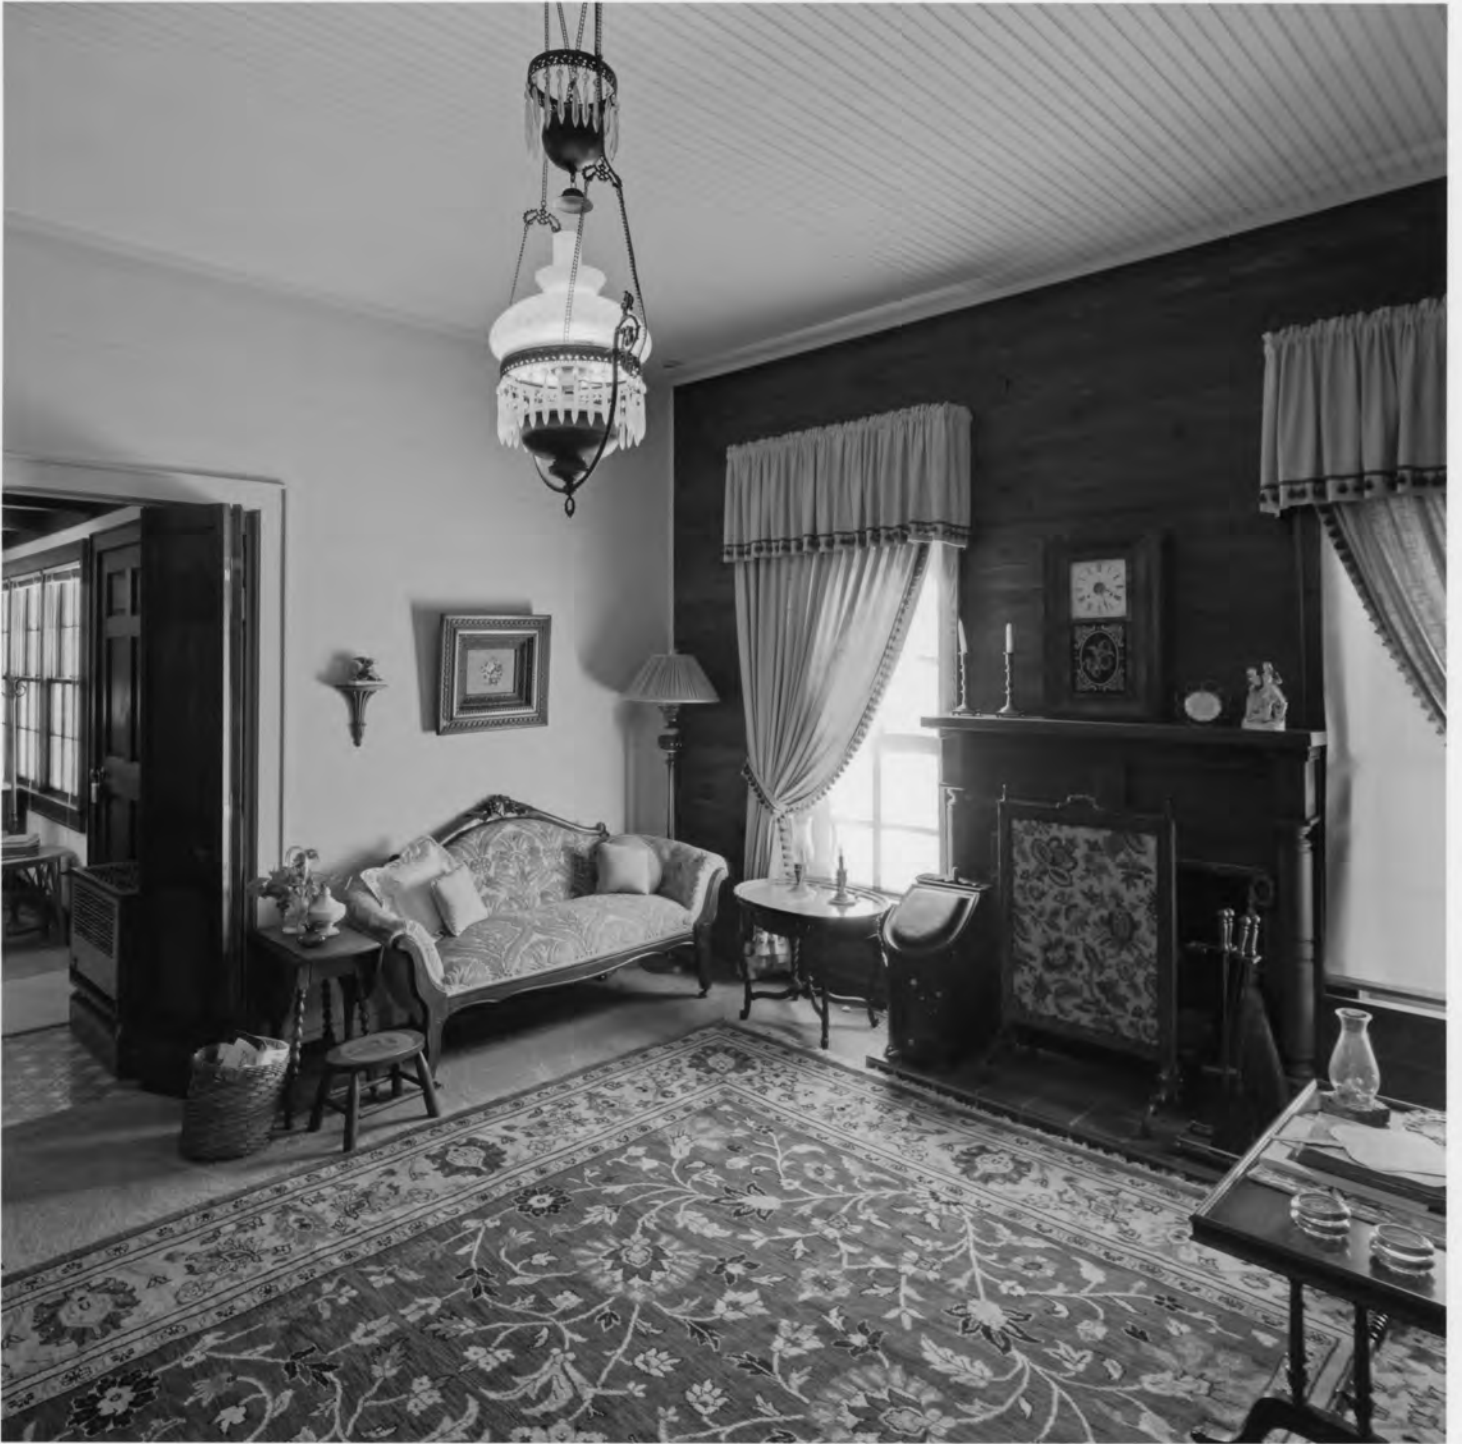
**Fannin-Cooper Farm  
Paulding County, Georgia  
Photograph 16 of 27**

Interior doors are original four-panel wood doors with metal hardware and white porcelain knobs. Both the front bedroom and central hall have original beadboard walls and ceilings. The living room has flush board walls and beadboard ceiling. The rear bedroom has three flush-board walls, the fireplace wall is gypsum board, and the ceiling is gypsum board. The kitchen walls and ceiling are gypsum board (photograph 18). The original pine floors are covered with carpet. The kitchen and utility areas have linoleum floors. Both bathrooms have tile floors. Original pine mantels are located in the two front rooms of the house (photographs 16 and 17).
