National Register of Historic Places Registration Form

Historic name: Budd Dairy Company
Other names/site number: Hamilton Milk Company, Borden Dairy Company/FRA00814-13
Name of related multiple property listing:
N/A
(Enter "N/A" if property is not part of a multiple property listing)

Street & number: 1086 North Fourth Street
City or town: Columbus State: OH County: Franklin
Not For Publication: NA Vicinity: NA

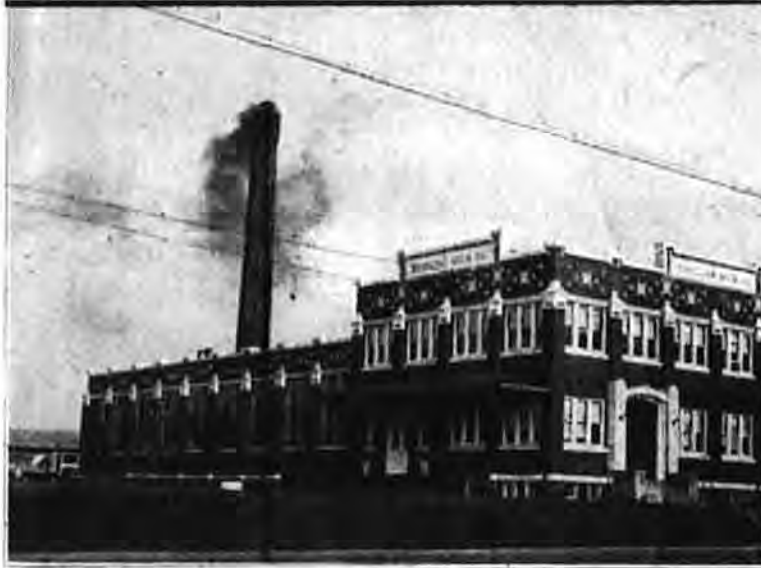
Figure # 5

Building at the time it was owned by Hamilton Milk Company c. 1920s. It is unchanged from its appearance during the Budd Dairy Company tenure with the exception of a change of signage in the parapet.

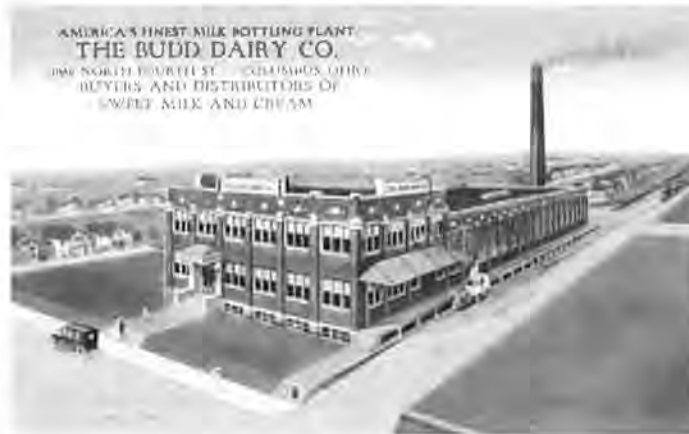
Figure # 8

Postcard of the Budd Dairy Company with the following in the lower left corner
“Our assembly hall is a popular meeting place for clubs, luncheons and private parties.”
(source: Reeb, Diebel, Ruffing Postcard Collection, Columbus Metropolitan Library)

follows: "One notable feature of the building is an assembly hall, kitchen and laboratories, arranged especially for the use of the company's customers and friends, frequently used for parties, luncheons, club banquets, either during the day or evening. This known as Budd's Assembly Hall."²¹ Two postcards of the period, also make note of the assembly hall. One stated, "The Budd Dairy Co. America's Finest Milk Bottling Plant. 1086 North Fourth Street, Columbus, Ohio. Buyers and Distributors of Sweet Milk and Ice Cream. Our assembly hall is a popular meeting place for clubs, luncheons and private parties." (figure # 8). Another postcard described the assembly hall as the location of some of the "first Radio Dance events in Columbus with KDKA broadcasts from Pittsburgh." To be sure, this was not a typical function of dairy production facilities.

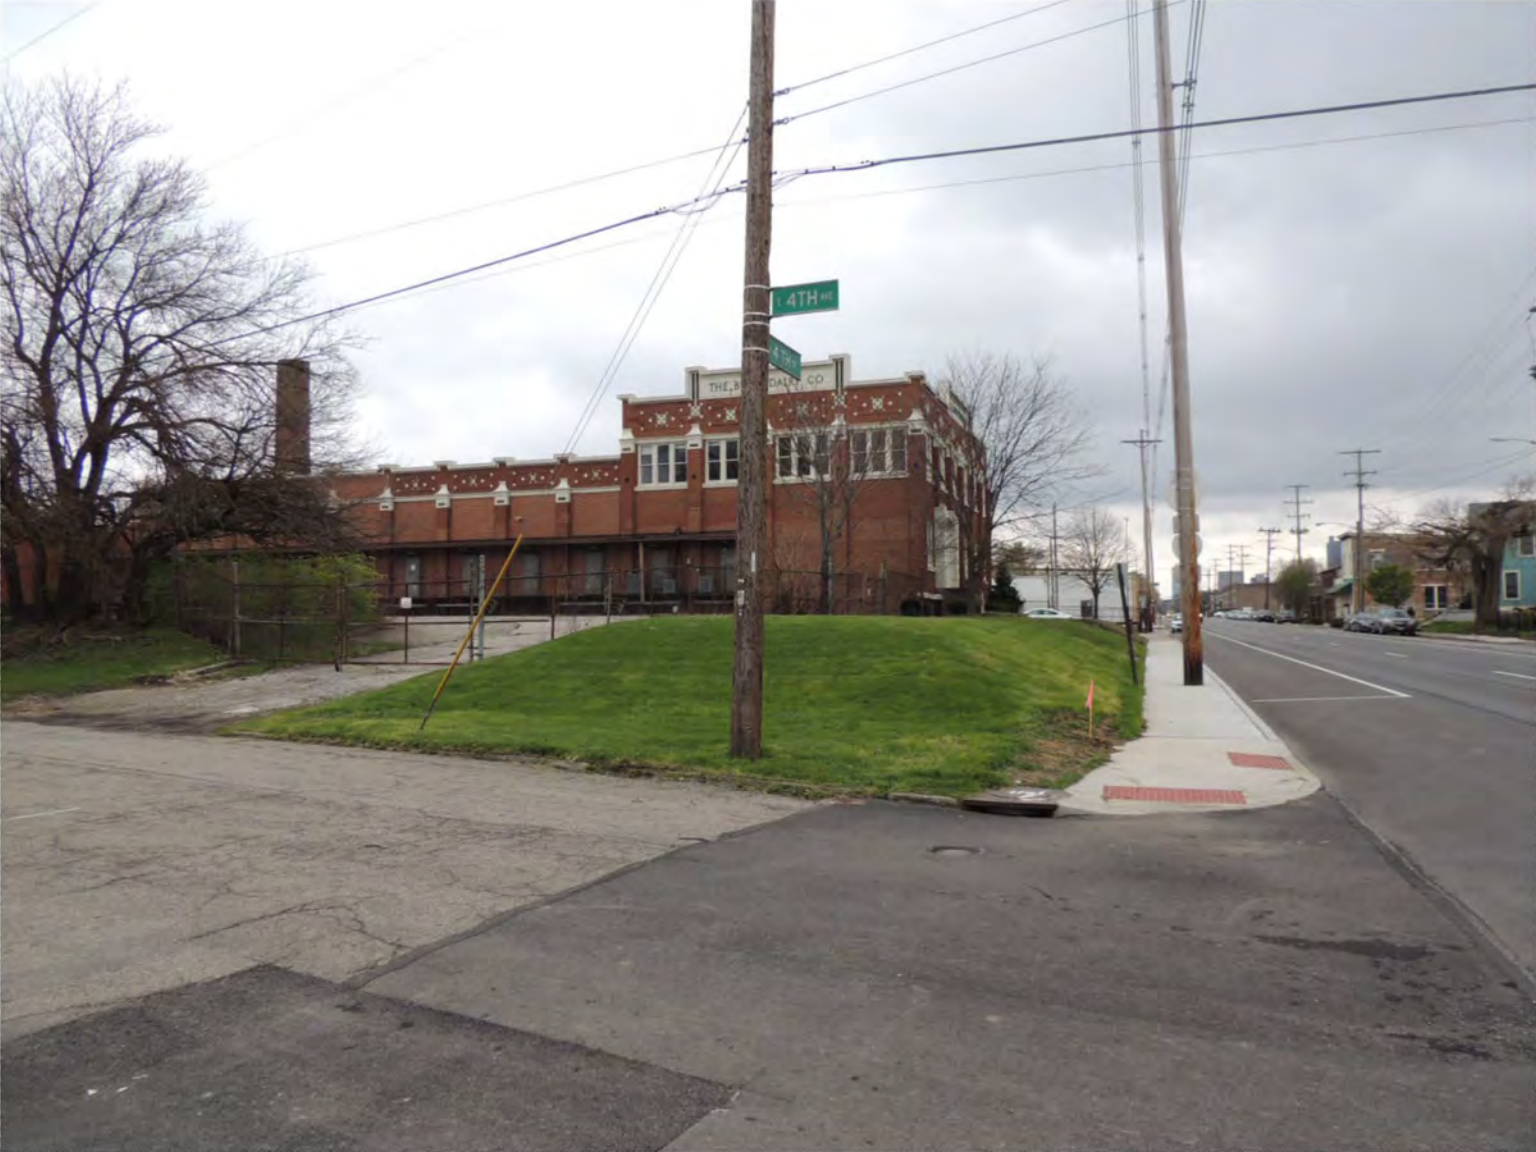
Photo #1: North façade of Dairy building, camera facing south

The Budd Dairy Company site is bounded by North Fourth Street on the west, East Fourth Avenue on the north, Detroit Avenue on the south, and North Sixth Street on the east (Photo 1). Because all these streets except Fourth Avenue are oriented north-south or east-west and Fourth Avenue is canted some 12-1/4 degrees to the west of north, the site is trapezoidal in form. Its southeast quadrant is set off from the dairy property by alleys and is occupied by residential properties unrelated to the Budd operation. The original part of the dairy was built in a rectangular form with its west elevation parallel to North Fourth Street; as a result, the dairy, too, is at an angle in relation to the north-south and east west streets, on a raised site some five or six feet above the level of the street (Photo 2). A large paved parking lot, reached from North Fourth by a sloped driveway, is south of the building (Photo 3), while a smaller lot, also reached by a

The original dairy building has two distinct portions, a two-story office/administrative area in front (the west end of the building), and a single-story production area at the rear (Photos 1 through 7). The front portion, measuring 71 by 47 feet, has tri-partite one-over-one windows on
